January 13, 2025

TREE ASSESSMENT, PROTECTION, AND MITIGATION PLAN

Job Location: 1 HOT SPRINGS RD., Santa Barbara, CA 93108

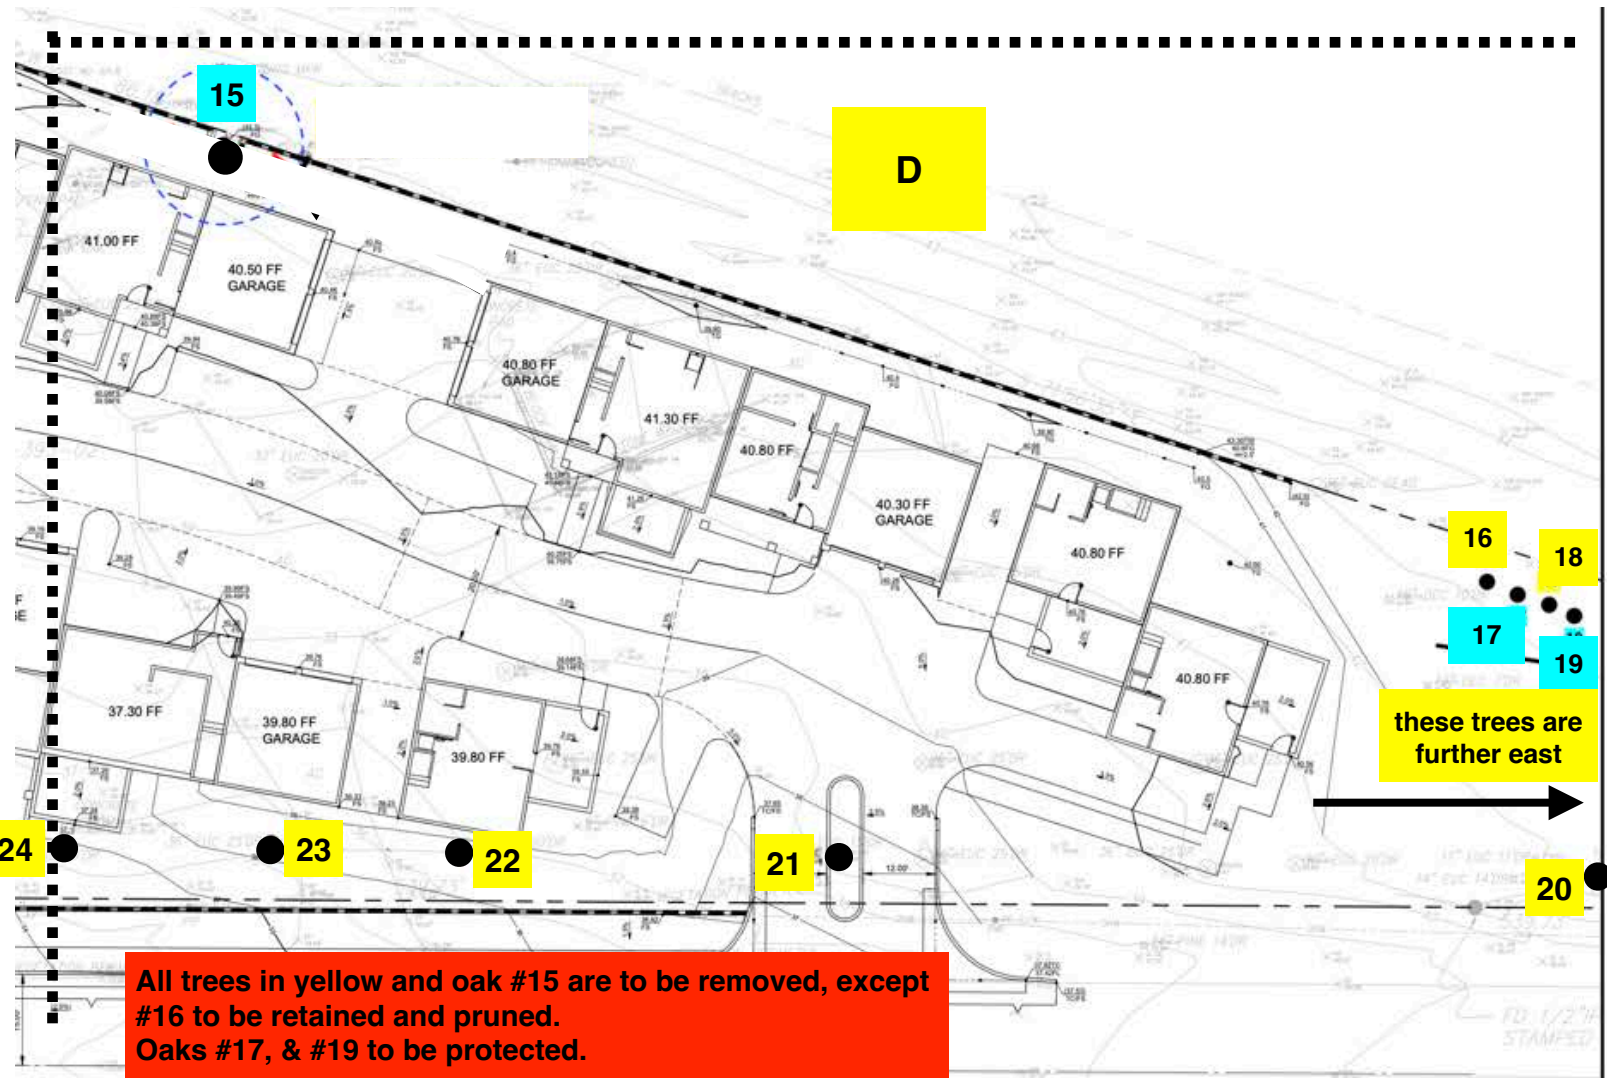
All trees in yellow and oak #15 are to be removed, except #16 to be retained and pruned. Oaks #17, & #19 to be protected.

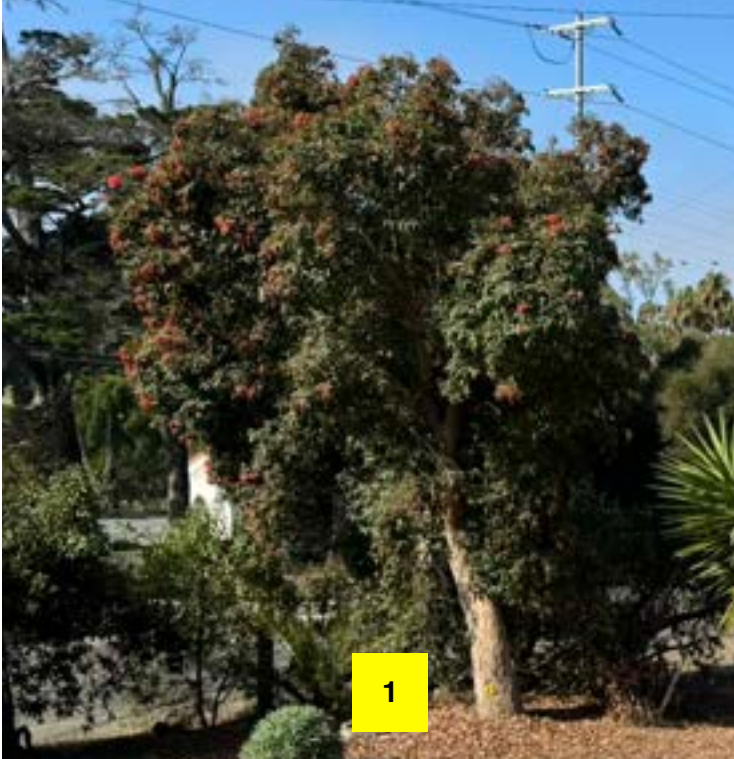
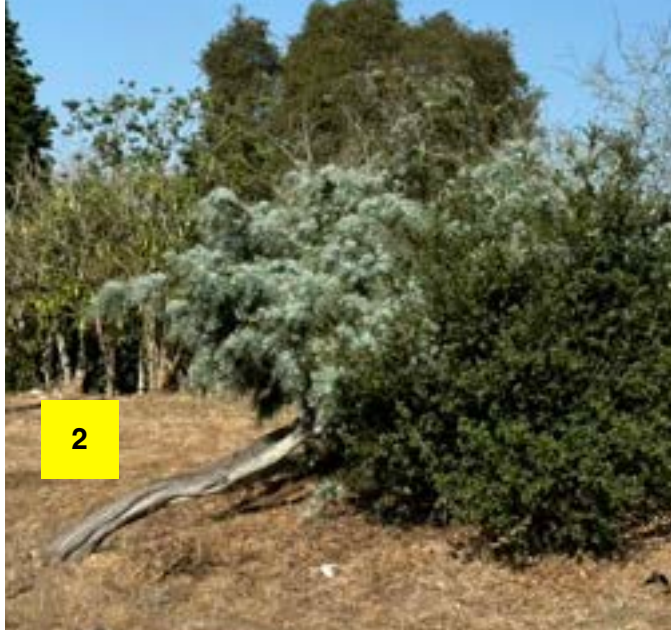
#1, a Flowering Eucalyptus (not a true euc) is in the proposed entryway along with #2, a fallen Bailey Acacia and #3 a young Silver Wattle Acacia. Cypress #3 is also in the middle of the project and is in decline.

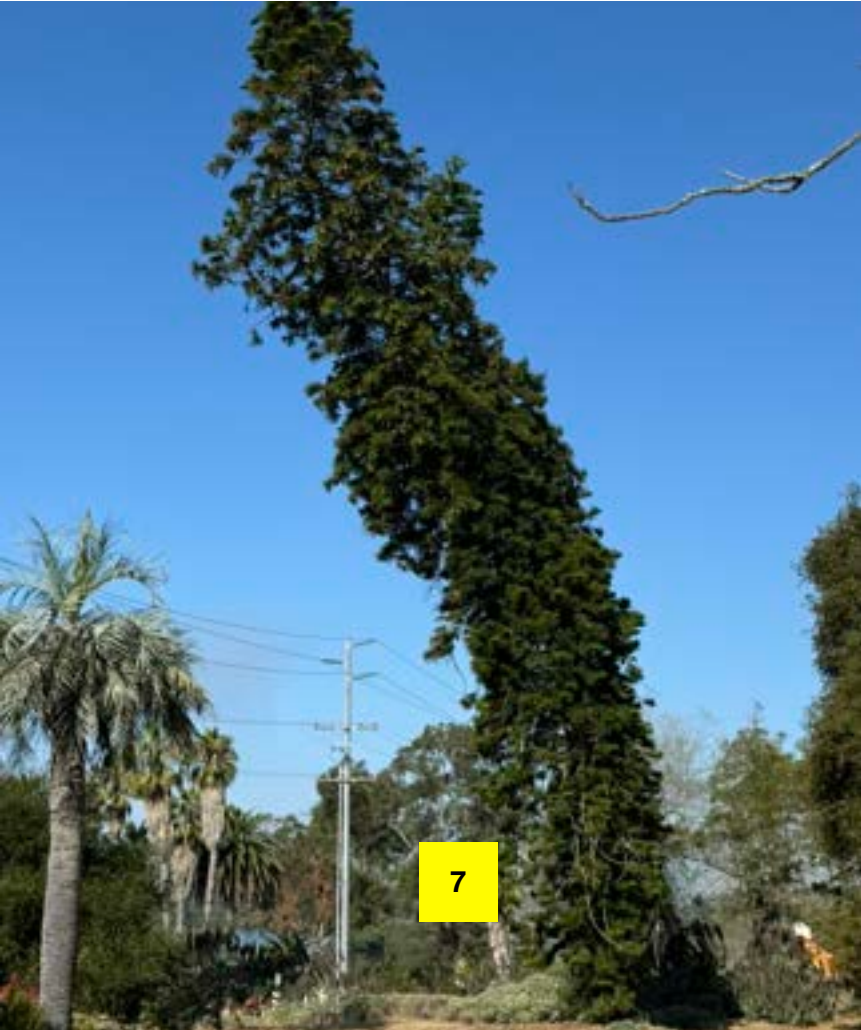
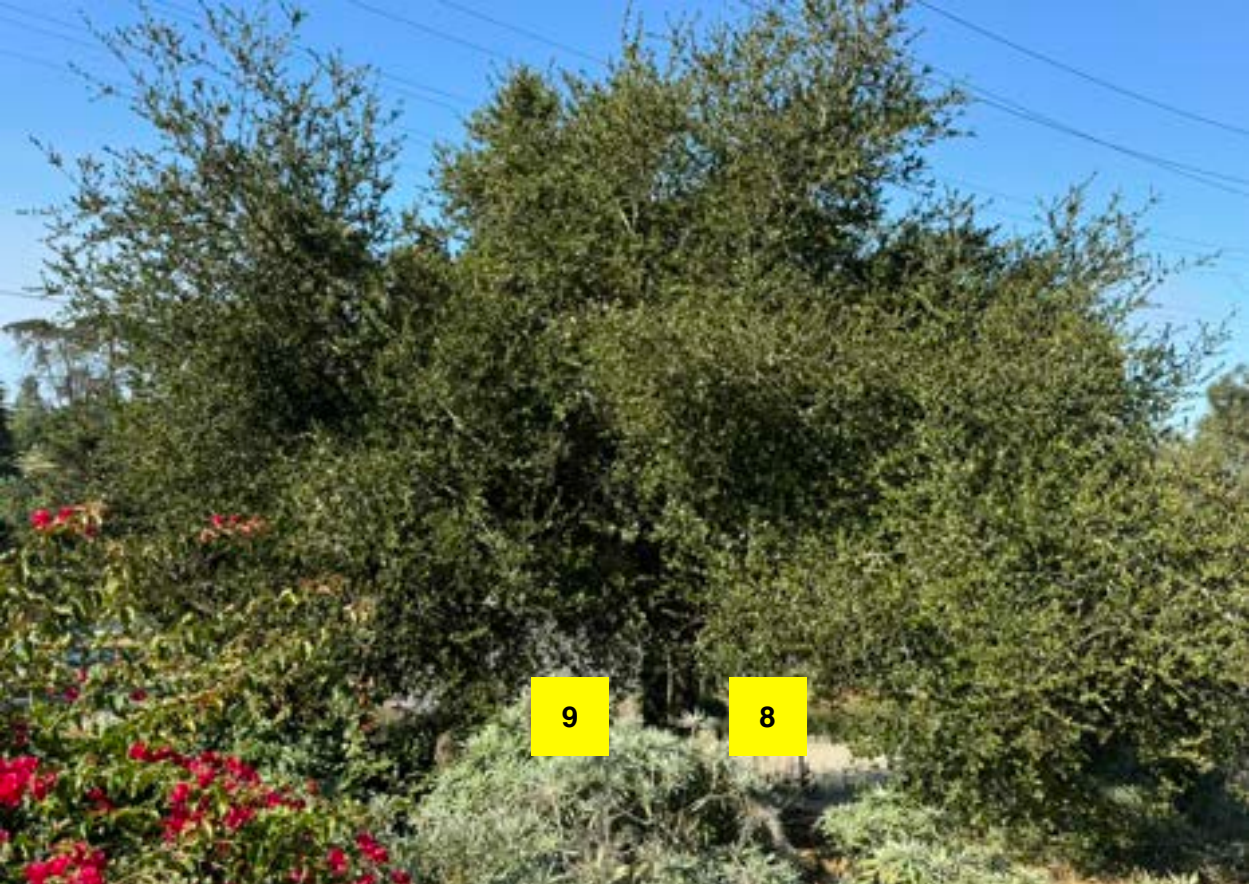
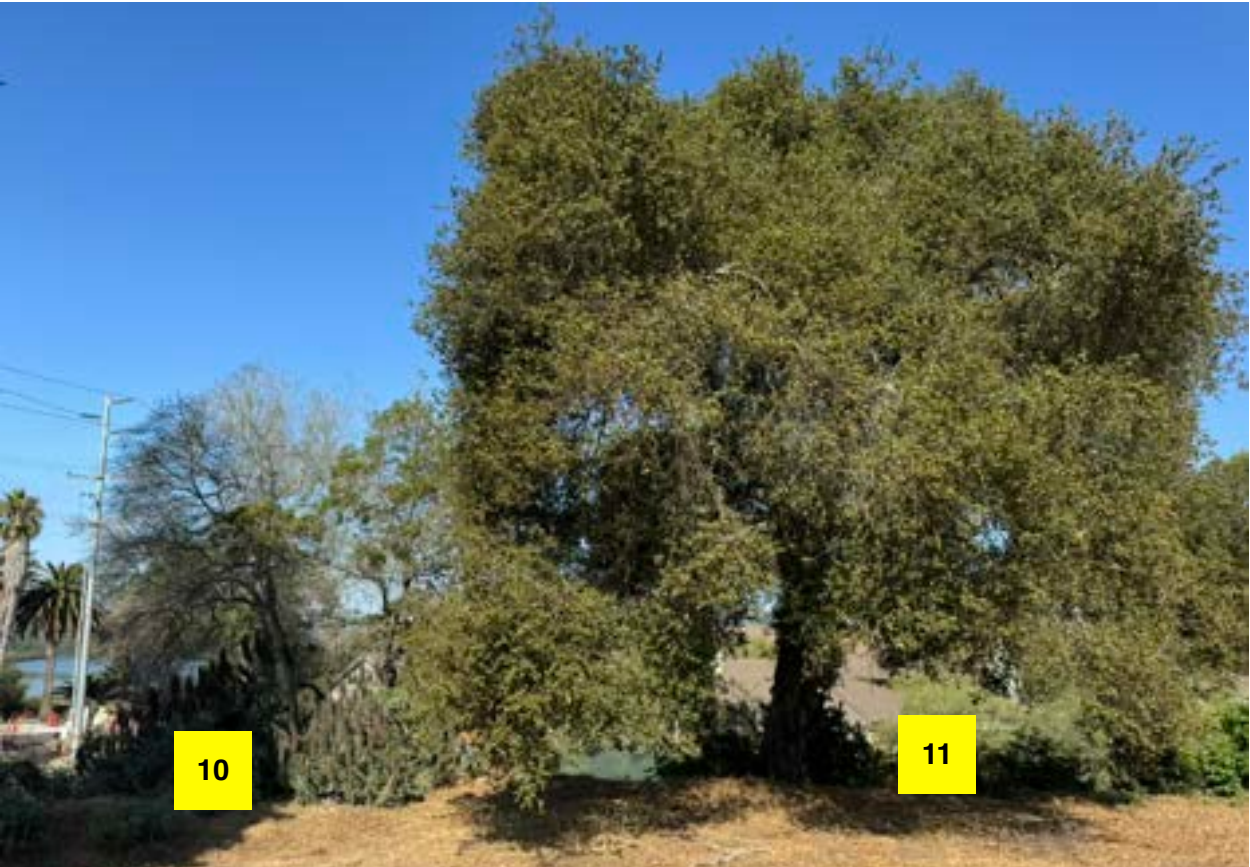
Oak #8 and 39 are side by side and west of the project area.
Pittosporum #10 is in decline and needs to be removed.
Oak #11 is also west of the project area.

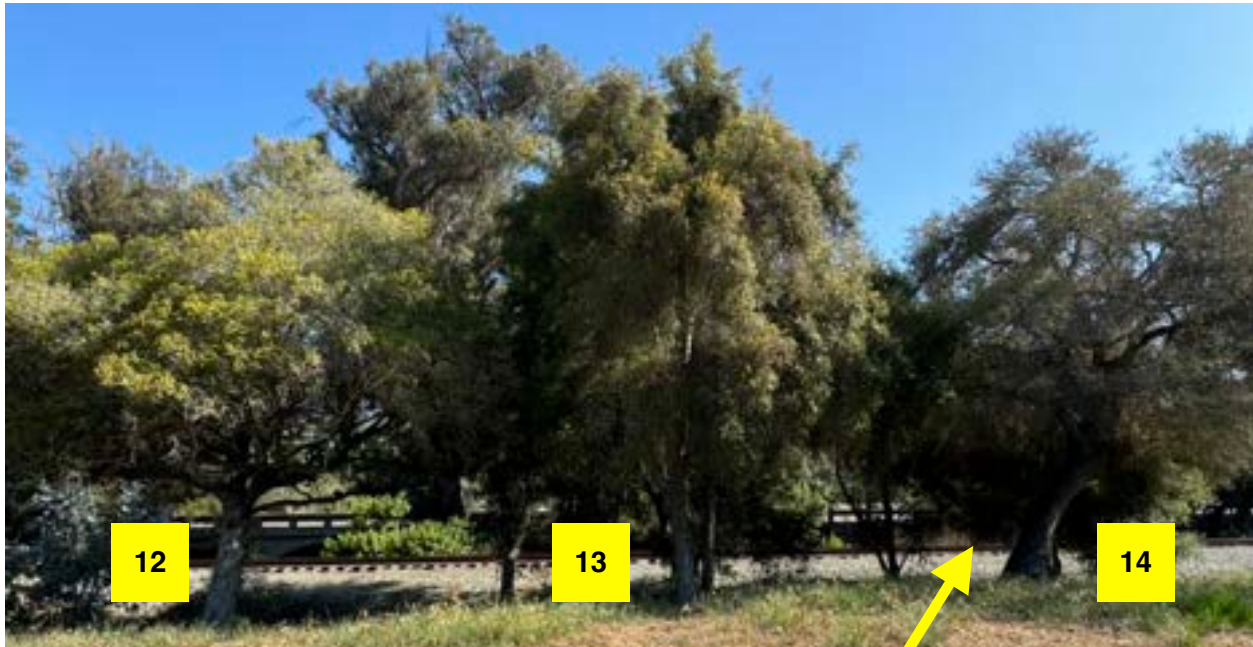
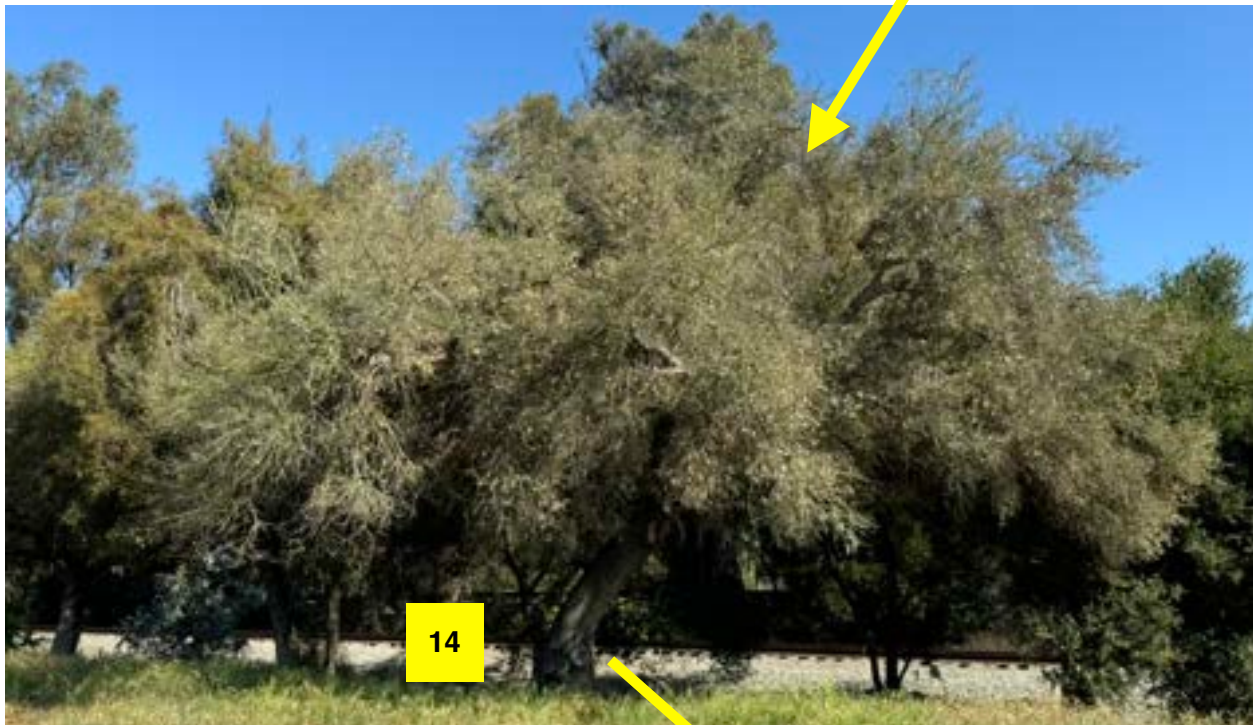
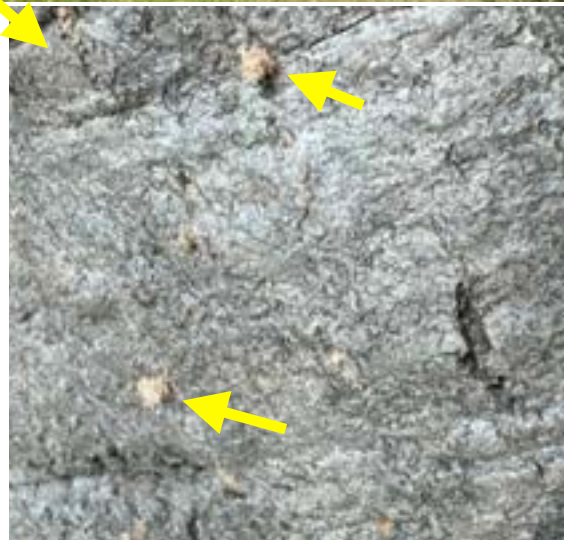
Oak #14 is dead from oak bark beetle infestation. Small inset shows holes in the trunk where beetles entered and bored into the xylem (water conduction tissue). This is easier to see in the field.

Trees #12 and #13 (Pittosporum and Eugenia) are non-natives and are to be removed due to their location along the proposed retaining wall.

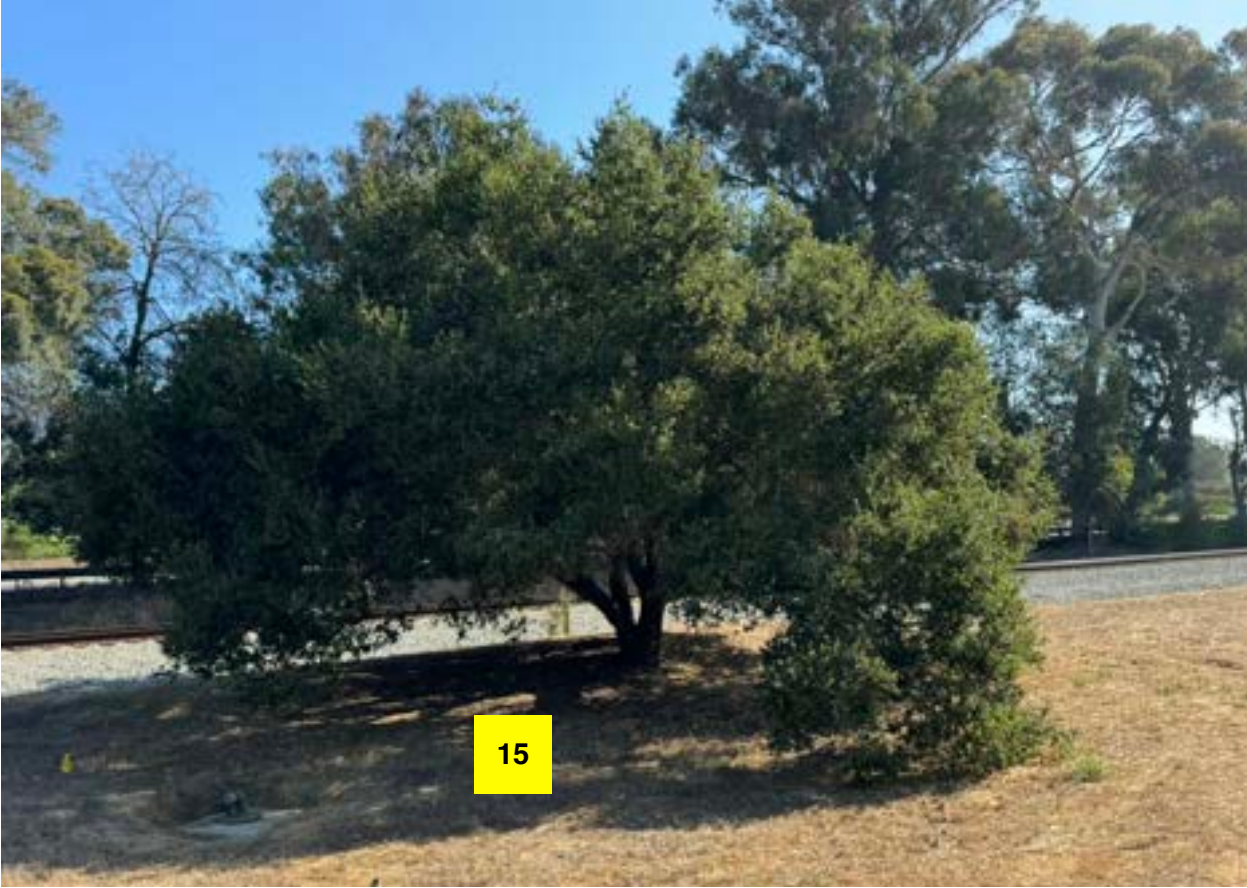
Oak #15 is to be removed.

7. Activities within construction areas where trees are to be protected must be monitored by the project arborist, primarily near oak #15.

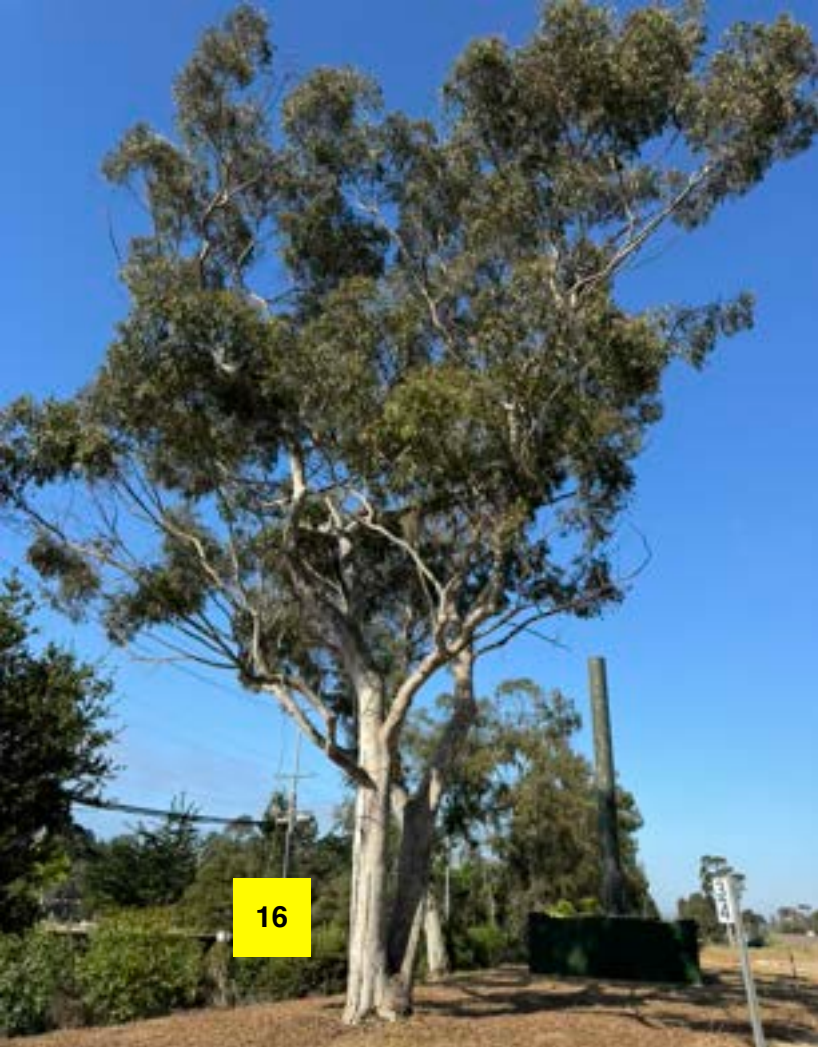
Sugar Gum Eucalyptus #16 is east of the project area and can be retained and poses a low risk if properly pruned.

6. Prior to construction, prune trees to be retained. Remove the deadwood and lift low and heavy limbs where they may conflict with workers and construction.

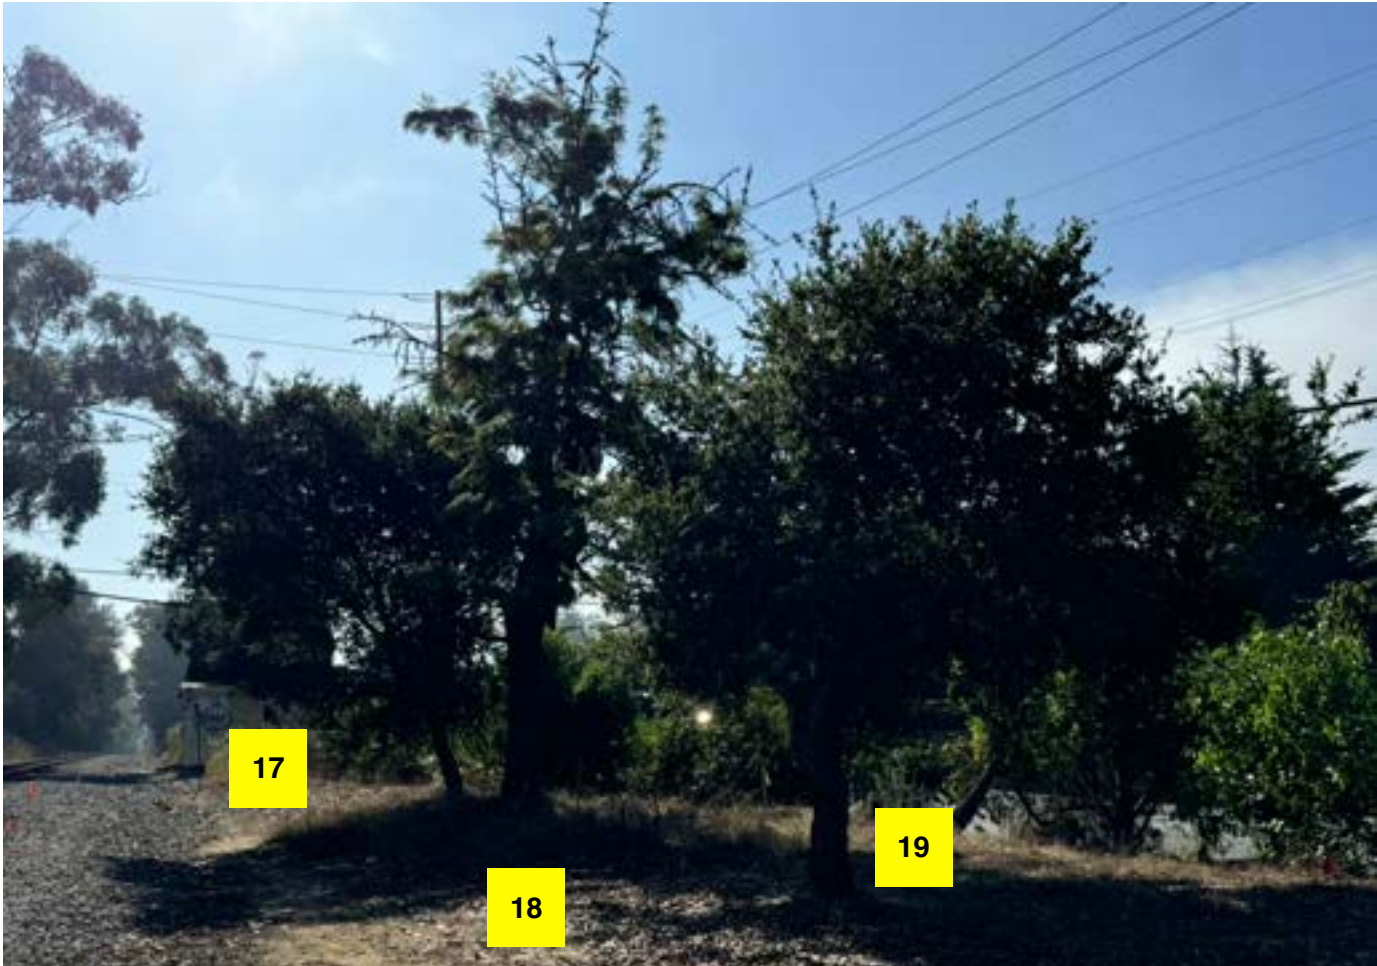
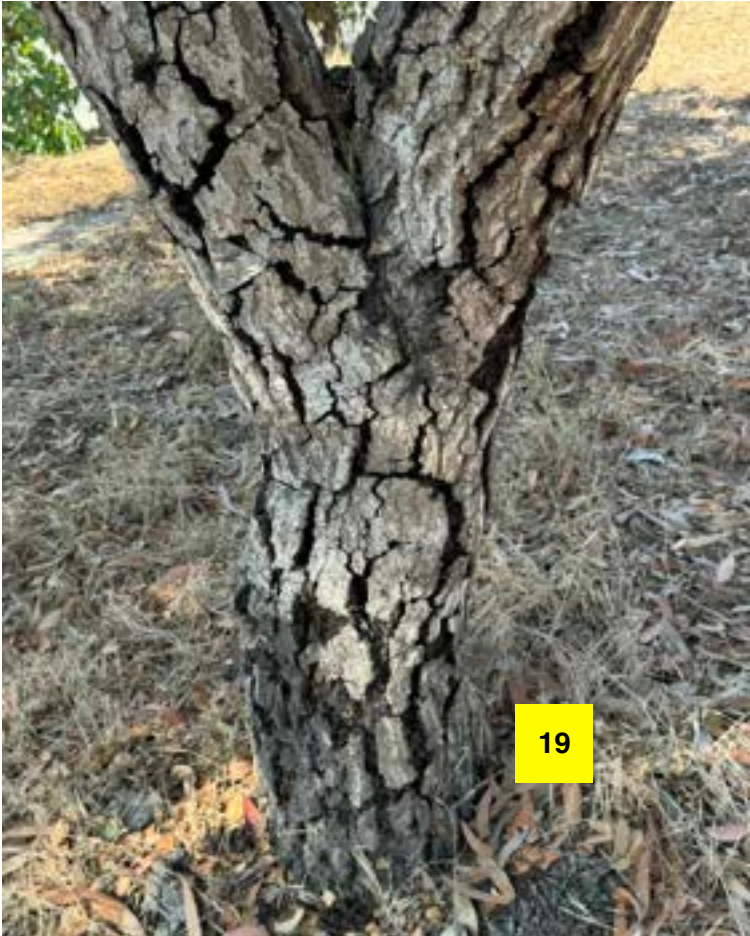
Trees #17 - #19 are also east of the project area. #18 is a Silk Oak (non-native) and in poor condition. Oak #19 is infested with sycamore borer but can be retained and is likely to survive.

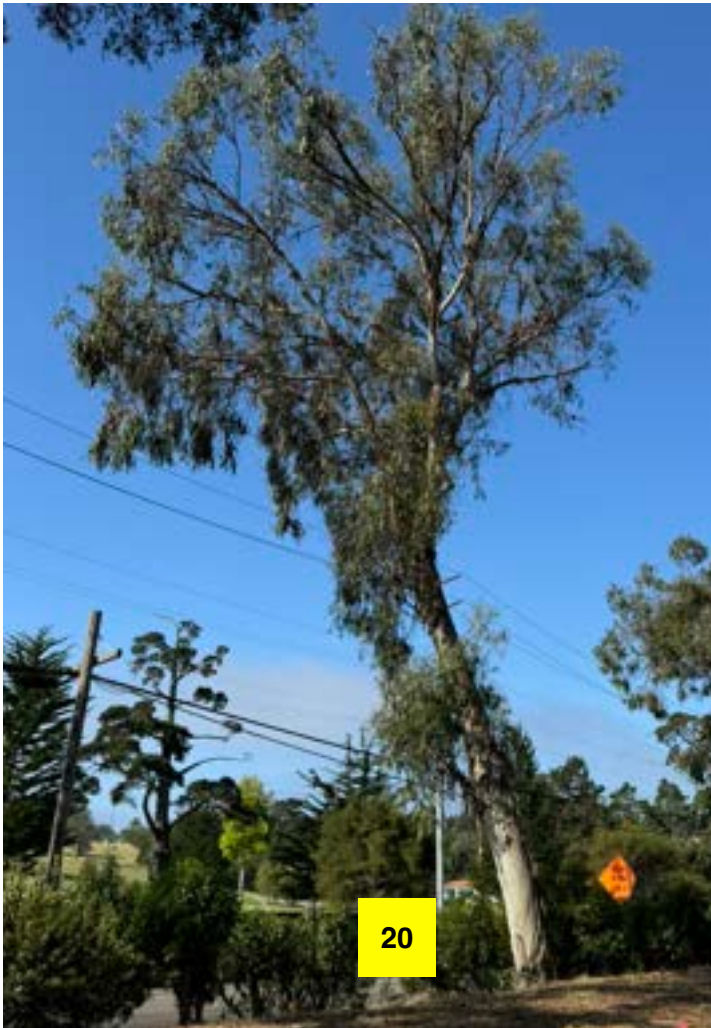
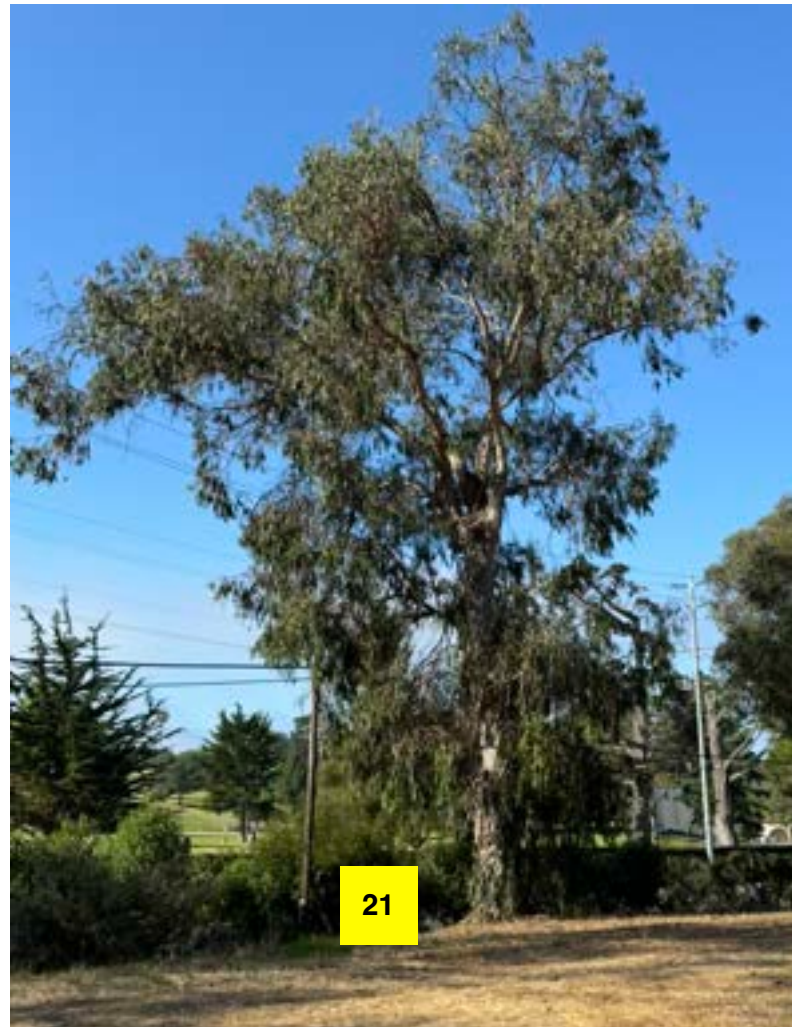
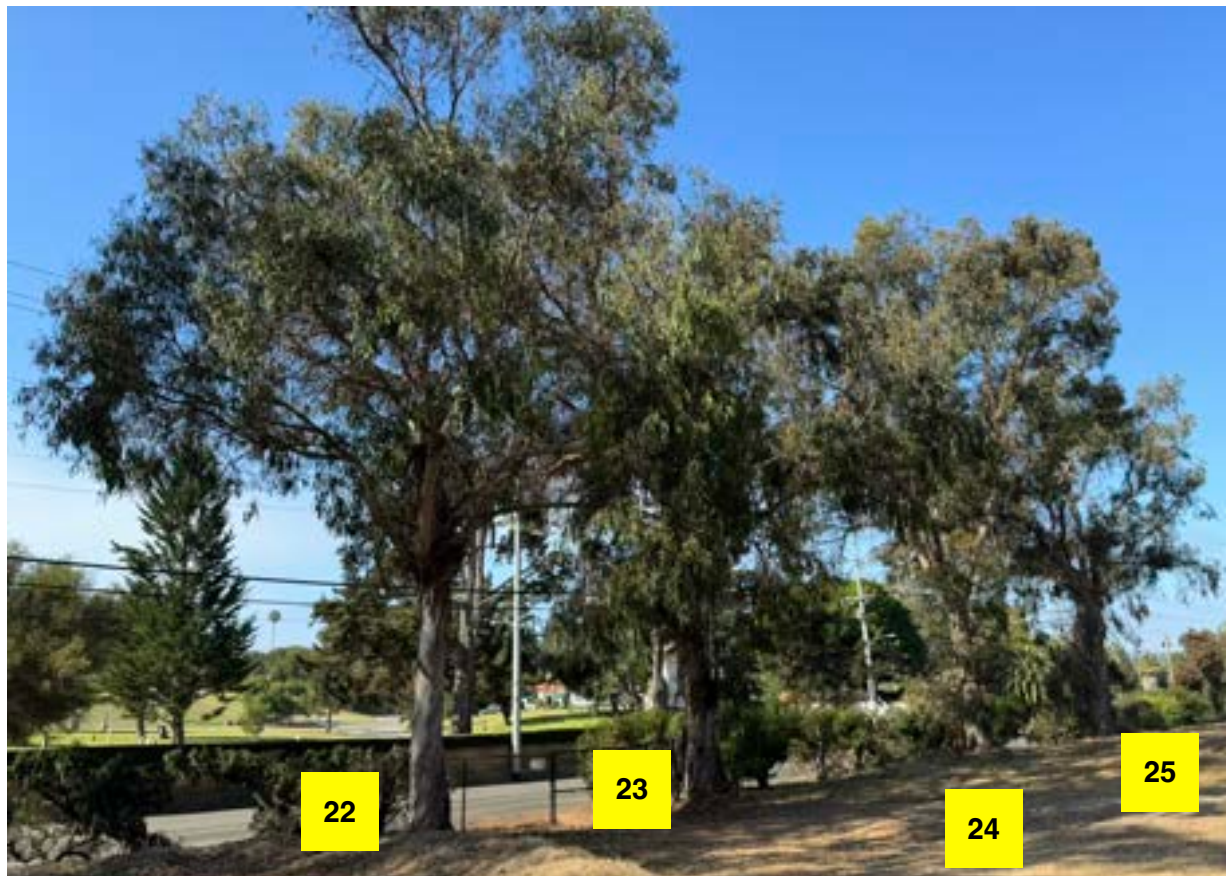
Six Blue Gum Eucalyptus along the project site that overhang Channel Drive and the proposed new residences. These are proposed to be removed.
