GILDA PUENTE-PETERS
ARCHITECTS

CENTRAL LIBRARY
ACCESSIBILITY SURVEY

July, 2007

CITY OF SANTA
BARBARA

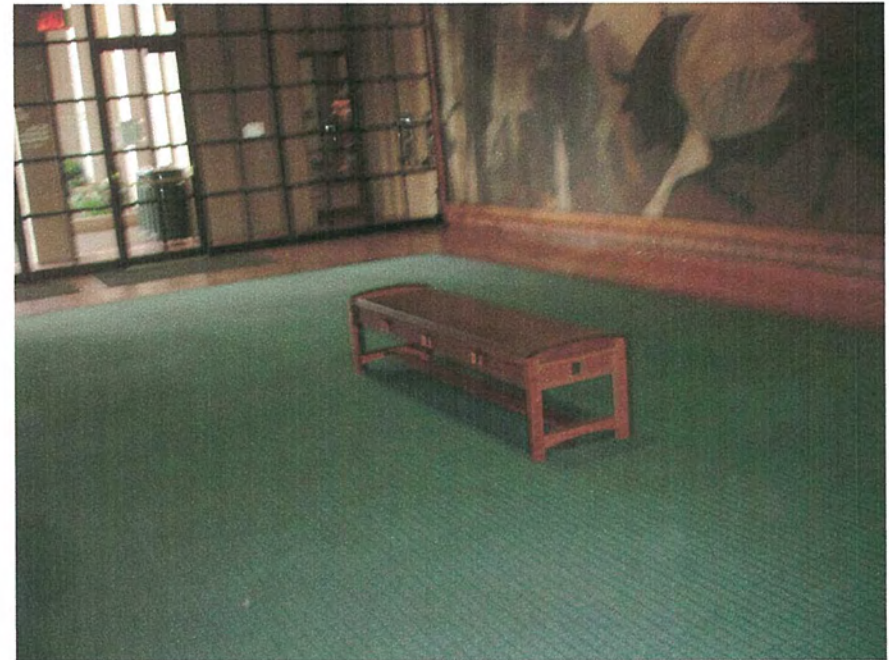
Building - Photo # 2

Benches provided do not have back support and arm.

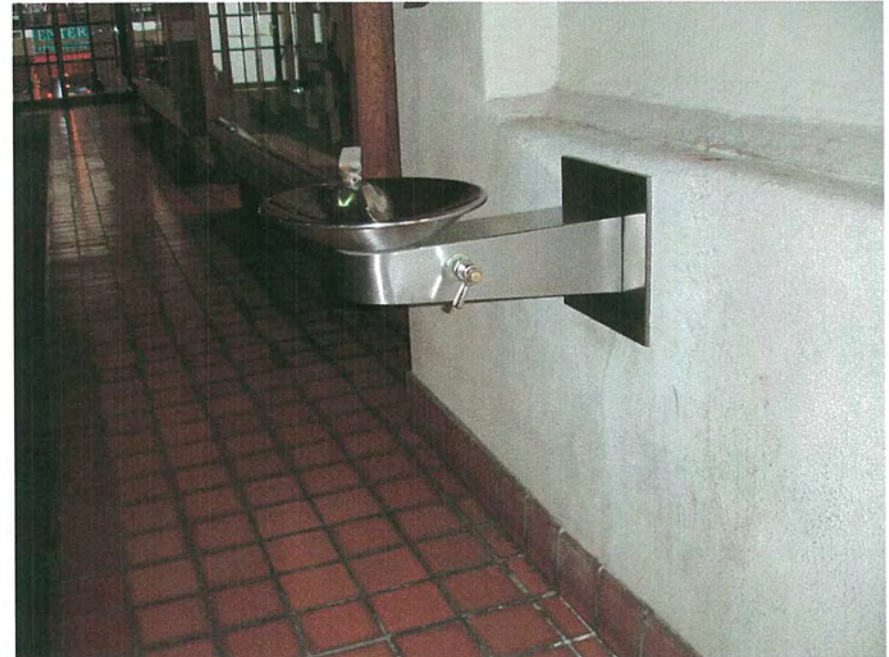
Building - Photo # 4

Drinking fountain does not have compliant knee clearance for wheelchair users, spout is mounted too high. Drinking fountain is not located in an alcove or protected by rails or wing walls, and is not high/low.

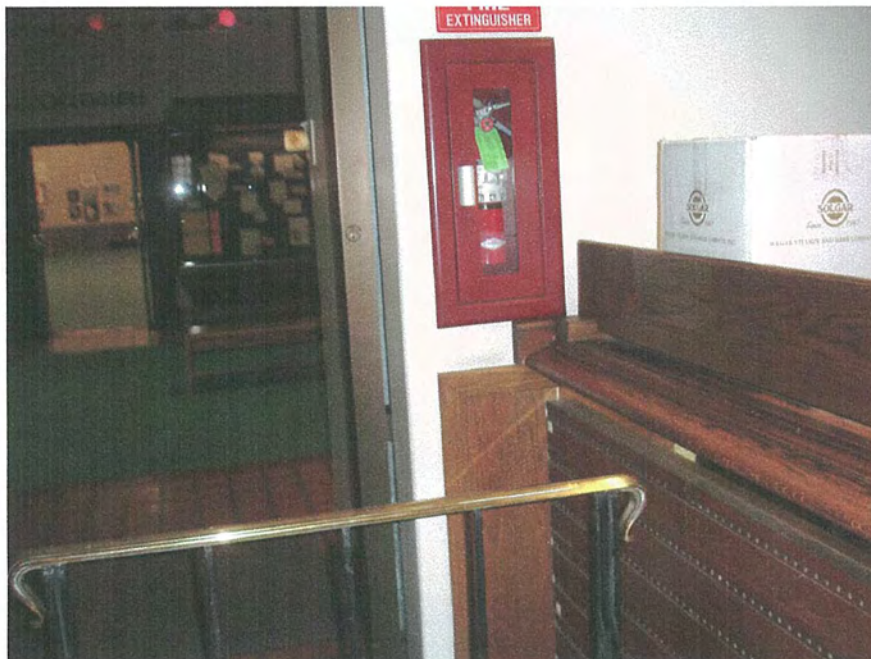
Building - Photo # 5

Fire extinguisher operable mechanism requires tight grasping to operate and is mounted too high. There is not the required wheelchair use 30"x48" in front of the fire extinguisher.

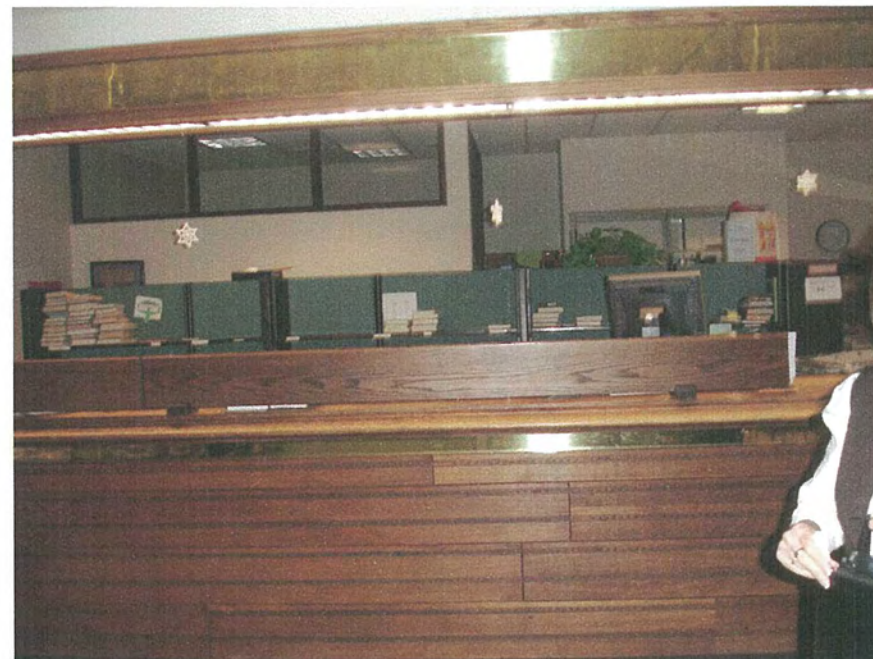
Building - Photo # 6

Check-in counter is too high 41" and does not have a low section of 34" maximum height by 36" minimum width, for wheelchair users.

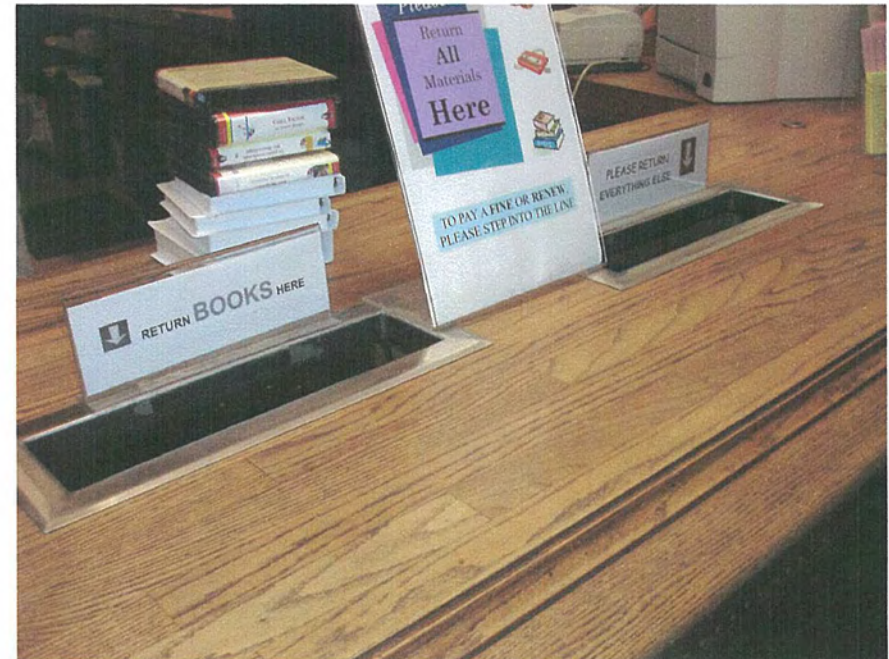
Building - Photo # 8

Book return mounted on check-out counter is too high 41" and does not have a low section of 34" maximum height by 36" wide minimum for wheelchair users

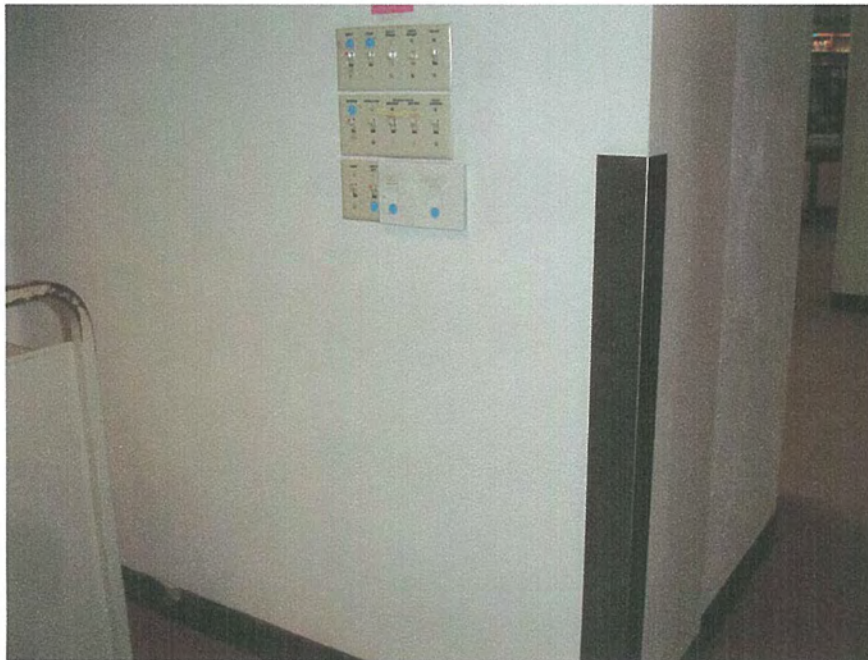
Building - Photo # 9

Light switches are mounted too high, ranging from 50" to 55" high.

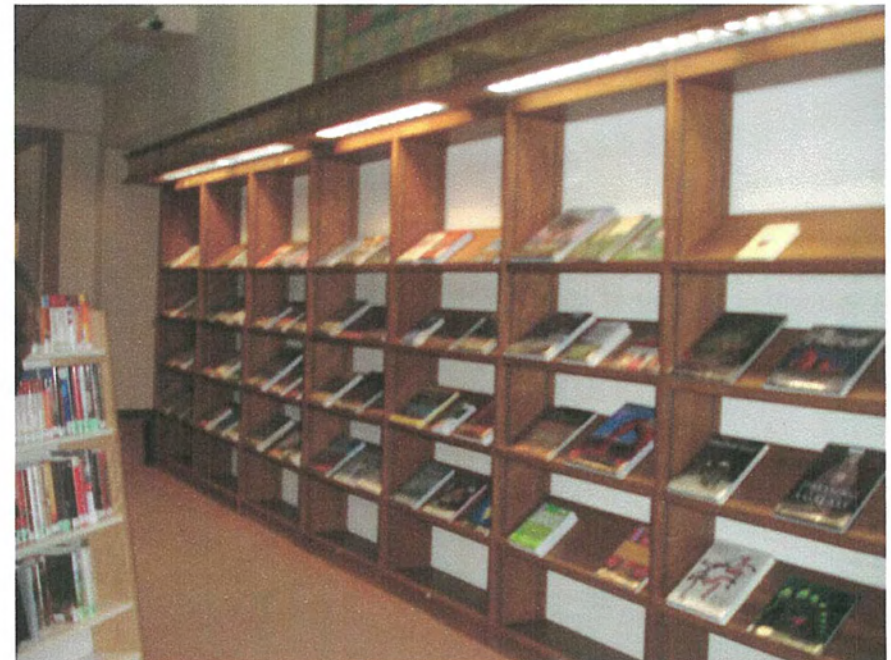
Building - Photo # 10

Book stacks high shelves range from 64" to 74" high. There is not a sign indicating that there are attendants available to assist retrieving books upon request.

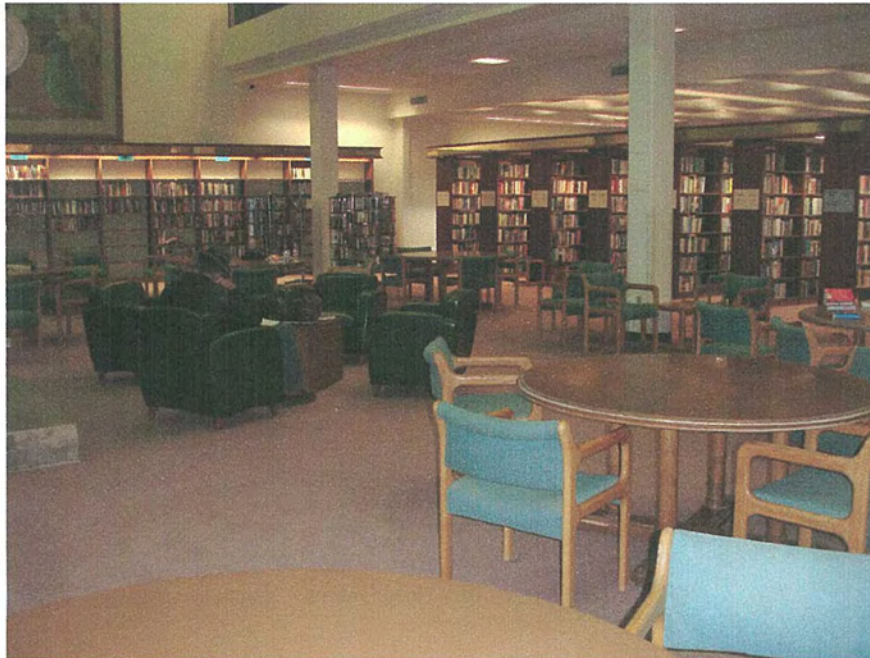
Building - Photo # 11

Reading tables does not have the required knee clearance due to the leg configuration.

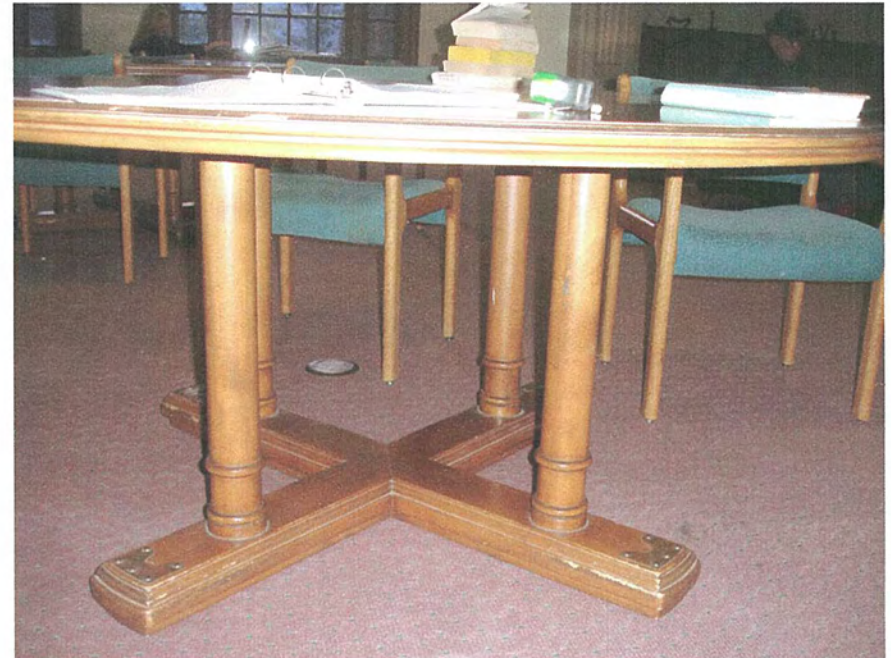
Building - Photo # 12

Reading tables does not have the required knee clearance due to the leg configuration. 17" deep by 30" wide clear required.

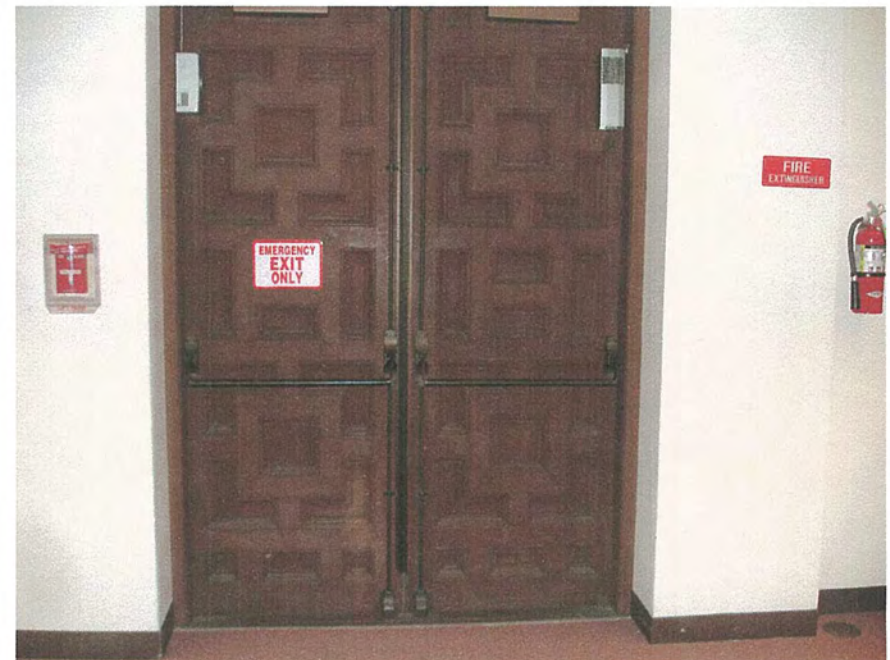
Building - Photo # 14

Fire alarm pull station requires tight grasping to operate and double action. There is no Tactile and Braille "Emergency EXIT" sign and directional sign to accessible exit. Fire extinguisher is mounted too high.

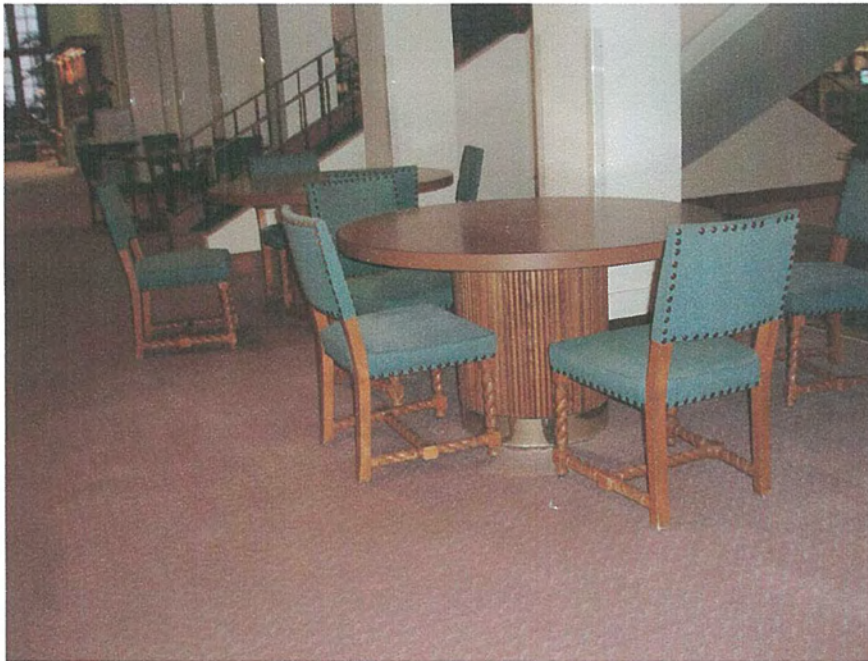
Building - Photo # 15

Reading tables does not have the required knee clearance due to the leg configuration. 17" deep by 30" wide clear required – 16" deep provided.

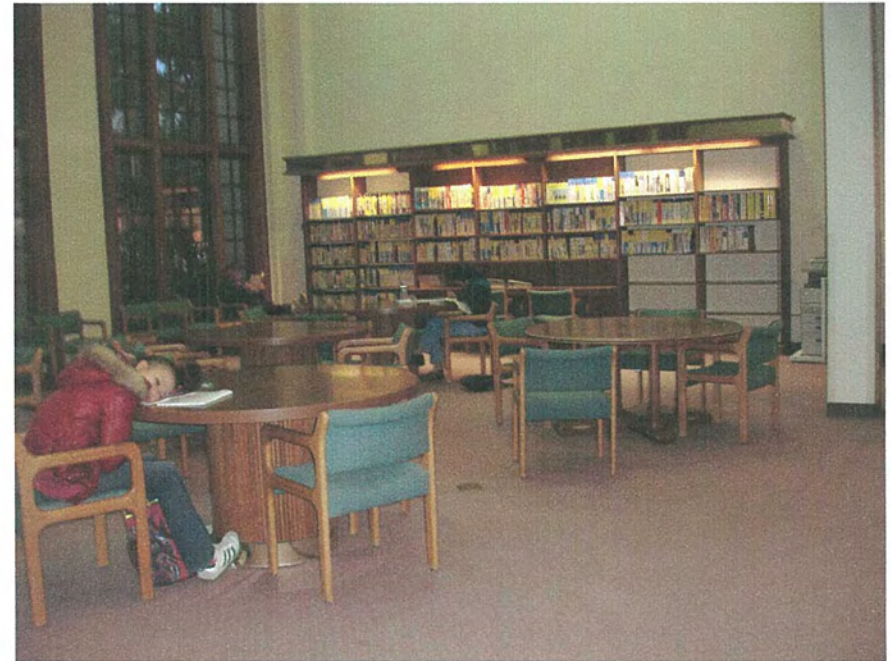
Building - Photo # 16

Reading tables does not have the required knee clearance due to the leg configuration. 17" deep by 30" wide clear required – 16" deep provided. There are no strobe lights.

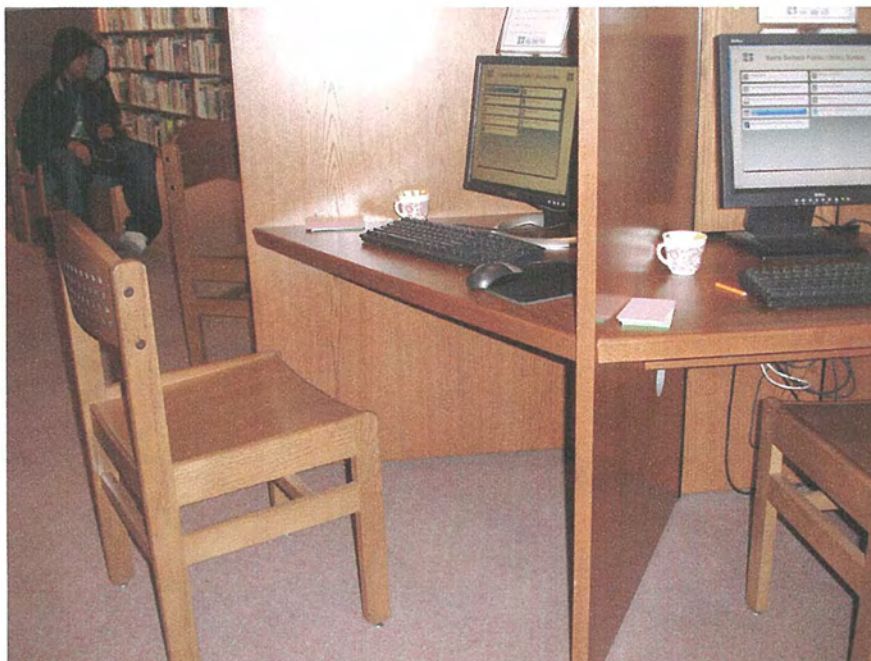
Building - Photo # 17

Computer tables do not have the required knee clearance due to the support configuration and 25" high instead of 27" minimum.

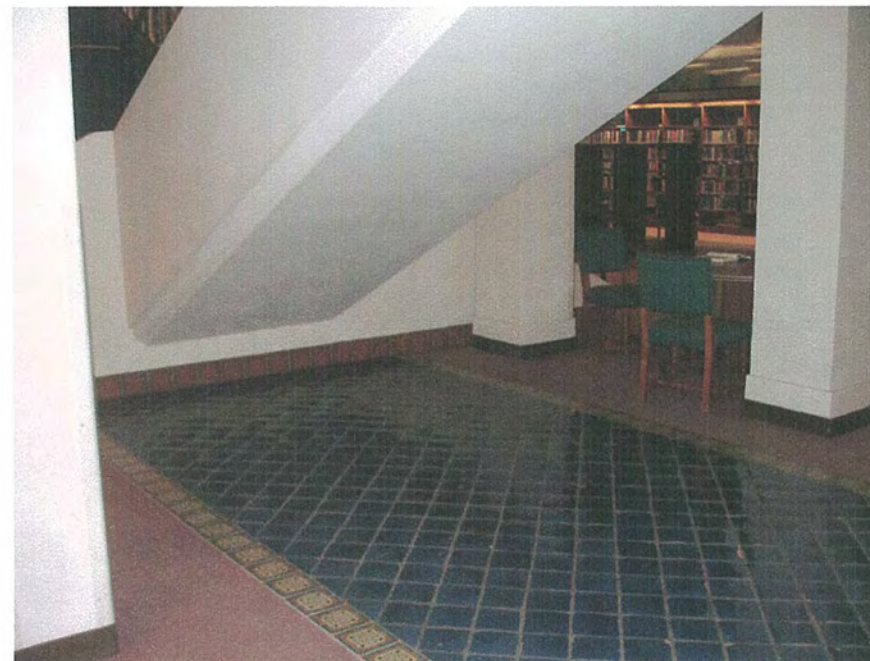
Building - Photo # 18

Underside of the stairs below 80" high does not have a cane detectable area for blind pedestrians at the floor level or within 27" high maximum.

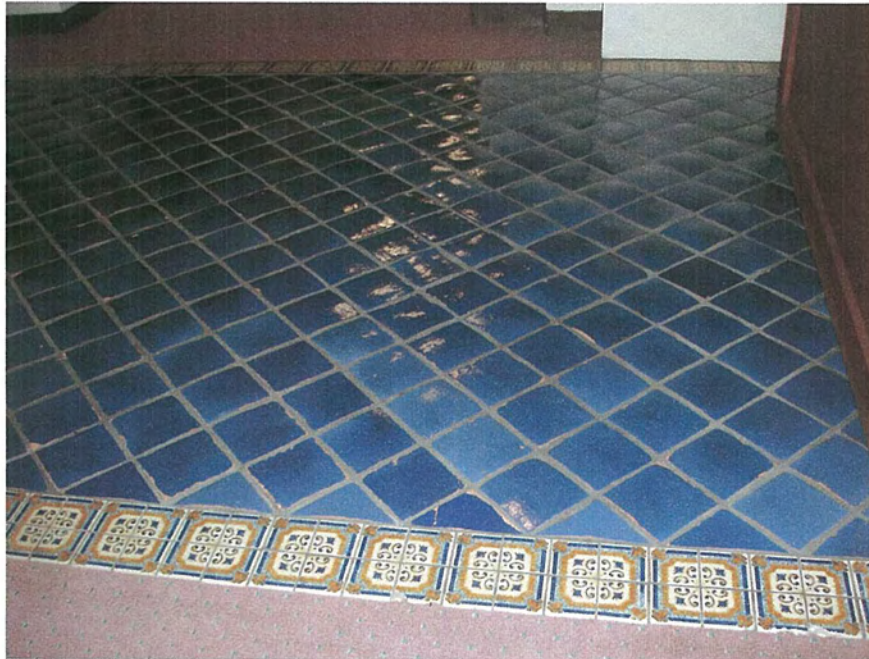
Building - Photo # 19

Ceramic tile flooring is not slip resistant.

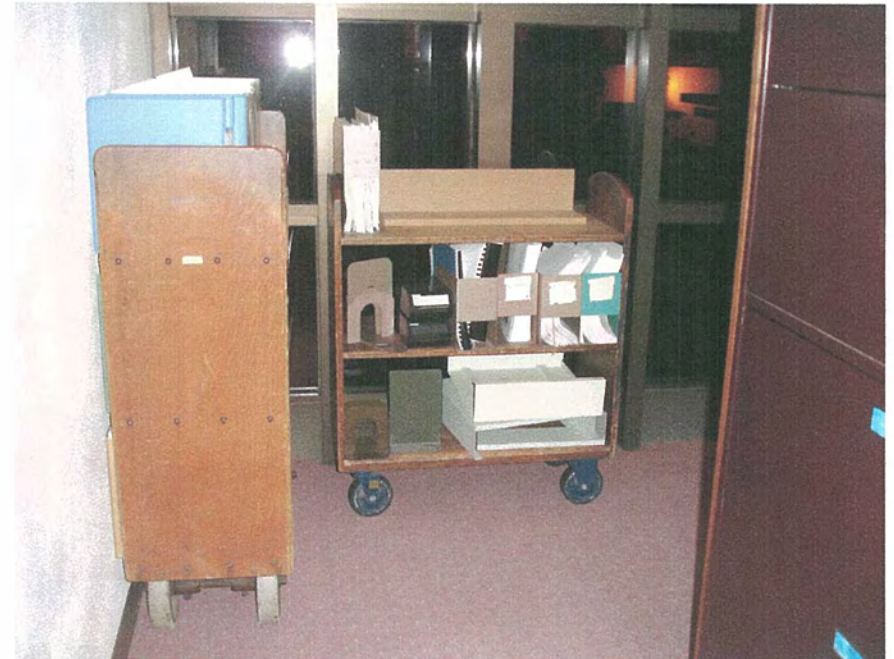
Building - Photo # 20

Path of travel between file cabinets and movable carts is 34" wide instead of 36" minimum.

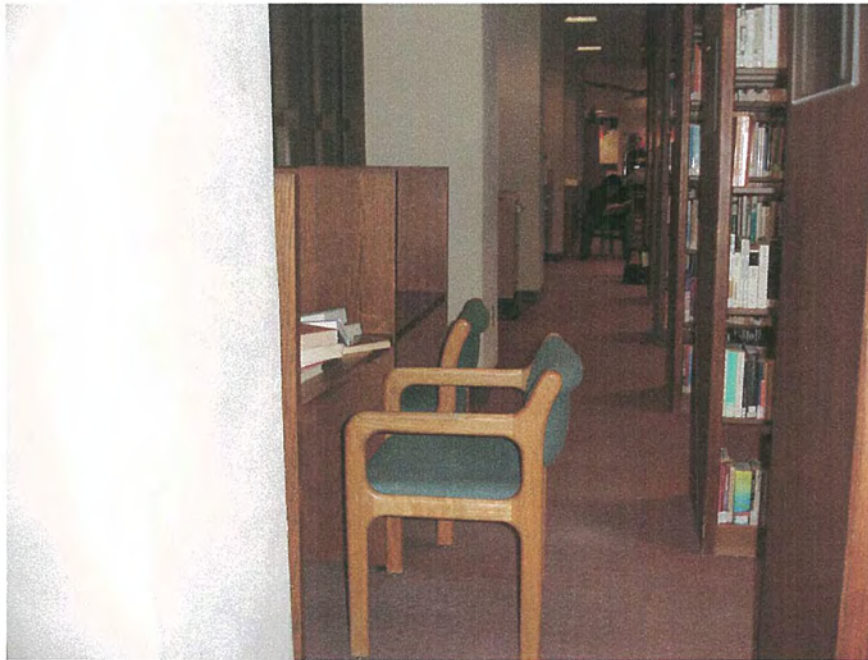
Building - Photo # 21

Path of travel between book stacks, chair and built-in reading carrels is 24" wide instead of 36" minimum.

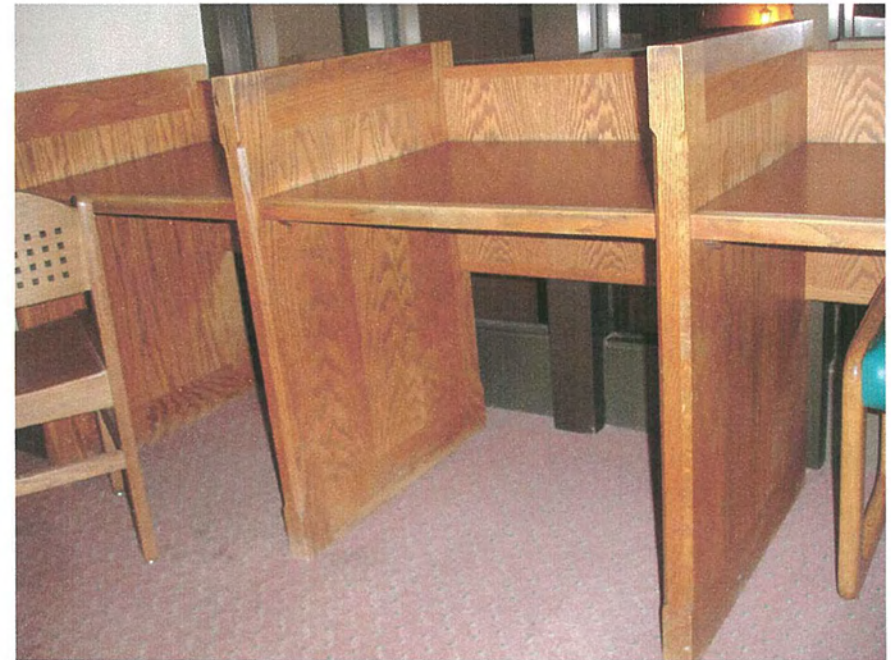
Building - Photo # 22

There is no identification international symbol of accessibility at reading carrels.

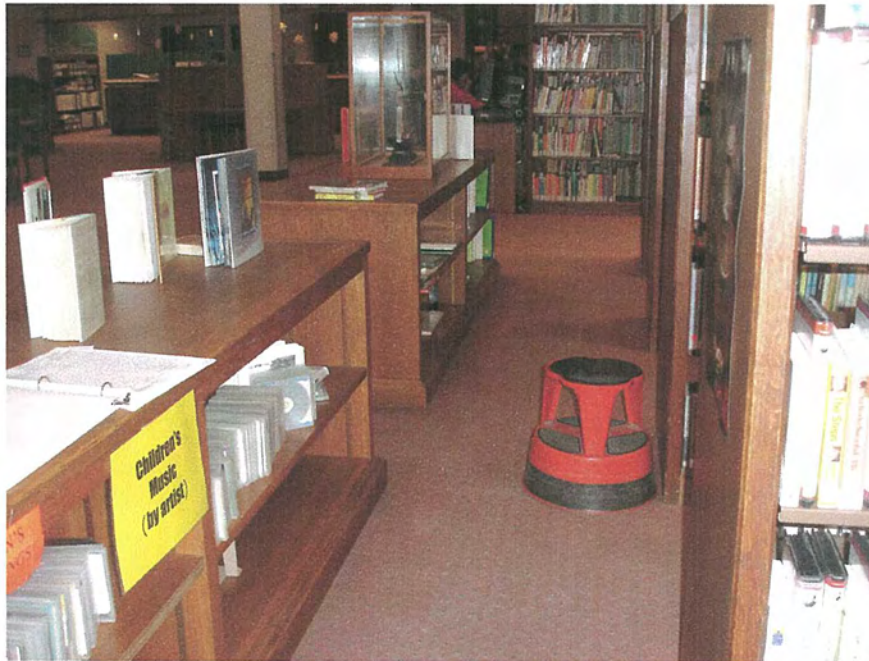
Building - Photo # 23

Path of travel between book stacks and children's music bookcases is 32" wide instead of 36" minimum.

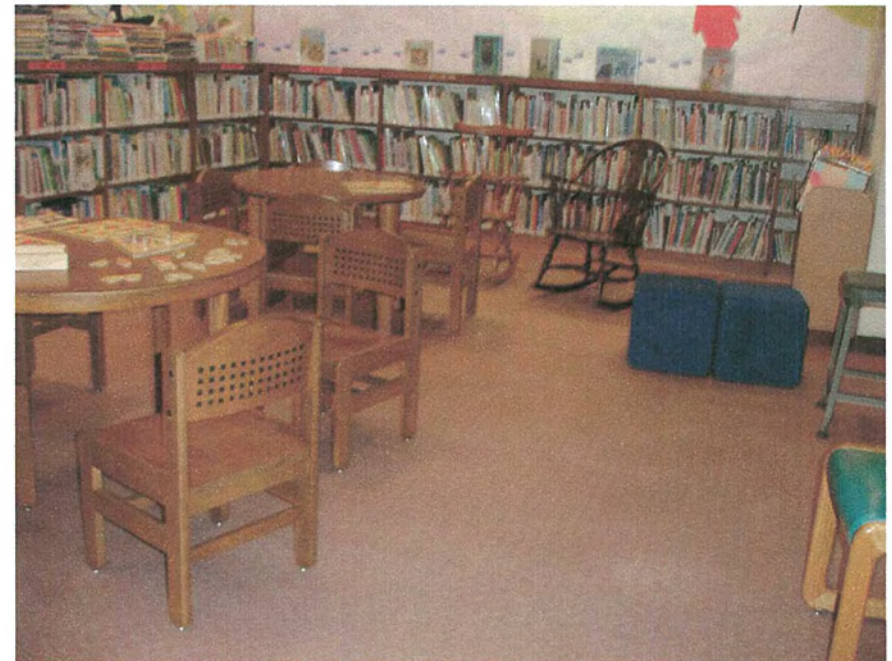
Building - Photo # 24

Children reading tables do not have the required wheelchair clearance 20" wide between legs.

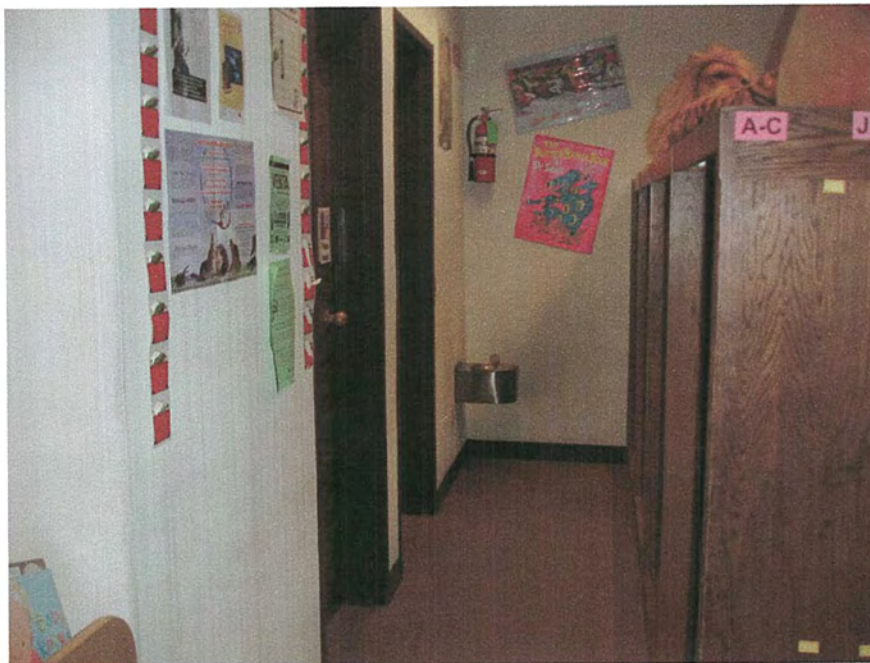
Building - Photo # 25

Drinking fountain does not have the required alcove and wheelchair maneuverable clearance.

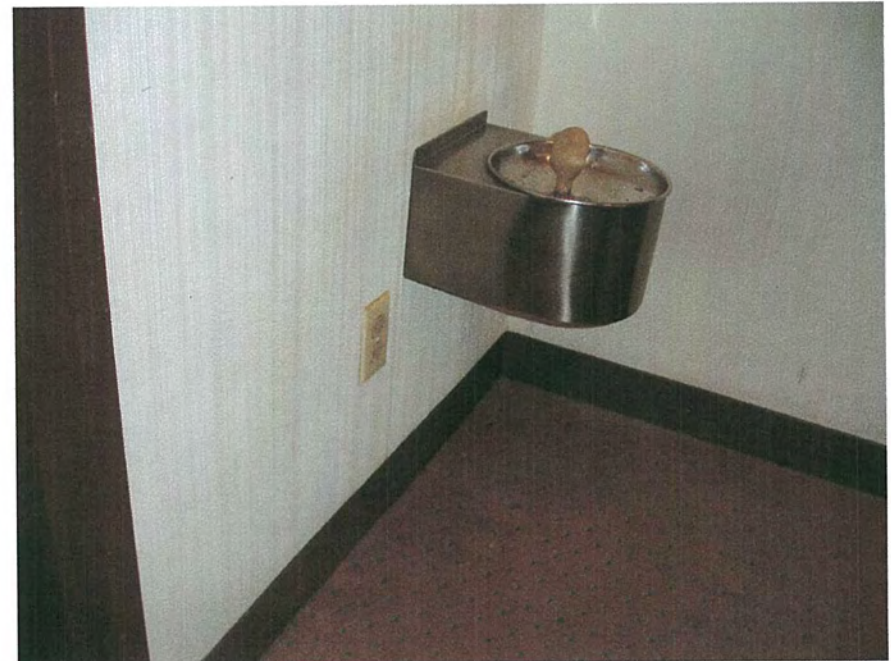
Building - Photo # 26

Drinking fountain is not high/low and located in an alcove. There is a narrow path of travel to it and no wheelchair maneuverable clearance.

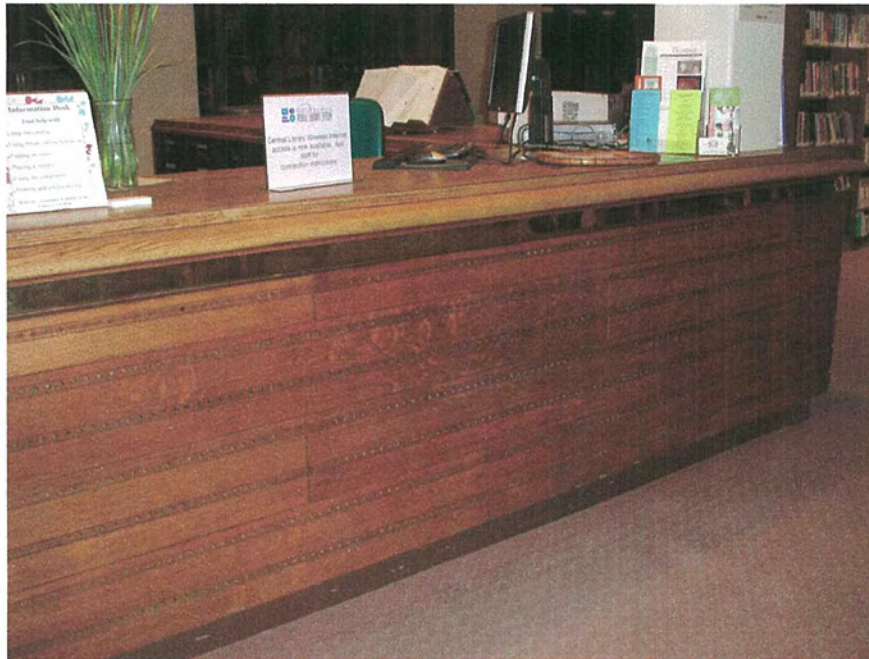
Building - Photo # 27

Information center counter is too high 41" and does not have a low section of 34" maximum height for wheelchair users.

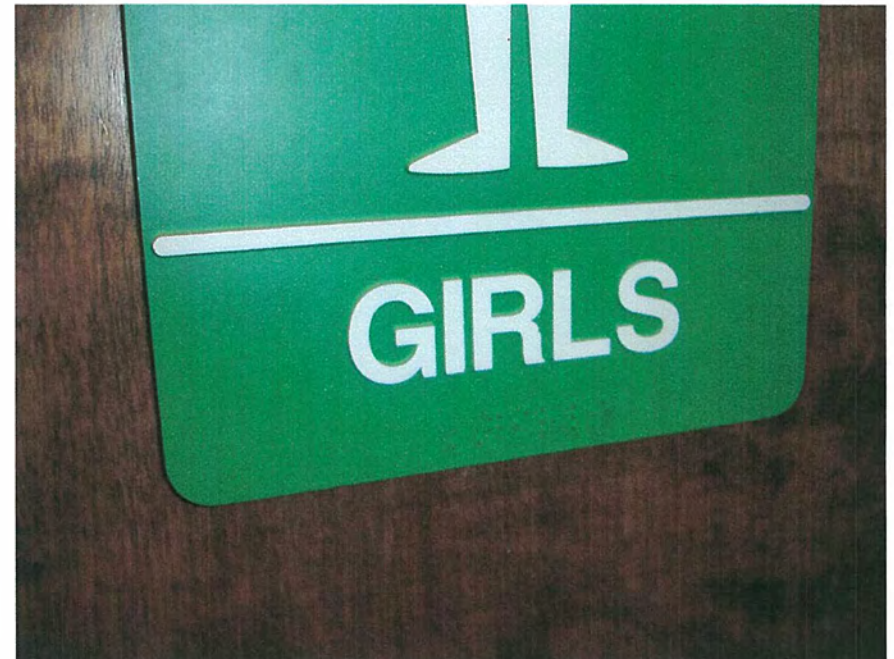
Building - Photo # 28

Girls tactile and Braille room identification sign is mounted on the door instead of adjacent to the latch side of the door.

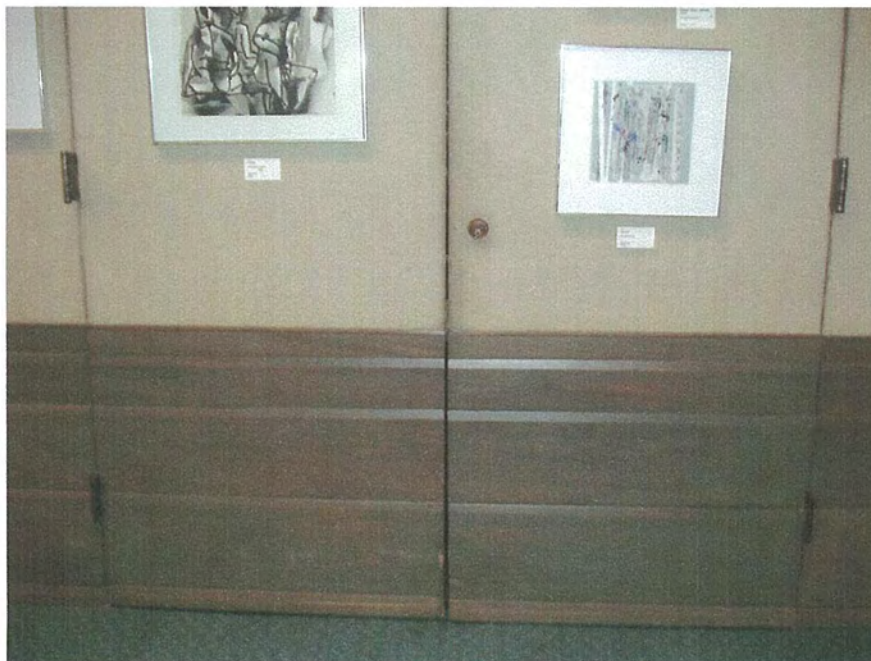
Building - Photo # 31

Doorknobs require tight grasping and twisting of the wrist to operate. There is no Tactile and Braille entrance identification sign.

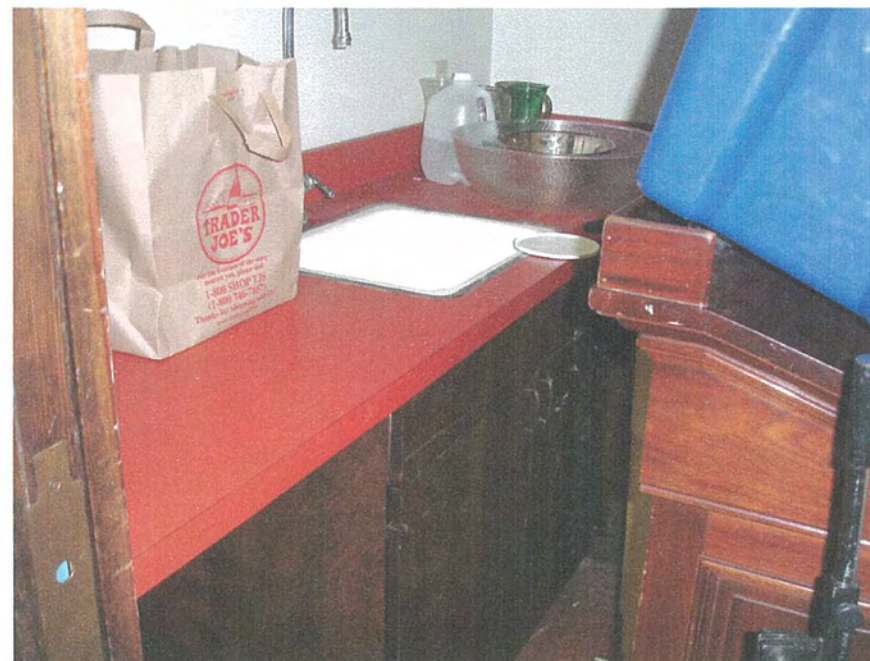
Building - Photo # 32

Kitchen sink does not have knee clearance and wheelchair maneuverable clearance to access sink. Stored items also block its use.

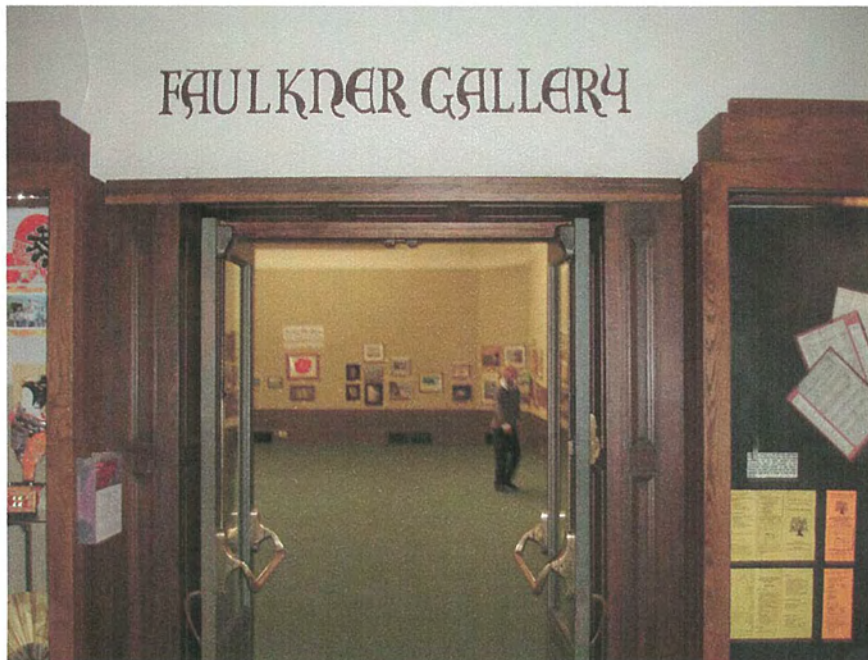
Building - Photo # 33

Each door leaf has 16" clear opening. Panic bar protrudes 5" into the path of travel – maximum protrusion allowed by code above 27" is 4". There is no tactile and Braille room identification sign.

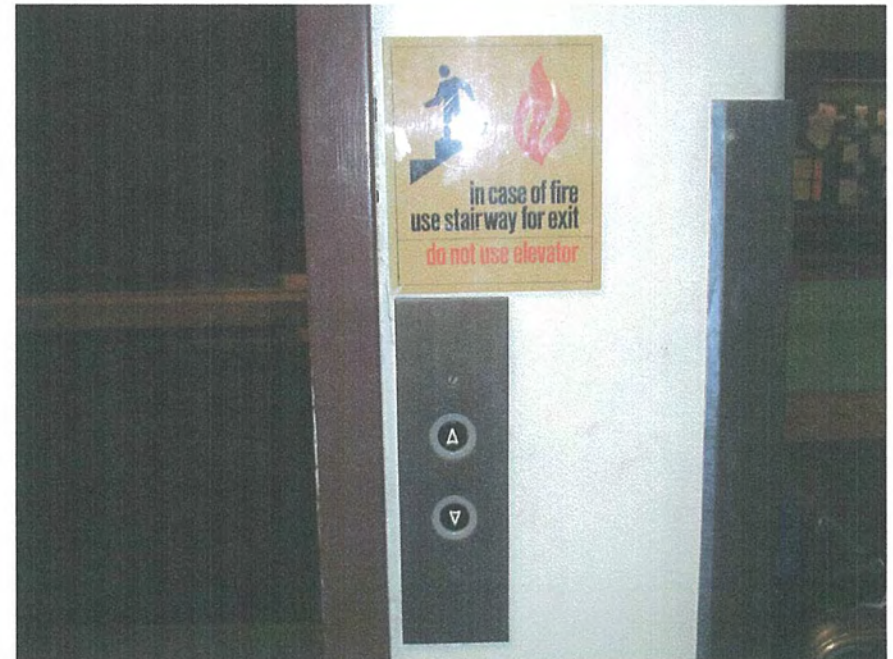
Building - Photo # 34

Elevator call buttons are not fully illuminated and flush with the adjacent panel instead of projecting from it not to require pinching to operate.

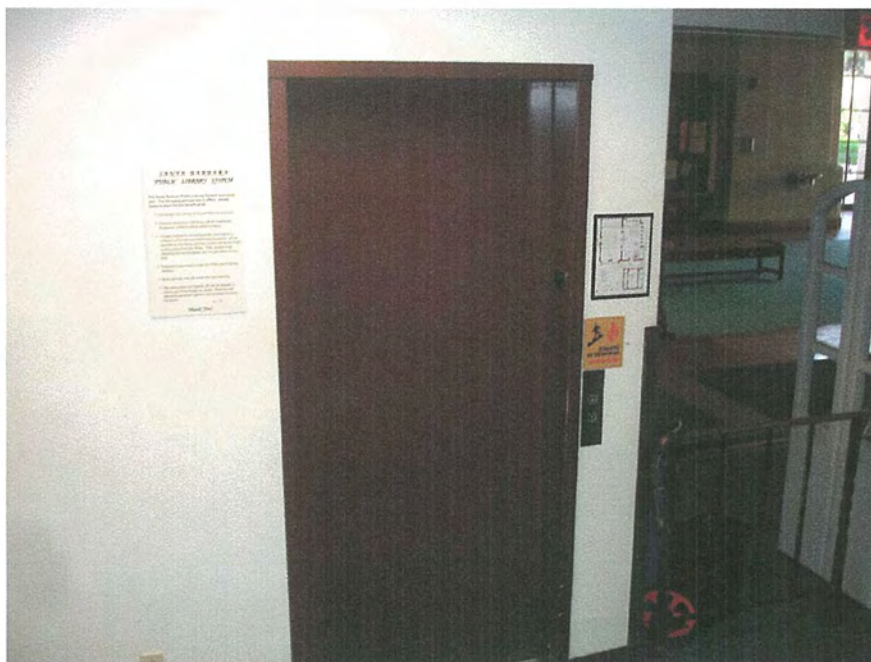
Building - Photo # 35

There are no hallway lanterns mounted at 72" minimum above finish floor.

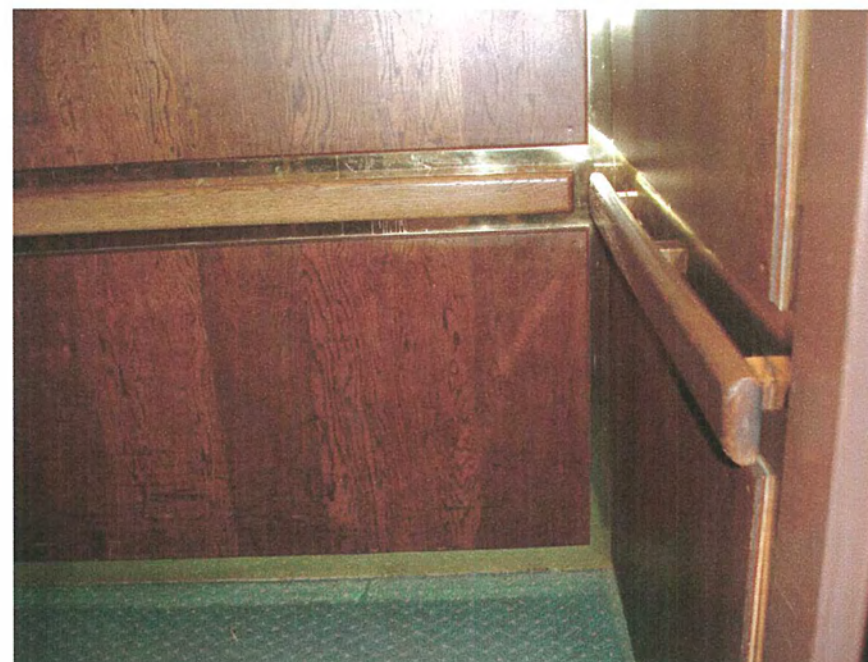
Building - Photo # 36

Handrail is 3 ½" wide and mounted too high at 38" instead of 31" to 33" maximum.

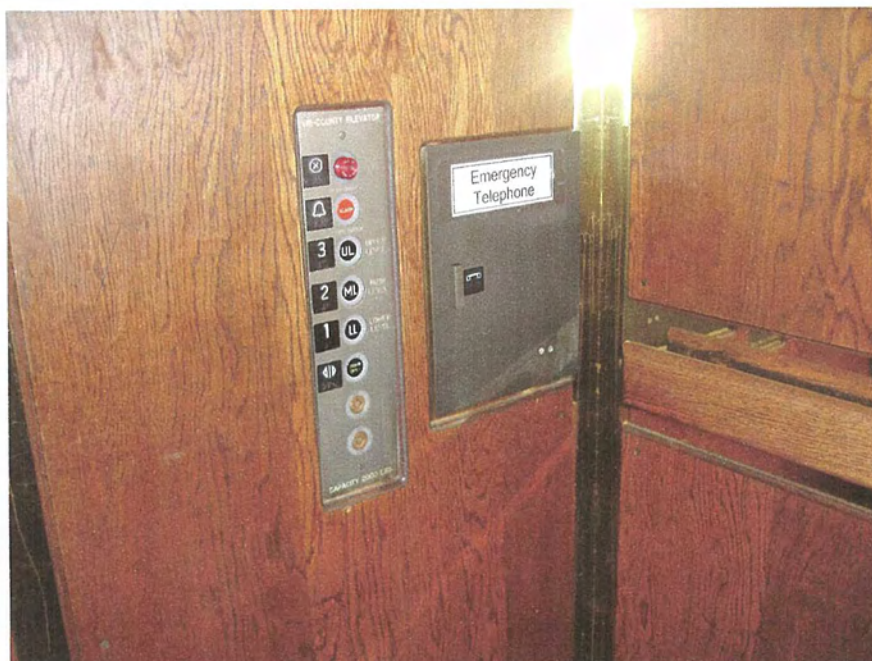
Building - Photo # 37

Car control buttons are recessed and not fully illuminated. Emergency buttons are mounted at 46" high instead of the 35" maximum required by code. Emergency telephone does not have a compliant opening hardware and is mounted too high.

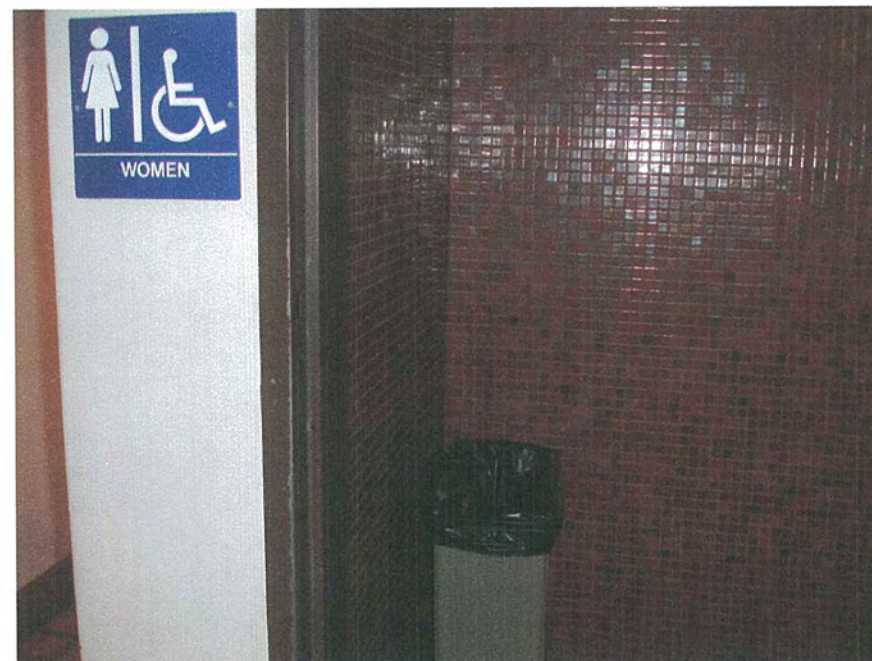
Building - Photo # 38

Room identification sign has Federal Braille instead of California Contracted Grade 2 Braille.

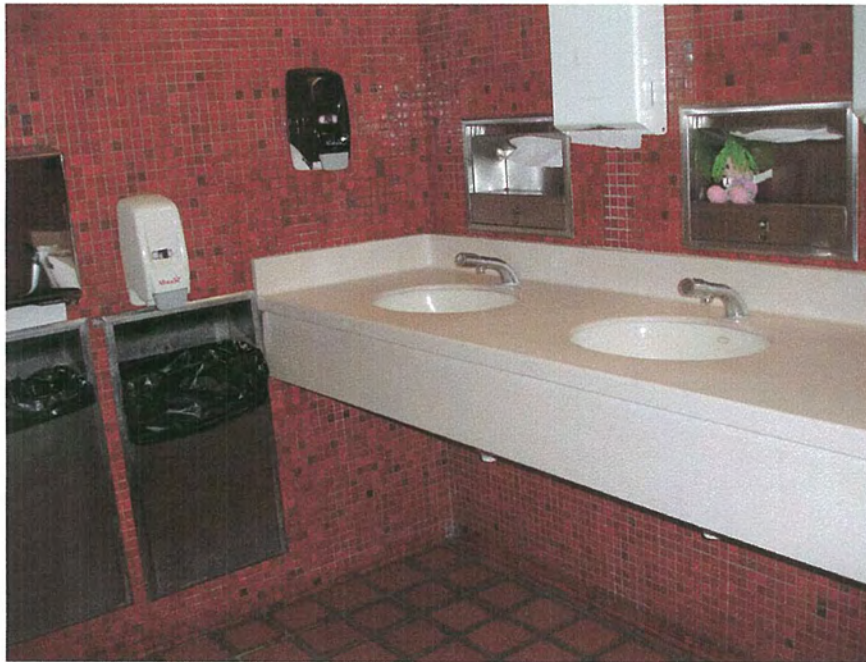
Building - Photo # 39

Vanity knee clearance is 26 ½" instead of 29" at the front and the top of counter 36 ¾" high instead of 34" maximum.

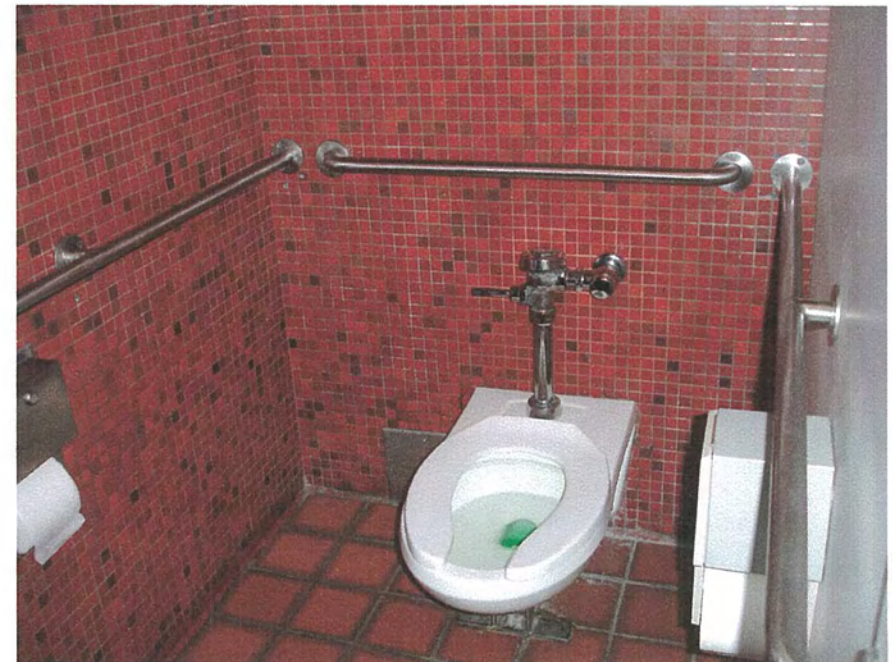
Building - Photo # 40

Water closet compartment is too narrow – 45" wide instead of 60". Flush valve is located at the narrow side. Water closet is located 25" from the wall to the centerline of fixture instead of 18" maximum.

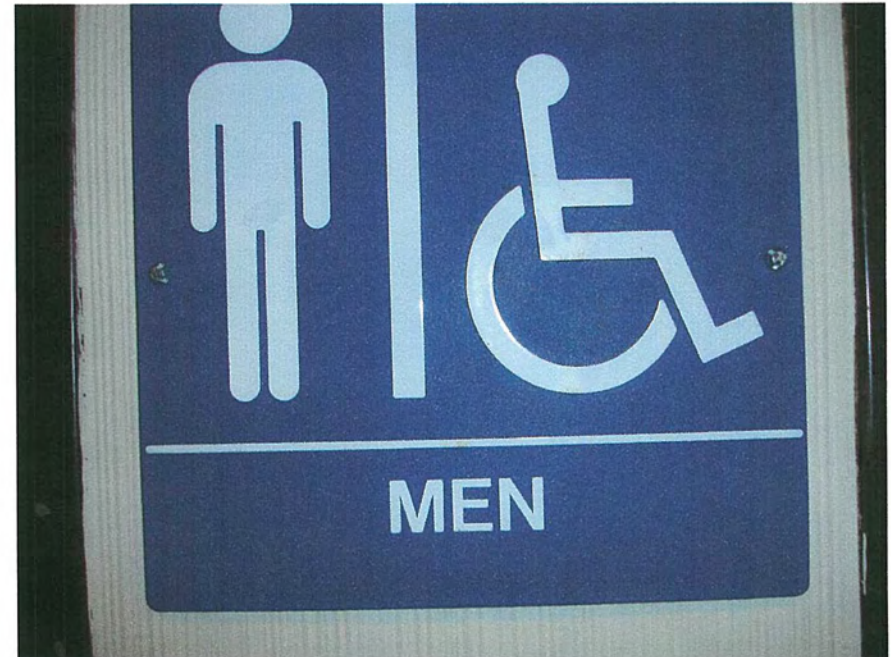
Building - Photo # 42

Room identification sign has Federal Braille instead of California Contracted Grade 2 Braille.

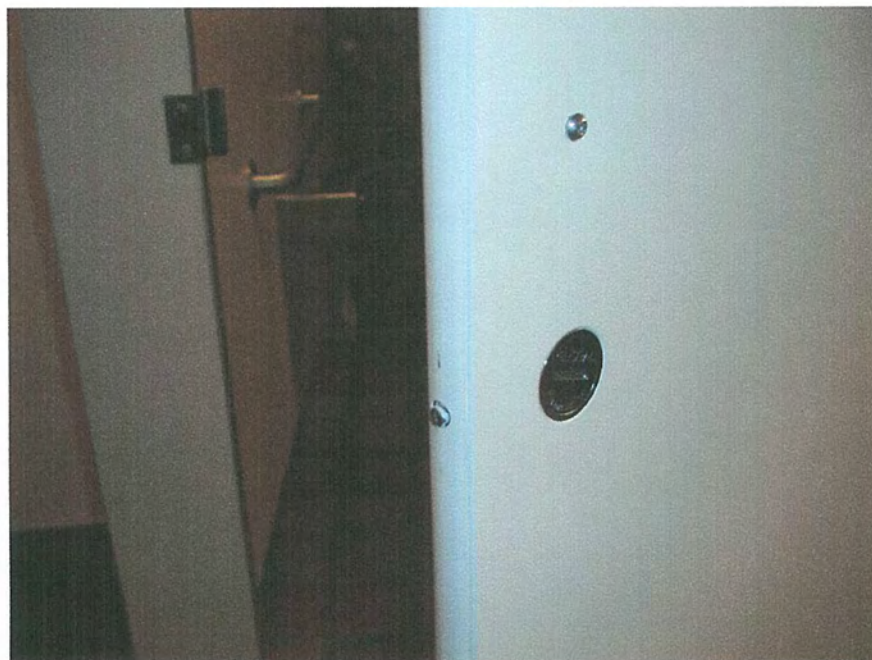
Building - Photo # 45

Compartment door does not have accessible type of hardware that does not require tight grasping, pinching or twisting of the wrist to operate and U-pulls on both sides of door.

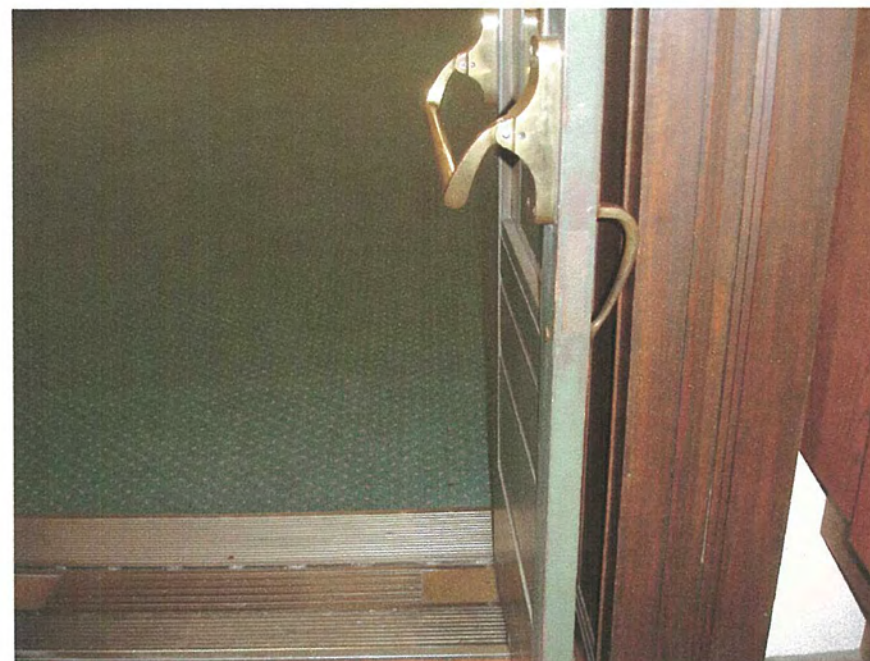
Building - Photo # 46

Panic bar protrudes 5" into the path of travel – maximum protrusion allowed by code above 27" is 4".
