GILDA PUENTE-PETERS
ARCHITECTS

CENTRAL LIBRARY
ACCESSIBILITY SURVEY

July, 2007

CITY OF SANTA
BARBARA

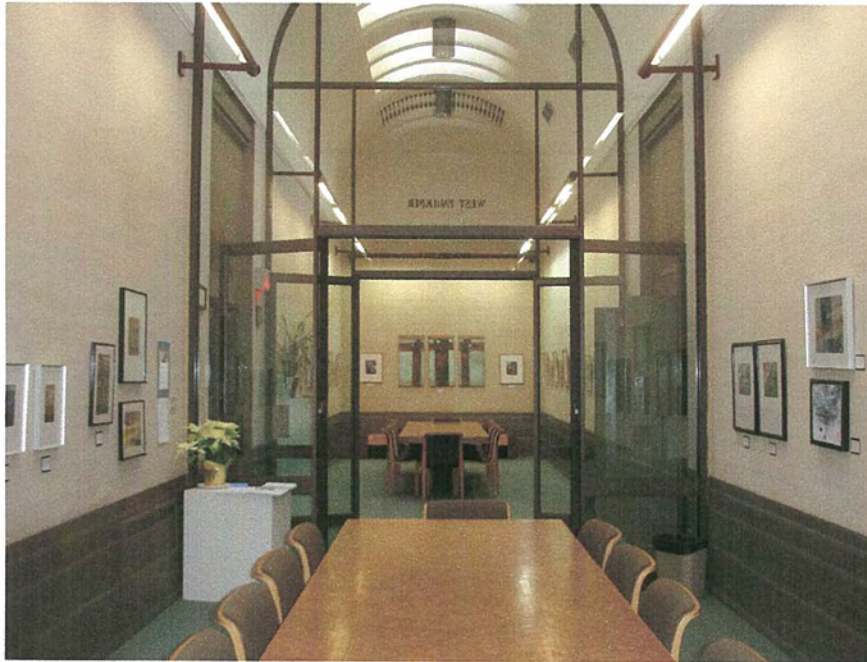
Building - Photo # 47

The glass doors have 5" bottom kick plate instead of the required 10" smooth kick plate. There is no tactile and Braille room identification sign.

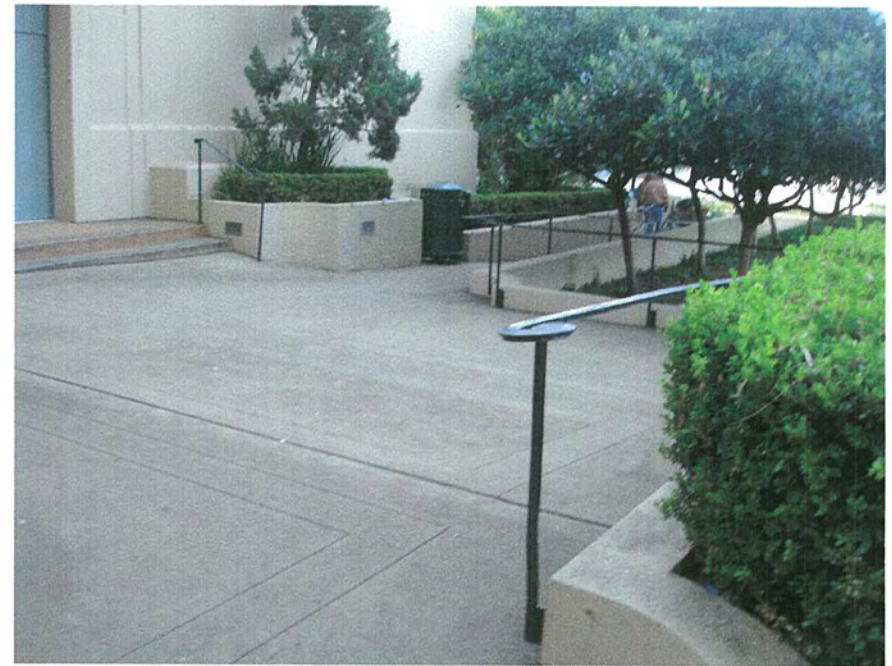
Building - Photo # 48

Stair has uneven treads and no contrasting color striping. Handrails do not have the required top and bottom extensions.

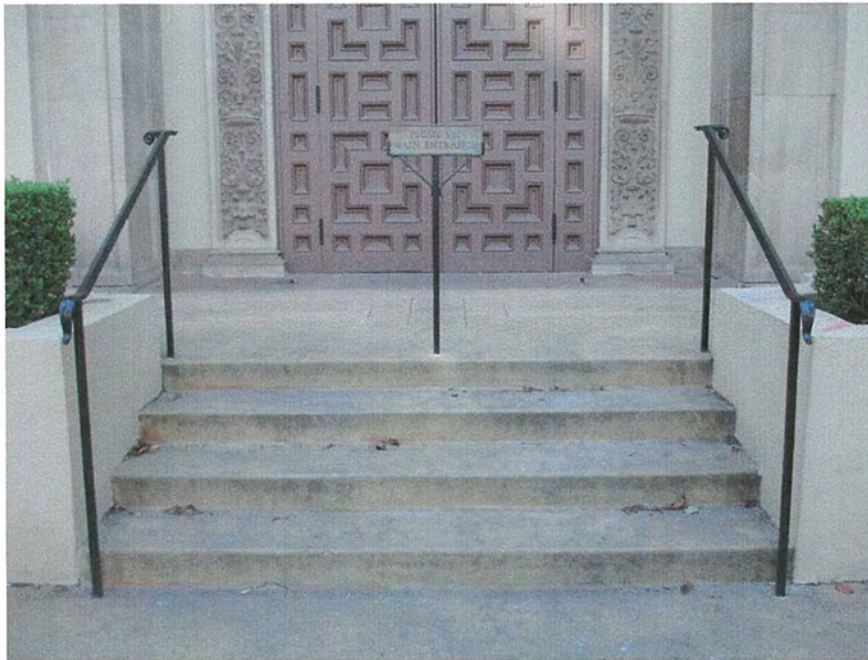
Building - Photo # 49

Stair has uneven treads and no contrasting color striping. Handrails do not have the required top and bottom extensions. There is not a directional sign with an ISA International Symbol of Accessibility and an arrow indication the direction to the accessible entrance.

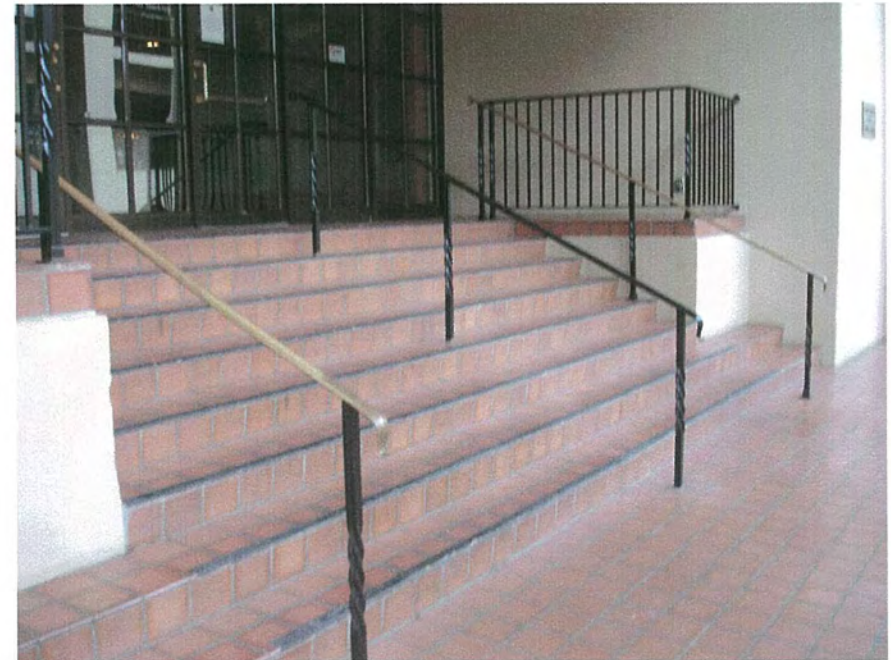
Building - Photo # 50

Stairs do not have the required 2" contrasting color striping. Handrails do not have the required top and bottom extensions. Guardrail height is 37" instead of the required 42" minimum.

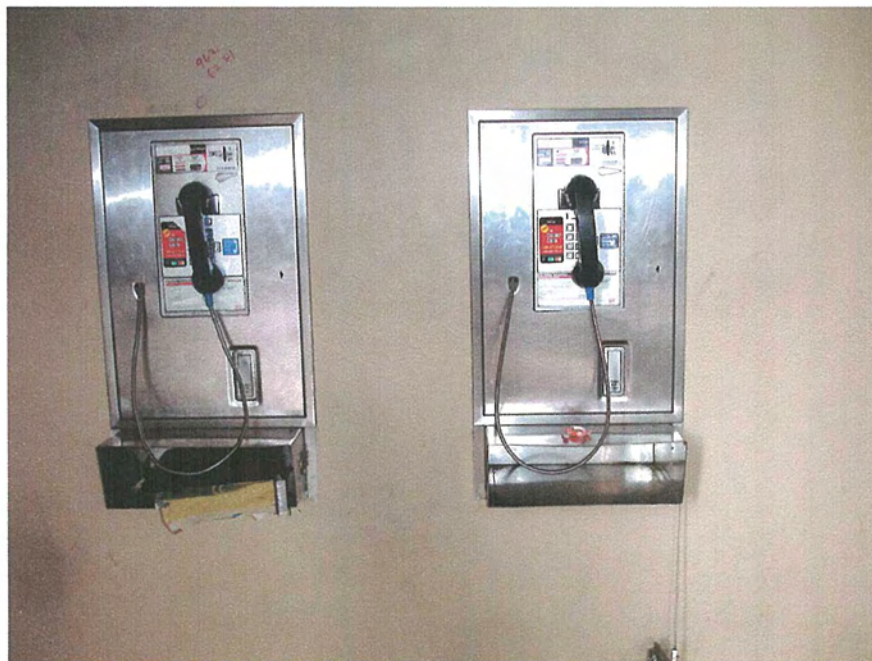
Building - Photo # 51

Telephone has fading hearing amplification sign. There is no outlet for personal TTY systems as well as public TTY telephone.

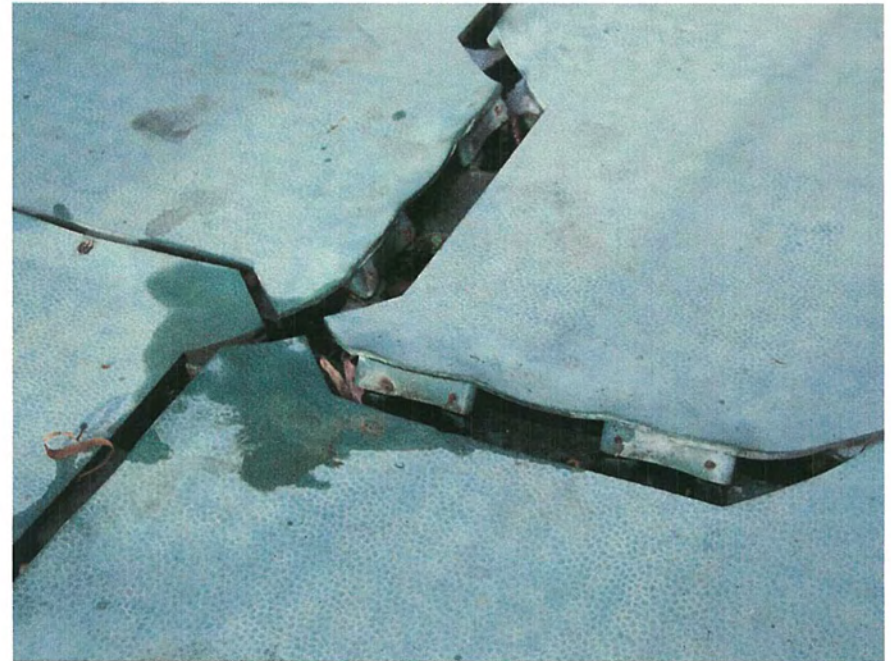
Building - Photo # 4

Terrace rubber pavers have more than 1" gap, becoming a tripping hazard.

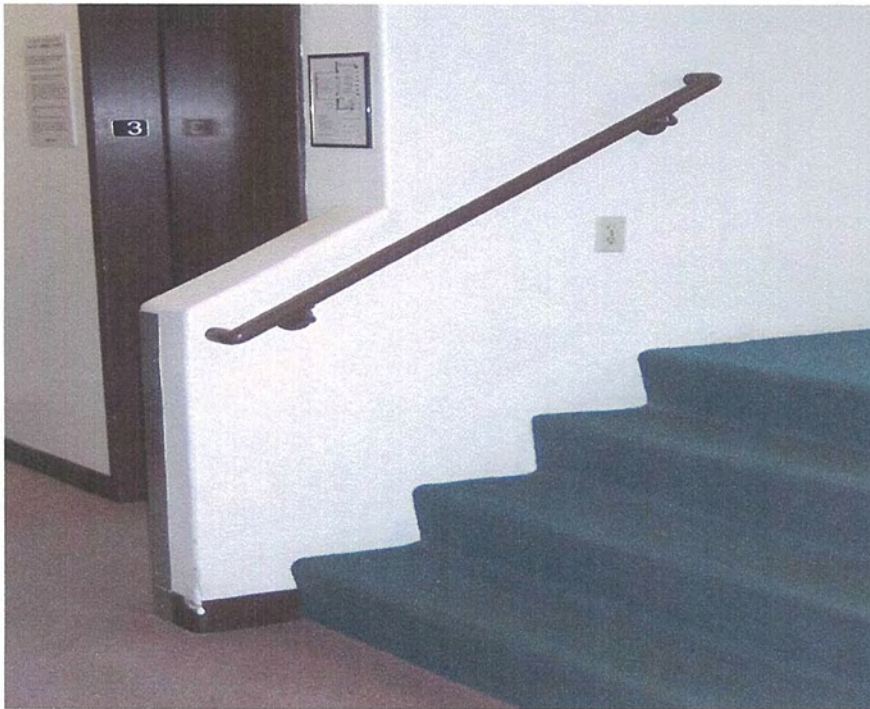
Building - Photo # 7

Stairs do not have contrasting color striping. Handrails do not have the required extensions.

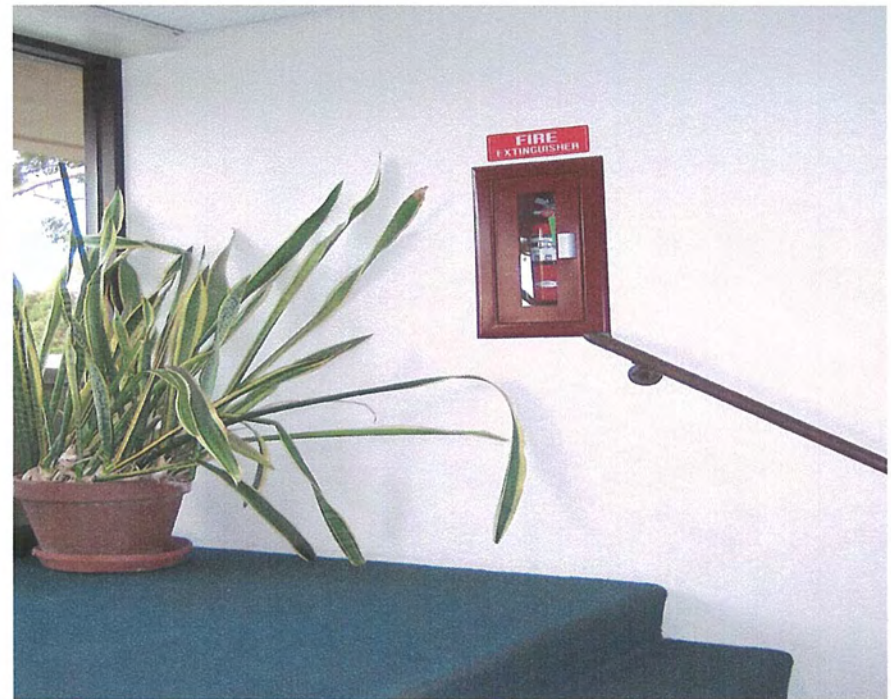
Building - Photo # 8

Stairs do not have contrasting color striping. Handrails do not have the required extensions. Fire extinguisher U-pull requires grasping to operate.

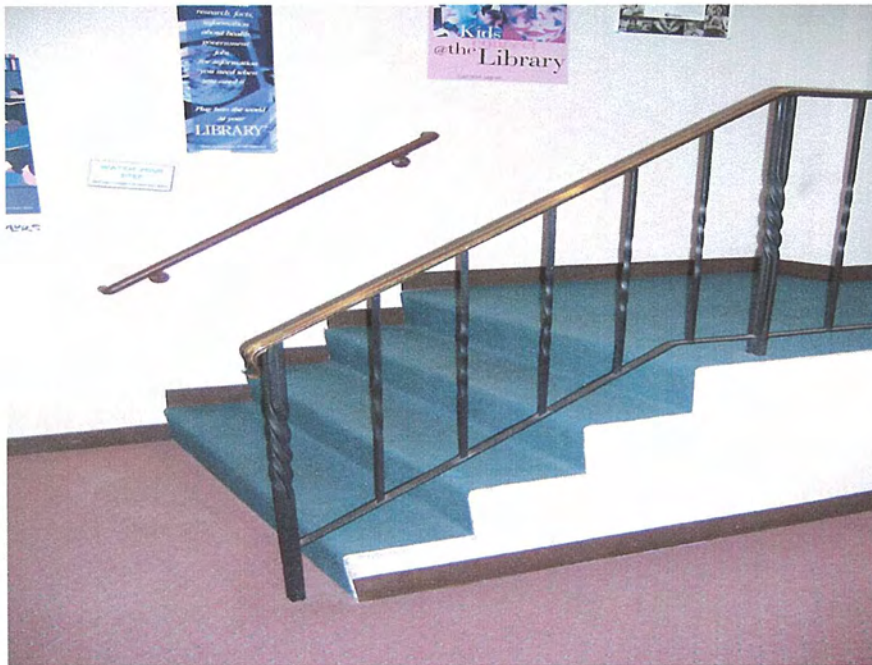
Building - Photo # 9

Stairs do not have contrasting color striping. Handrails do not have the required extensions.

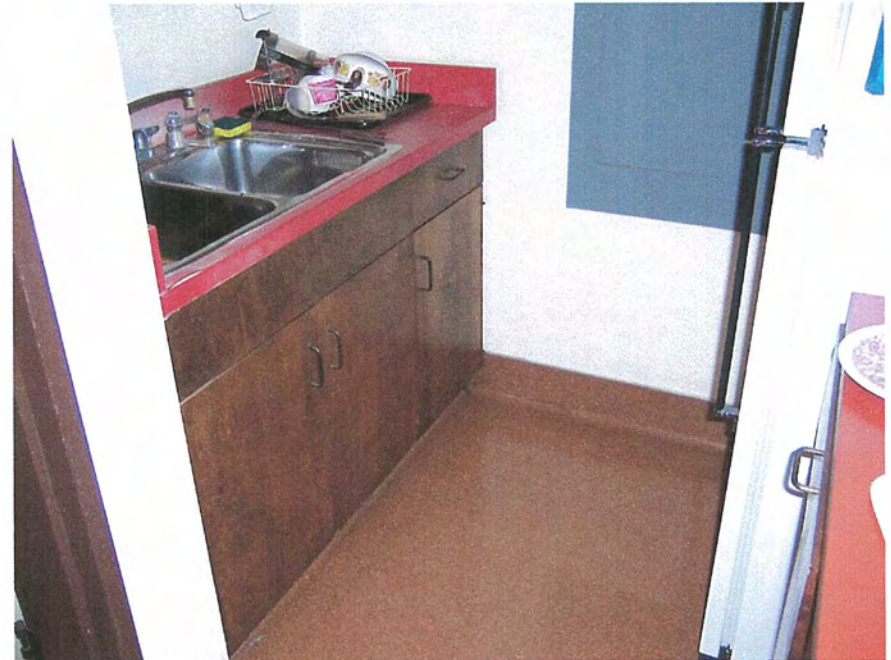
Building - Photo # 10

*Non-accessible sink – no knee clearance provided.
Path of travel 42" wide without a 60" turn around space.*

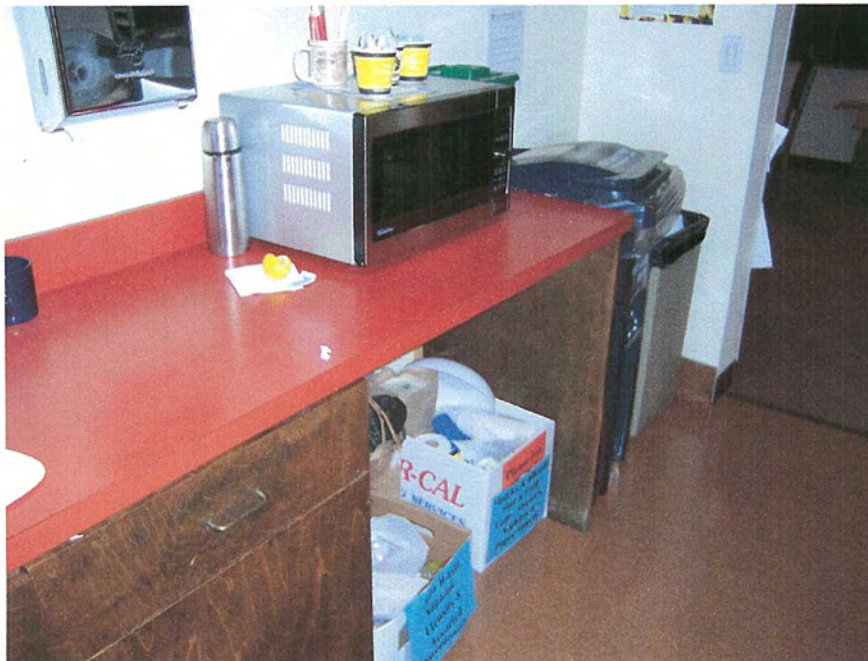
Building - Photo # 11

Stored items block the knee clearance provided at microwave.

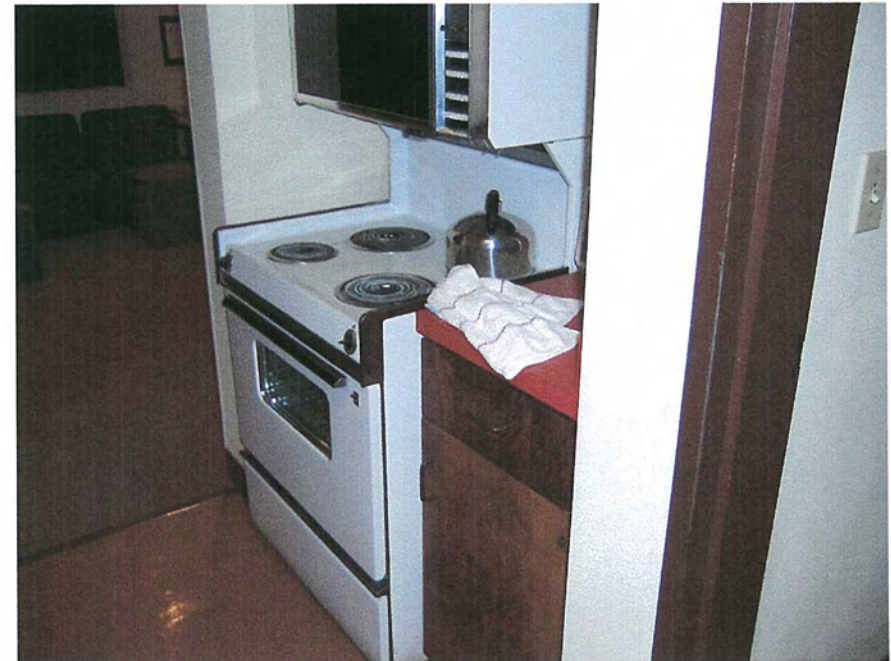
Building - Photo # 12

Range controls mounted as high as 64" above finish floor.

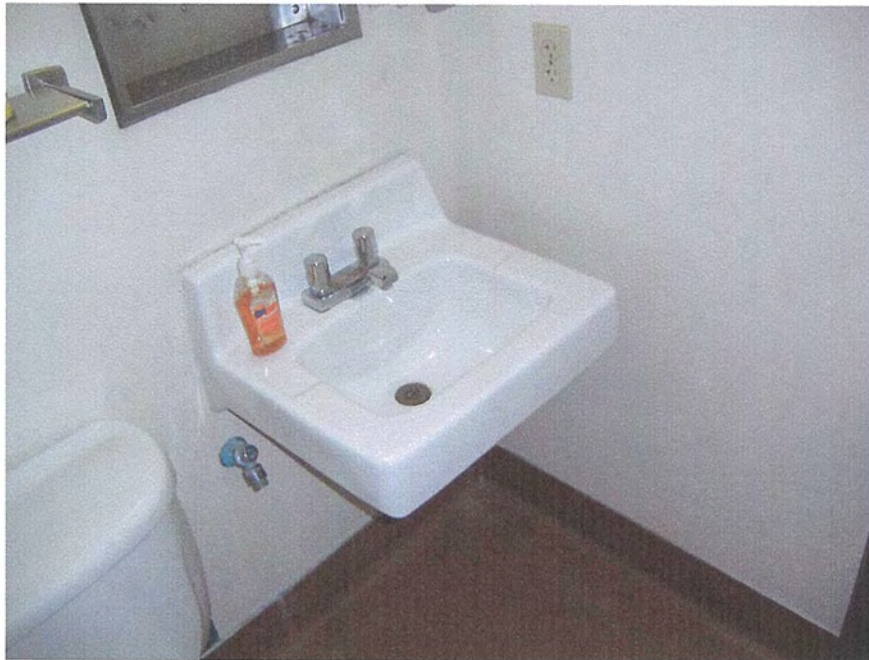
Building - Photo # 13

Restroom is too small and not wheelchair accessible, it does not have the required maneuverable clearances, grab bars, strobe lights. Sink does not have the required knee clearance; mirror is mounted too high.

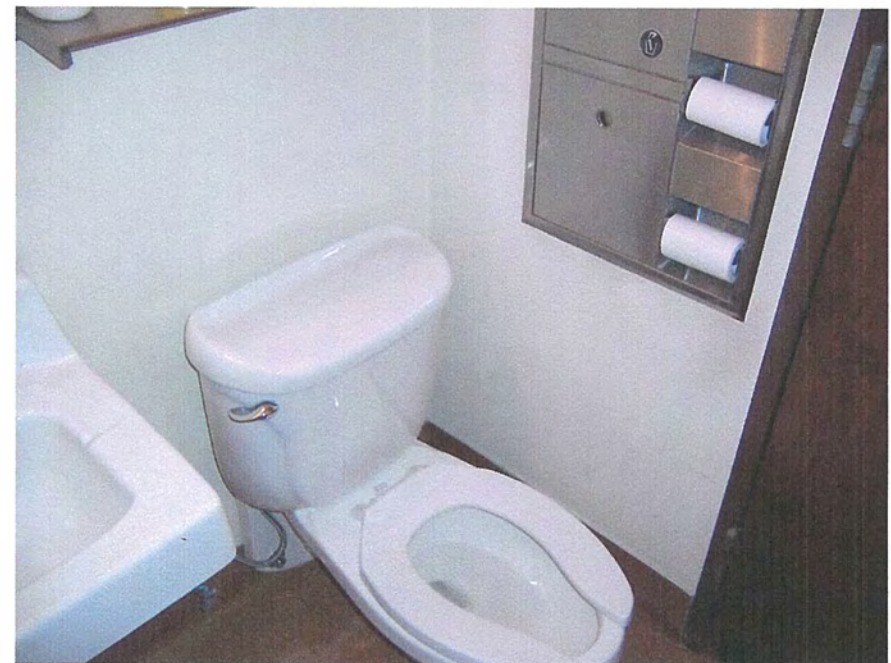
Building - Photo # 14

Restroom is too small and not wheelchair accessible, it does not have the required maneuverable clearances, grab bars, strobe lights. Feminine towel receptacle is mounted too high.

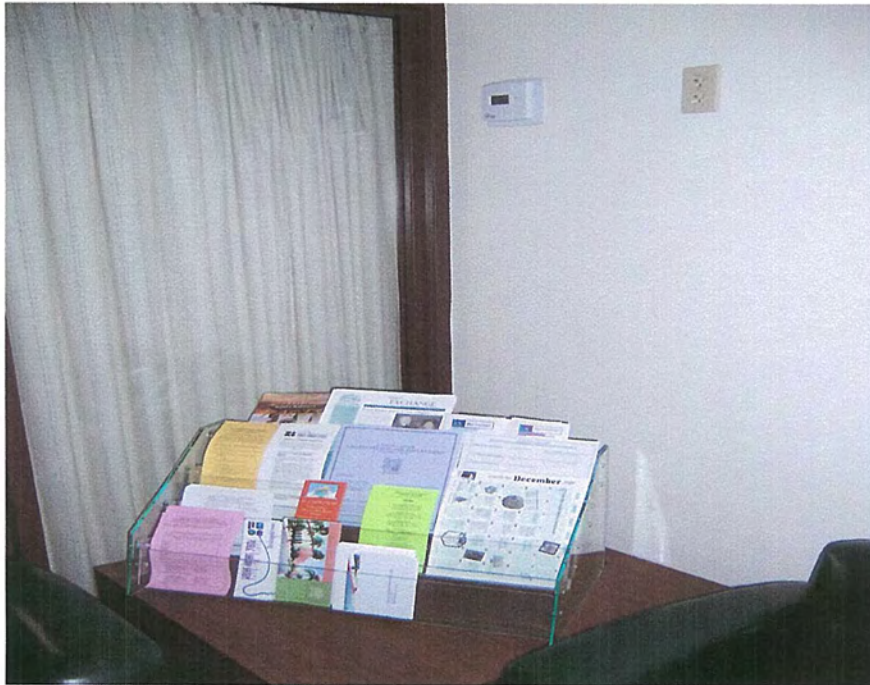
Building - Photo # 15

Thermostat control is located at 72" high behind table.

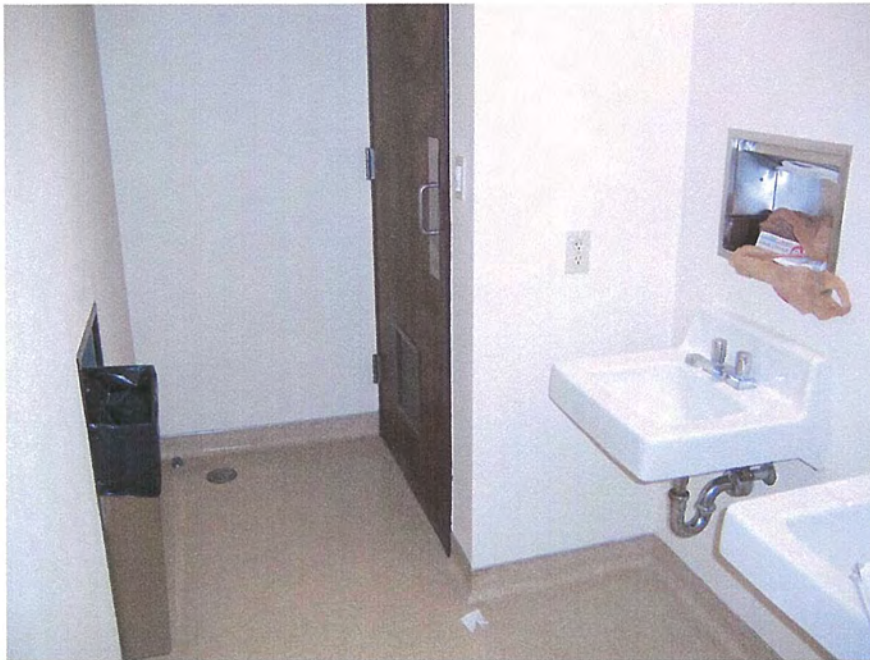
Building - Photo # 13

*Restroom is not accessible, vestibule too small;
sink does not have pipe insulation. Paper towel
dispenser is mounted too high.*

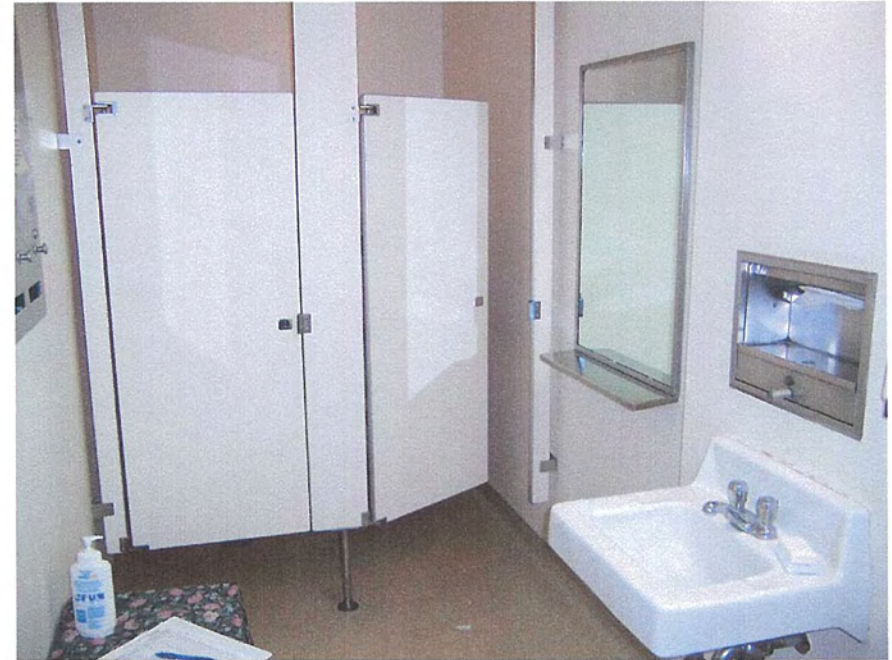
Building - Photo # 14

*Water closet compartments are not code
compliant, they do not have the required
wheelchair maneuverable clearance, grab bars.
Paper towel dispenser is mounted too high.*

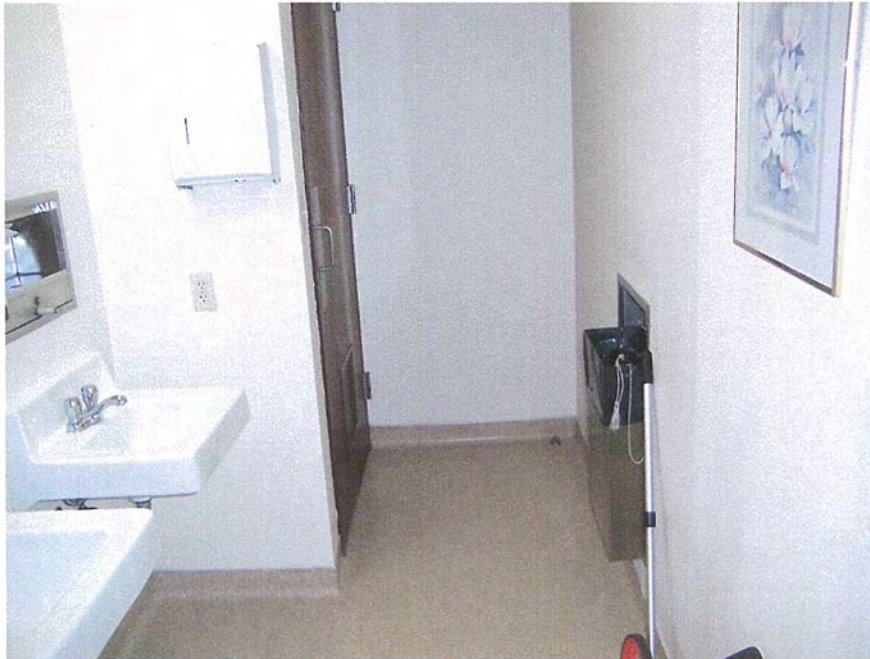
Building - Photo # 15

Restroom is not accessible, vestibule is too small, and sink does not have pipe insulation. Paper towel dispenser is mounted too high.

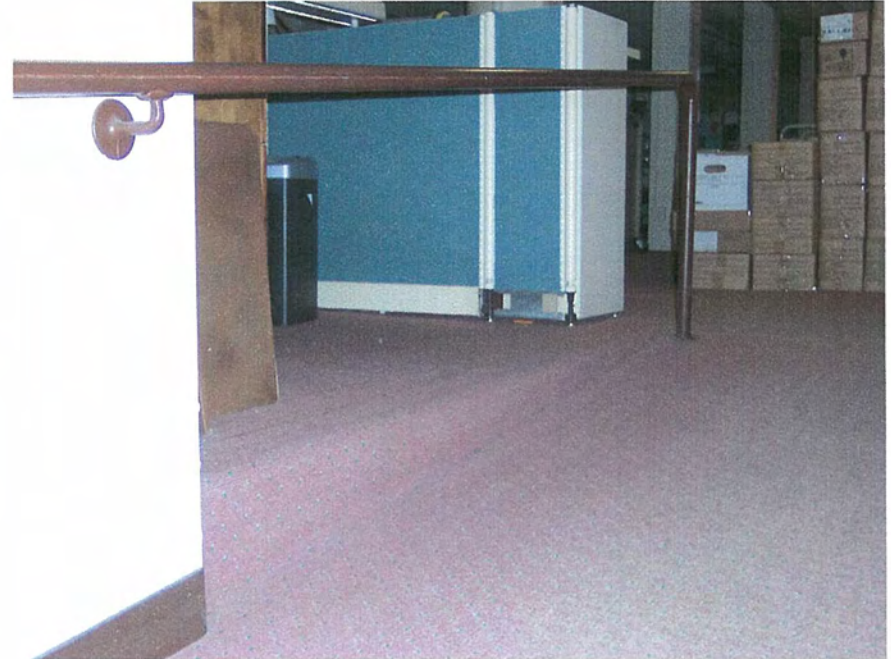
Building - Photo # 16

Ramp does not have the required wheel guides. Handrail does not have the required extensions
