**GILDA PUENTE-PETERS**  
**ARCHITECTS**

## **EASTSIDE BRANCH LIBRARY ACCESSIBILITY SURVEY**

**July, 2007**

**CITY OF SANTA  
BARBARA**

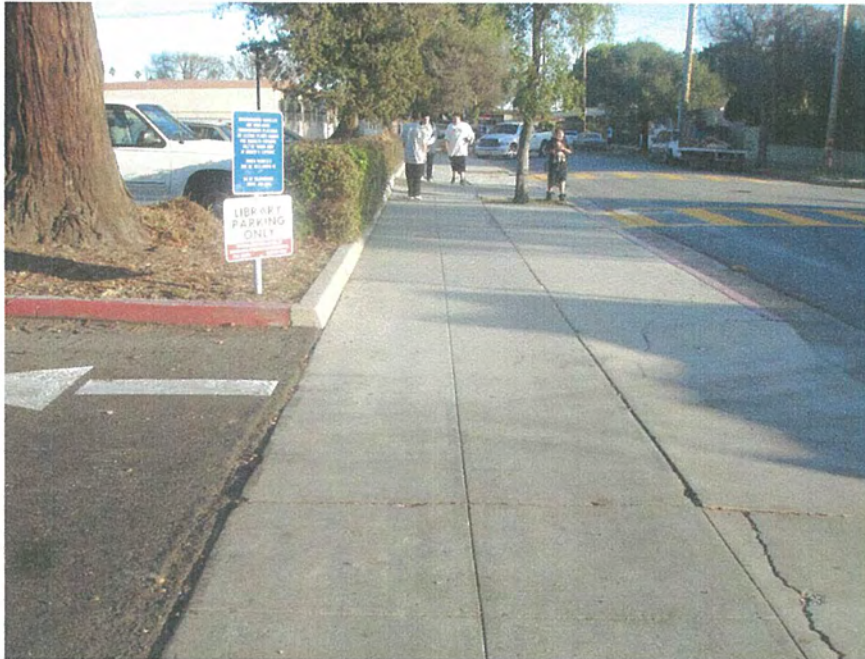
*Public Right-of-Way - Photo # 1*

*The sidewalk at the driveway entrances to parking lot do not have detectable warnings to warn blind and low vision pedestrians that they are going into a vehicular area. The crosswalks in the middle of the block do not have curb ramps. Concrete needs to be repaired.*

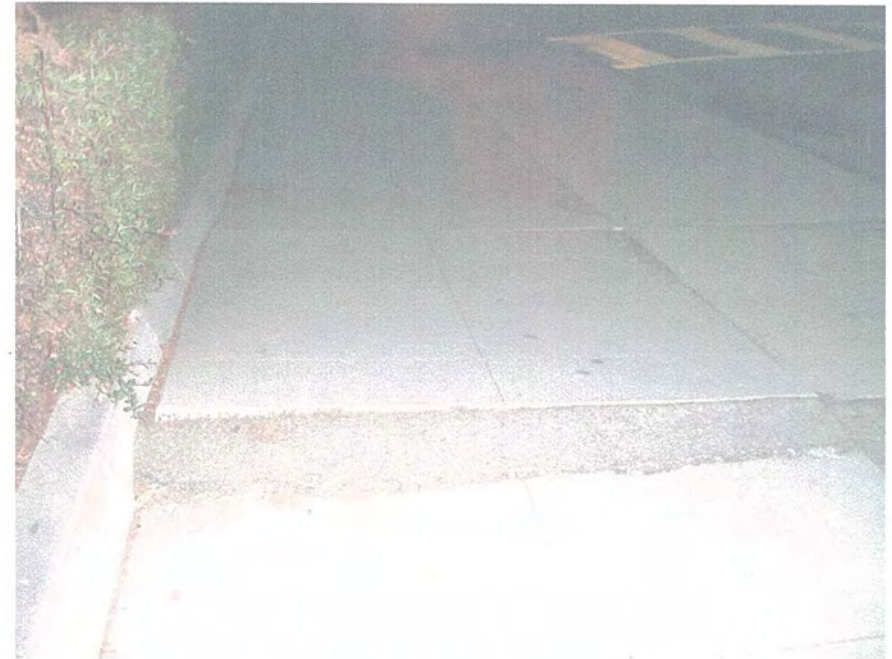
*Public Right-of-Way - Photo # 2*

*Sidewalk has excessive cross slopes. The crosswalk located in the middle of the block does not have curb ramps for wheelchair users.*

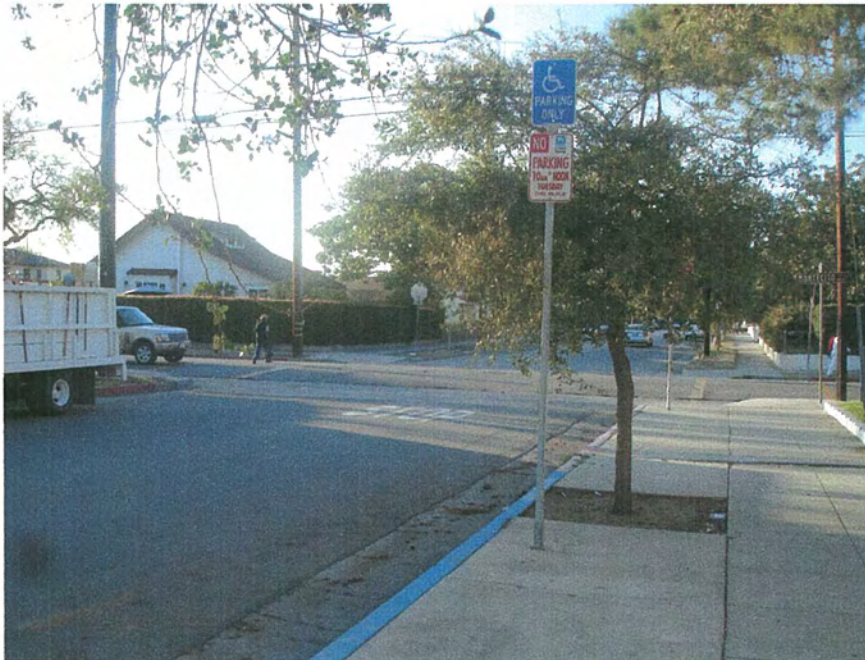
*Public Right-of-Way - Photo # 3*

*Tree wells are not leveled with the sidewalk level. The on-street accessible parking does not have a curb ramp in the back of the parking area for back wheelchair deployment vans.*

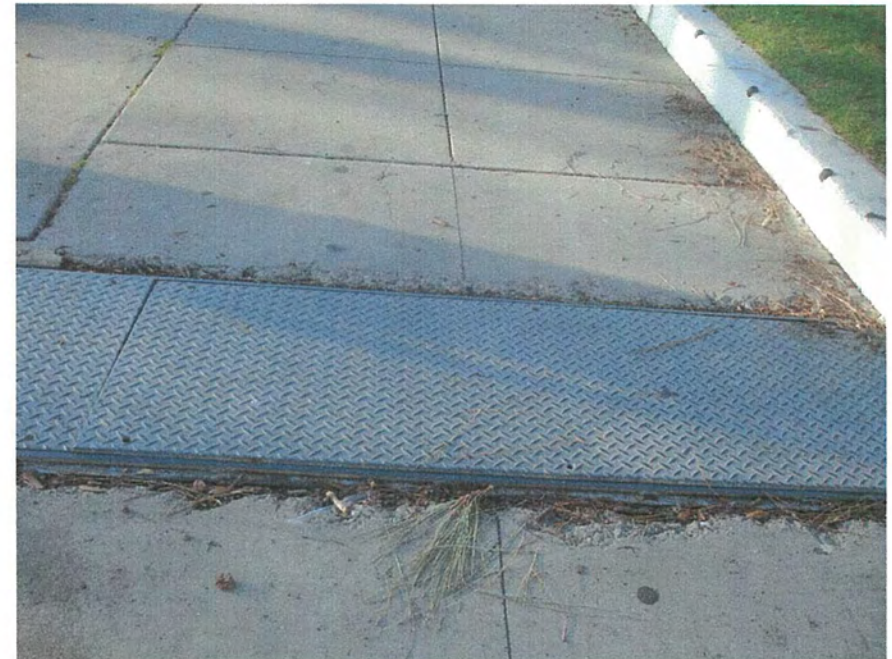
*Public Right-of-Way - Photo # 4*

*The utility cover has gaps greater than 1/2" that need to be filled in.*

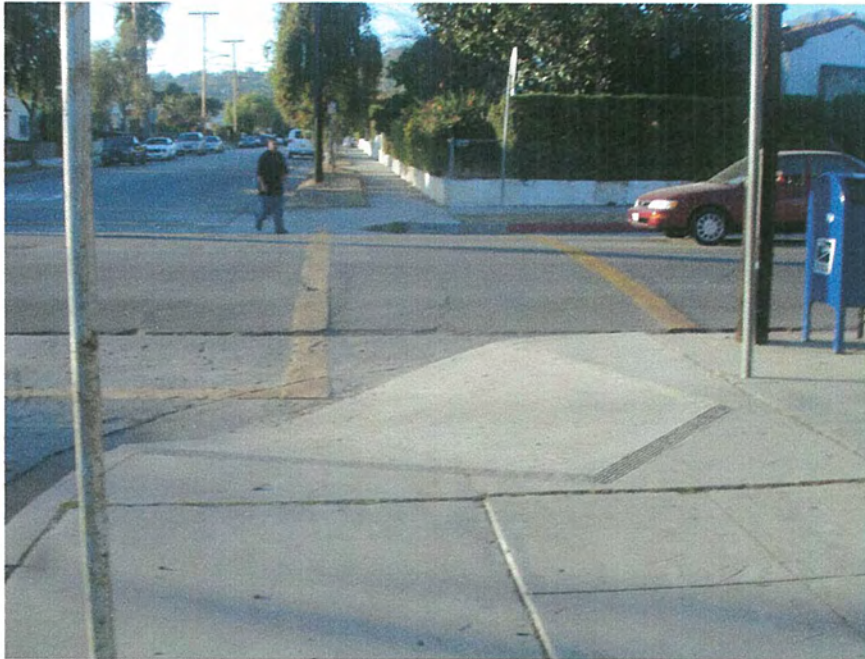
*Public Right-of-Way - Photo # 5*

*Curb ramp has excessive curb ramp and flare slopes. Grooves are 4" wide. There are no detectable warnings and the curb ramp does not contrast with the adjacent surface.*

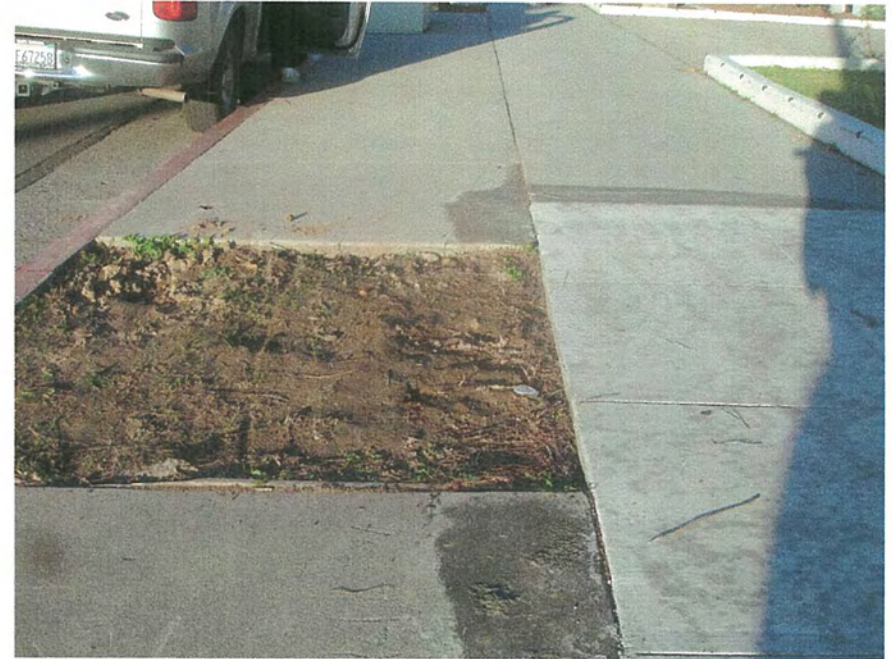
*Public Right-of-Way - Photo # 6*

*The tree well is not leveled with the sidewalk level. The sidewalk has excessive cross slopes and uneven surface.*

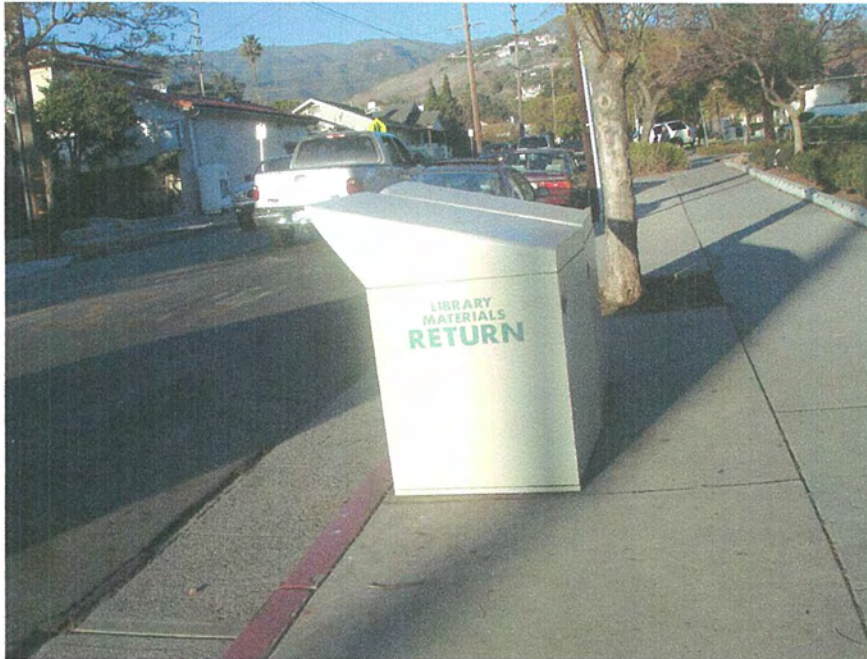
*Public Right-of-Way - Photo # 7*

*Book return is not accessible from the street level,  
mounted too high. An accessible book return should be  
provided from the sidewalk side, at an accessible height.*

ITEM/ LOCATION	CONDITION BARRIER	REQUIREMENT	EXISTING CONDITION	CODE REFERENCE	SUGGESTED RECOMMENDATION	QTY	UNIT TYPE	UNIT COST	TOTAL COST	PR	IMPL DATE
15 Book Return										\$2,000	
Reach Ranges											
Forward approach reach range to objects or controls.	Mounting height 48" or less than 15" high, when clear space allows only forward approach.	Book drop does not have a slot for book drop from the sidewalk. Photo #: 7	ADAAG: 4.2.5 T24: 1118B.5	Provide a new book drop with approach from the sidewalk - recommended height 34".	1	JOB	\$2,000	\$2,000	3

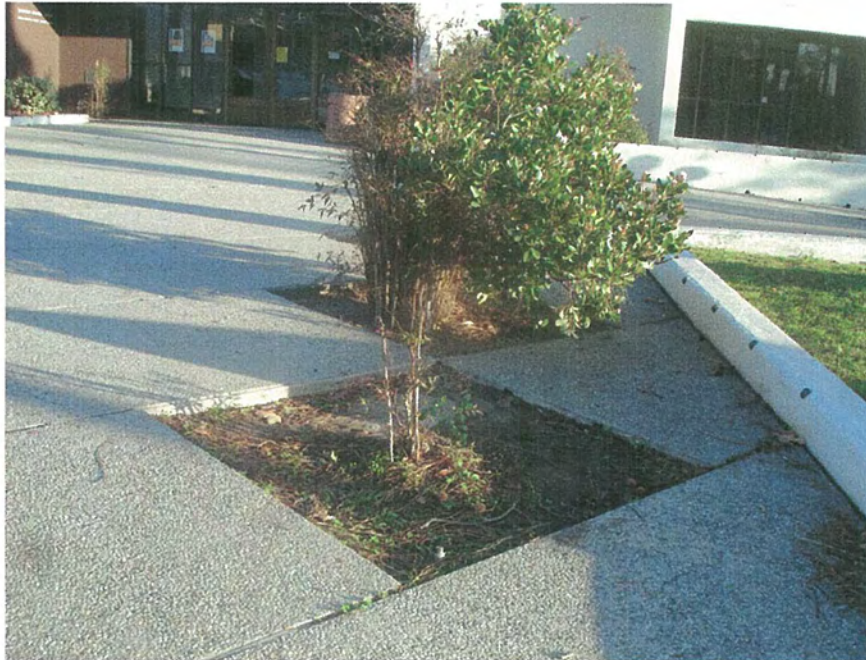
*Site - Photo # 1*

*Tree wells are not leveled with the walk level becoming a tripping hazard for pedestrians. The main entry plaza has some areas with excessive cross slopes.*

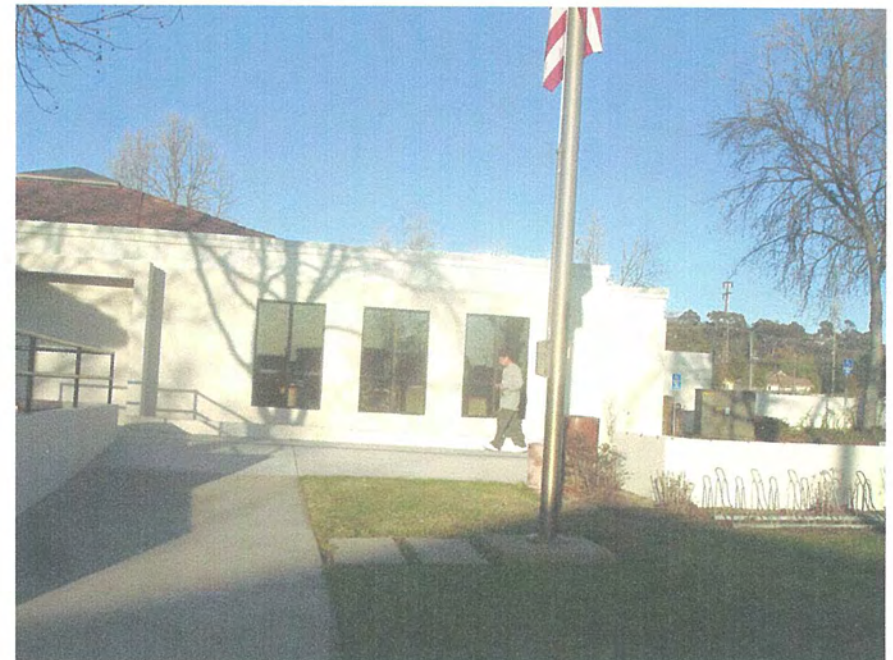
*Site - Photo # 2*

*There is not an accessible path of travel to flag pole. Flagpole operable mechanisms are mounted too high.*

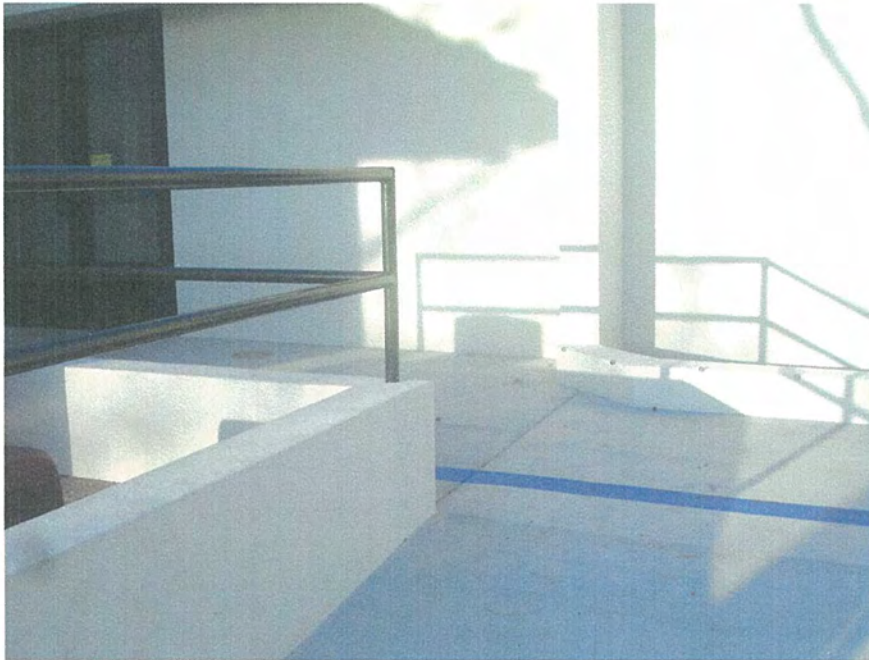
*Site - Photo # 3*

*Walk slope exceeds 5%, requiring compliant ramp handrails.*

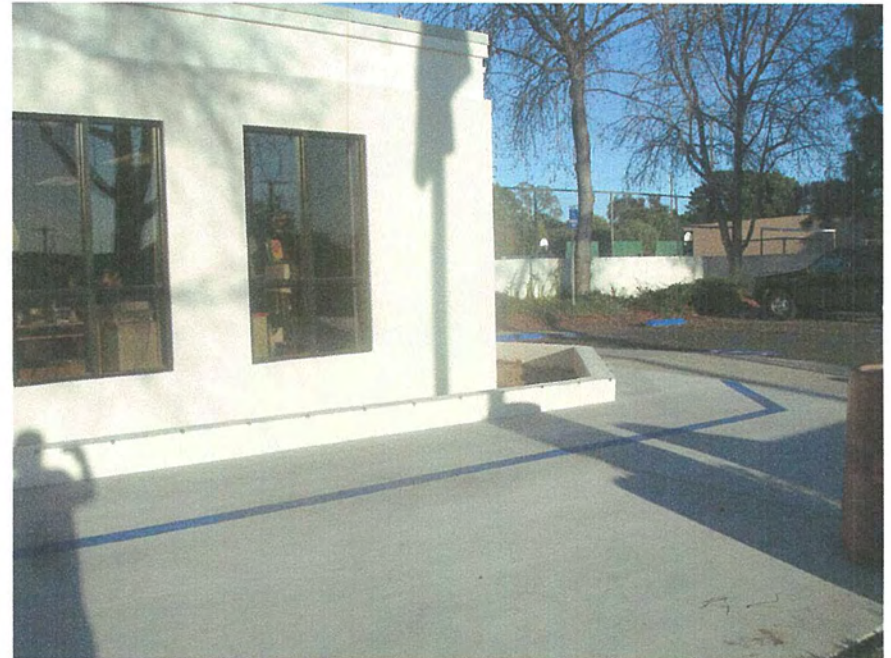
*Site - Photo # 4*

*There are more than 2% cross slope at some areas of the walk.*

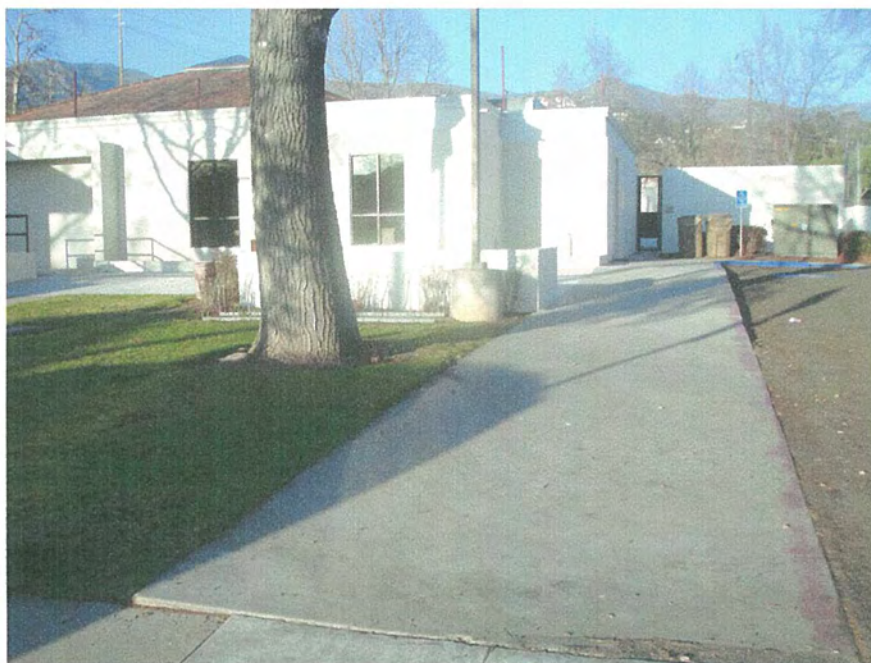
*Site - Photo # 5*

*Walk has excessive cross slope and a section of blended walk with driveway, without detectable warnings for blind pedestrians to warn them that they are entering a vehicular way.*

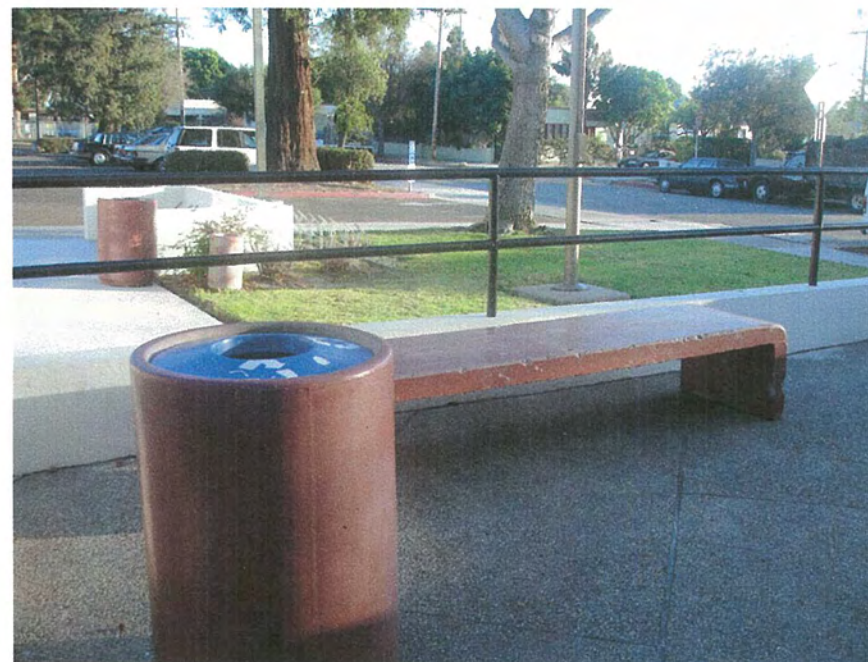
*Site - Photo # 6*

*The bench does not have a section with back and arms.*

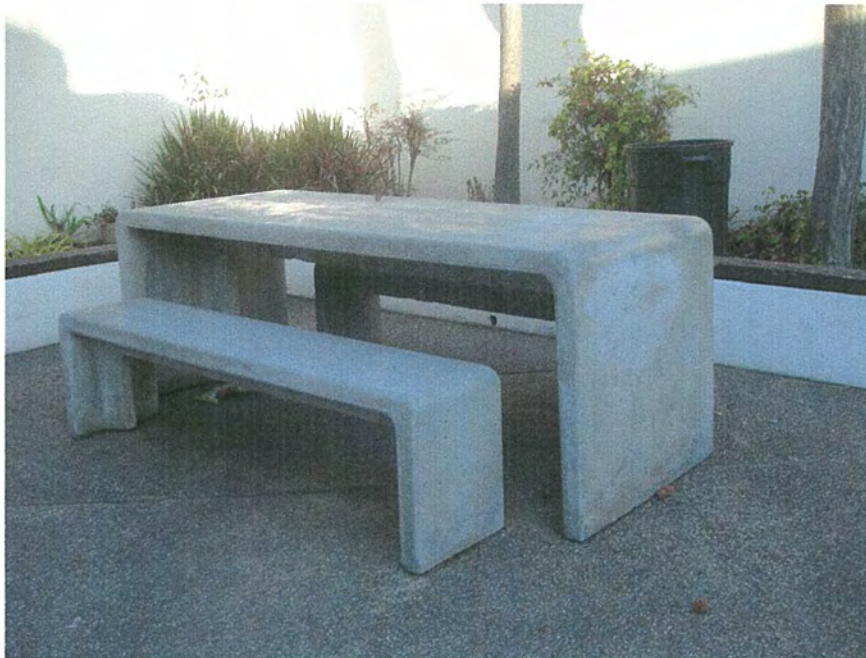
*Site - Photo # 7*

*The picnic table does not have the required knee clearance for a person with disabilities using a wheelchair to sit at the table.*

Recreation areas, picnic benches		Make a minimum of one picnic bench or 5% of all picnic benches provided accessible.	Picnic table does not have the required knee clearance and usable space for wheelchair users.  Photo #: 7	ADAAG: Recommended  T24: N/A	Provide extension for picnic bench end to make accessible.	1	JOB	\$500	\$500	3

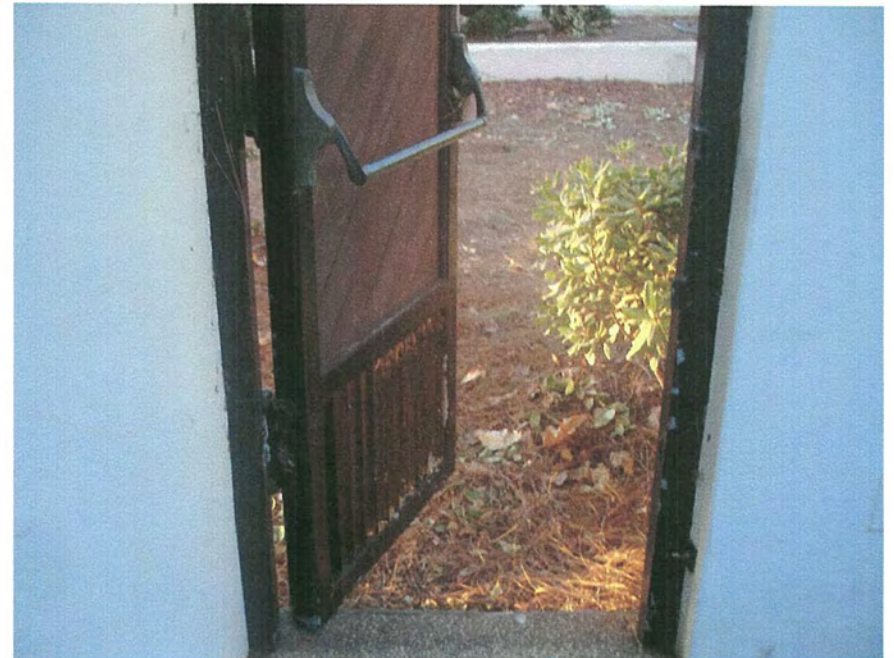
*Site - Photo # 8*

*Narrow exiting door/gate from the patio, does not have the required clear with and a smooth 10" kick plate. There is no accessible path of travel from this door/gate to the main entrance plaza to the library or the sidewalk. There is no tactile/Braille "EXIT" sign.*

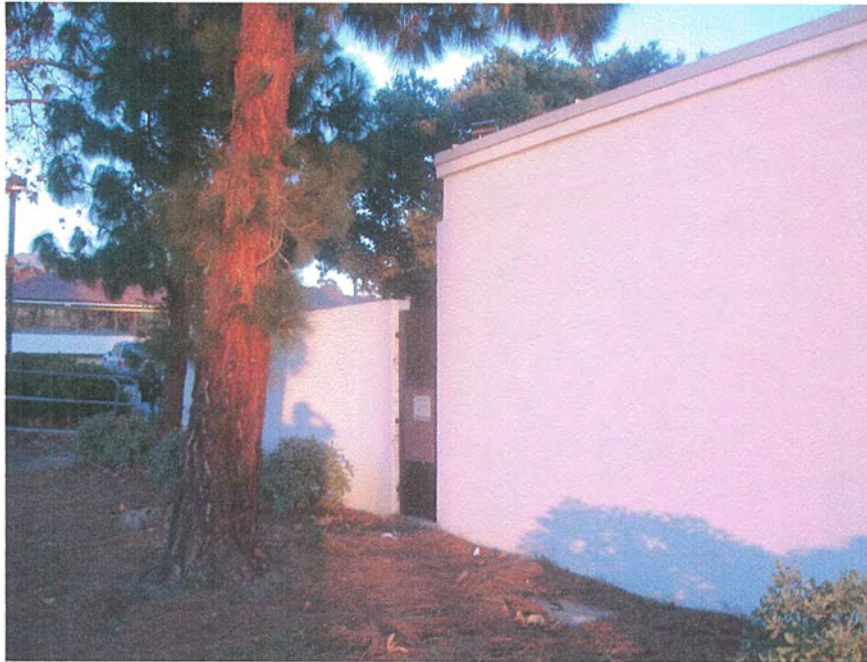
Site - Photo # 9

*There is no accessible path of travel from the door/gate to the main entrance plaza to the library or the sidewalk.*

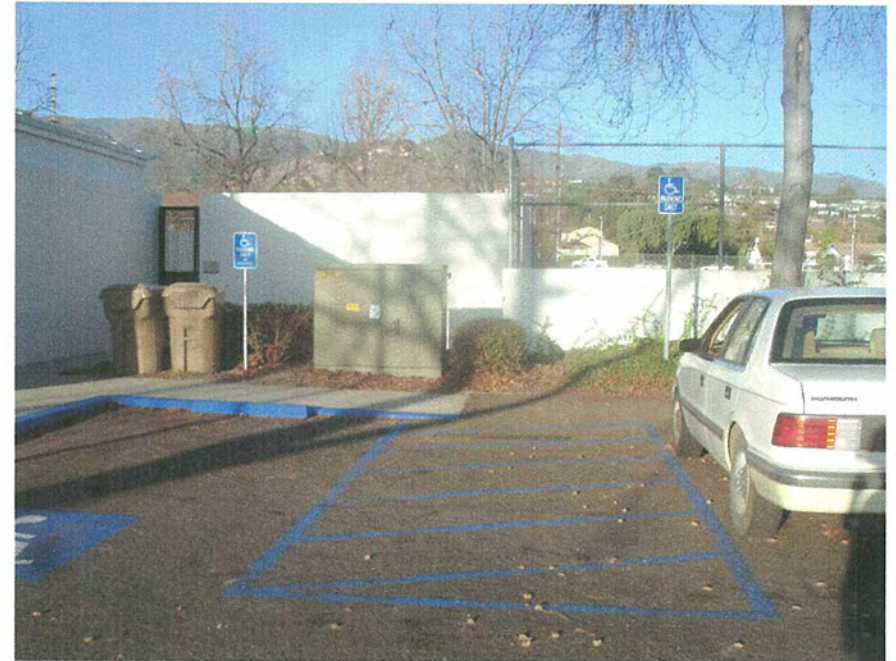
Site - Photo # 10

*There are no detectable warnings indicating blind pedestrians that they are going into a vehicular way. There is not the required "No Parking" sign painted at the access aisle. There are some excessive cross slopes at the parking stall.*

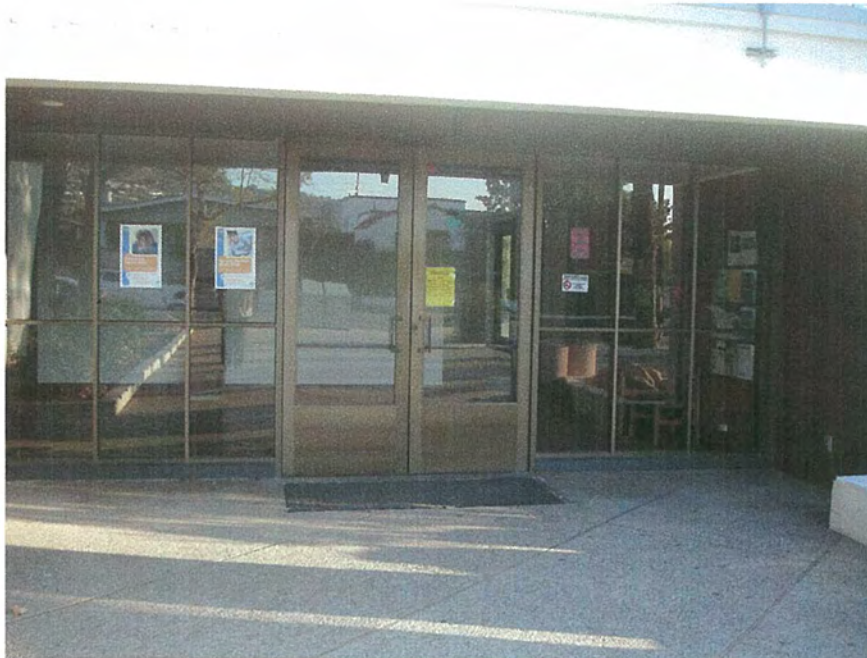
*Building - Photo # 1*

*There is no International Symbol of Accessibility indicating the accessible door. Automatic door does not have operating controls on the exterior of the door, only inside. There is no tactile and Braille entrance identification sign*

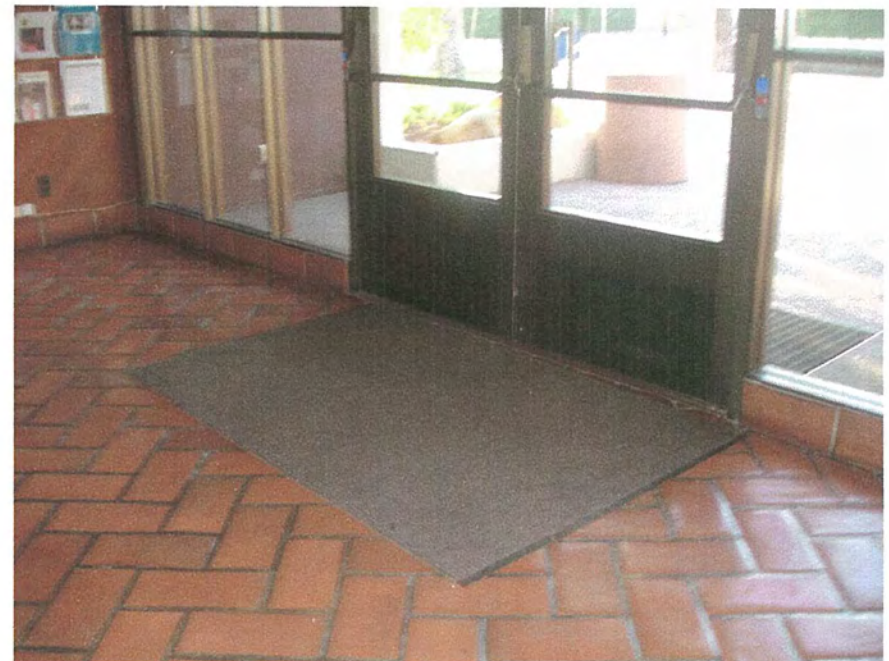
*Building - Photo # 2*

*Automatic door has the operating controls adjacent to the door, which requires wheelchair users to use the push plate and then quickly back out of the way of the door swing. Loose doormat needs to be secured. There is no tactile and Braille "EXIT" sign.*

Surface doormats.	Must be anchored to prevent interference with wheelchair traffic.	Loose doormat. Photo #: 2	ADAAG: 4.5.3 T24: 1133B.1.1.1.3;Fig. 11B-25	Anchor doormat to floor or remove it.	1 JOB	\$100	\$100	2
Surface doormats.	Must be anchored to prevent interference with wheelchair traffic.	Loose doormat. Outside 2" gap. Photo #: 1	ADAAG: 4.5.3 T24: 1133B.1.1.1.3;Fig. 11B-25	Anchor doormat to floor or remove it.	1 JOB	\$100	\$100	2
Door closers, pressure to open interior or exterior doors.	5 lbs. max. effort to open, closing time 3 seconds from 70 degree position and door stops 3" before latch, or provide automatic door openers.	Door force to open 16 lbs., door sweep 4 secs., back check 0 secs.	ADAAG: 4.13.10 & 11 T24: 1133B.2.5 & 1133B.2.5.1	Adjust existing door closer.	1 JOB	\$100	\$100	2

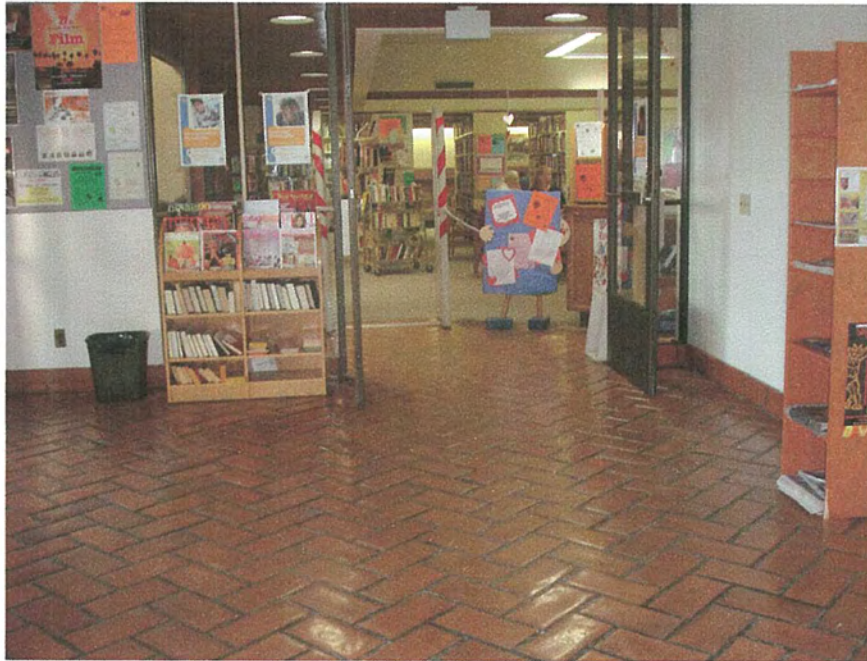
*Building - Photo # 3*

*Library lobby tile floor is not slip resistant and vibration free. There is no tactile and Braille room identification sign.*

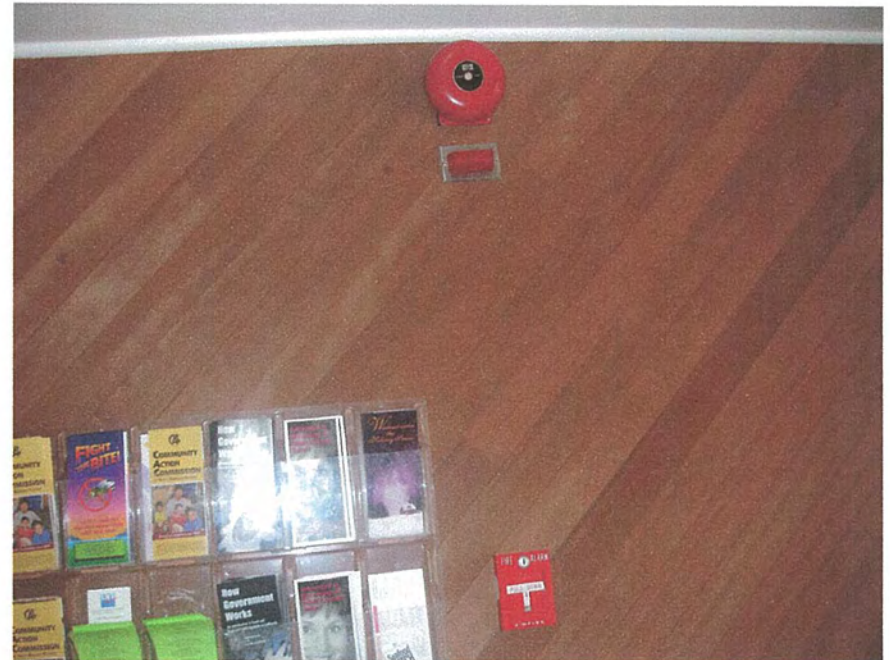
*Building - Photo # 4*

*Strobe light has red cover instead of the required white or clear cover. Fire alarm pull station requires tight grasping to operate and is mounted behind chairs.*

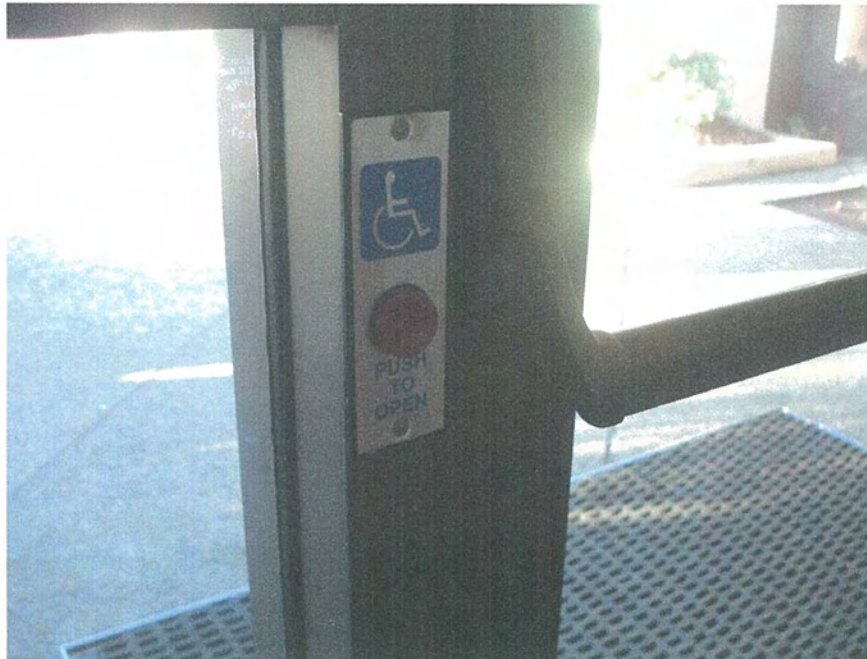
*Building - Photo # 5*

*Automatic door has the operating controls adjacent to the door, which requires wheelchair users to use the push plate and then quickly back out of the way of the door swing.*

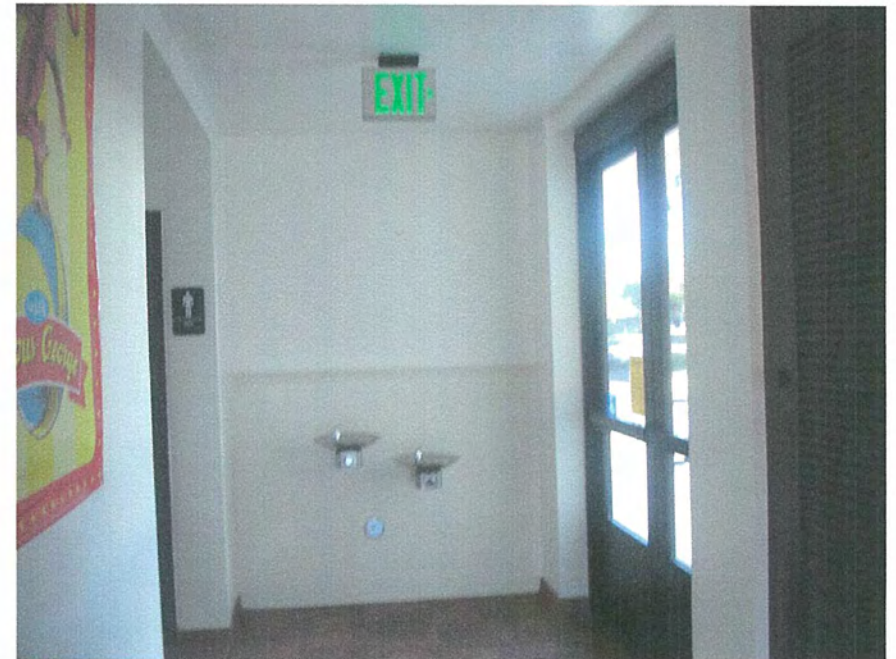
*Building - Photo # 6*

*There is no tactile and Braille "EXIT" sign.*

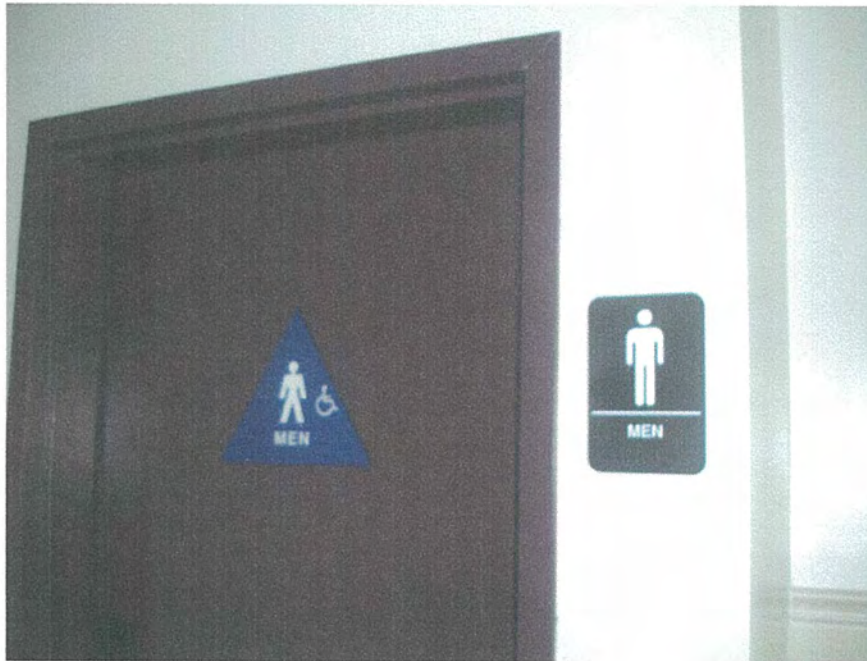
*Building - Photo # 7*

*Tactile Men's restroom sign adjacent to the door has Federal Braille instead of contracted Grade 2 Braille.*

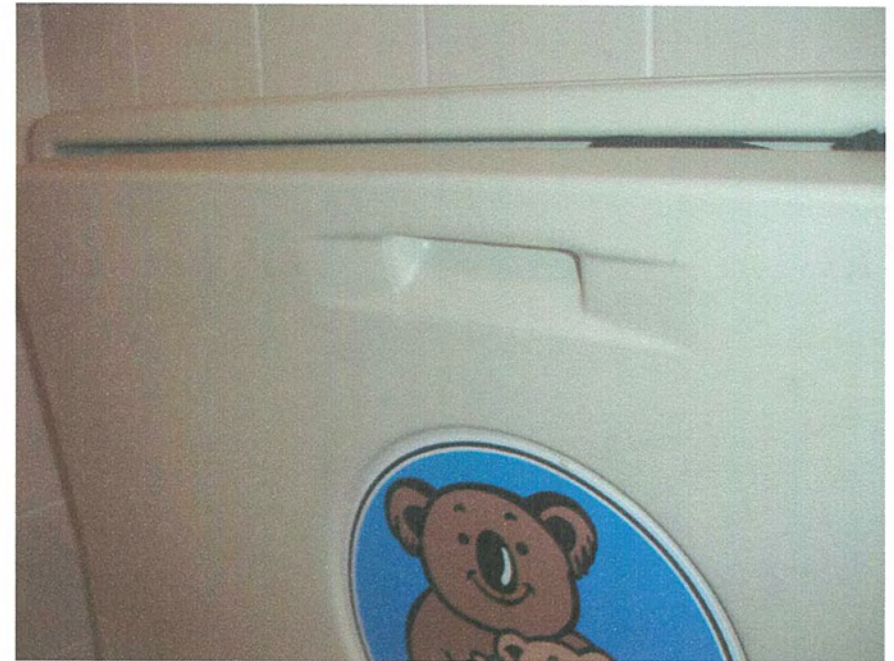
*Building - Photo # 8*

*Baby changer operable mechanism requires tight grasping to operate.*

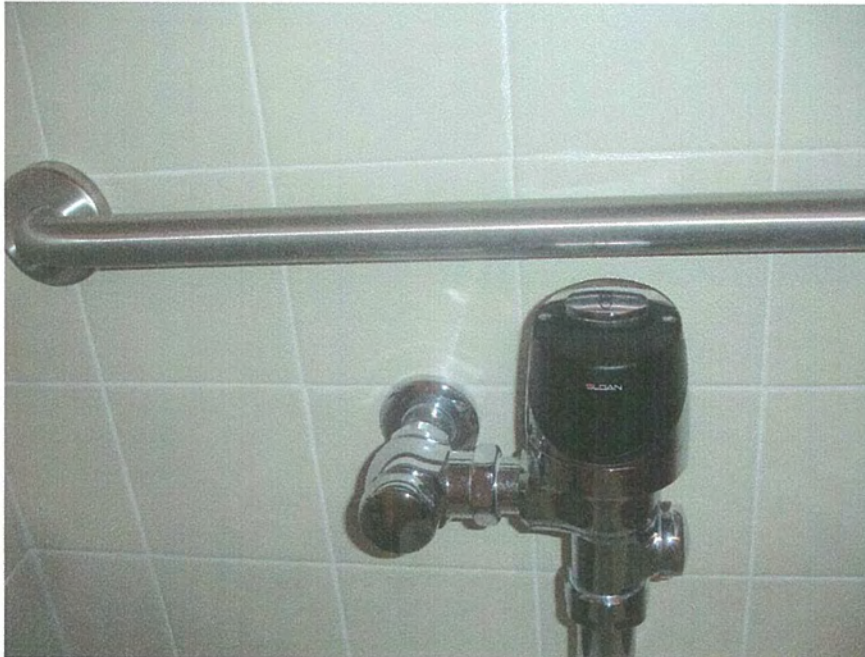
*Building - Photo # 9*

*There is not the required 1 ½" minimum clearance  
between grab bar and automatic flush valve.*

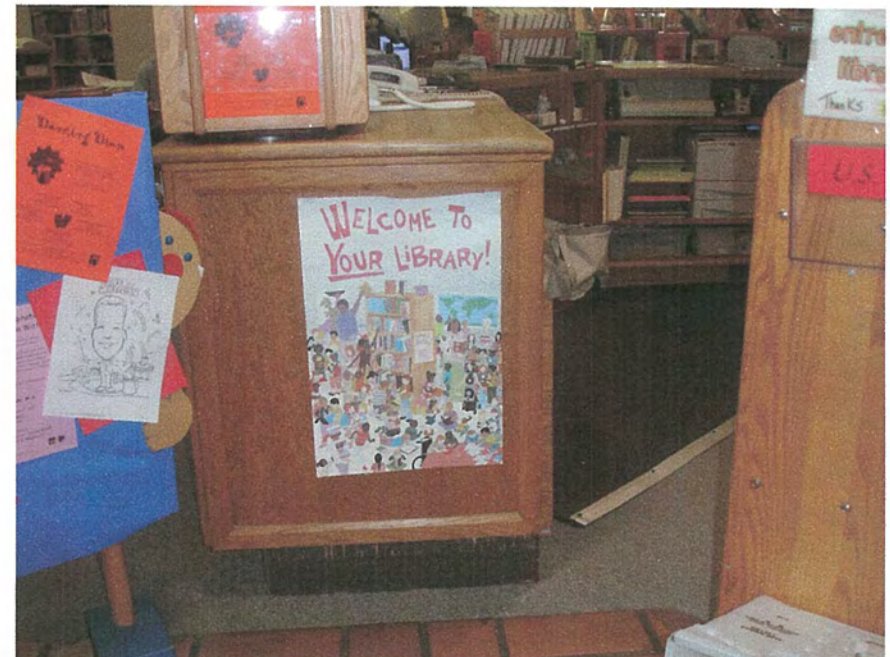
*Building - Photo # 10*

*Circulation to counter back work area is too narrow, less  
than 36" wide.*

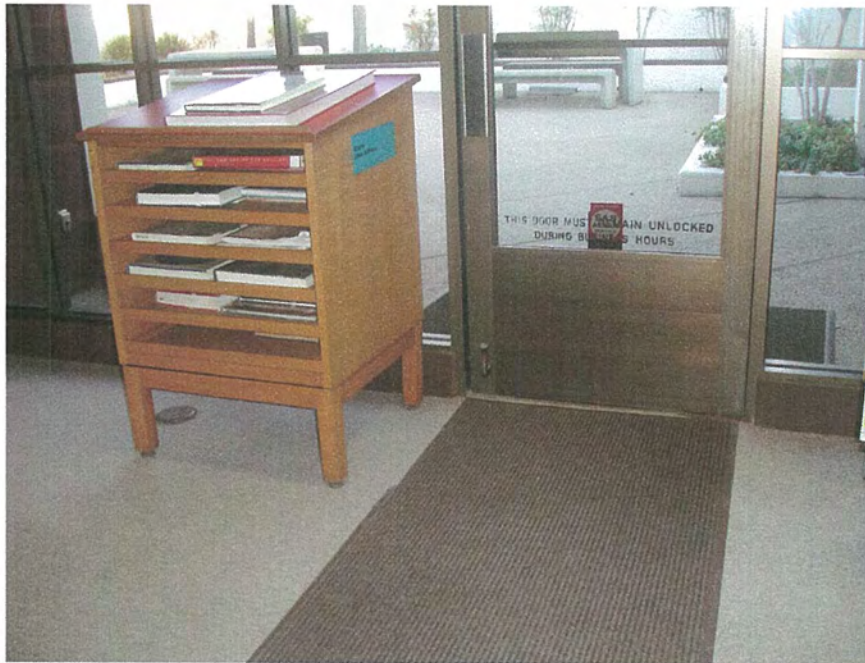
*Building - Photo # 11*

*Furniture blocks the required push side strike clearance at door. Loose doormats needs to be secured. Doorstop is located at the lower 10" kick plate area required to be smooth. There is no tactile and Braille "EXIT ROUTE" sign.*

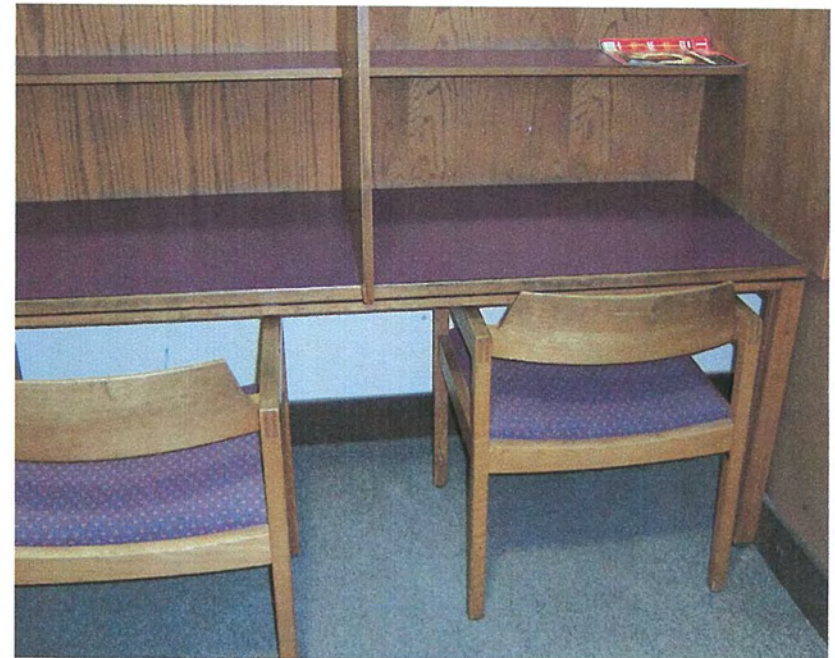
*Building - Photo # 12*

*Built-in study carrel does not have the required knee clearance.*

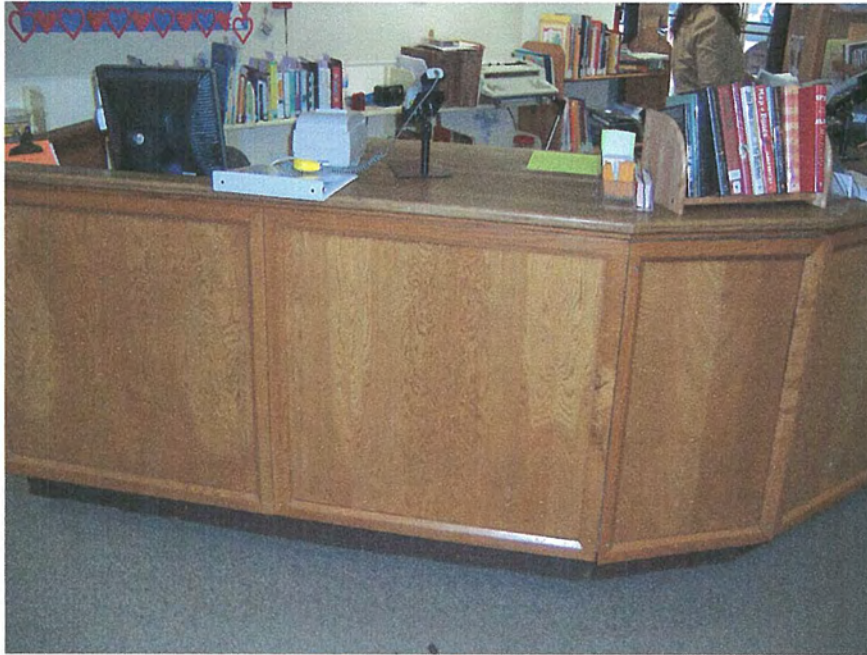
*Building - Photo # 13*

*Library counter is too high and does not have a low section of 34" maximum height by 36" minimum width, for wheelchair users.*

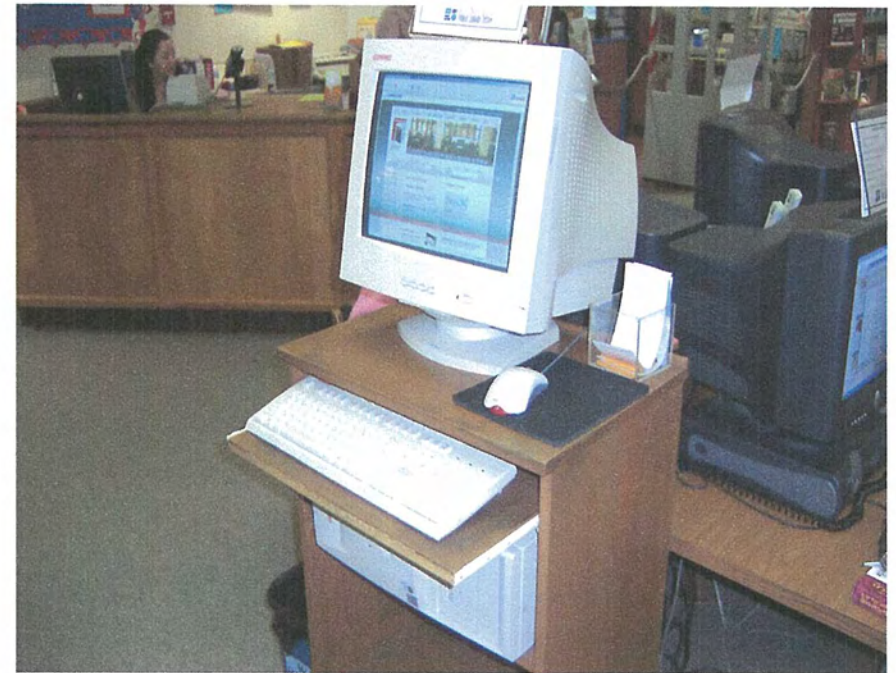
*Building - Photo # 14*

*Computer library catalog is not accessible, it does not have the required knee clearance and is mounted too high.*

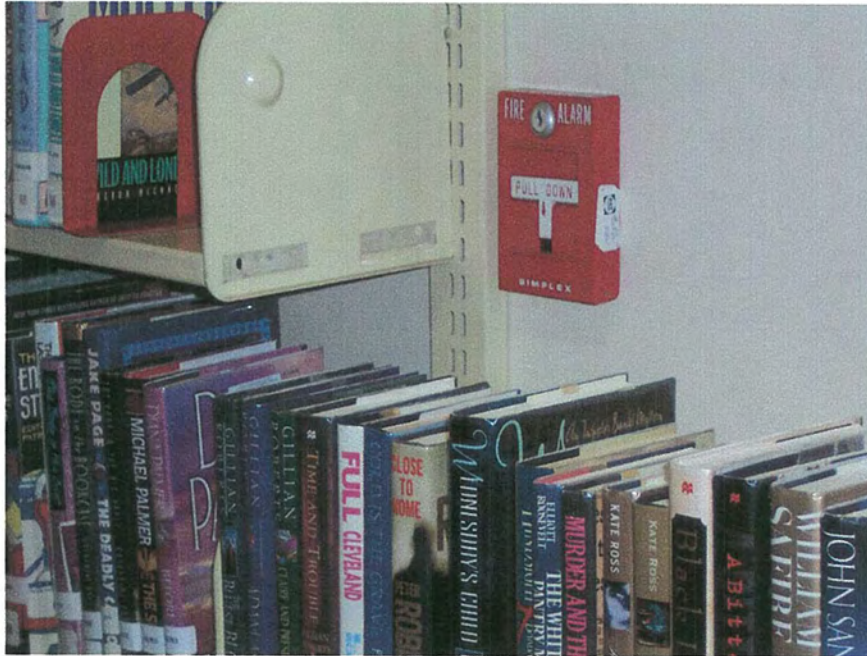
*Building - Photo # 15*

*Fire alarm pull station requires tight grasping to operate and is mounted too high behind bookcase.*

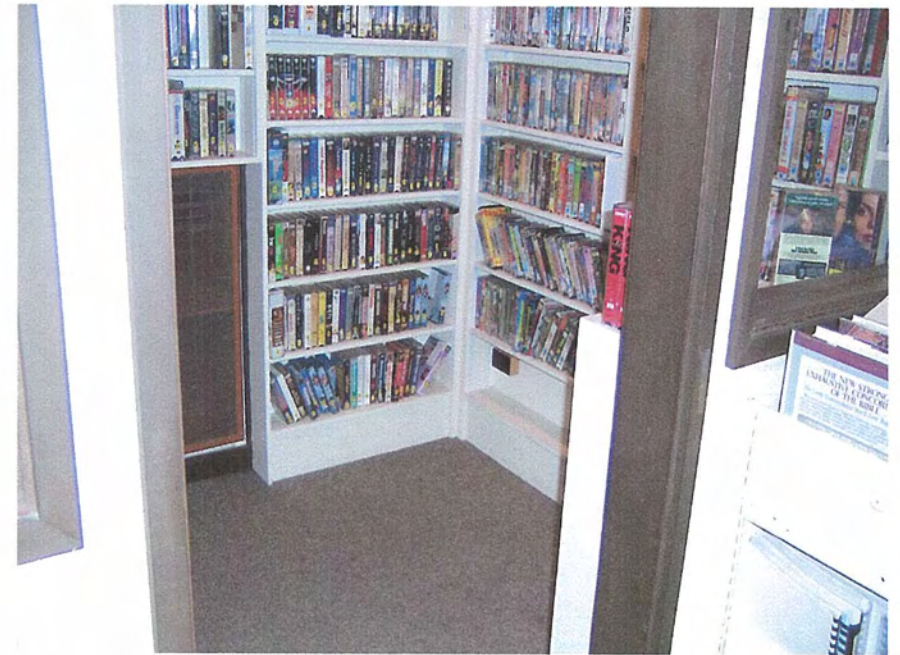
*Building - Photo # 16*

*Video bookshelves mounted above 56" high, require sign indicating that there is an attendant at the library that will help retrieving videotapes. A similar sign shall be posted at the main library counter.*

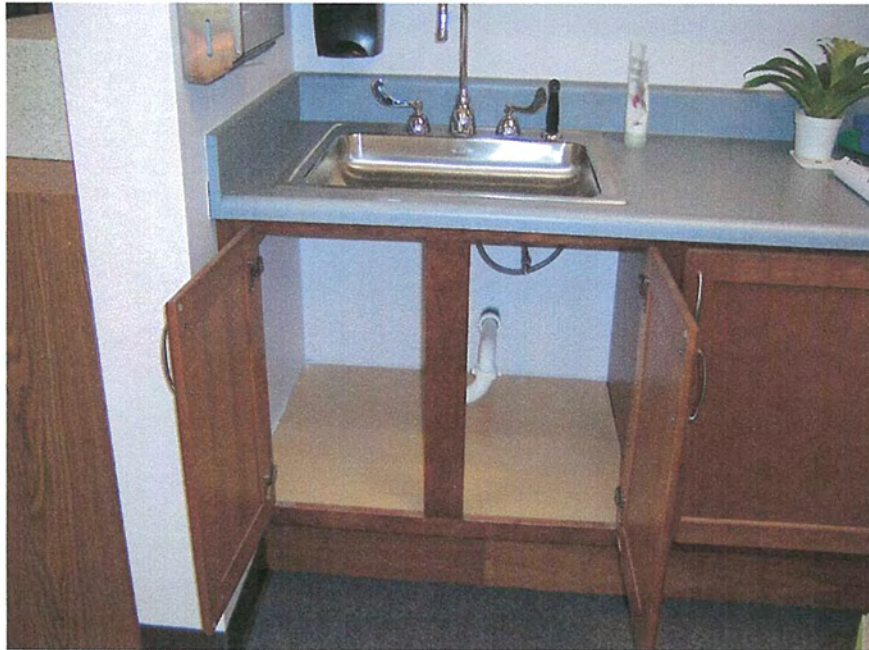
*Building - Photo # 17*

*Sink is not accessible, it does not have the required knee clearance.*

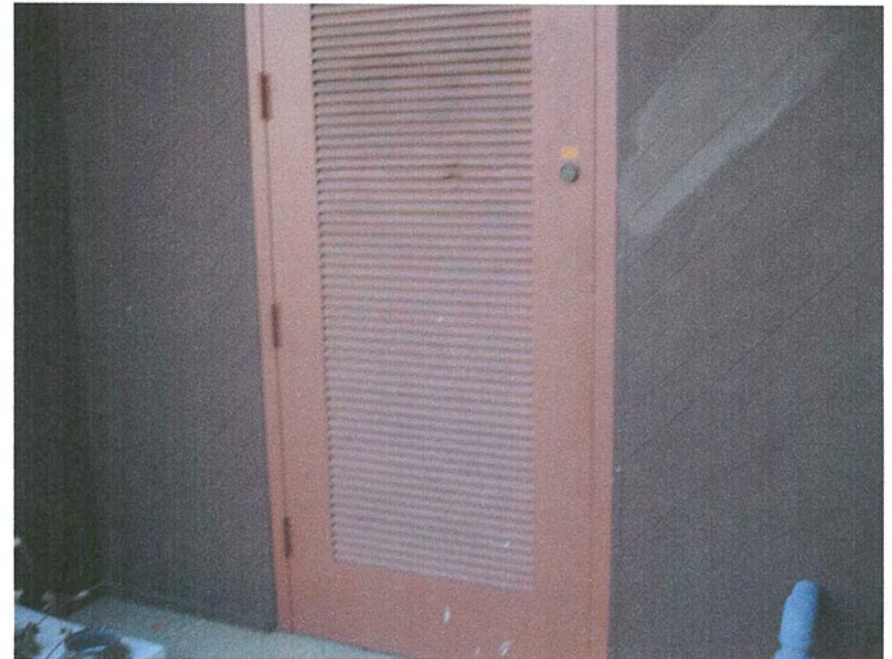
*Building - Photo # 18*

*There is not lever hardware and tactile and Braille sign.*
