**CABRILLO PAVILLION ARTS
CENTER**
ACCESSIBILITY SURVEY

June, 2007

**CITY OF SANTA
BARBARA**

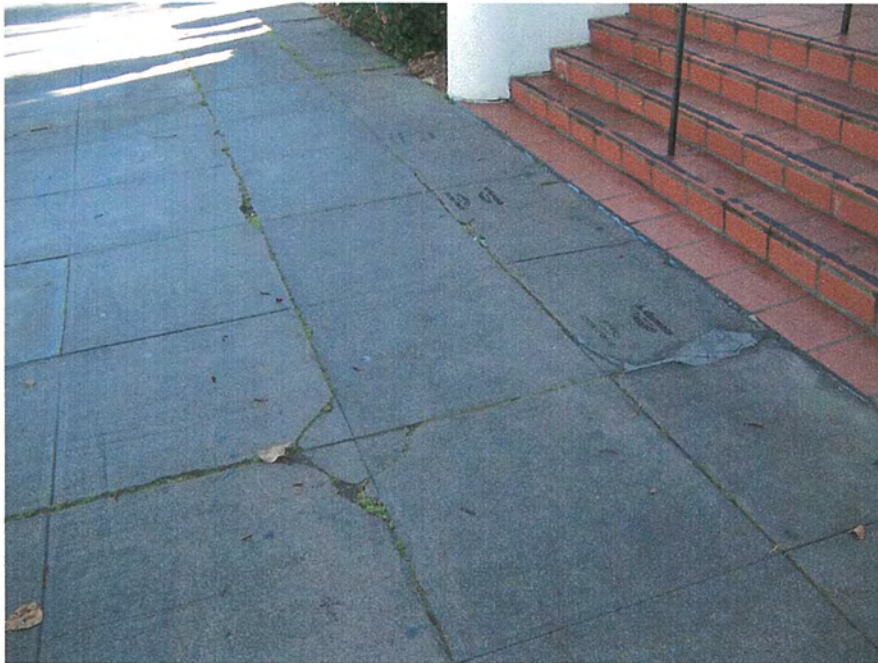
Public Right-of-Way - Photo # 1

Sidewalk has uneven surfaces and cracks at several locations and need maintenance.

Surface stable, firm, slip resistant.	Surfaces with <6% gradient shall have a medium salted finish	Uneven surface with gaps, grass and cracks. Photo #: 1	ADAAG: 4.5.1 T24: 1133B.7.1.1	Repair existing surface, cracks and offsets.	3E+ 03	SF	\$10	\$25,500	2
---------------------------------------	--	---	----------------------------------	--	-----------	----	------	----------	---

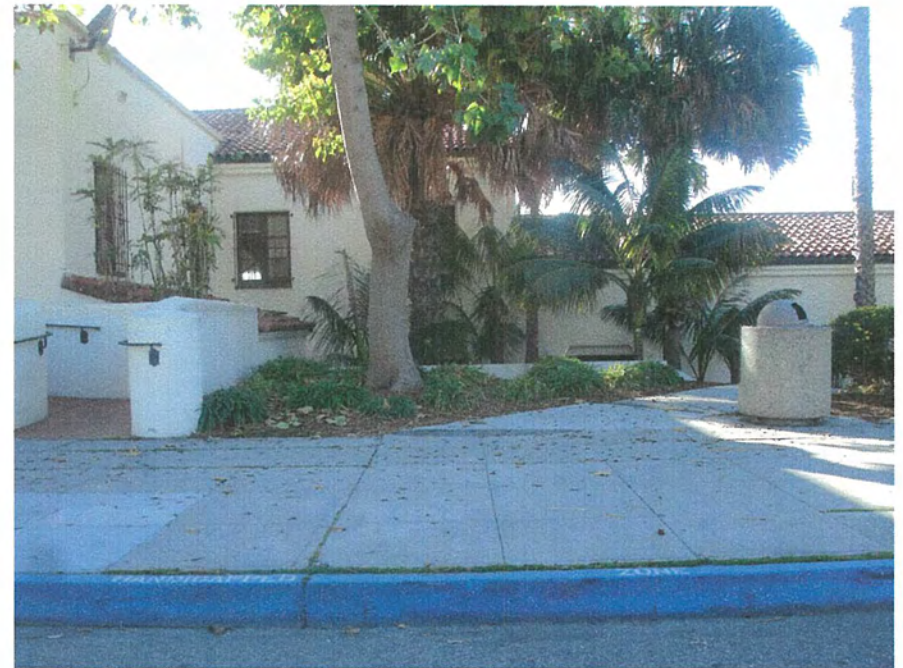
Public Right-of-Way - Photo # 2

On-street accessible parking does not have a curb ramp at the back of the parking space for access from street to sidewalk of vans with back wheelchair lifts.

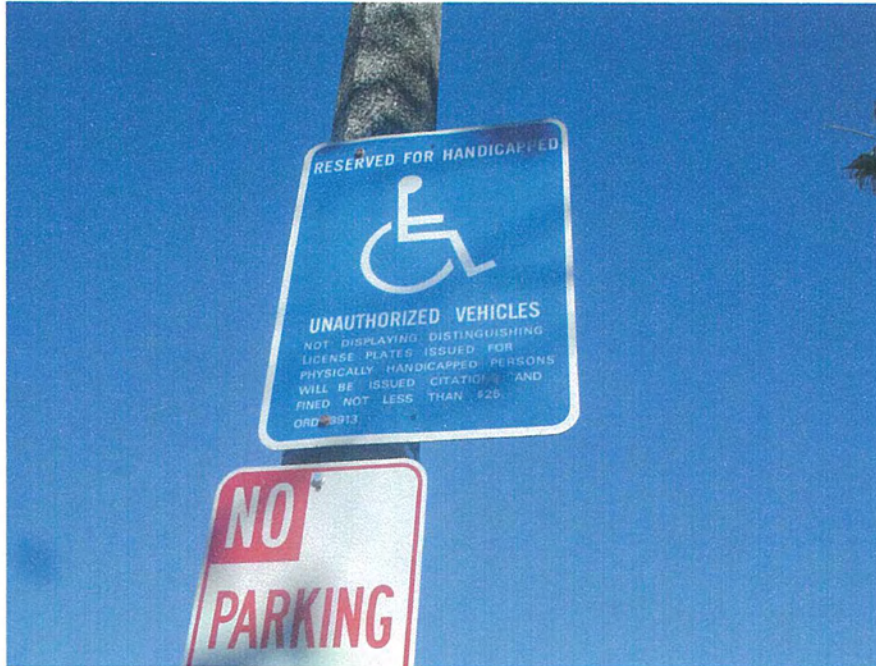
Public Right-of-Way - Photo # 3

*On-street accessible parking sign uses the term
"Handicapped" instead of "Persons with disabilities".*

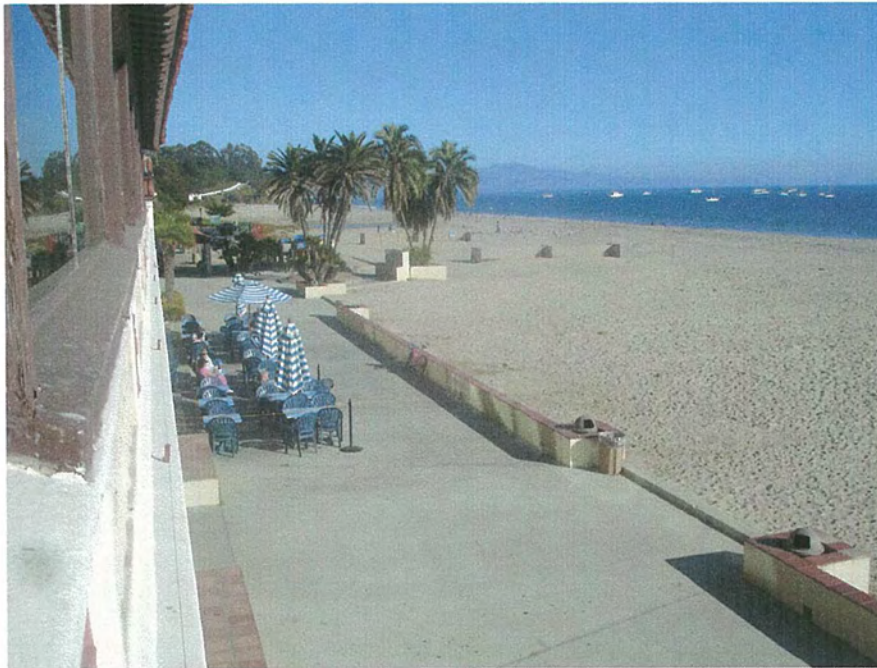
Site - Photo # 1

Walk 4.5% - 5.8% cross slope. There is no accessible path of travel with a firm stable and slip resistant surface to provide beach access at this location.

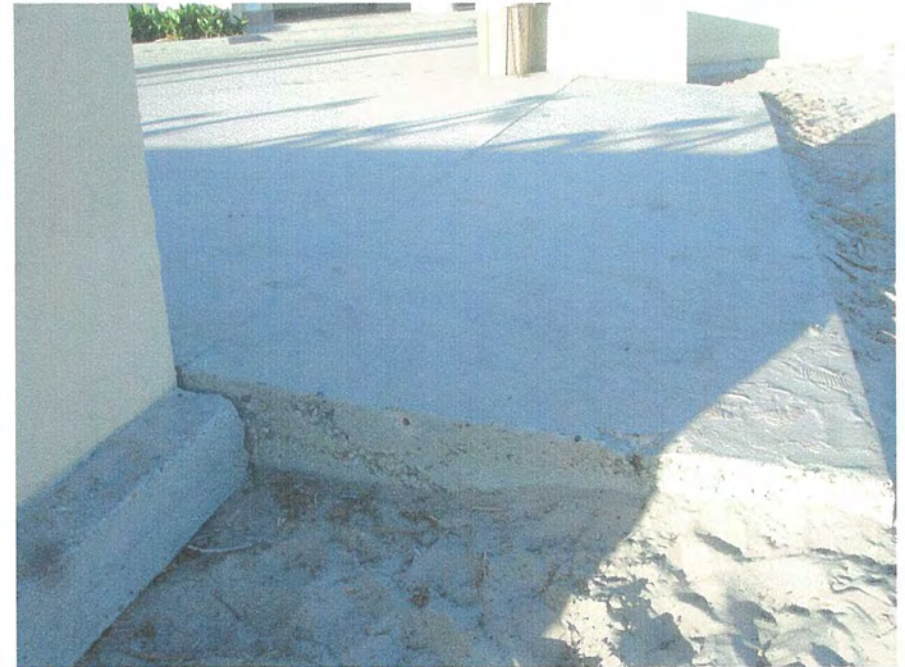
Site - Photo # 2

Ramp running slope 11.6% slope. There is a 3"-5" drop-off to the beach sand surface and 9" drop on the sides.

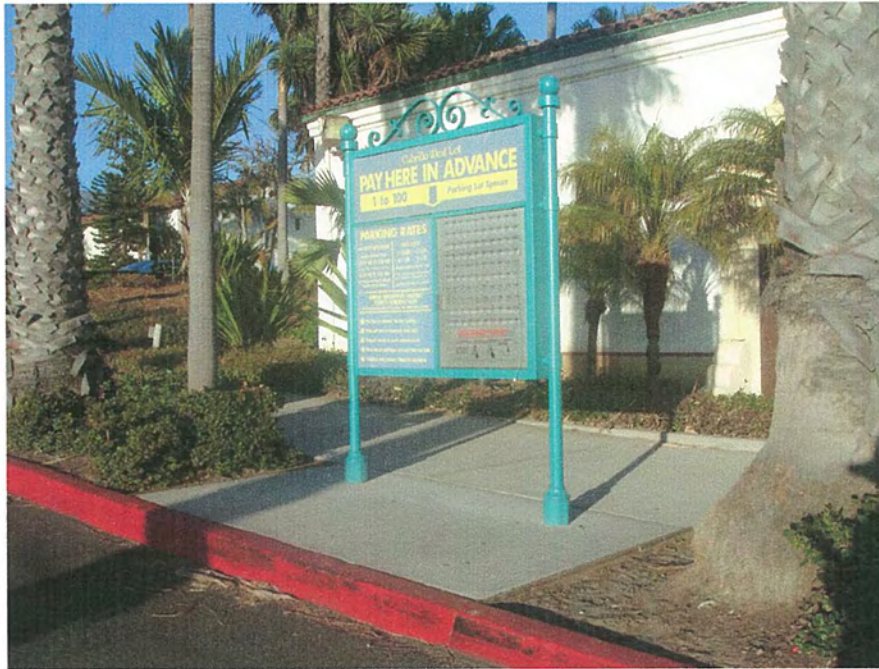
Site - Photo # 3

There is no level area in front of parking fee slots, 4.8% slope. Parking fee slots are not located on an accessible path of travel 24" wide passage.

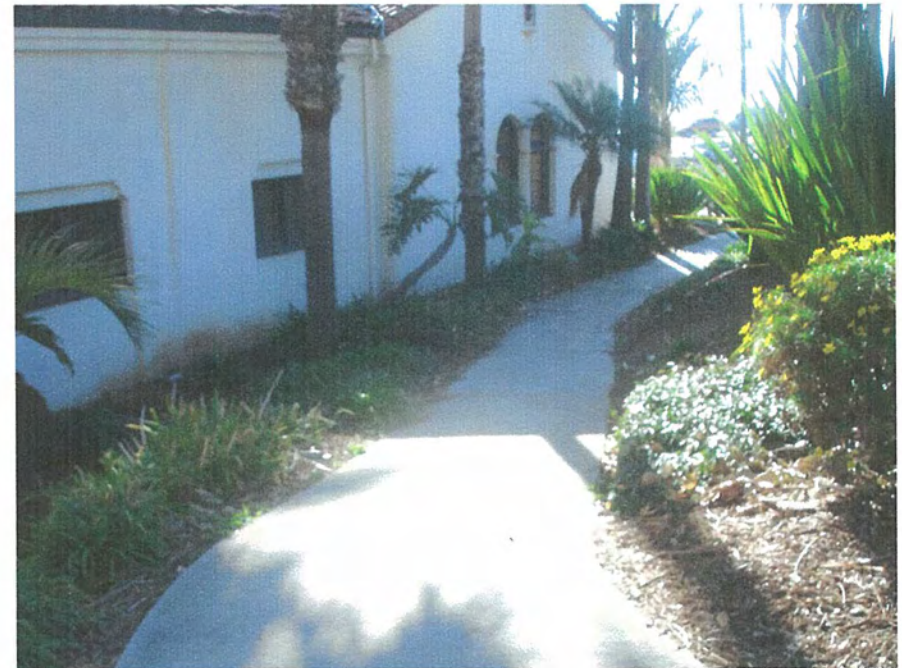
Site - Photo # 4

Running slope ranges from 6.8% to 21.4%. There are no handrails provided.

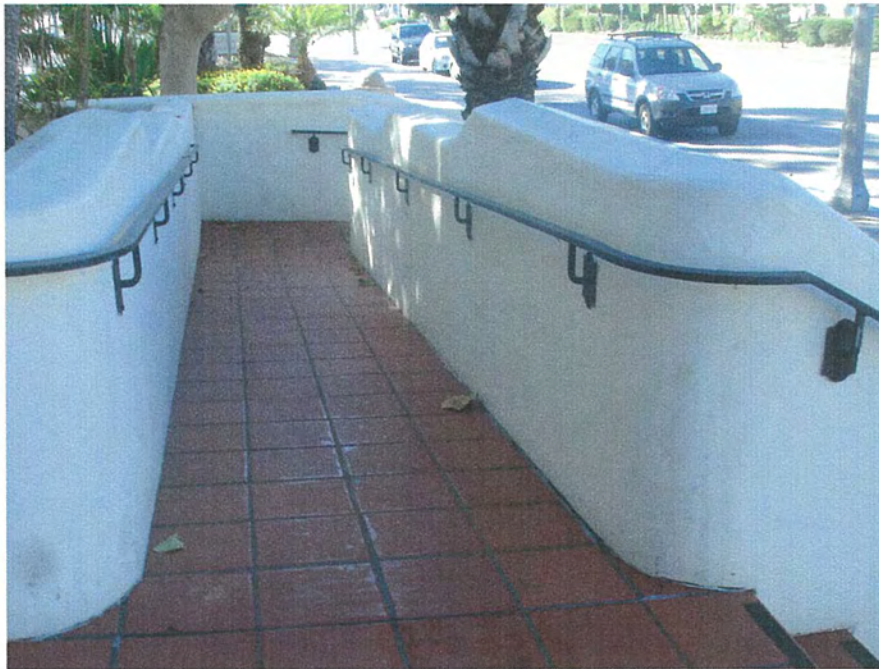
Site - Photo # 5

*Ramp cross slopes range from 2.8%-3.7% slope,
running slope is 9.5%-9.7% .*

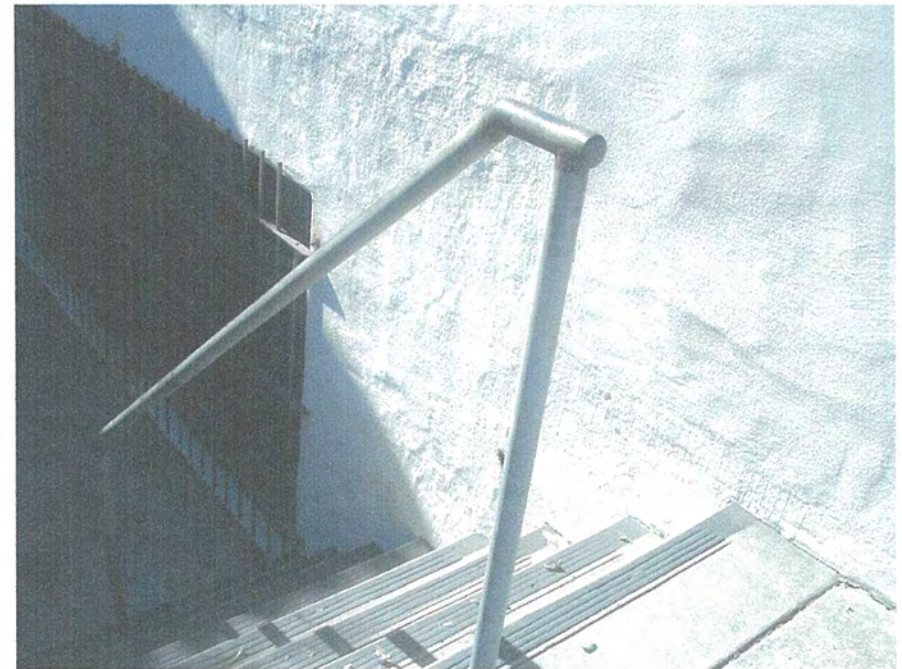
Site - Photo # 6

*There are no handrails on both sides of stair, no top and
bottom extensions.*

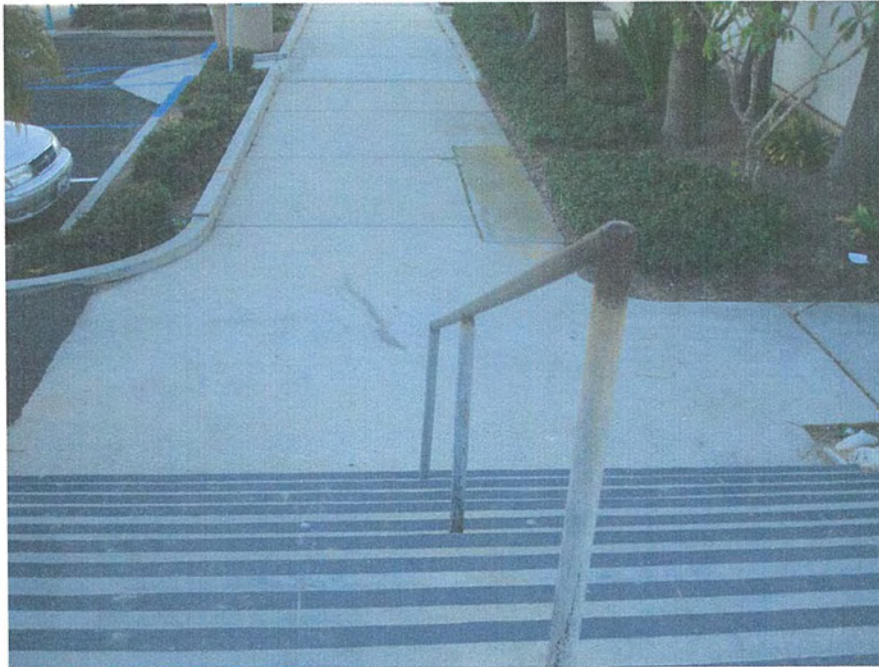
Site - Photo # 7

Handrails mounted at 31" high, there are no handrail extensions.

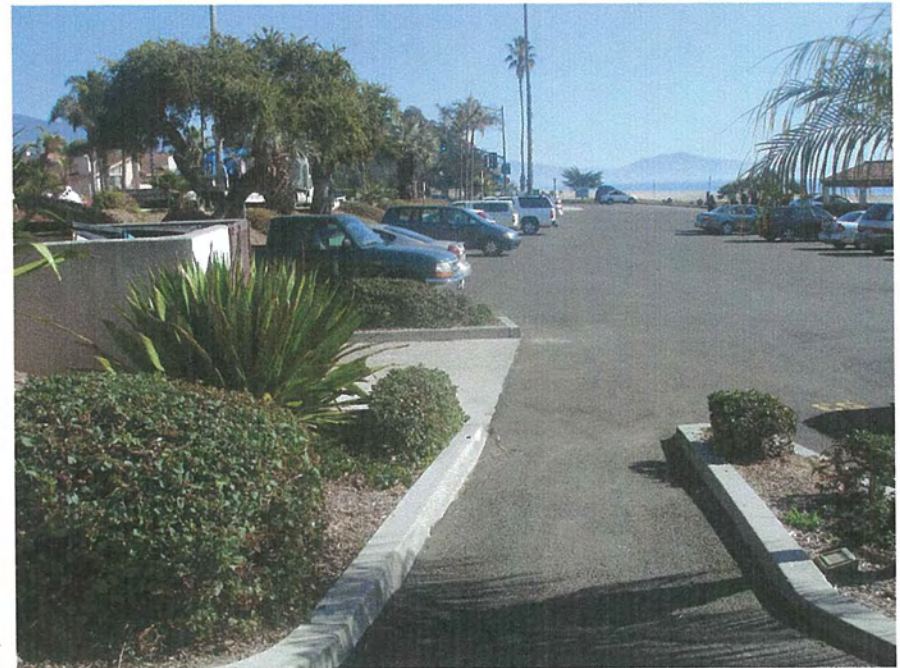
Site - Photo # 8

No detectable warnings provided at bottom of walk at entrance to parking lot to warn blind pedestrians that they are entering into a vehicular way.

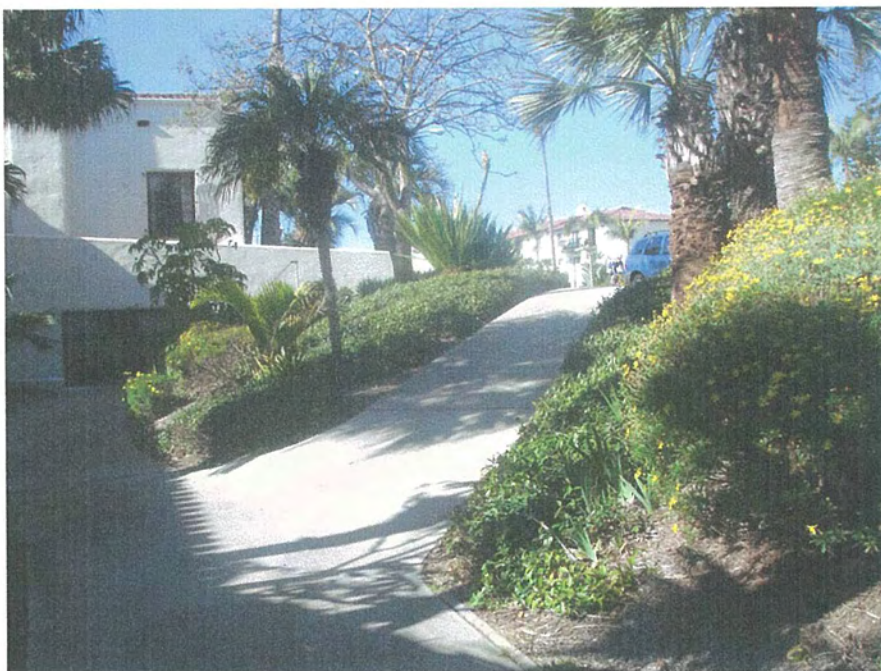
Site - Photo # 9

Ramp running slope 19.5%. Provide directional signs at the top and bottom of sloped walk, directing to the accessible path of travel, indicating that there is a steep slope in this area.

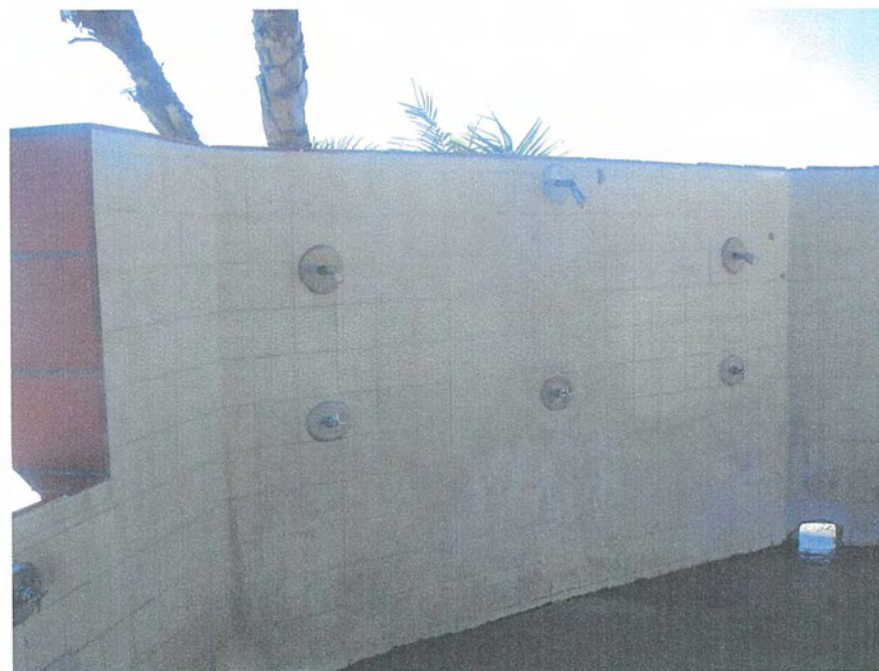
Site - Photo # 10

Shower controls require continuous grip. Provide accessible type hardware.

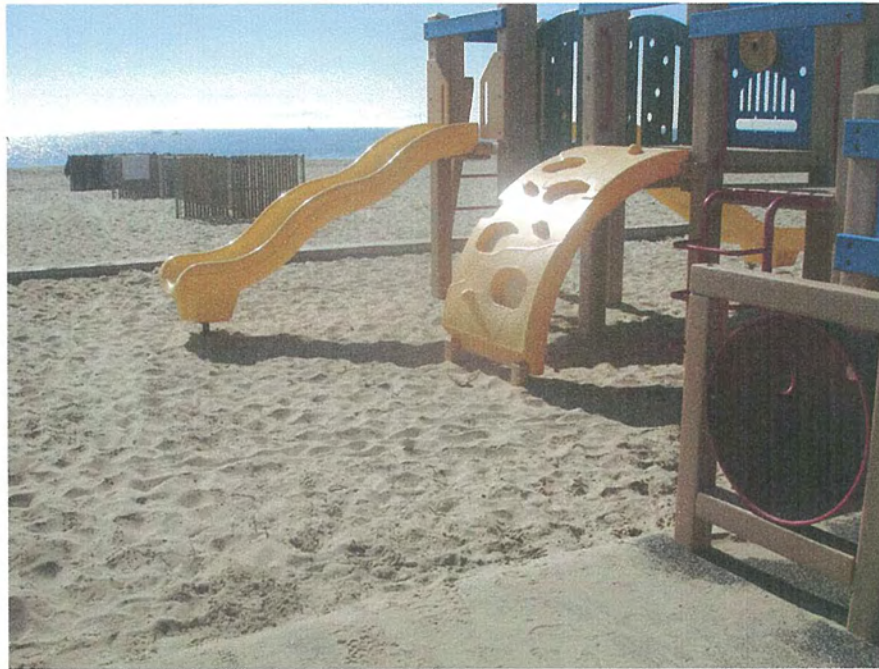
Site - Photo # 11

There is not resilient surface connecting the exiting points and elements of play structure. Sand play area at ground level only. Provide a new section of elevated sand plan area with a knee clearance and an accessible path of travel to it.

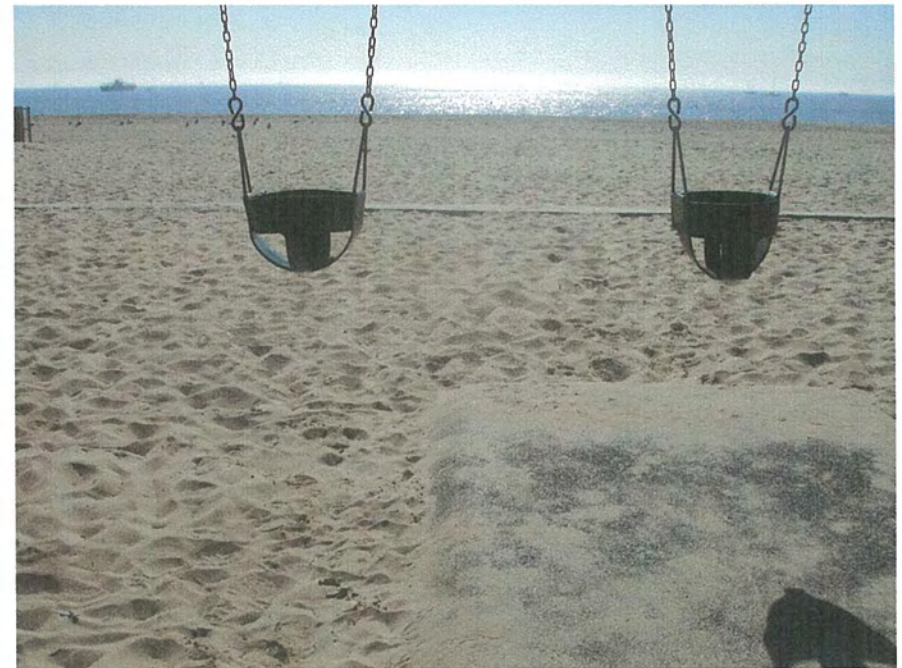
Site - Photo # 12

There is a drop greater than 1/4" to sand surface. Maintain the sand level at the same height of children's play area resilient surface.

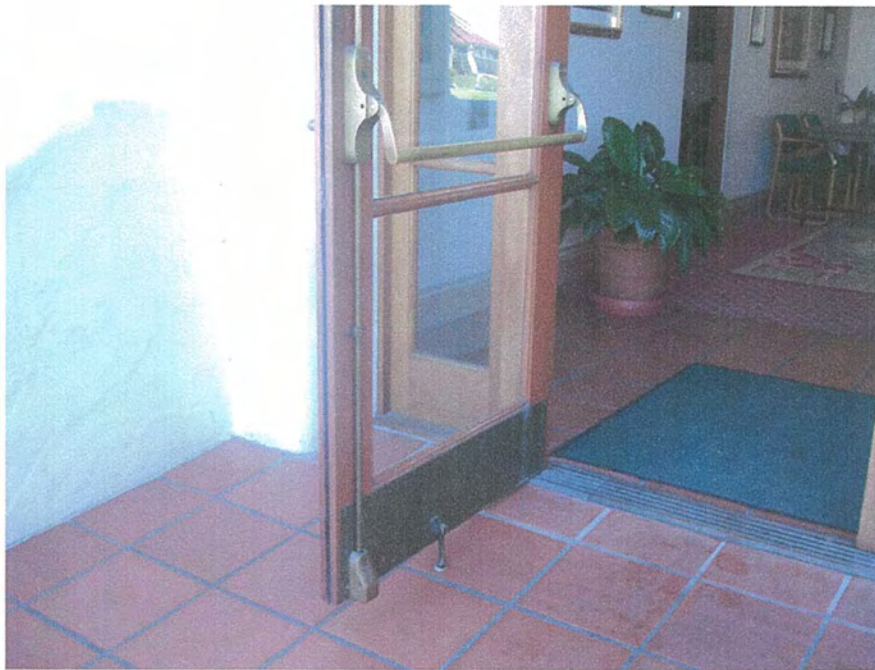
Building - Photo # 1

Doorstop and panic rod are located at the kick-plate area required to be smooth. 9" kick plate provided instead of the required 10" minimum kick-plate area. Loose doormat needs to be secured. Door landing has a 7.7% running slope.

Surface doormats.	Must be anchored to prevent interference with wheelchair traffic.	Loose doormat. Photo #: 1	ADAAG: 4.5.3 T24: 1133B.1.1.1.3;Fig. 11B-25	Anchor doormat to floor or remove it.	1 JOB	\$100	\$100	2
Bottom Kick plate.	10" high min. smooth, uninterrupted surface at push side of doors on accessible route. (CA only). Except for automatic & sliding doors.	Door does not have a compliant kick plate - 9" high and panic rod is located within kick plate area. Photo #: 1	ADAAG: T24: 1133B.2.6; Fig. 11B-29	Provide 10" high kick plate covers.	2 JOB	\$300	\$600	3
Bottom Kick plate-door stop.	10" high min. smooth, uninterrupted surface at push side of doors on accessible route. (CA only). Except for automatic & sliding doors.	Door stop mounted at kick plate area. Photo #: 1	ADAAG: T24: 1133B.2.6; Fig. 11B-29	Remove door stop when altering area. Provide wall mounted door stop.	2 JOB	\$40	\$80	2

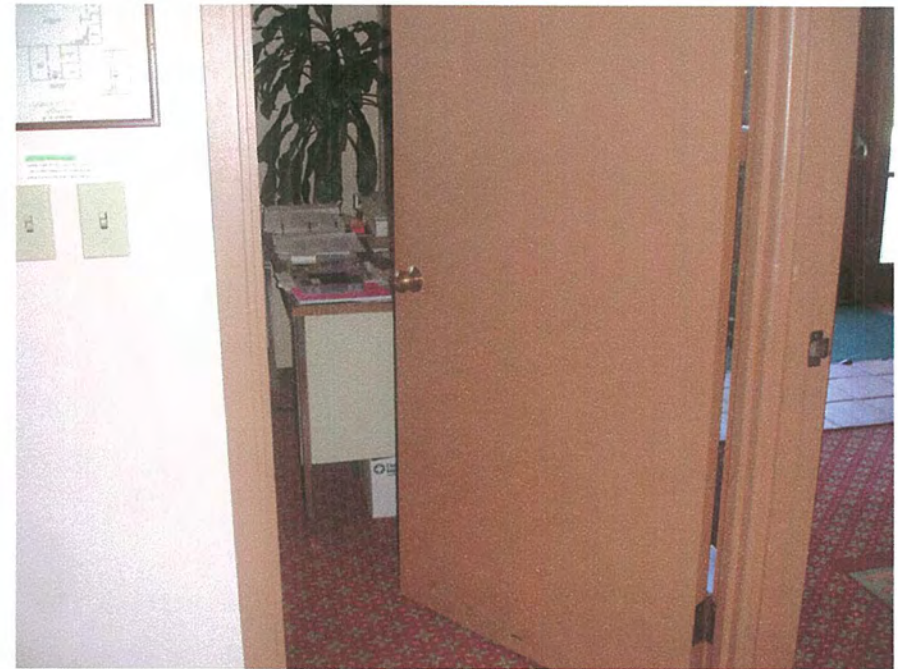
Building - Photo # 2

Doorknob requires tight grasping to operate. There is not the required tactile and Braille room identification sign mounted adjacent at the latch side of the door. Desk is located 46" in front of the door reducing the required wheelchair maneuverable clearance required to be 60".

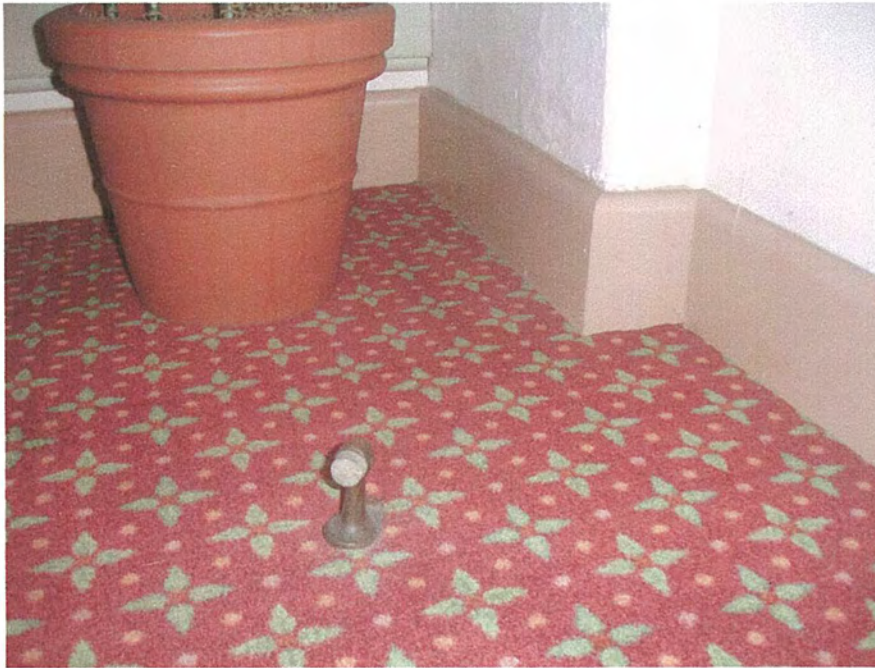
Building - Photo # 3

Floor stop is located at 16" from the wall becoming a tripping hazard.

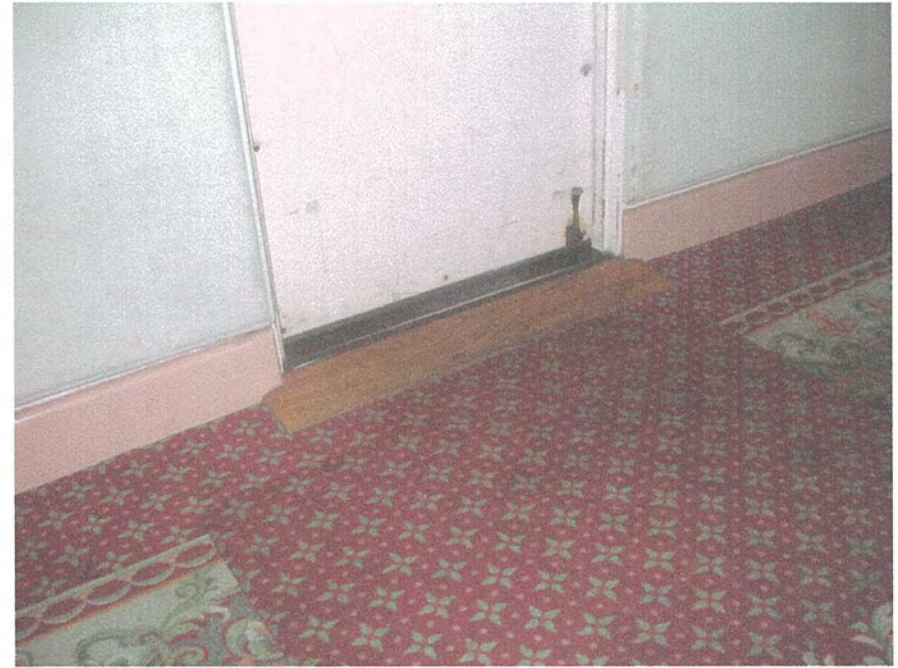
Building - Photo # 4

1 ½" high threshold, instead of the required ½" beveled maximum. Loose doormat needs to be secured. Doorstop is located at the kick-plate area required to be smooth.

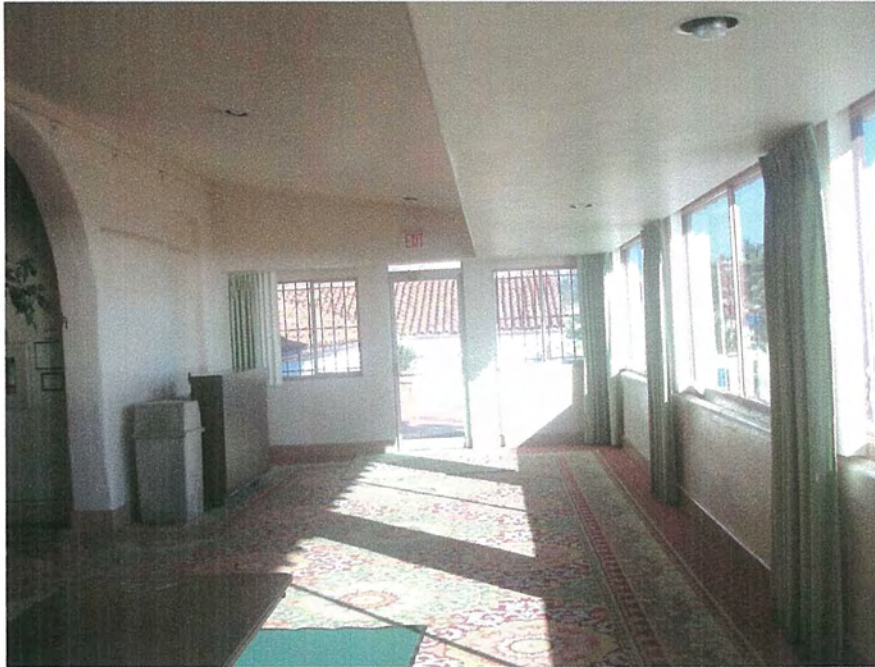
Building - Photo # 5

There is not the required tactile and Braille room identification sign and "EXIT ROUTE" signs at the East and West side doors leading to the terrace. There are no strobe lights. Loose doormat need to be secured.

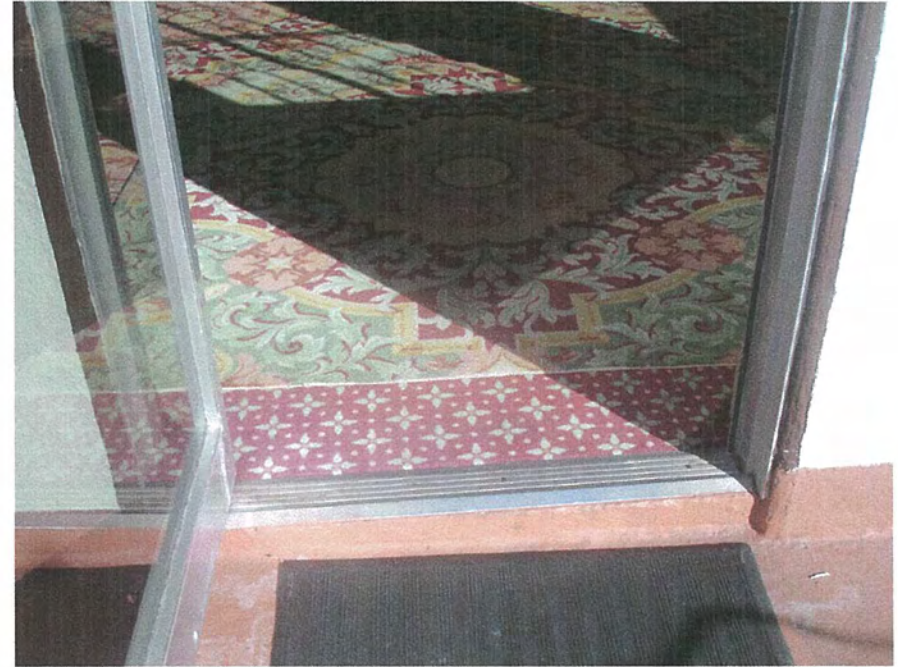
Building - Photo # 6

Doors at both ends of the enclosed terrace have a 30 3/4" clearance instead of the required 32" clear opening. There is 3" drop to the exterior terrace. Loose doormats need to be secured.

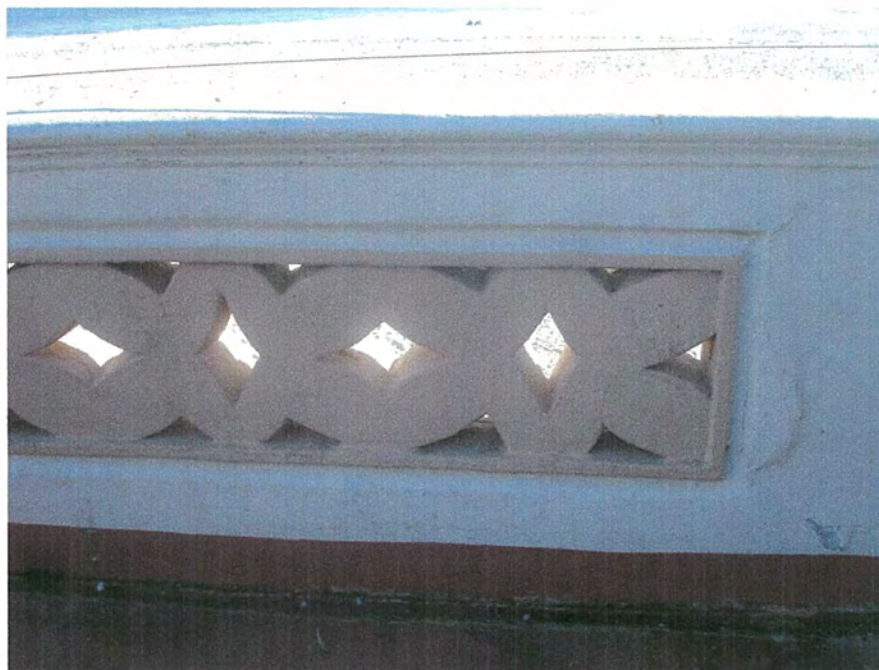
Building - Photo # 7

Guardrail is 40" high instead of the required 42" minimum height above finish floor.

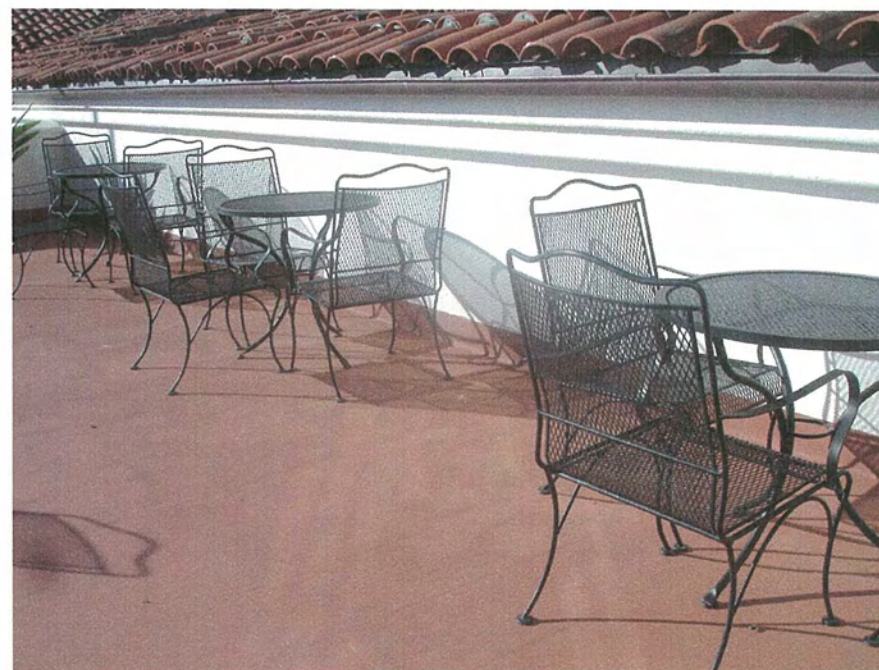
Building - Photo # 8

Tables do not have the required knee clearance for wheelchair users.

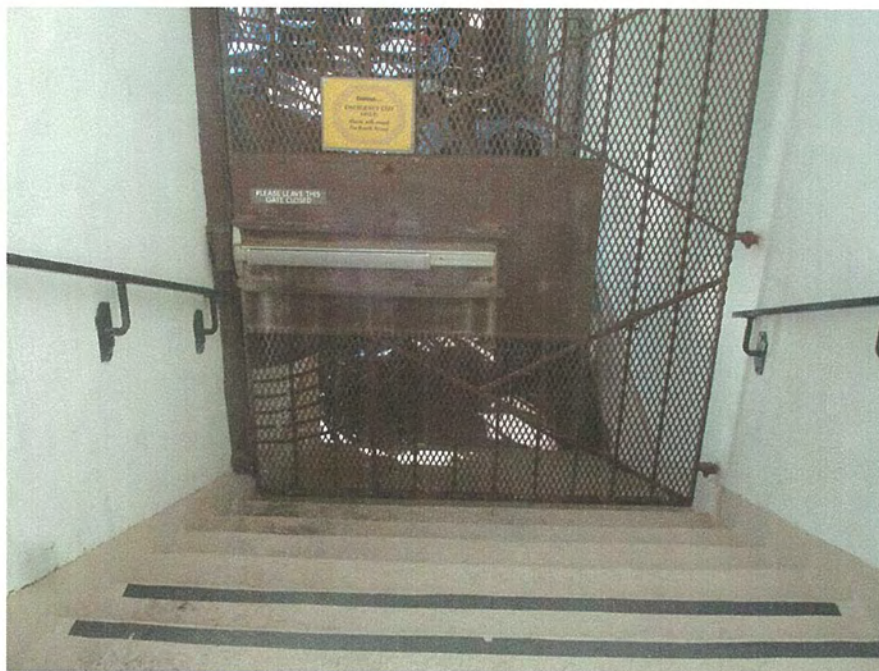
Building - Photo # 9

Door is located in the middle of the stairway without compliant landings in either side. Contrasting color striping not provided at all stair treads. There is no tactile and Braille "EXIT" sign.

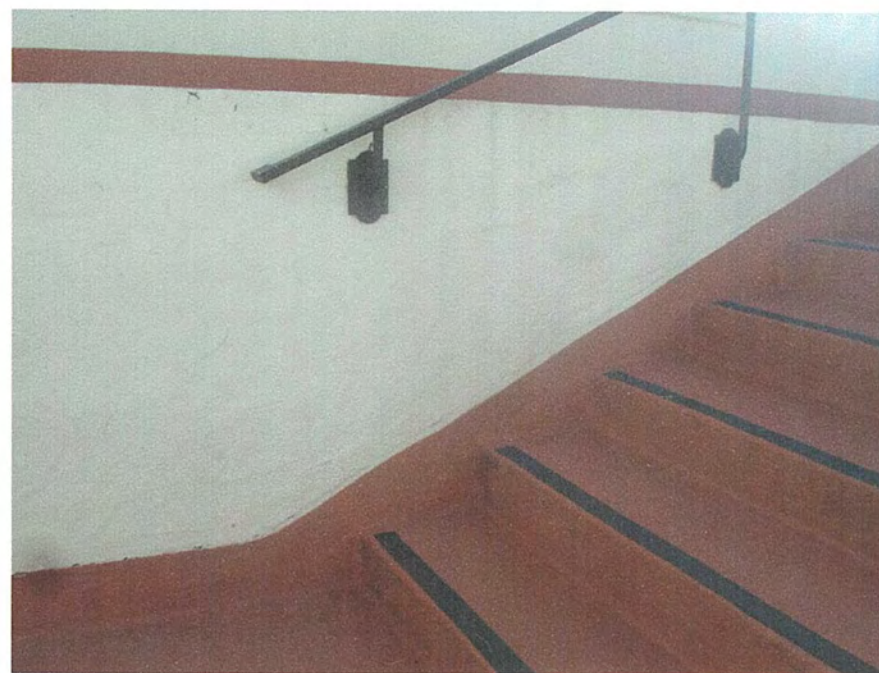
Building - Photo # 10

Stair does not have compliant handrail extensions at top and bottom of stair. Handrail mounted at 33" high instead of the minimum 34" high.

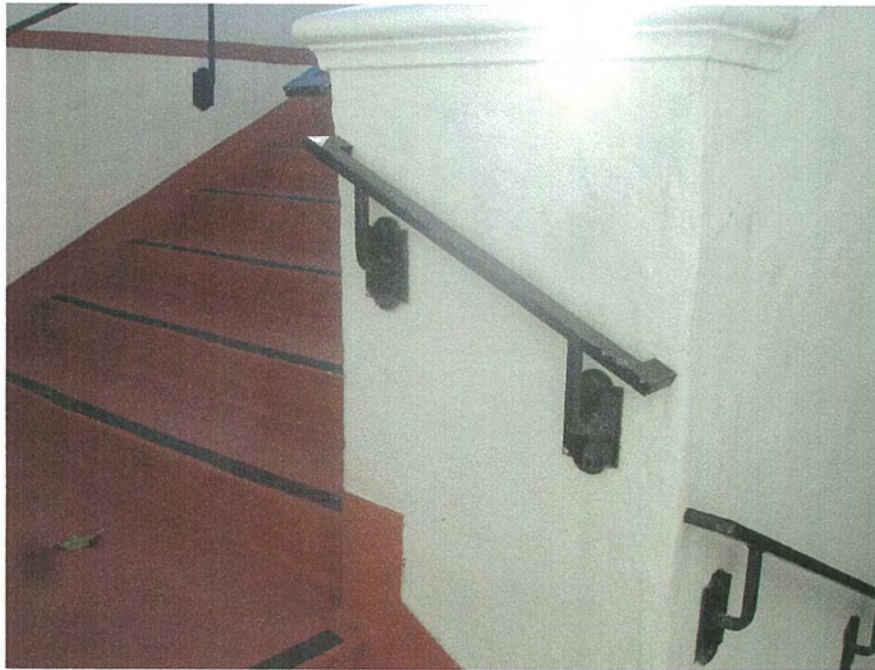
Building - Photo # 11

Intermediate handrails are not continuous..

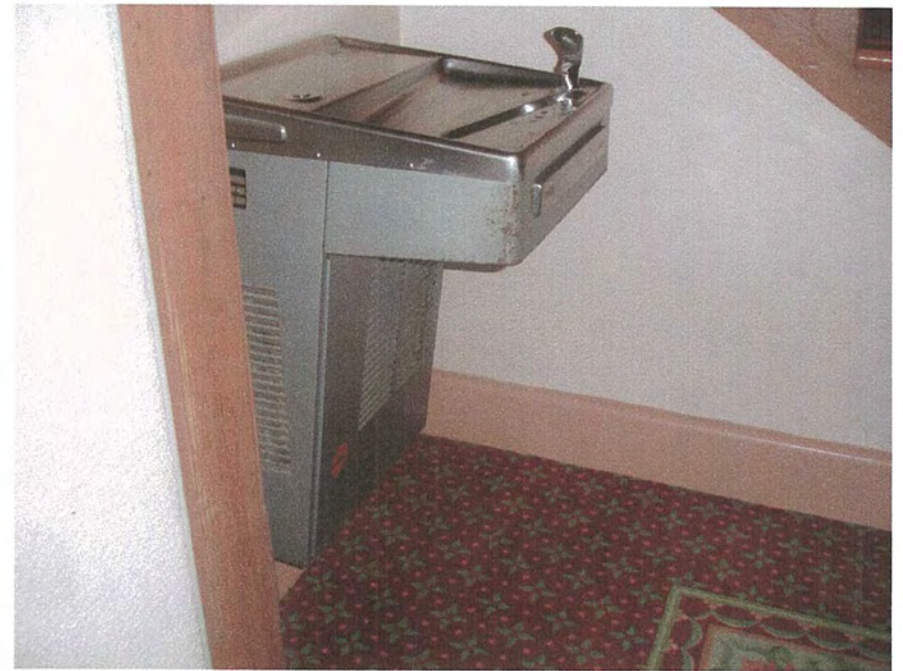
Building - Photo # 12

The drinking fountain alcove has one side with a 12" deep alcove instead of the required 18" minimum.

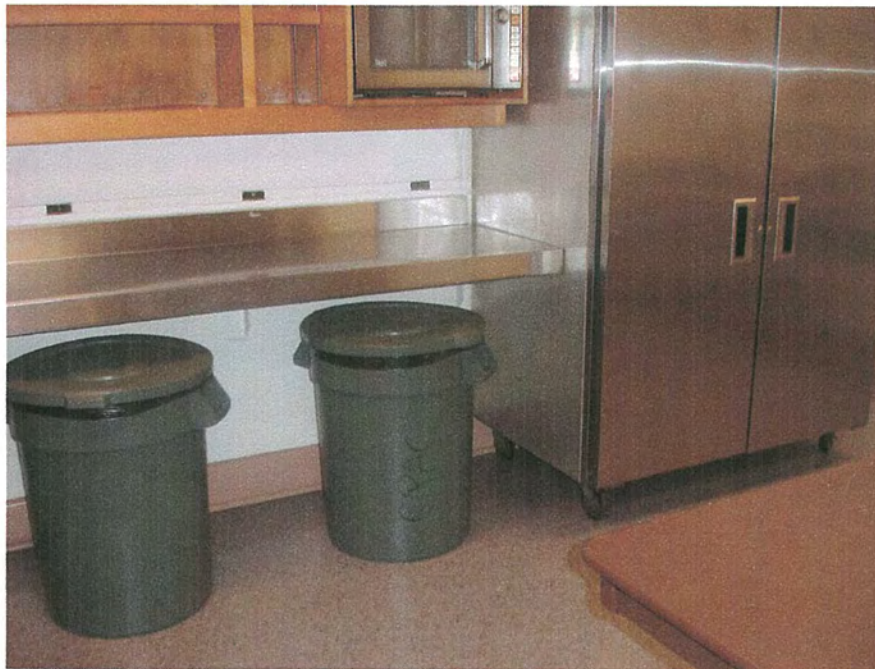
Building - Photo # 13

Kitchen counter does not have a 34" max. high section for wheelchair users – counter 35 1/2" high. Microwave controls are mounted at 64" high.

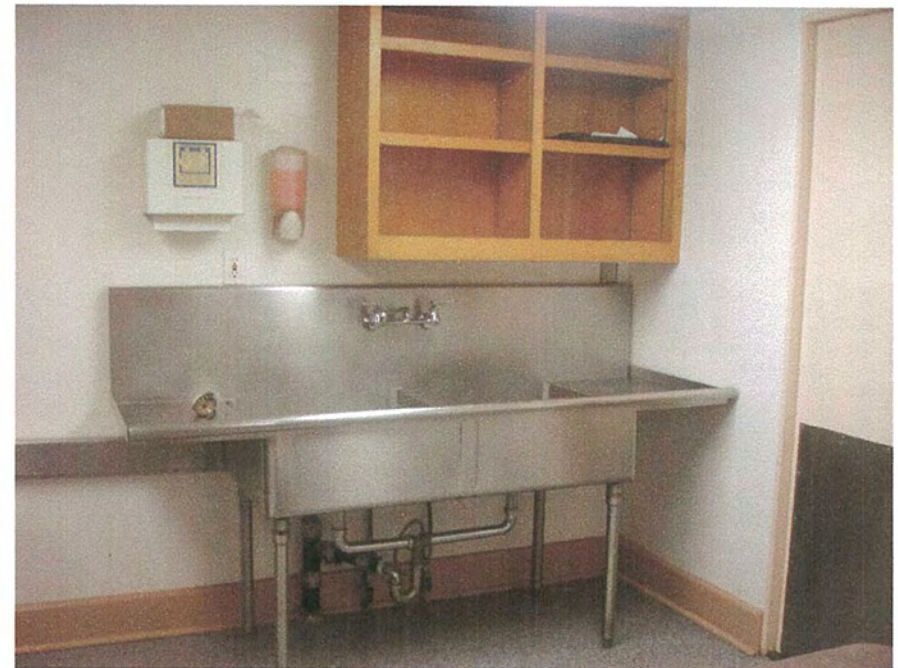
Building - Photo # 14

Paper towel dispenser is mounted at 55" high and soap dispenser at 54" high instead of the required 40" high maximum to operable mechanisms. Kitchen sink is not accessible.

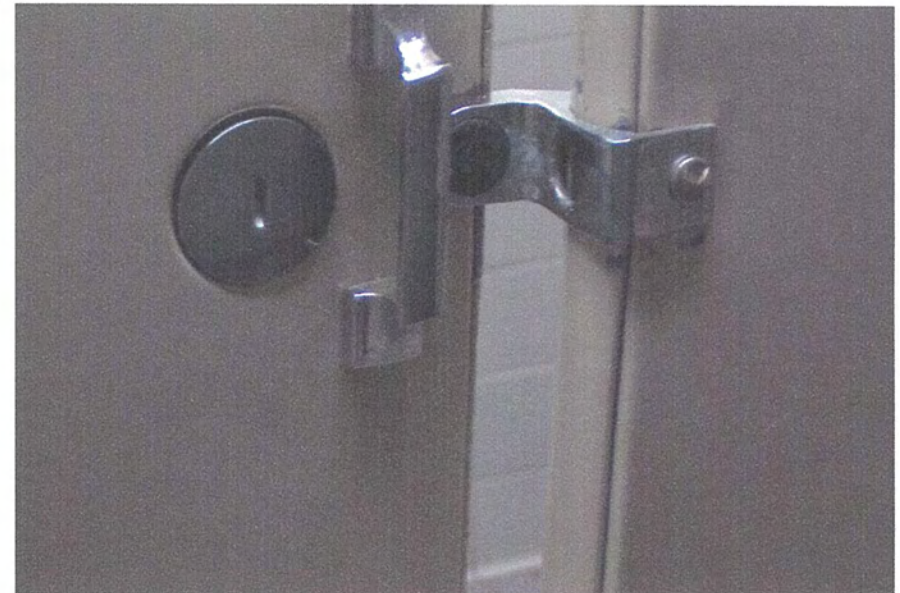
Building - Photo # 16

Stall door hardware requires grasping to operate and is mounted for an out swinging door. Provide a slide or flip over type of hardware.

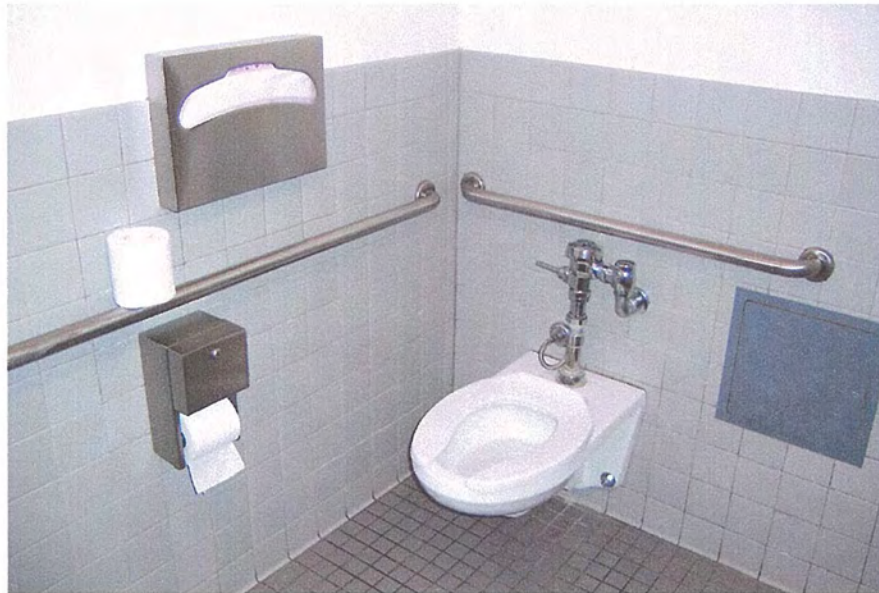
Building - Photo # 17

The seat cover dispenser is mounted too high – 47” high above grab bar. Flush valve is mounted on the narrow side of stall.

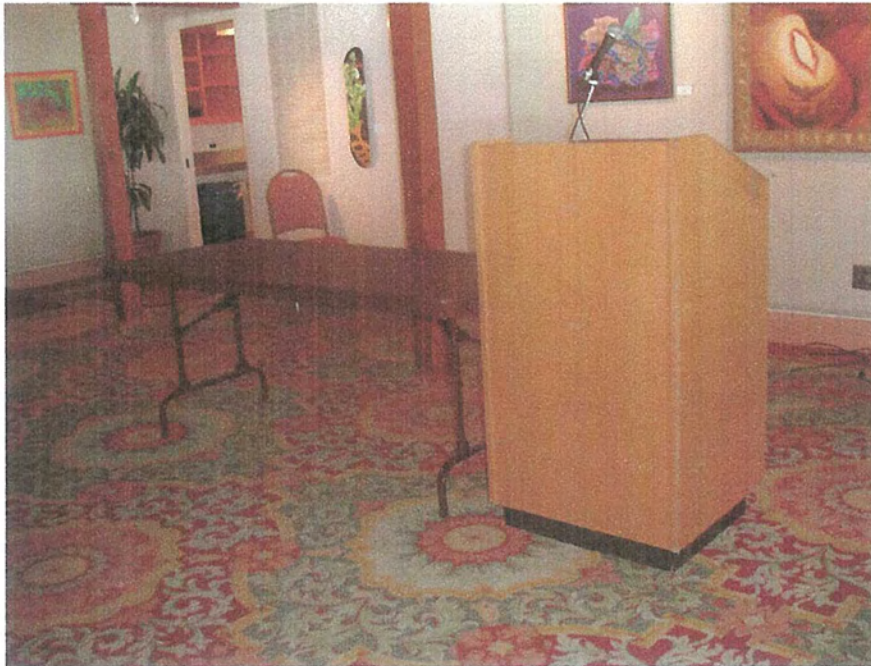
Building - Photo # 19

High podium is not accessible; provide an additional low podium with compliant knee clearance and height. As an interim solution a table has been provided on the side.

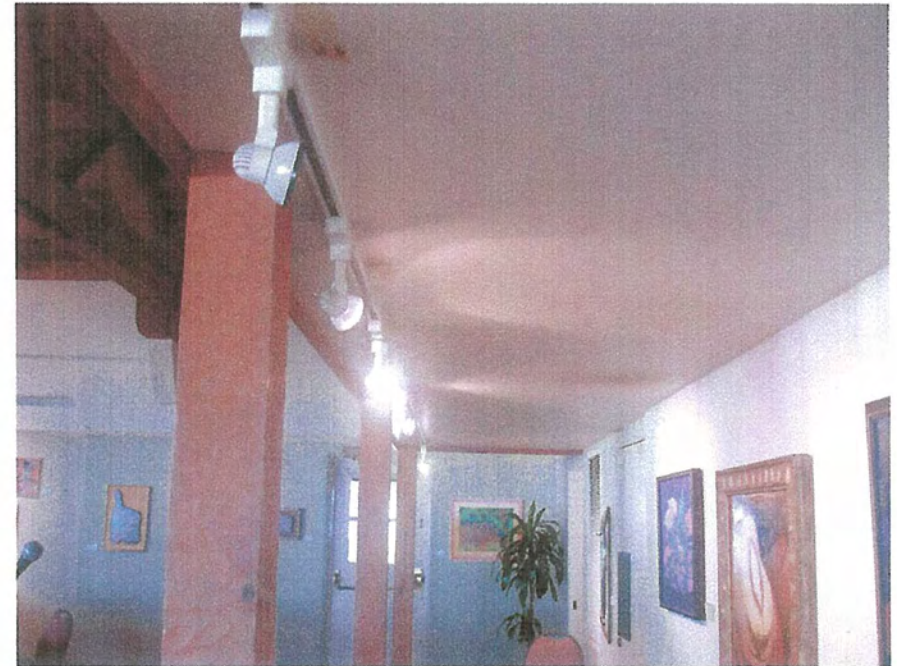
Building - Photo # 20

Track lights are mounted below 80" high, becoming an overhead obstruction.

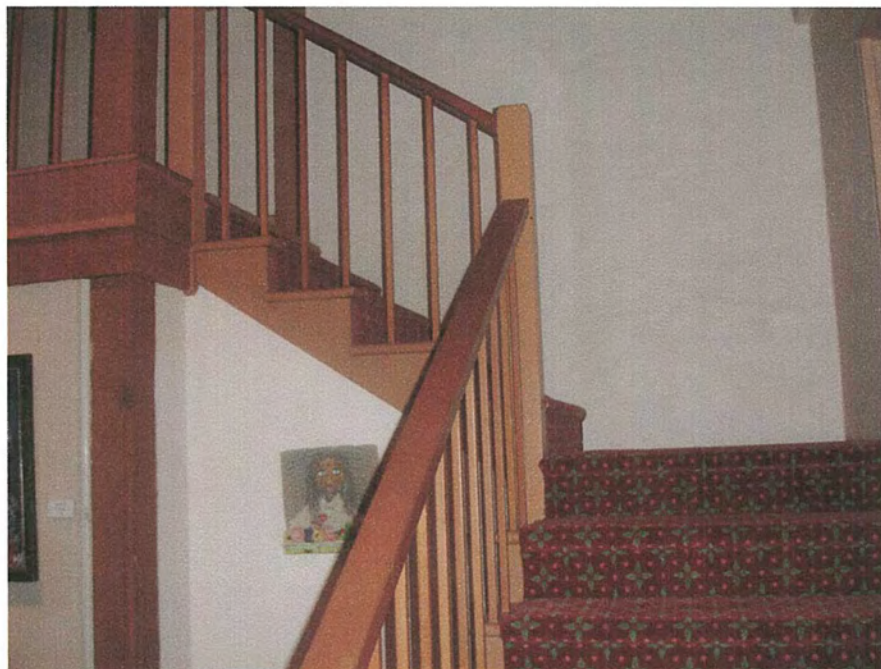
Building - Photo # 1

Guardrail has 5 1/4" gap between vertical rails instead of the required 4" maximum. There are no compliant handrails extensions at top and bottom of stair. The handrail is not continuous. The handrail gripping size is not compliant.

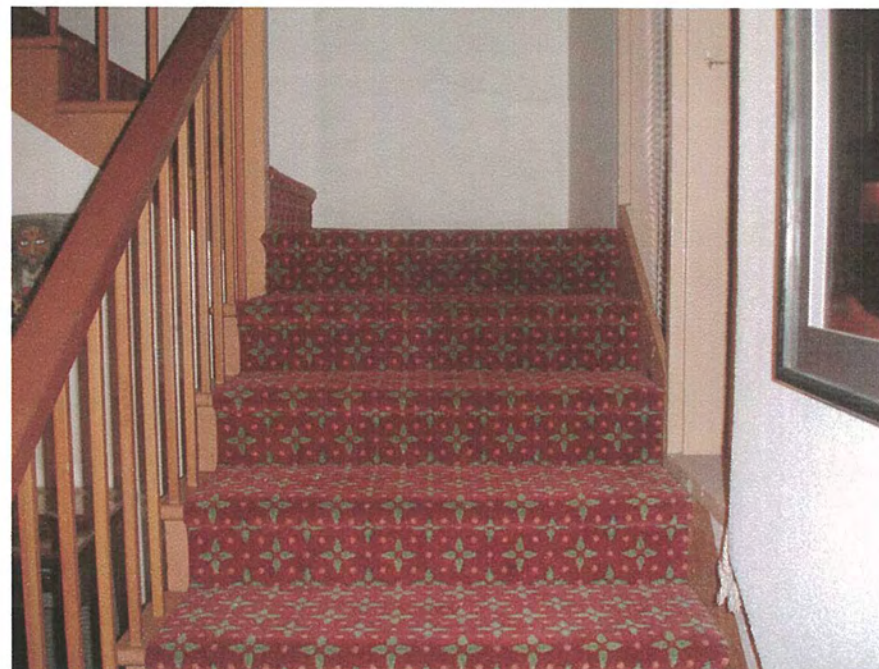
Building - Photo # 2

There are no compliant contrasting color striping at top, bottom and intermediate landing stair treads.

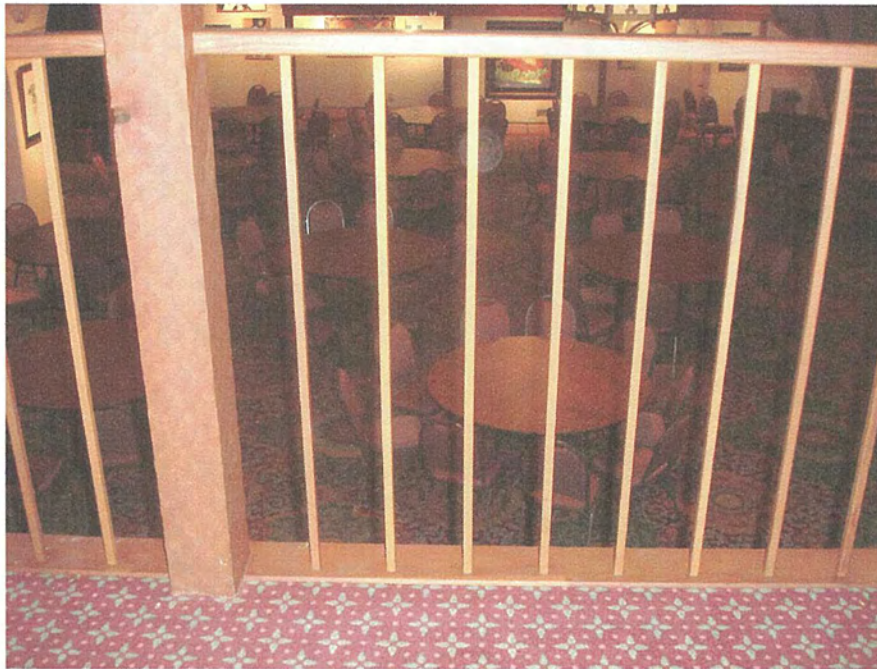
Building - Photo # 1

Guardrail has 5 1/4" gap between vertical rails instead of the required 4" maximum.
