**CABRILLO PAVILLION ARTS
CENTER**
ACCESSIBILITY SURVEY

June, 2007

**CITY OF SANTA
BARBARA**

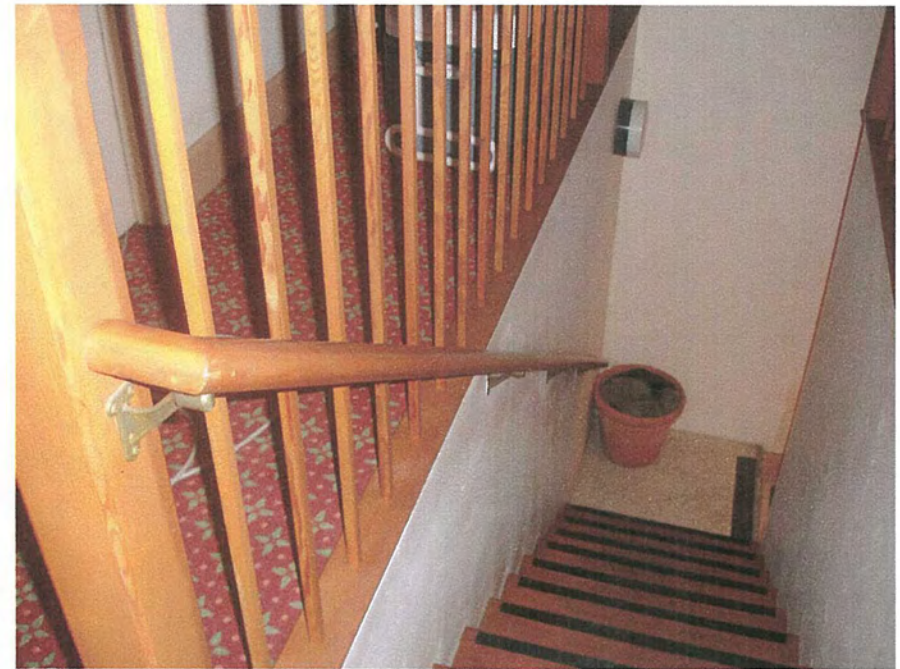
Building - Photo # 2

There are no compliant handrails extensions at top and bottom of stair.

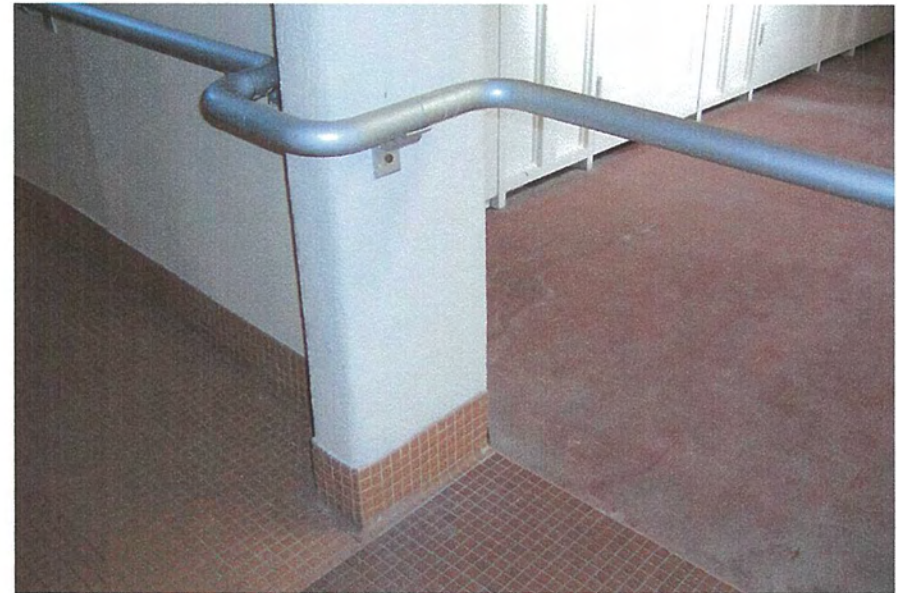
Building - Photo # 2

Handrail has 90-degree turns.

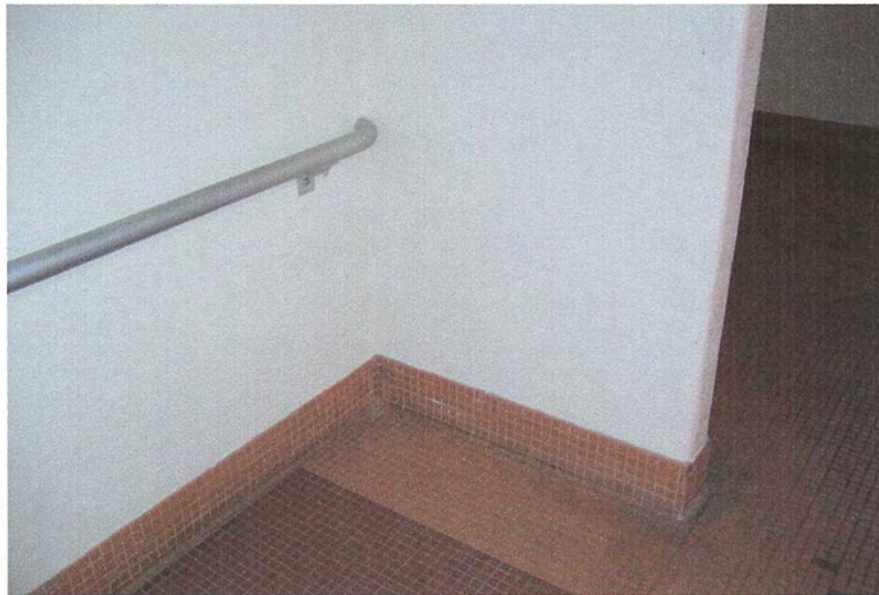
Building - Photo # 3
Handrail dead-ends on wall.

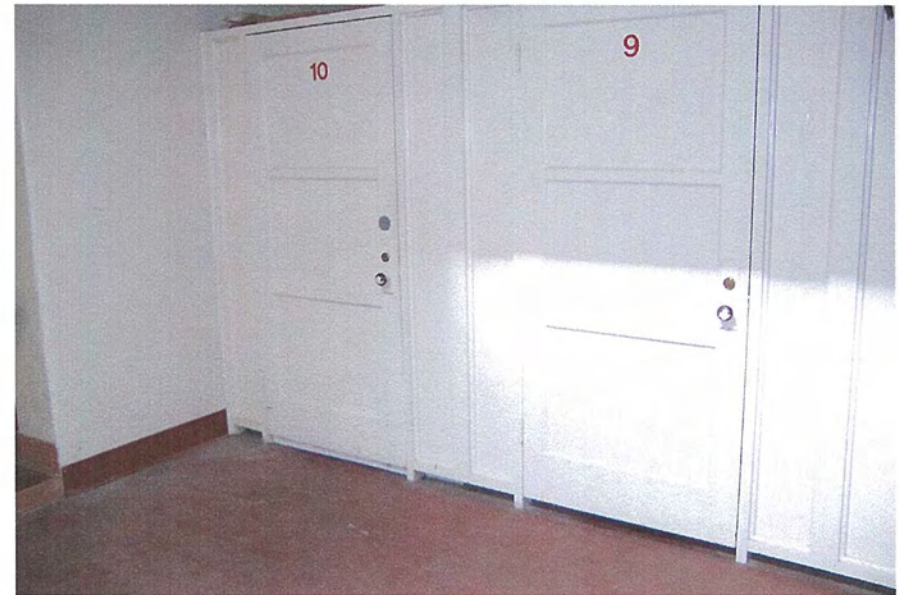
Building - Photo # 4
*Storage cubicles do not have compliant hardware,
knobs require tight grasping and twisting of the wrist.*

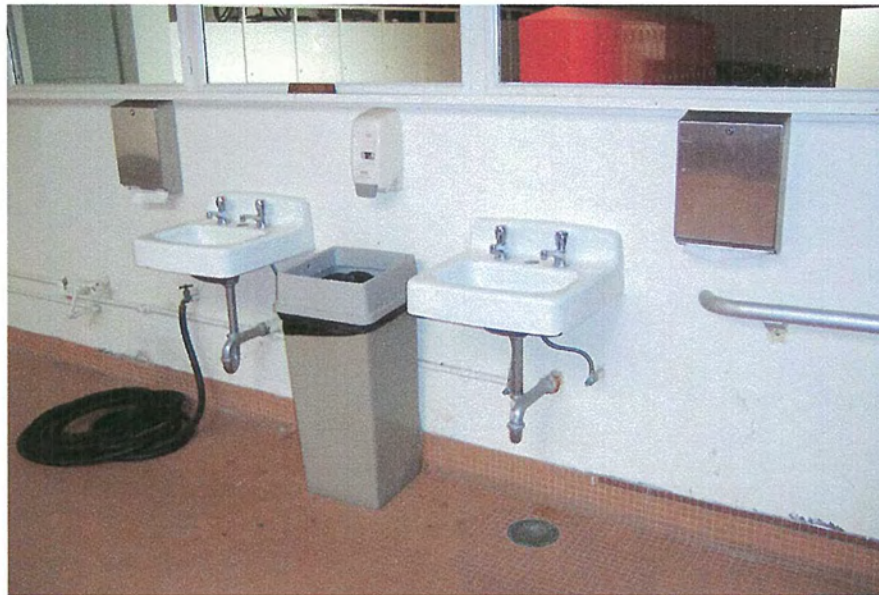
Building - Photo # 5

Mirror mounted too high – 54 ½”, sink do not have pipe insulation.

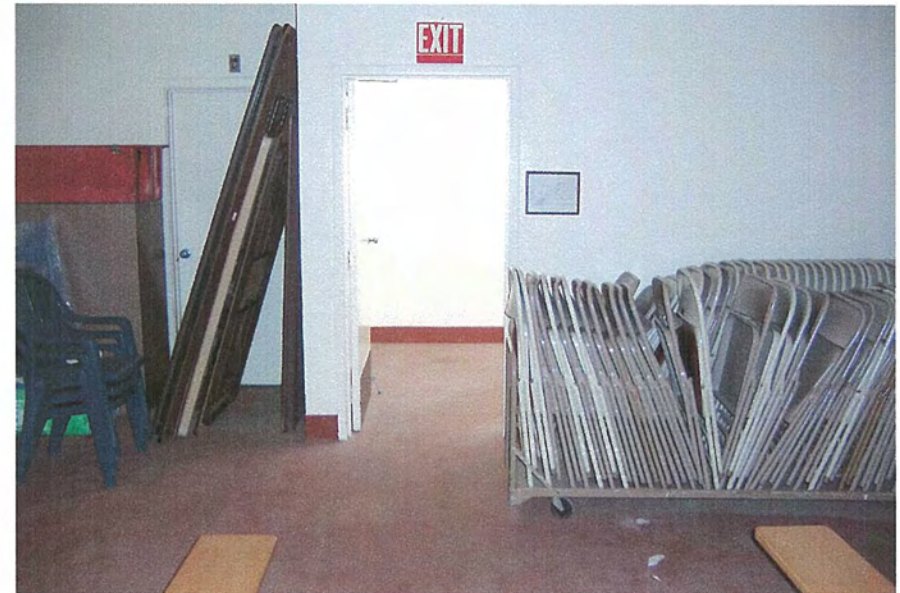
Building - Photo # 6

There is not the required tactile and “EXIT ROUTE” sign.

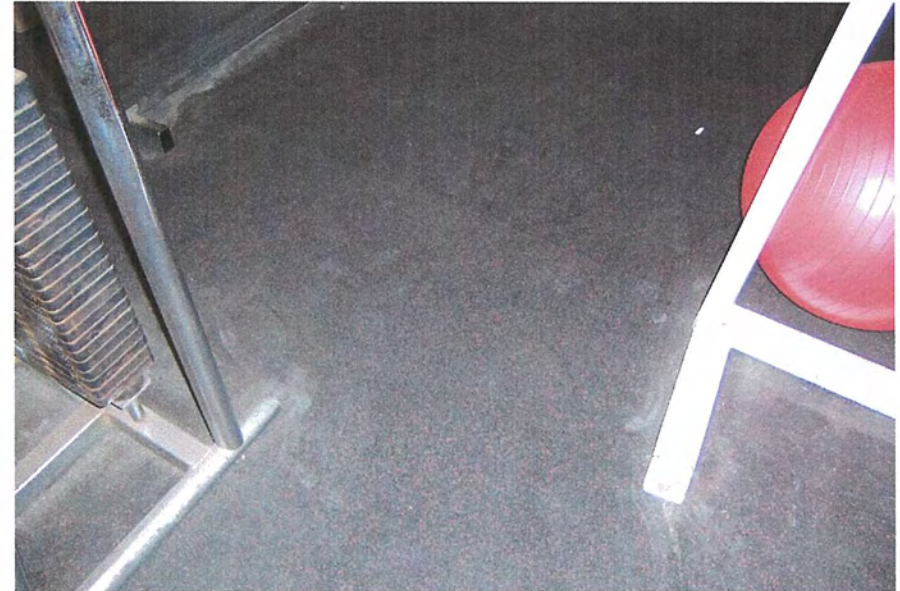
Building - Photo # 8

Path of travel to exercise machines is 27" wide instead of the required 36" wide minimum.

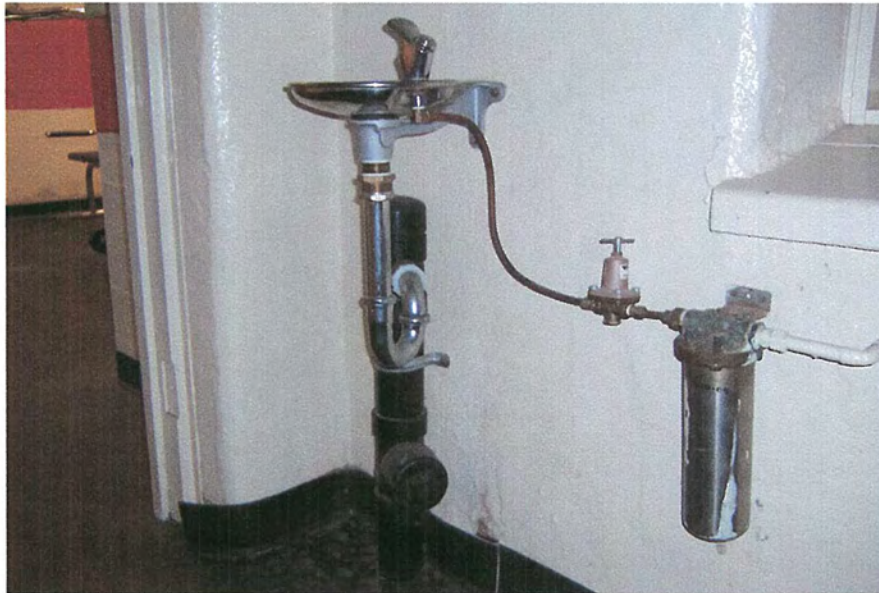
Building - Photo # 9

Drinking fountain is not accessible, is not high/low with compliant knee clearance and alcove.

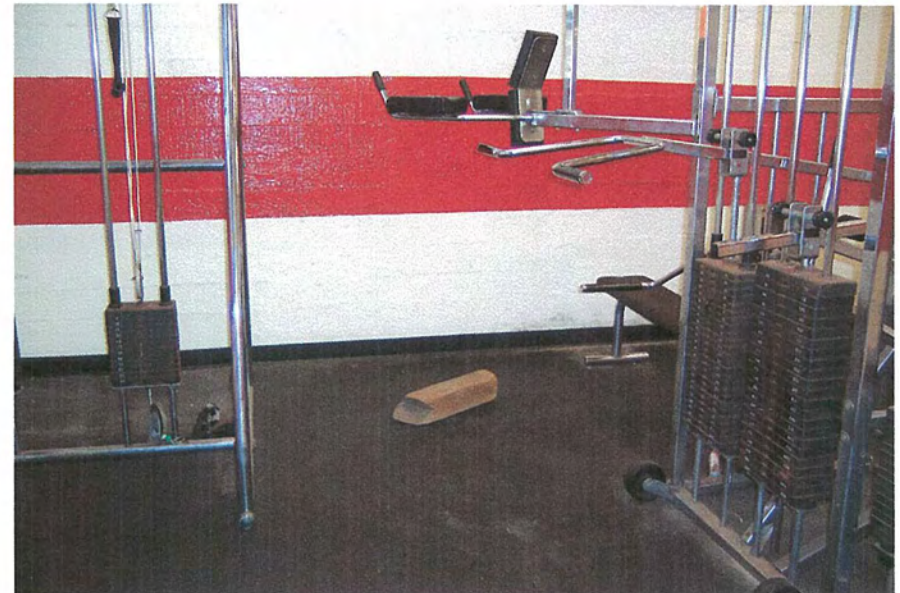
Building - Photo # 10

Machine has hazardous overhead obstructions below 80" high, mounted at 60" high without cane detectable protection.

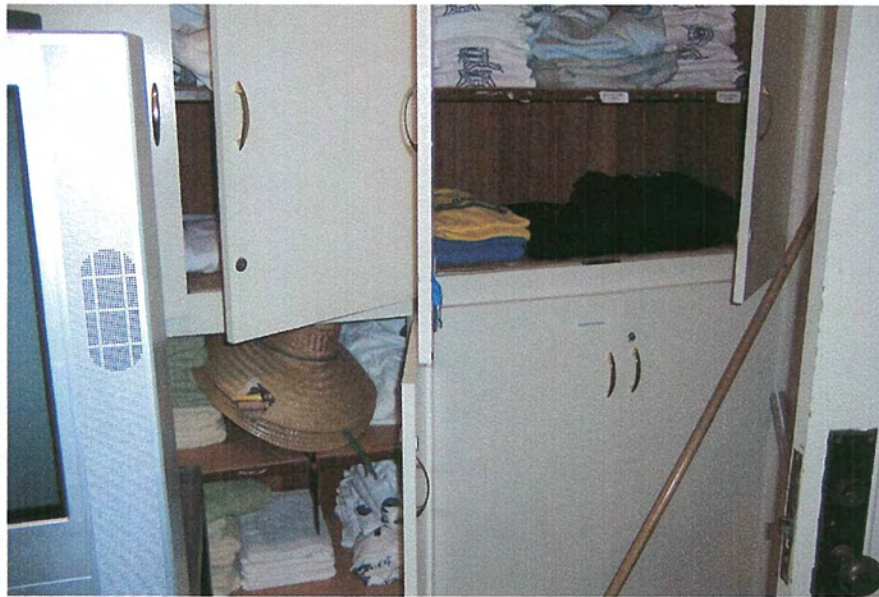
Building - Photo # 11

Pulls at upper cabinet mounted too high at 59" high.

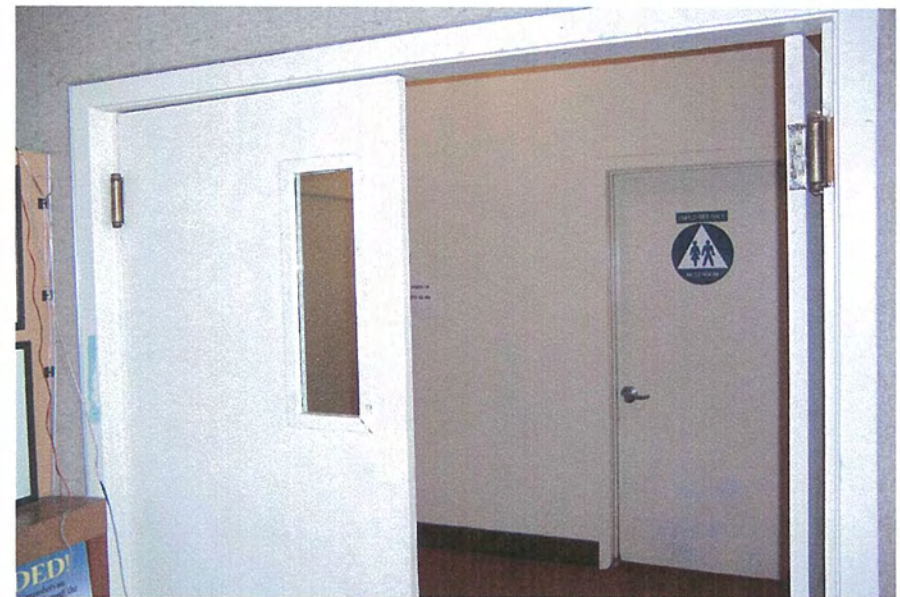
Building - Photo # 12

There is not the required tactile and Braille room identification sign.

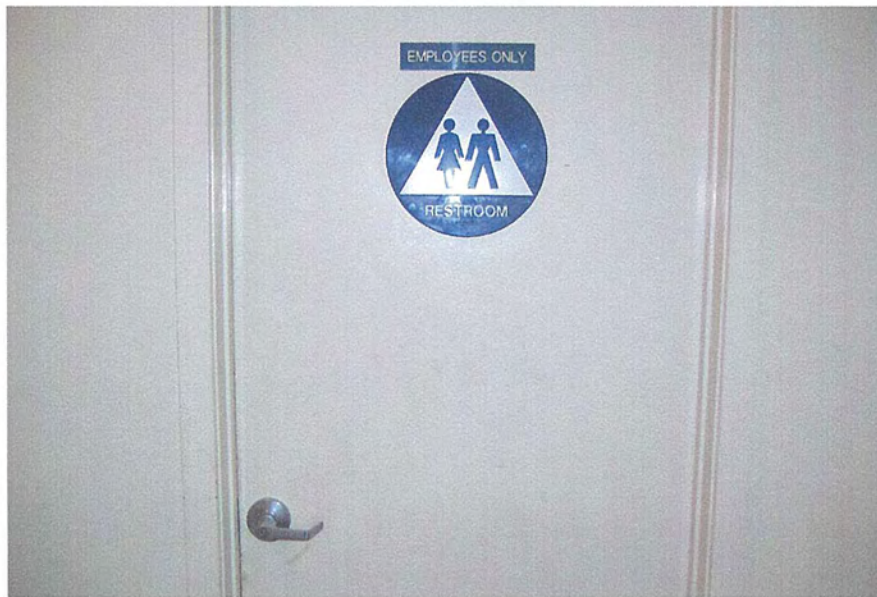
Building - Photo # 13

Door circle sign is mounted too high, 64" high to the centerline of sign. There is no tactile and Braille room identification sign.

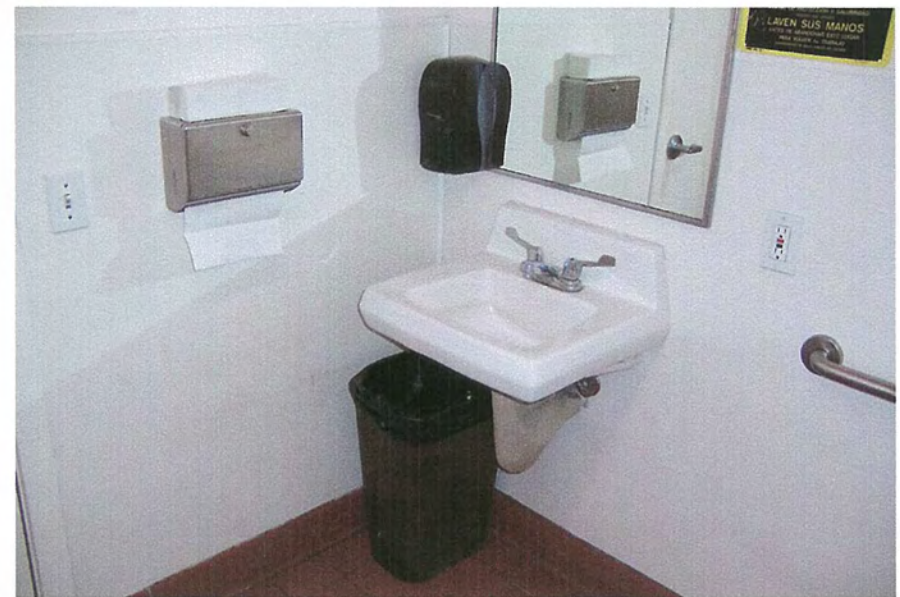
Building - Photo # 14

Sink knee clearance at 8" from the face of sink is 25" high instead of the required 27" high minimum. Trash receptacle is blocking the required wheelchair clearance.

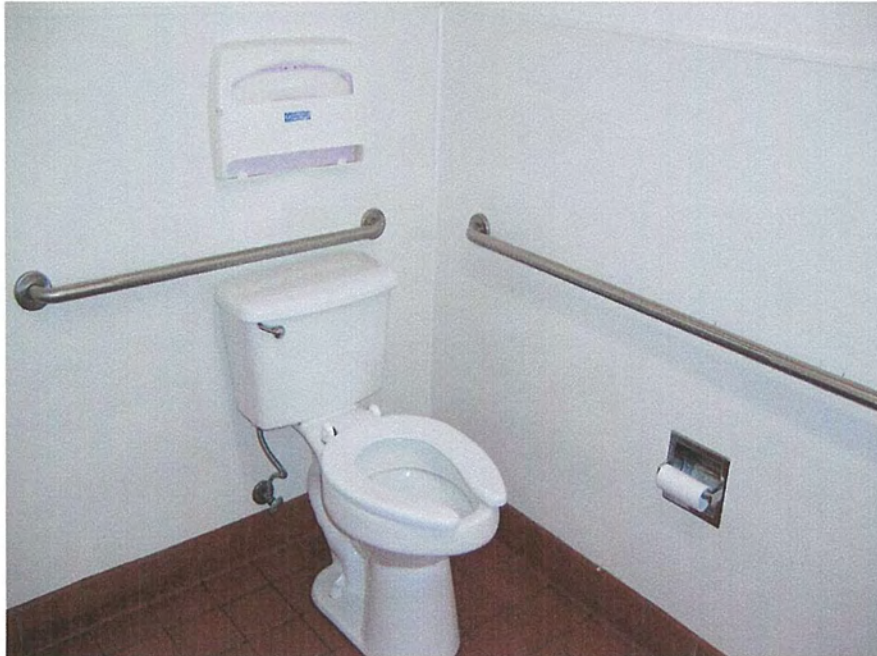
Building - Photo # 15

Seat cover dispenser is mounted at 47" high instead of the required 40" maximum

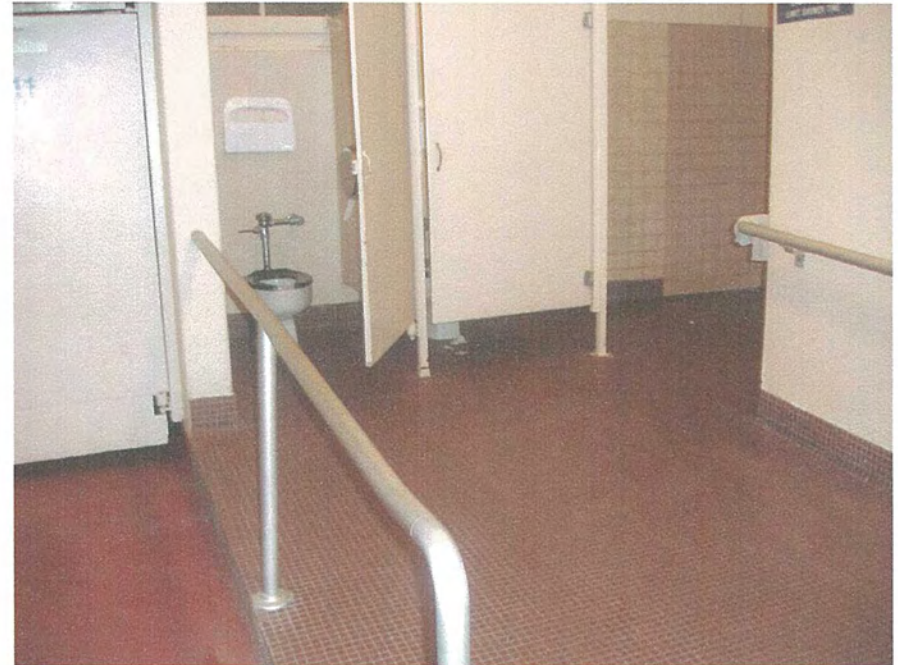
Building - Photo # 16

Ramp does not have a compliant landing with 2% maximum slope in either direction. There are no wheel guides at ramp freestanding handrail. Narrow water closet stall is non-compliant.

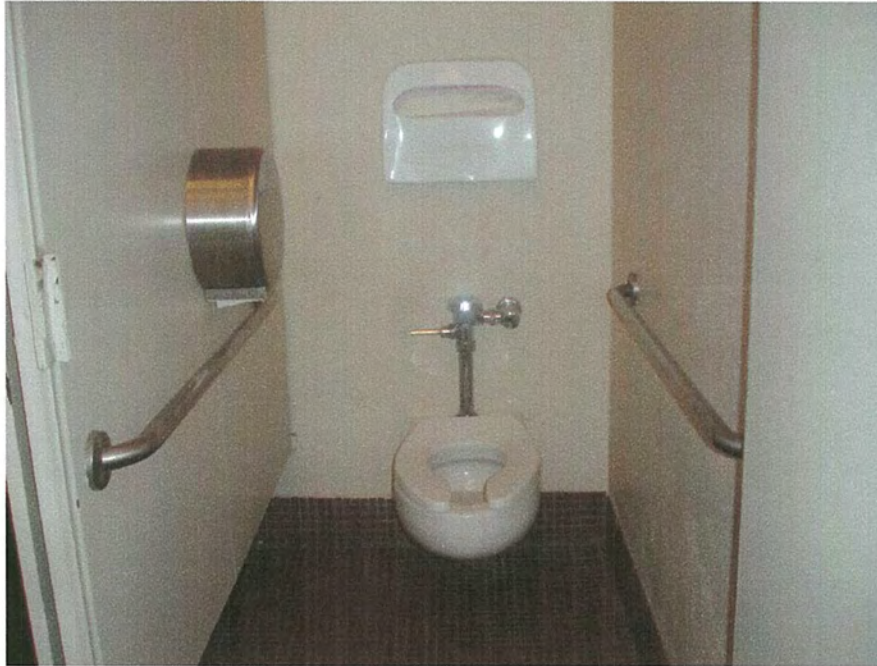
Building - Photo # 17

Toilet paper dispenser should be located below grab bar or 18" above, not to block the use of grab bar.

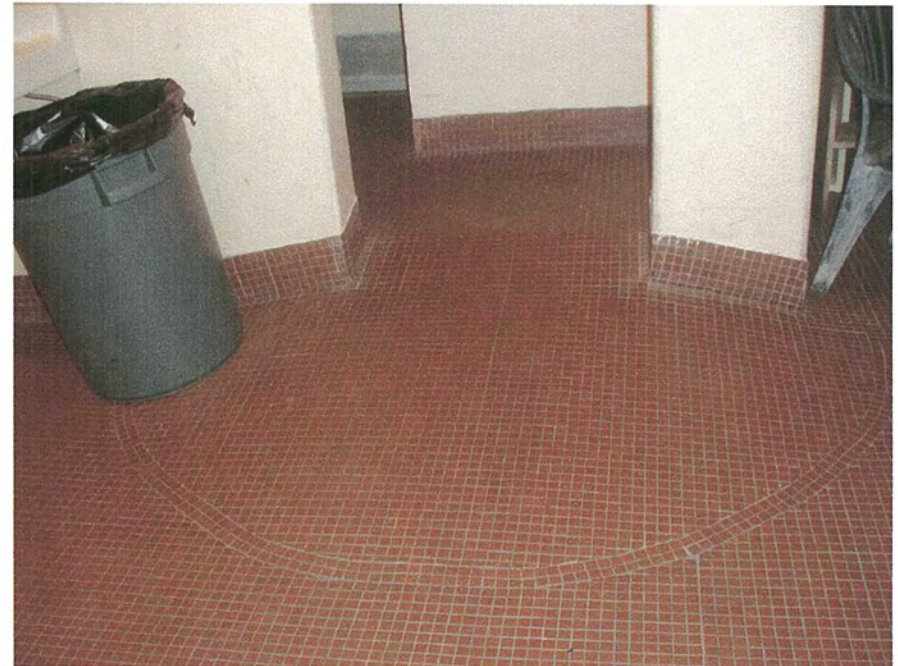
Building - Photo # 18

Entrance to showers has 15.8 % slope and excessive cross slope. Area needs to be modified. Provide directional signage to accessible shower entrance.

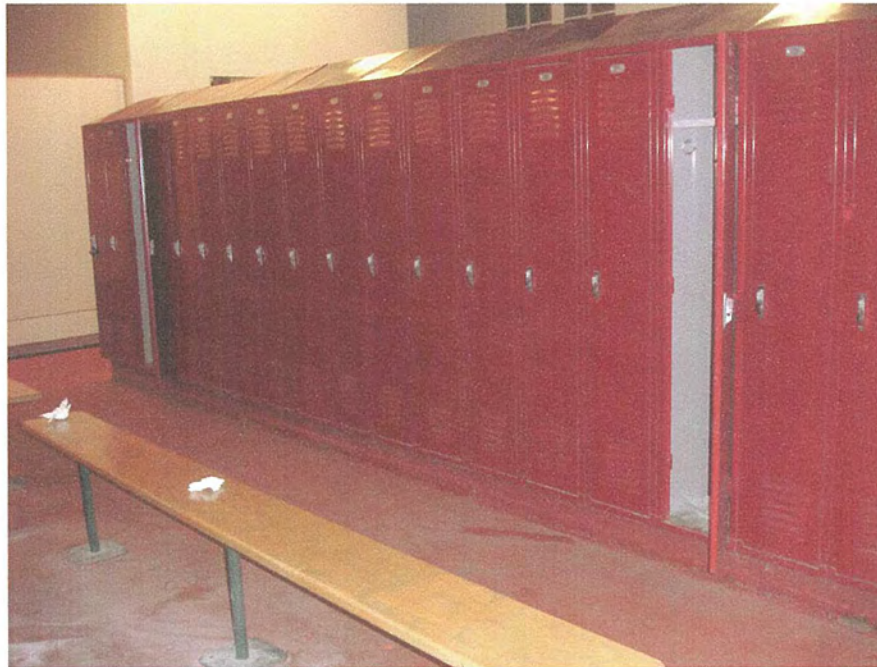
Building - Photo # 19

Lockers are not accessible, do not have compliant hardware, ISA identification sign, shelf mounted at 48" maximum height. There is no compliant wheelchair maneuverable clearance and 24" by 48" bench.

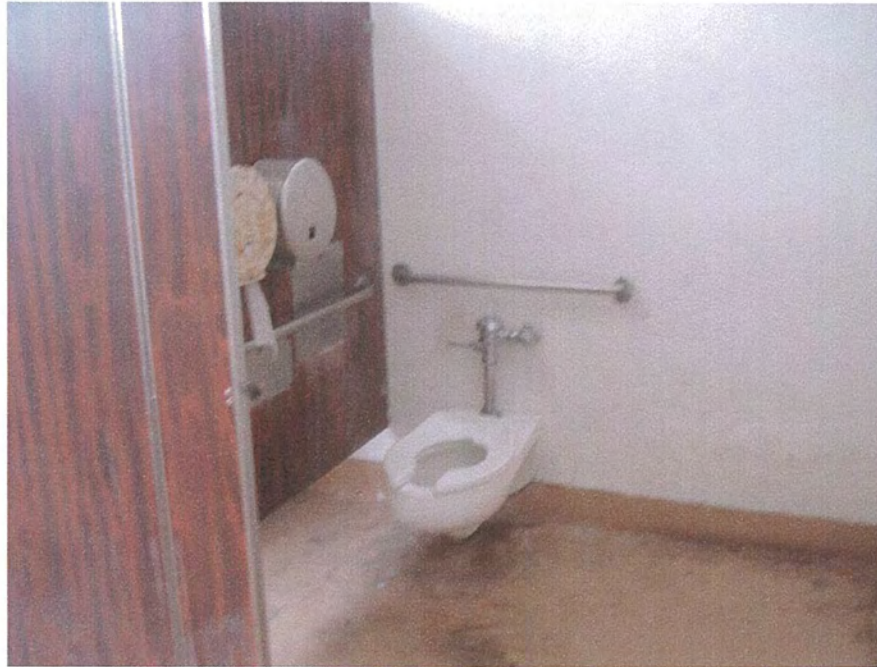
Building - Photo # 21

*Flush valve mounted at the narrow side of the stall.
Water closet seat is too low, 15 1/4" high.*

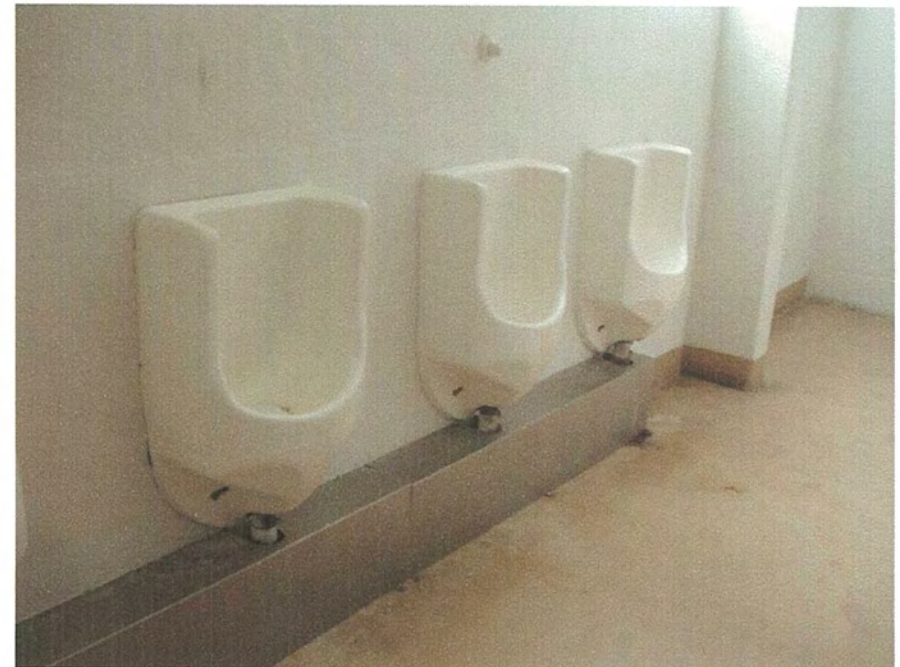
Building - Photo # 22

*Urinal rim is too high mounted at 24" high instead of the
required 17" maximum.*

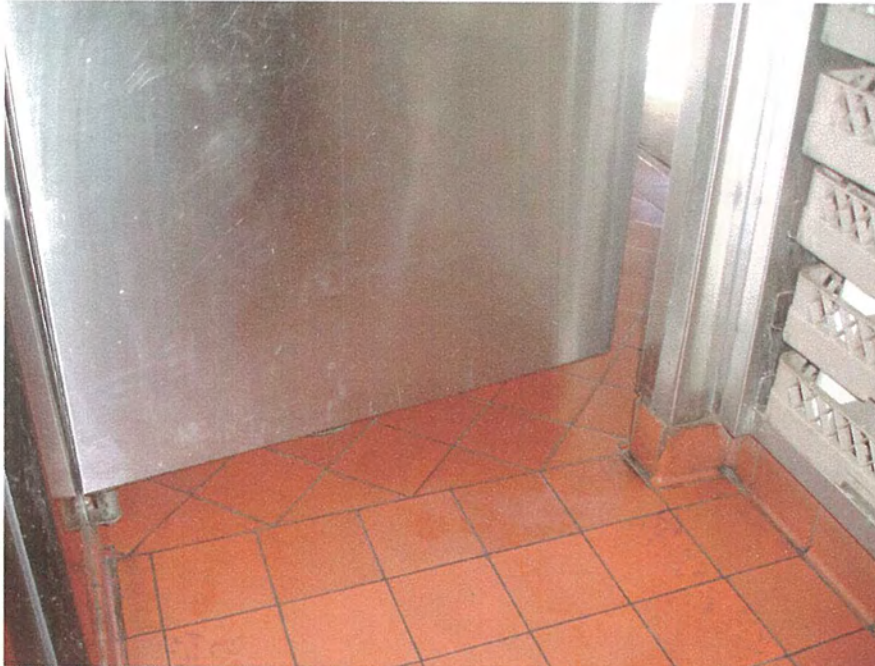
Building - Photo # 23

Gate has 6" space at the bottom instead of the required 3" maximum height.

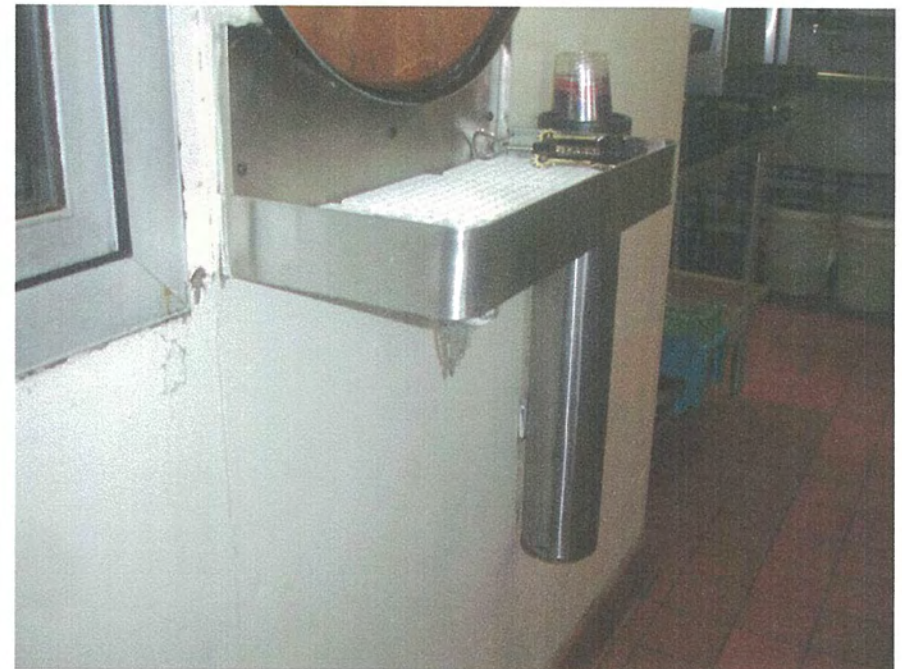
Building - Photo # 24

Beer drain protrudes 9" into the path of travel at 40" high without a cane detectable area at 27" high maximum.

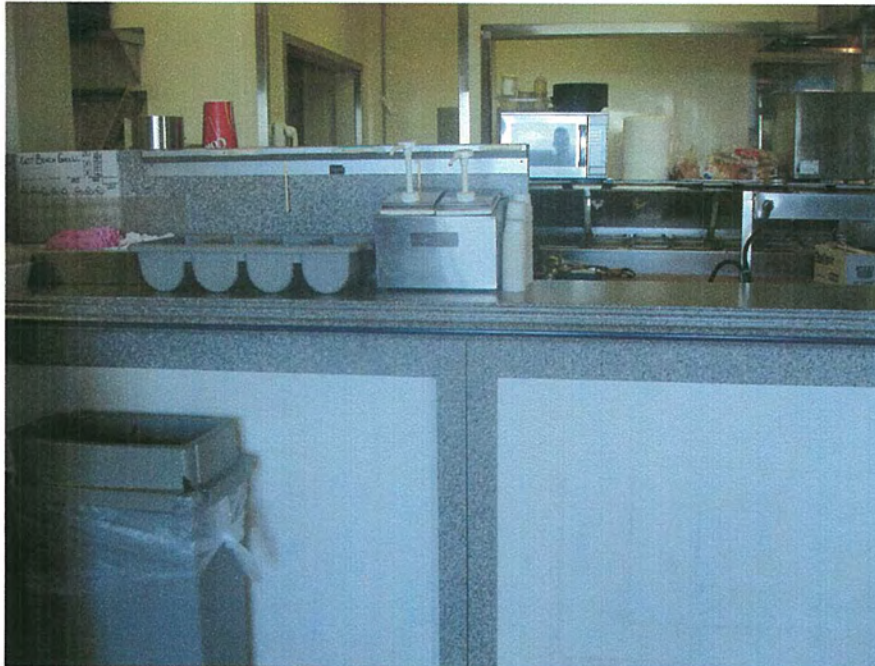
Building - Photo # 25

Condiments located at 56" high counter, out of reach for wheelchair users.

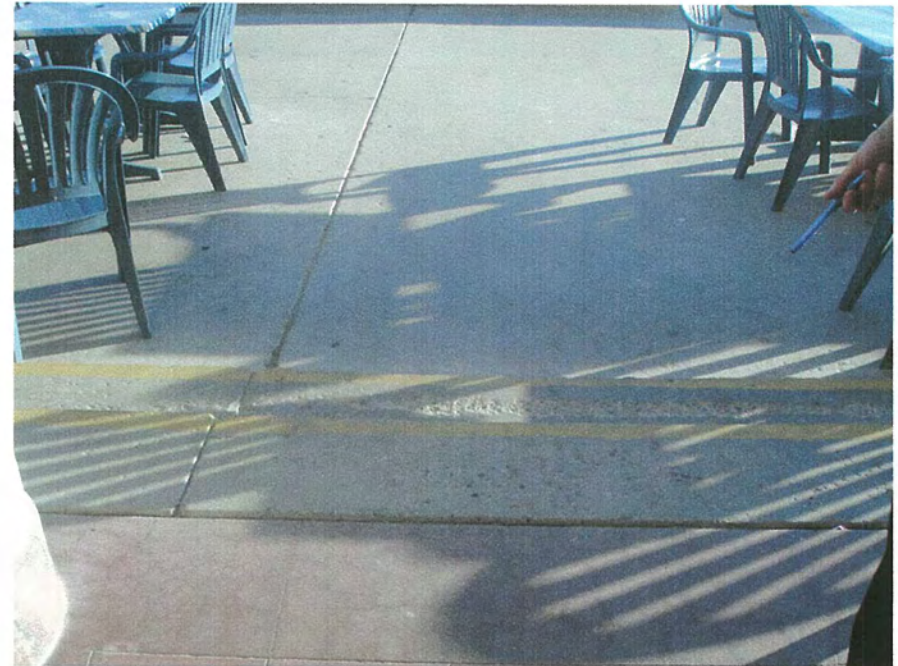
Building - Photo # 26

Two steps at main outdoor dining aisle do not have handrails.

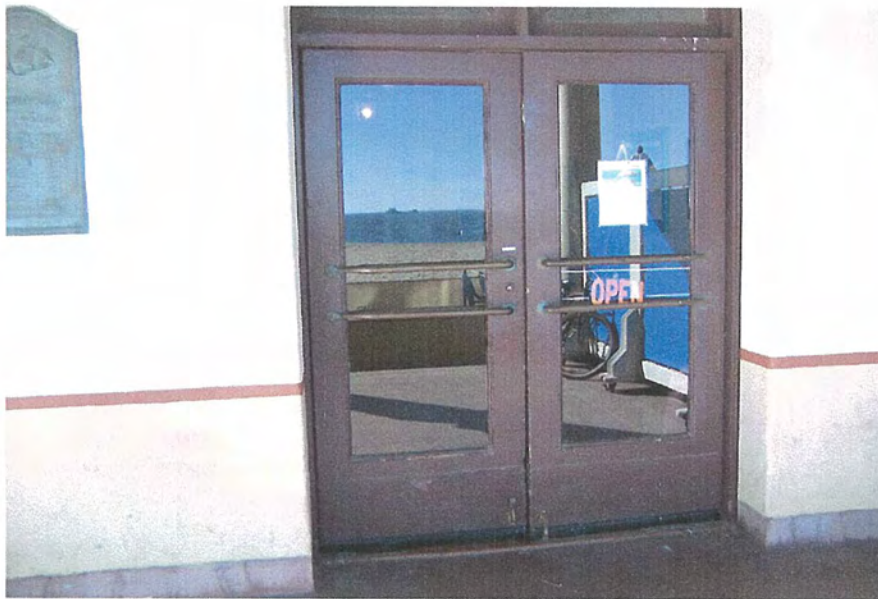
Building - Photo # 27

There are no tactile and Braille room identification and "EXIT" signs, as well as an ISA International Symbol of Accessibility sign mounted at the door active leaf. Loose doormat.

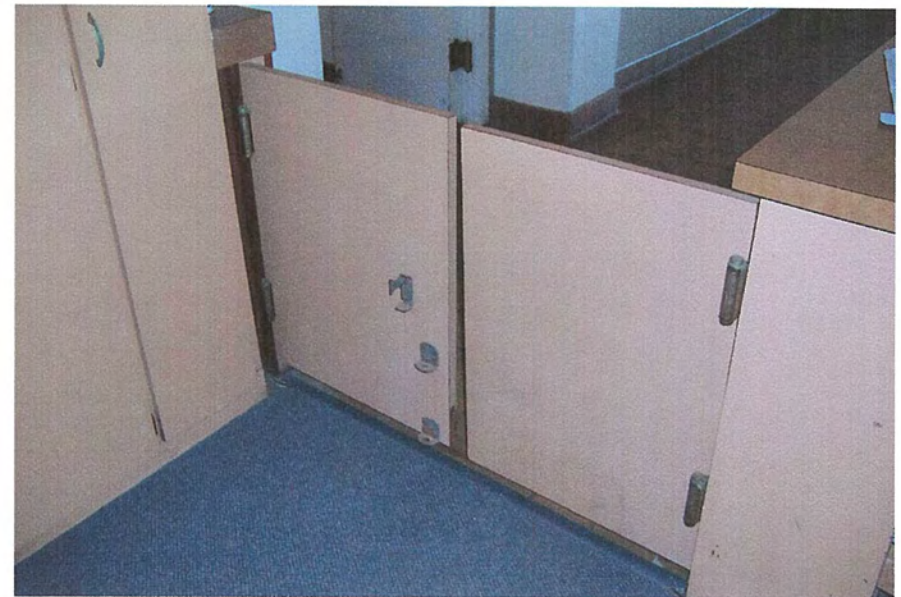
Building - Photo # 28

Double acting gate clearance of each leaf is 21 ½" clear with requires a 32" minimum clear gate.

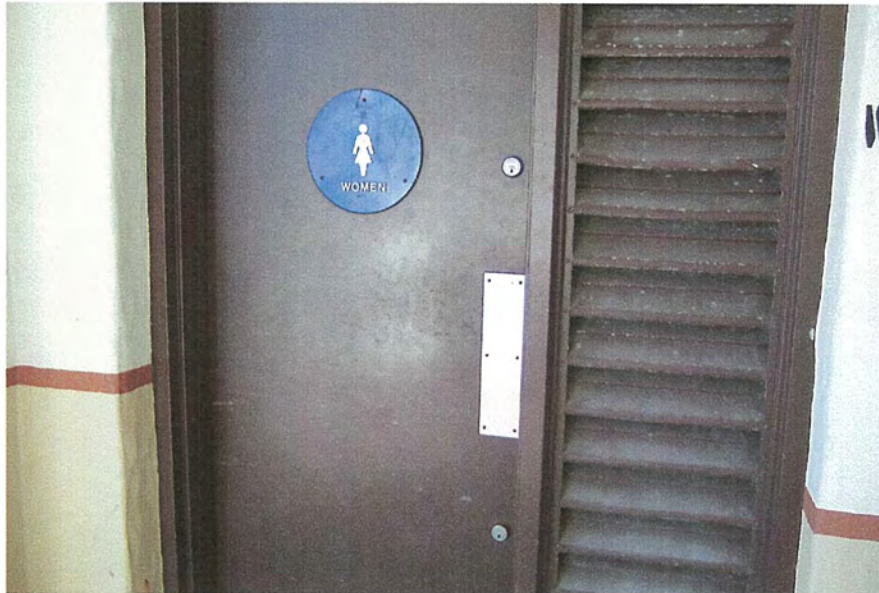
Building - Photo # 29

There is no tactile and Braille restroom identification sign. Cylinders for keys require tight grasping to operate.

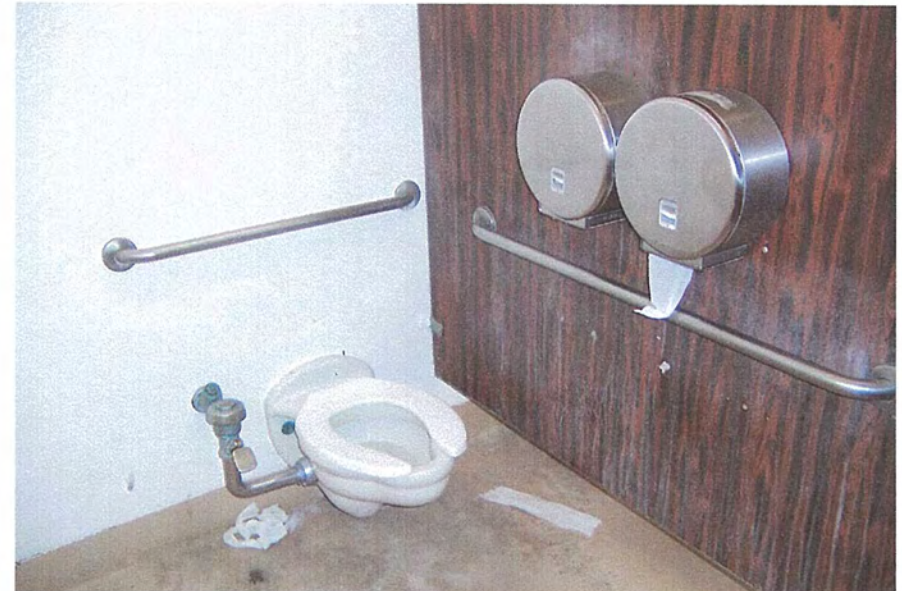
Building - Photo # 30

Flush valve foot pedal type requires 13 lbs. to operate. Water closet seat mounted at 14" high instead of the required 17" to 19" high.
