GILDA PUENTE-PETERS
ARCHITECTS

**WESTSIDE COMMUNITY
CENTER**
ACCESSIBILITY SURVEY

June, 2007

**CITY OF SANTA
BARBARA**

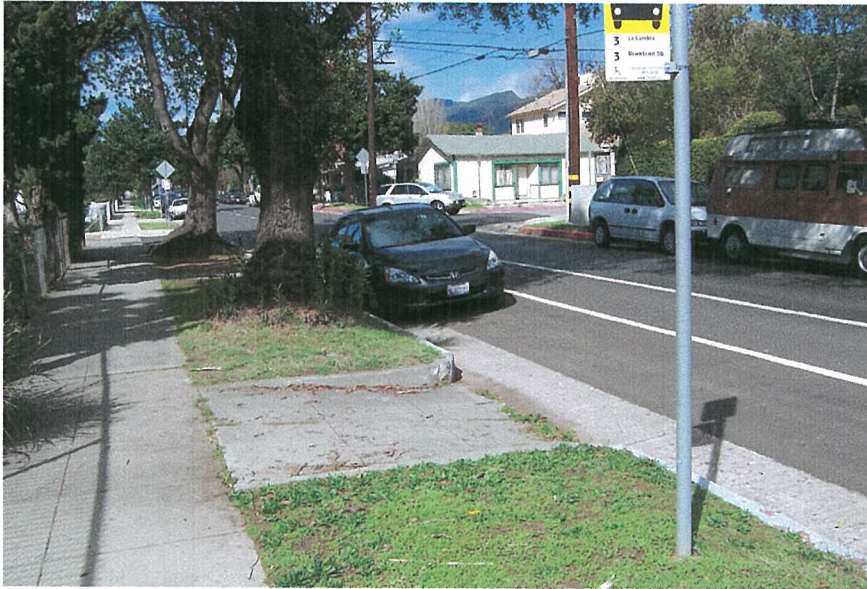
Public Right-of-Way - Photo # 1

Surface at bus stop is not accessible - grass adjacent to street.

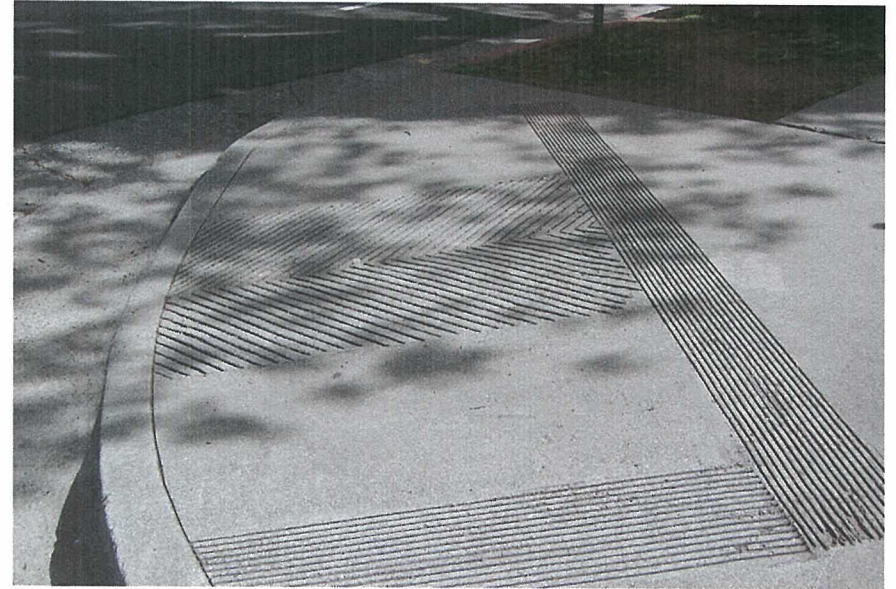
Public Right-of-Way - Photo # 2

Curb ramp running slope ranges from 9.7% to 11.1%. Flare sides 15.7%- 15.9%. No detectable warnings and contrasting color with adjacent surface.

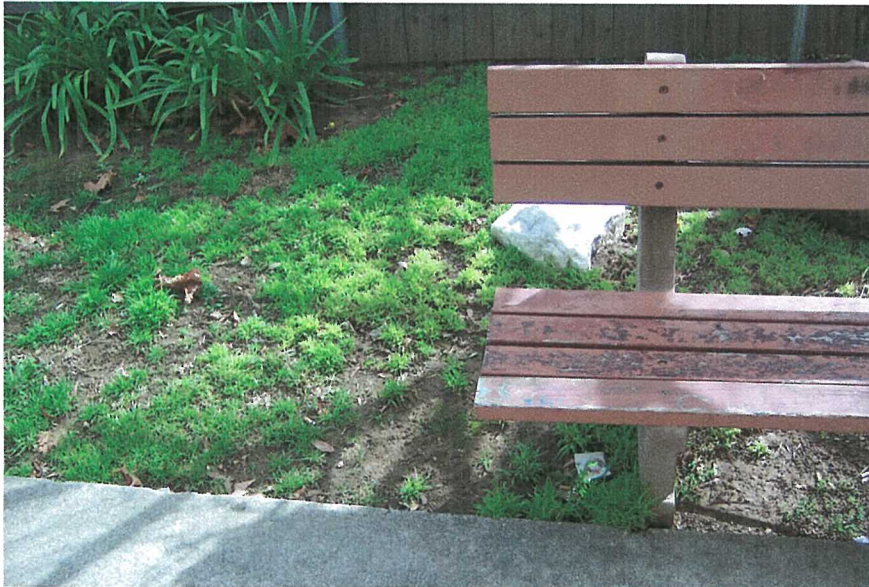
Site - Photo # 1

Bench does not provide space for a wheelchair user to be seated shoulder to shoulder with a person seated on the bench.

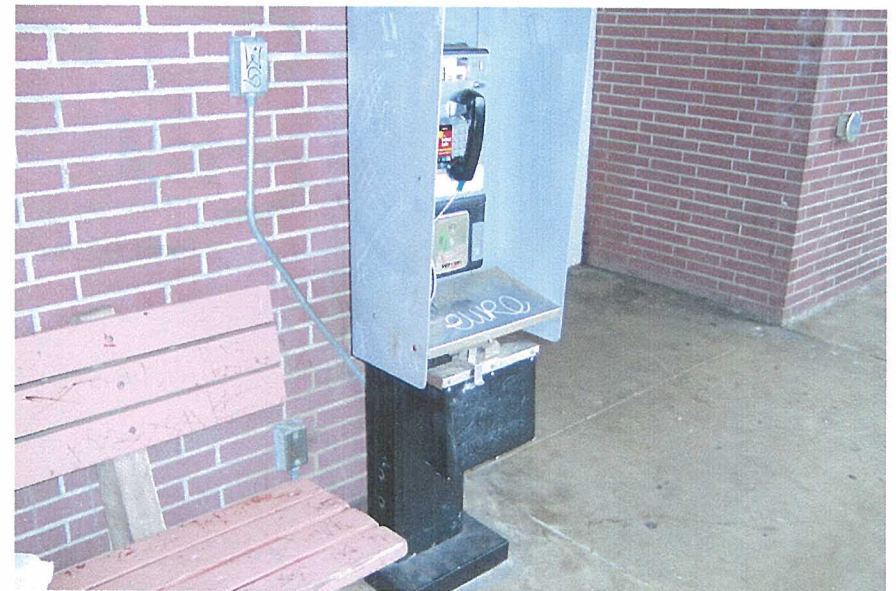
Site - Photo # 2

Telephone coin slot mounted too high at 56" high.

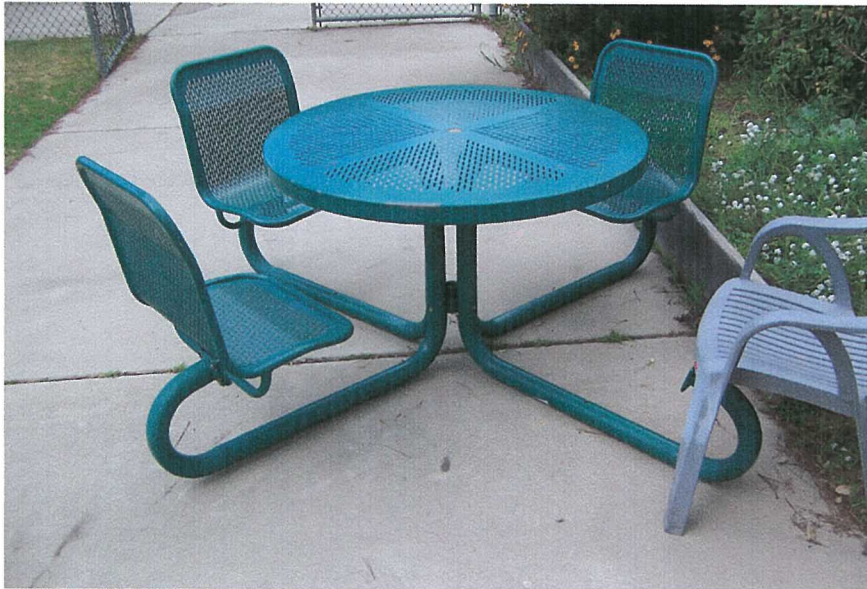
Site - Photo # 3

Table does not have the required knee clearance due to the leg configuration.

Recreation areas, picnic benches	Make a minimum of one picnic bench or 5% of all picnic benches provided accessible.	Table does not have the required knee clearance due to the leg configuration. Photo #: 3	ADAAG: Recommended T24: N/A	Provide extension for picnic bench end to make accessible.	1	JOB	\$500	\$500	2	
----------------------------------	---	---	---------------------------------------	--	---	-----	-------	-------	---	--

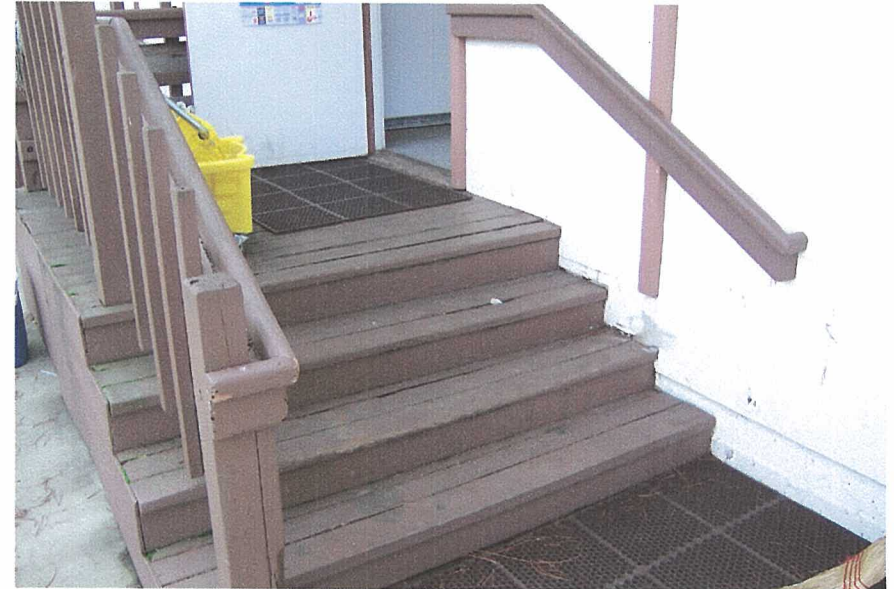
Site - Photo # 4

Loose doormat. Handrails are not compliant, mounted too low. The handrail extensions are non-compliant. No stair contrasting color striping.

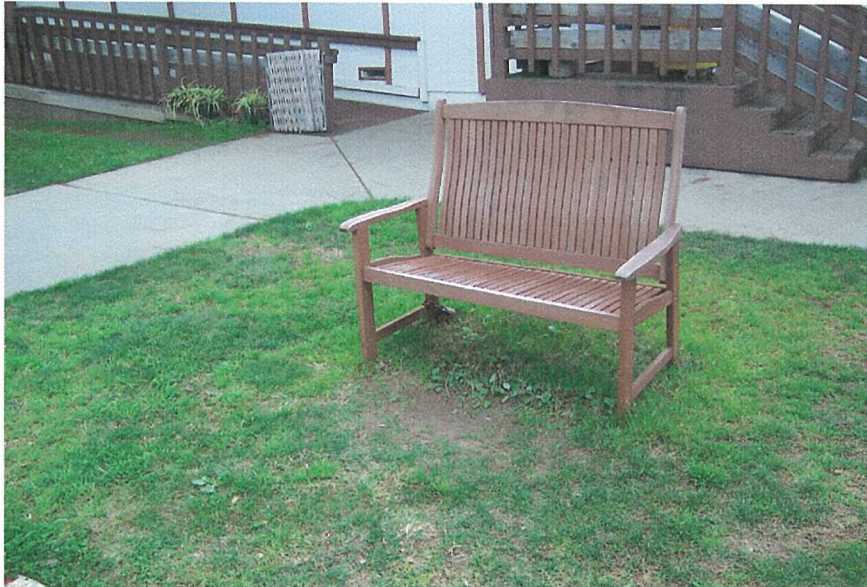
Site - Photo # 5

*Ramp has non-compliant handrails and rotted wood.
Bench does not have an accessible path of travel to it
and a space for a wheelchair user to be seated shoulder
to shoulder with a person seated on the bench.*

Recreation areas, picnic benches	Make a minimum of one picnic bench or 5% of all picnic benches provided accessible.	Existing picnic table is not located in a firm, stable and slip resistant surface. Photo #: 5	ADAAG: Recommended T24: N/A	Relocate picnic table to a firm surface.	1	JOB	\$50	\$50	3
----------------------------------	---	--	------------------------------------	--	---	-----	------	------	---

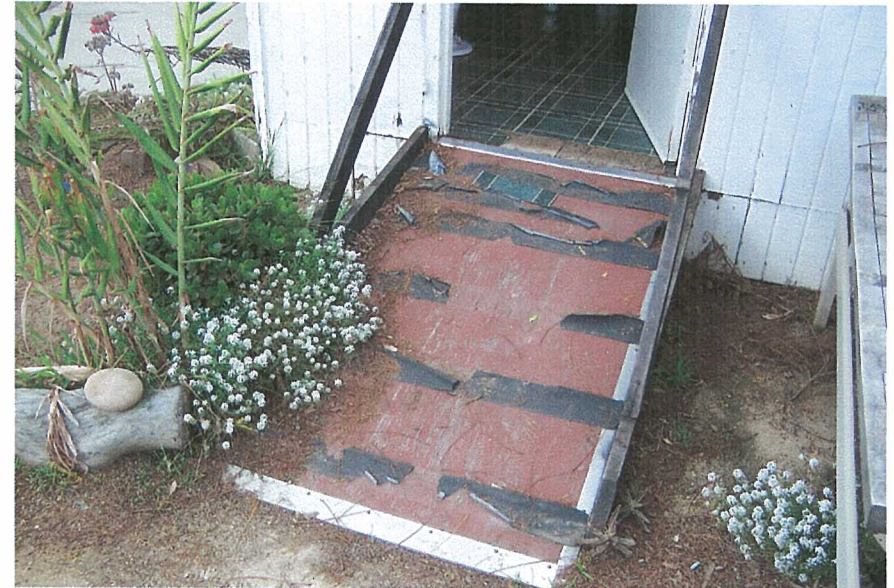
Site - Photo # 6

*Ramp is not compliant it has a steep 12" drop. Landing
and handrails are not compliant.*

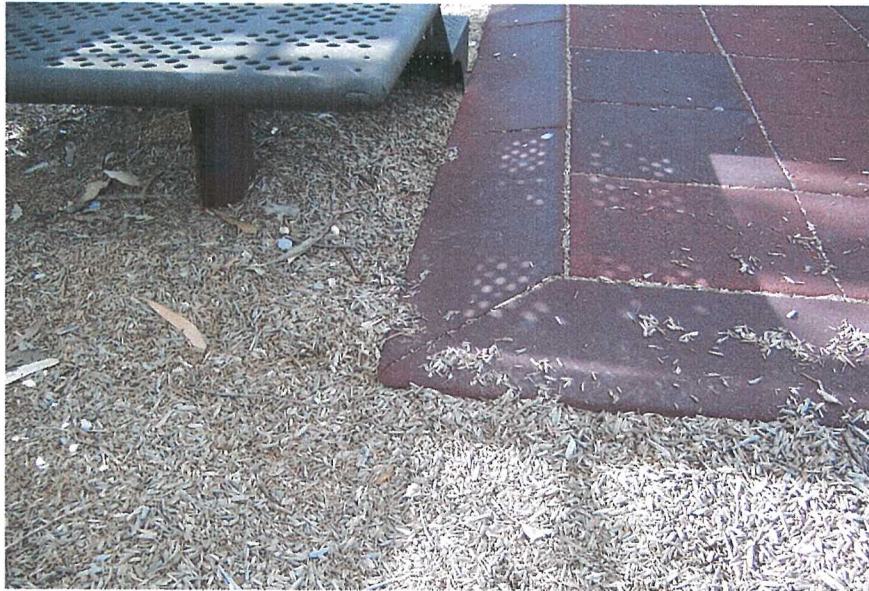
Site - Photo # 7

Slope of rubber mat adjacent to transfer platform has a 13% slope, which does not allow the wheelchair to get close enough to do the transfer.

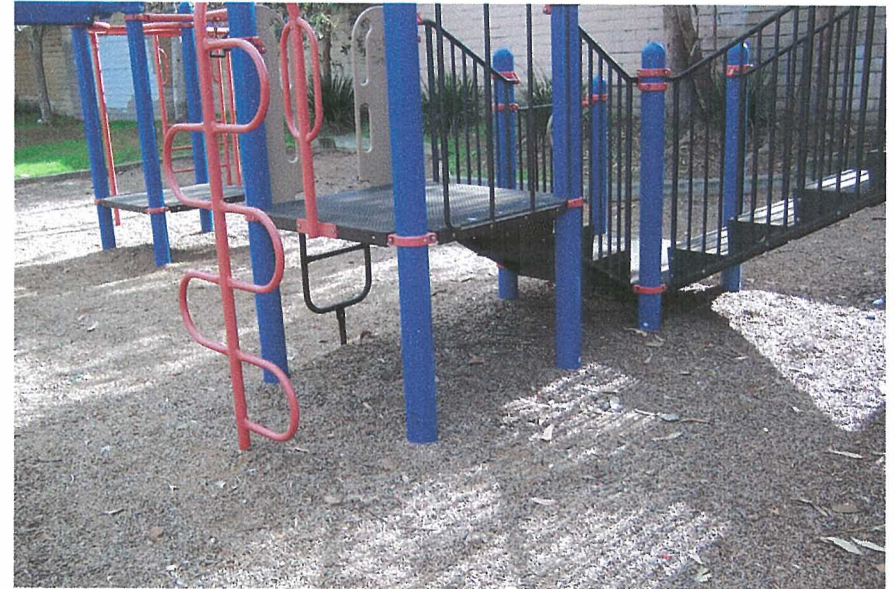
Site - Photo # 8

There is bark surface around the play structure, which is not firm and stable surface.

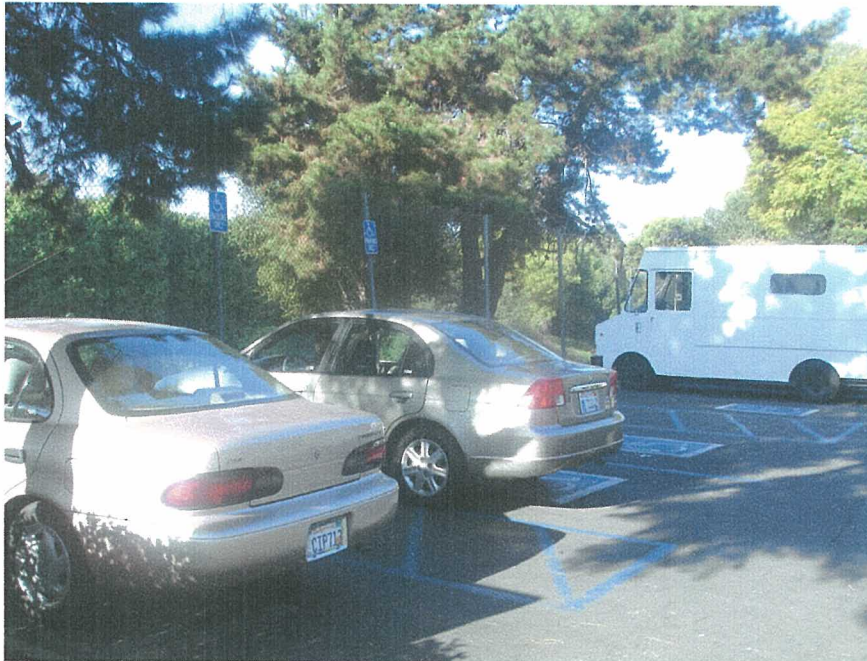
Site - Photo # 9

There is no direct path of travel from parking to walks leading to accessible entrances, forcing wheelchair users to go behind parked cars other than their own. "No Parking" is not painted at access aisles.

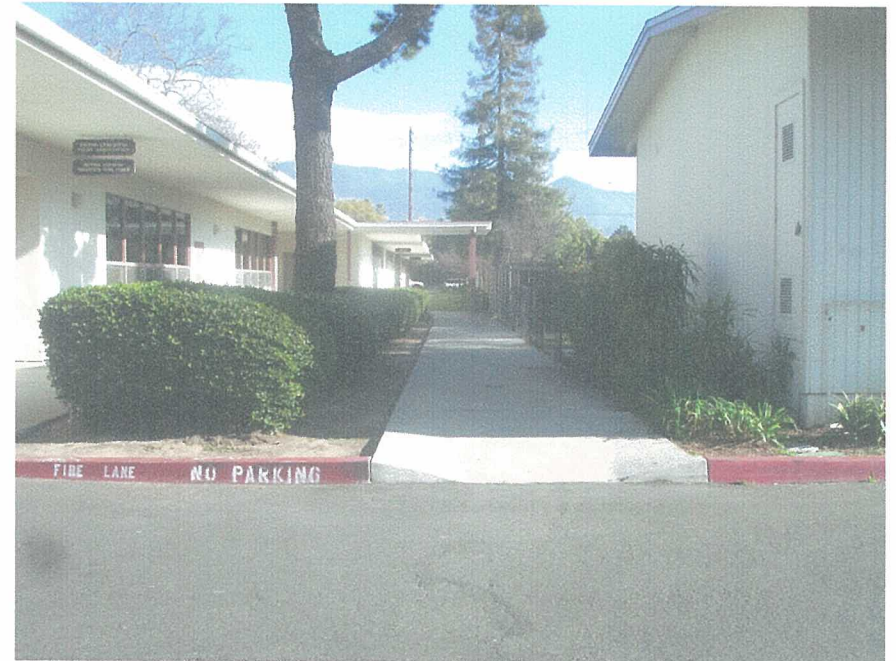
Site - Photo # 10

Curb ramp 40" wide instead of 48". It does not have detectable warnings and contrasting color with adjacent surfaces.

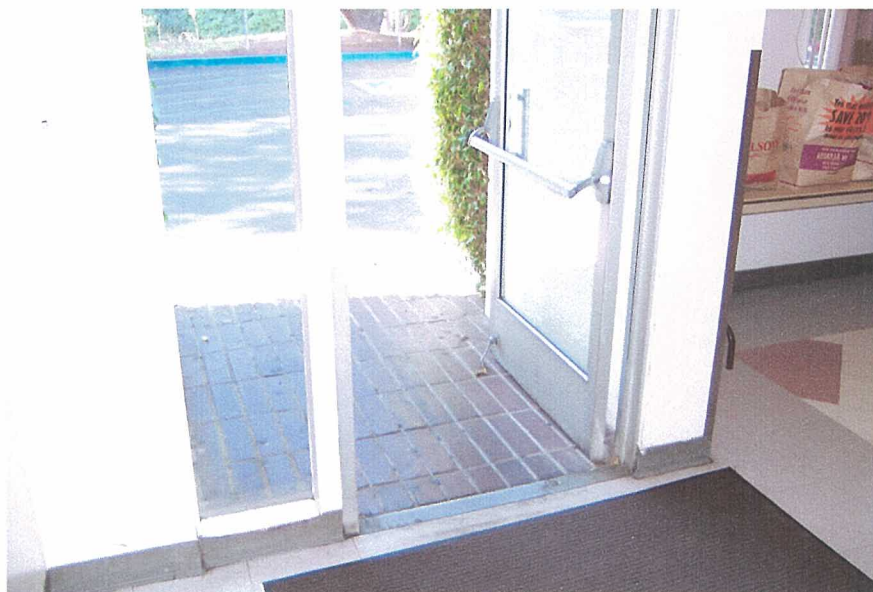
Building - Photo # 1

Door stop mounted at kick plate area required to be smooth

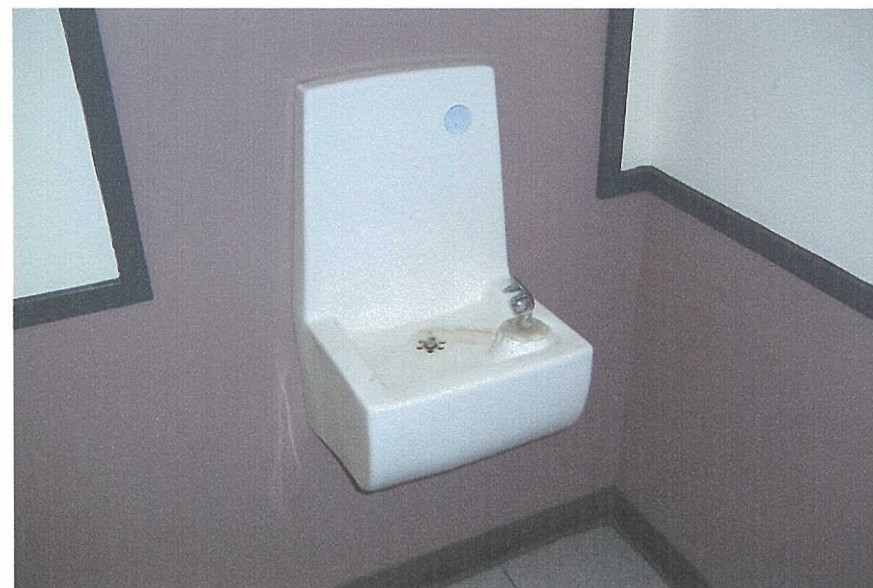
Building - Photo # 2

Drinking fountain does not have the required knee clearance - 12" deep, not high low, without wing wall at one side.

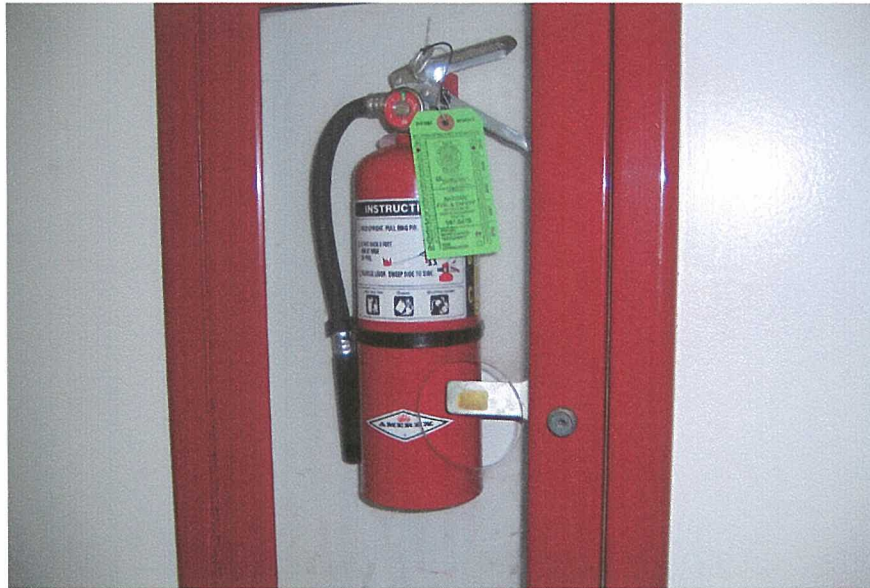
Building - Photo # 3

Fire extinguishers does not have compliant hardware, mounted at 54" high.

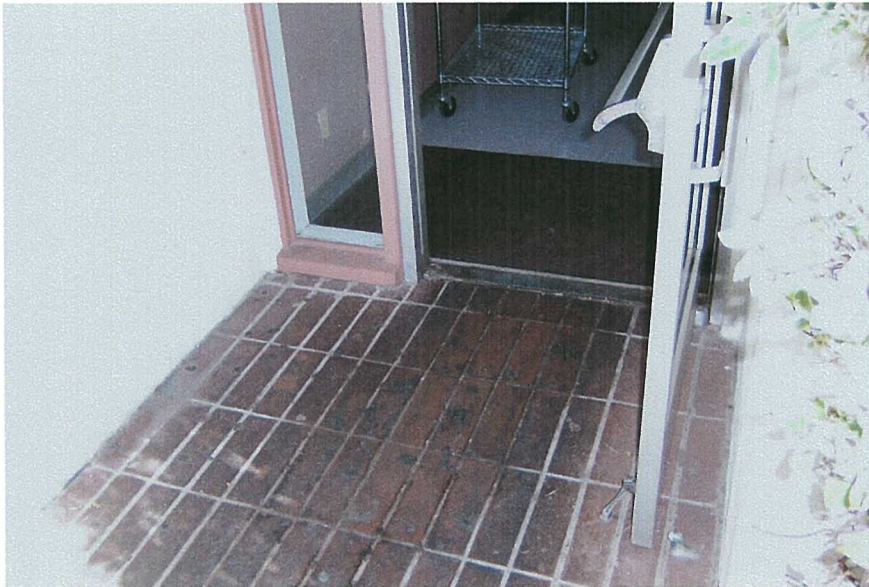
Building - Photo # 5

*Loose doormat, door stop mounted at kick plate area.
Strike side clearance at pull side of door*

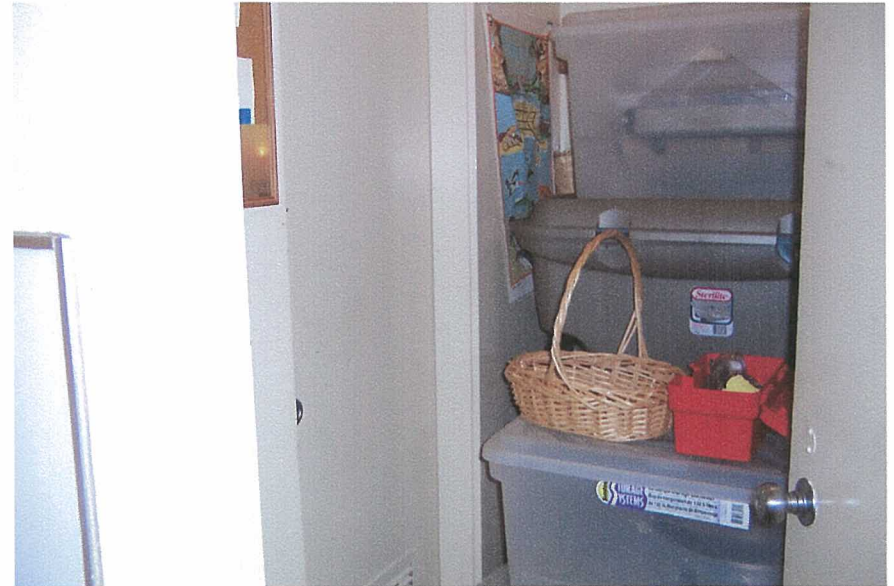
Building - Photo # 6

*Hardware is not accessible type. No tactile/Braille room
identification sign.*

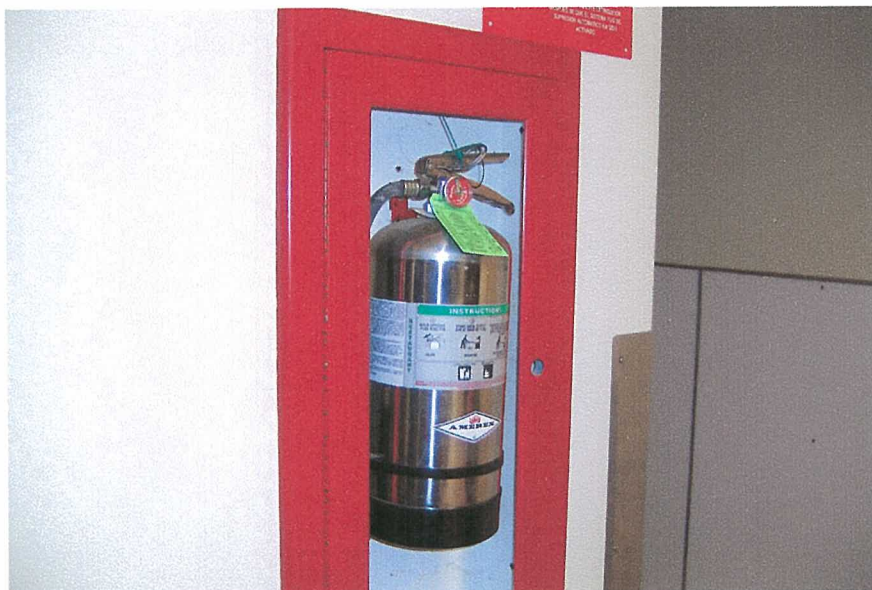
Building - Photo # 7

*Fire extinguisher does not have compliant hardware,
mounted at 61" high.*

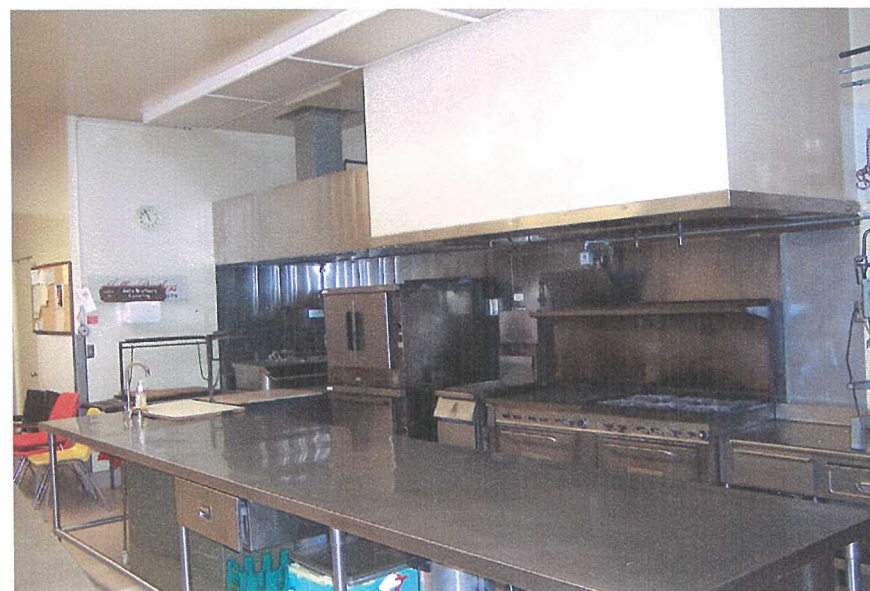
Building - Photo # 8

*Kitchen hood mounted at 75 3/4" high, instead of the
required minimum 80" high.*

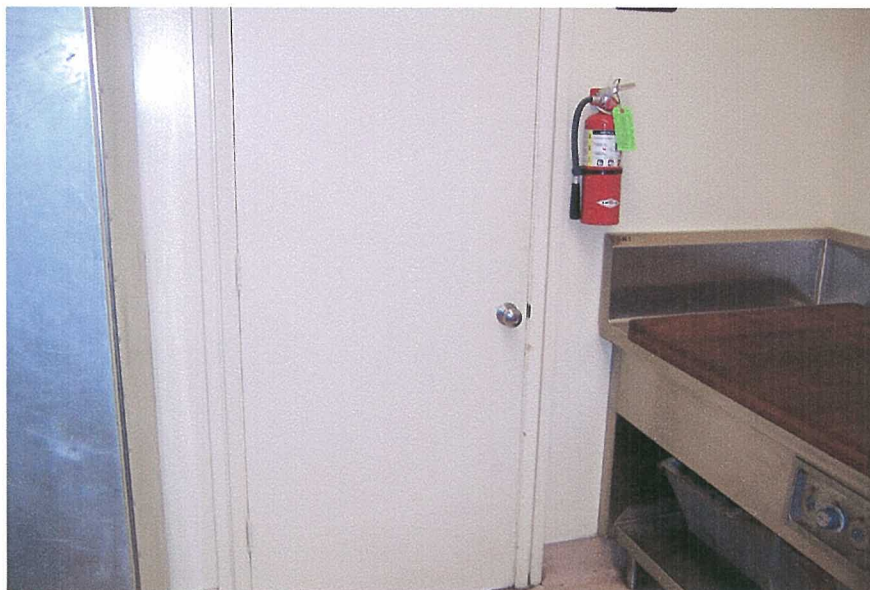
Building - Photo # 9

9" doors strike pull side due to the location of counter. Fire extinguisher does not have compliant hardware, mounted at 59" high. Doorknob is not accessible type hardware. No tactile/Braille room identification sign.

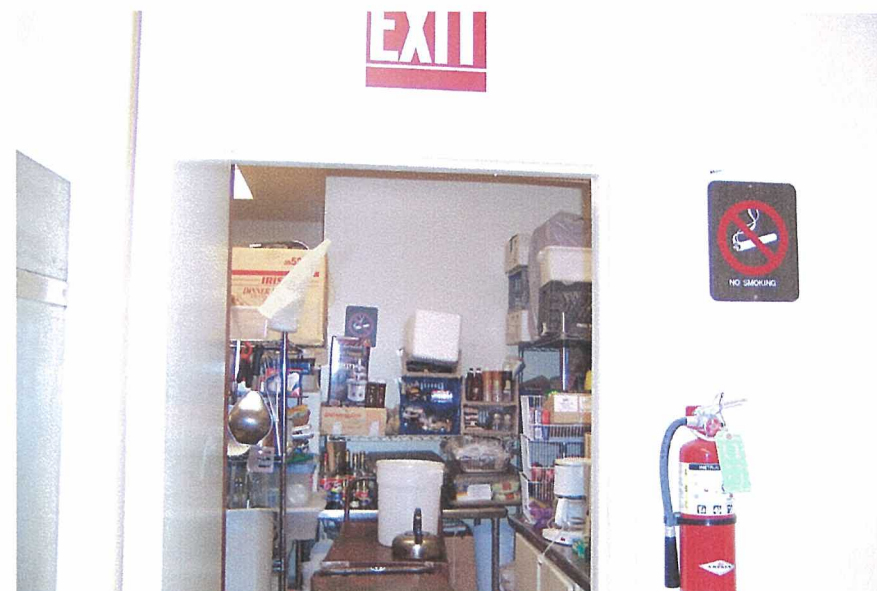
Building - Photo # 10

Fire extinguisher does not have compliant hardware, mounted at 59" high. No fire "EXIT" sign provided.

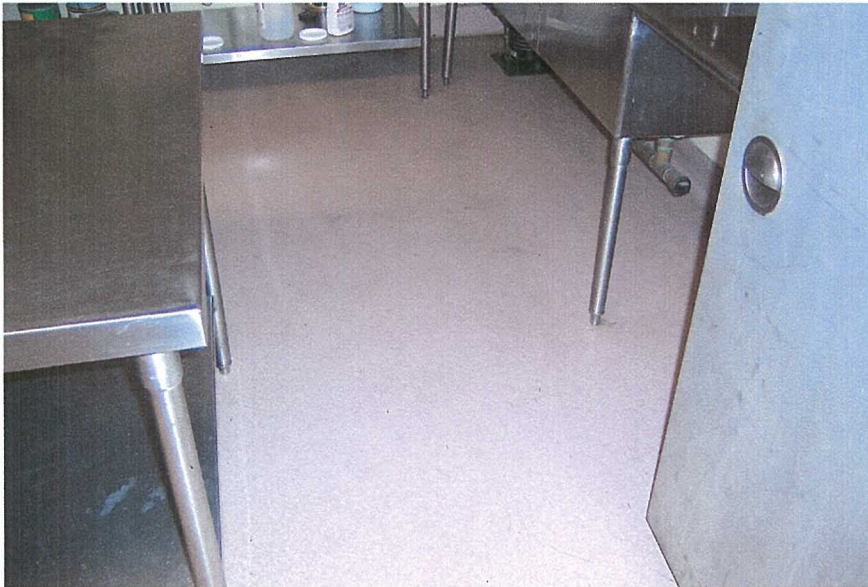
Building - Photo # 11

Path of travel at end of island is 29 1/2" wide instead to the required 36" wide minimum.

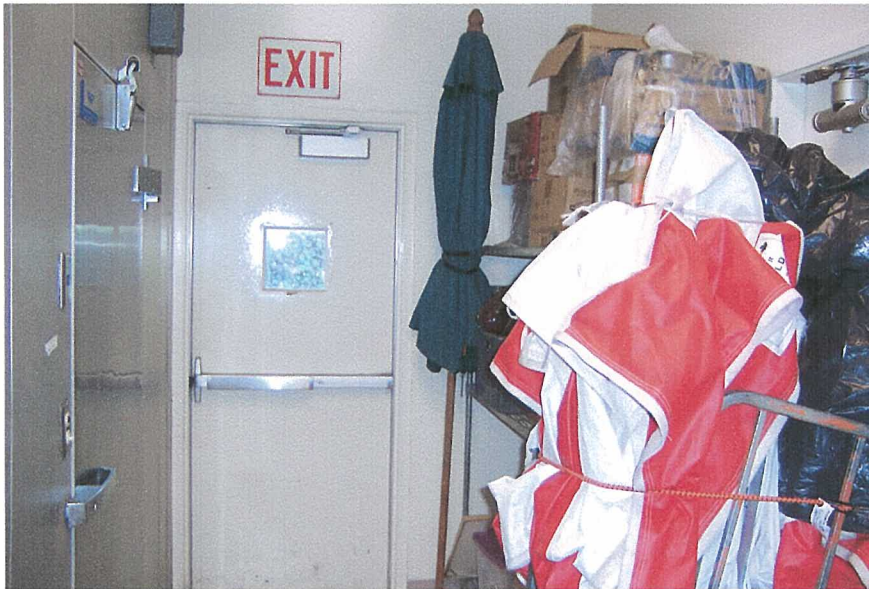
Building - Photo # 13

No fire tactile/Braille "EXIT" sign provided. Stored items further reduces the minimum required path of travel.

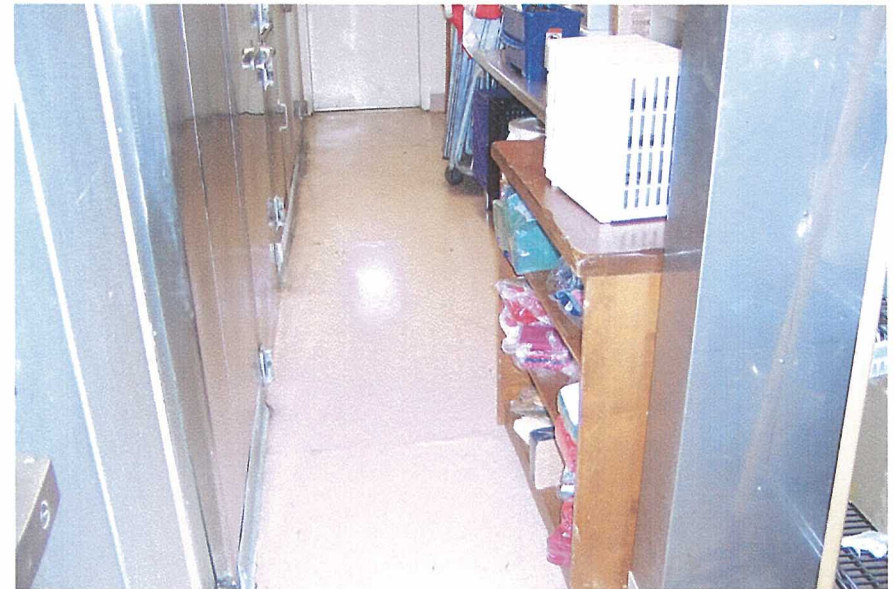
Building - Photo # 14

Path of travel at column is 35 1/2" wide instead to the required 36" wide minimum. Cabinet further reduces the minimum required path of travel.

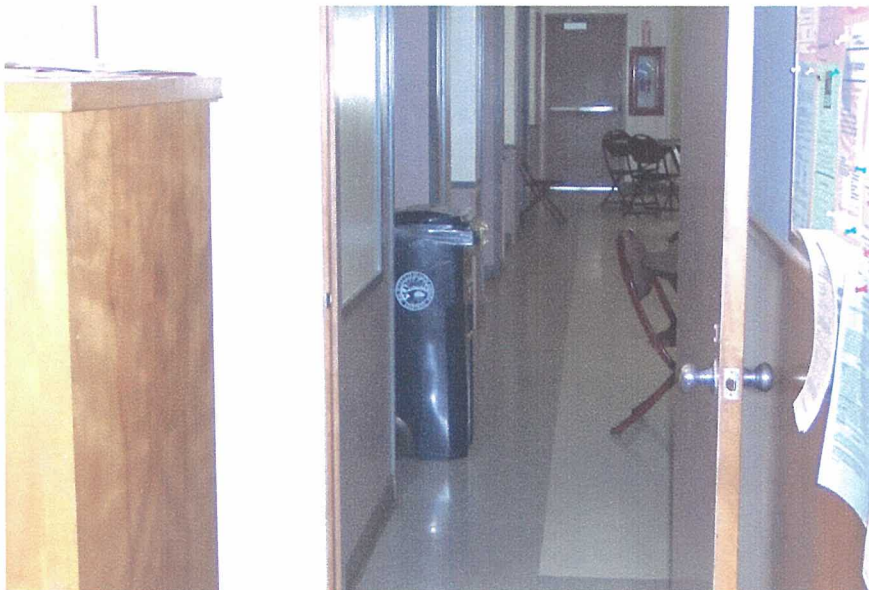
Building - Photo # 15

Hardware is not accessible type. No tactile/Braille room identification sign. Narrow door width is 27 1/2".

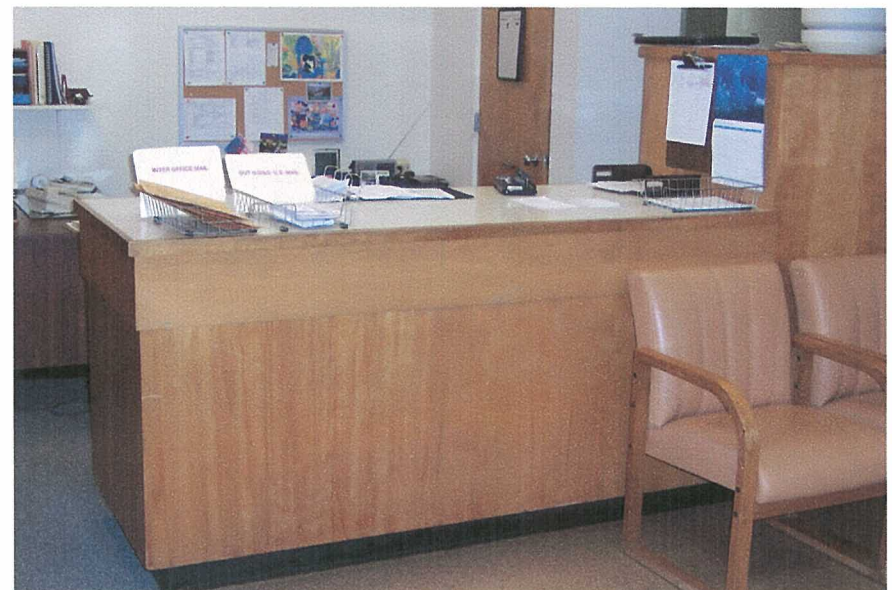
Building - Photo # 16

Counter mounted at 40" high does not have low area mounted at 34" high maximum.

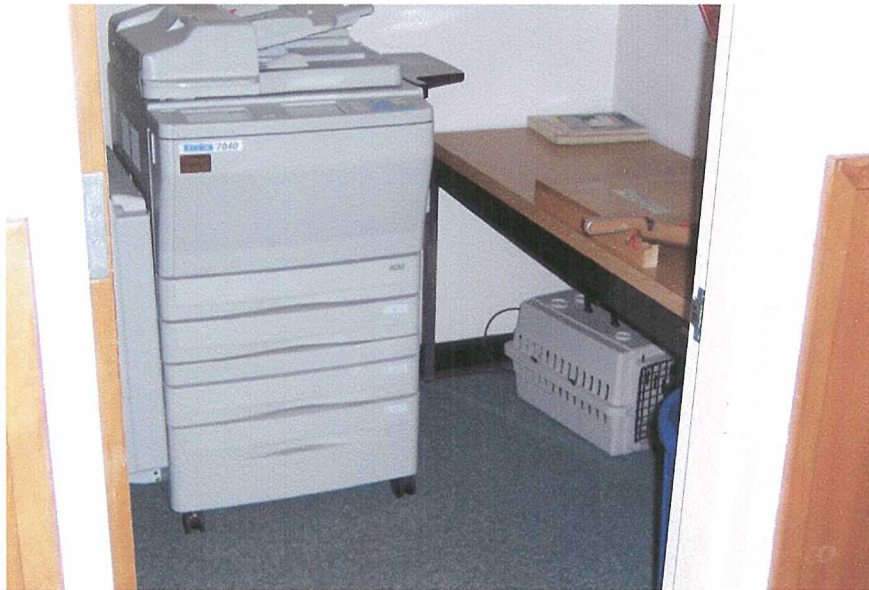
Building - Photo # 17

15" doors strike pull side to table and 47" in front of door to copier .

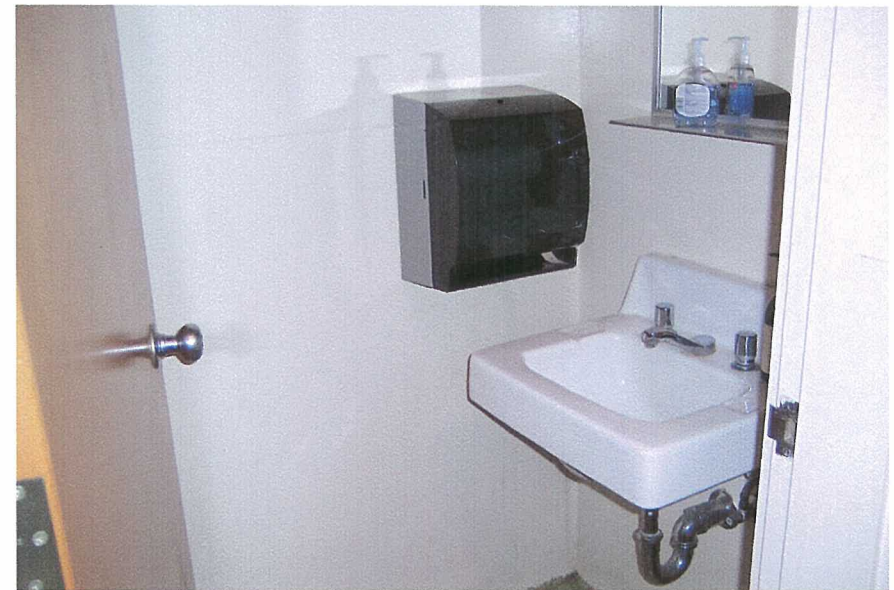
Building - Photo # 18

Small inaccessible restroom, does not have the required maneuverable clearances, narrow door, no grab bars, no pipe insulation, mirror mounted too high.

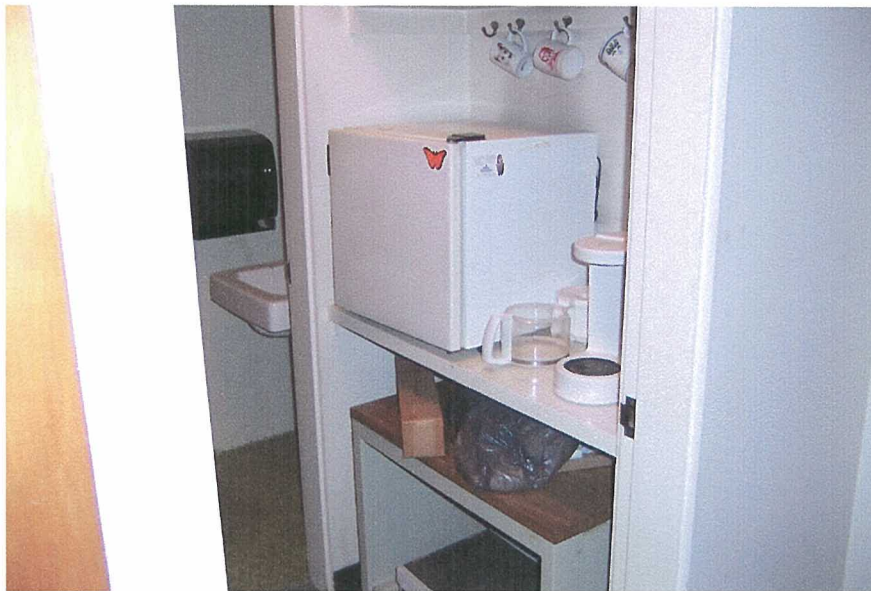
Building - Photo # 19

Small kitchenette does not have the required wheelchair maneuverable clearance.

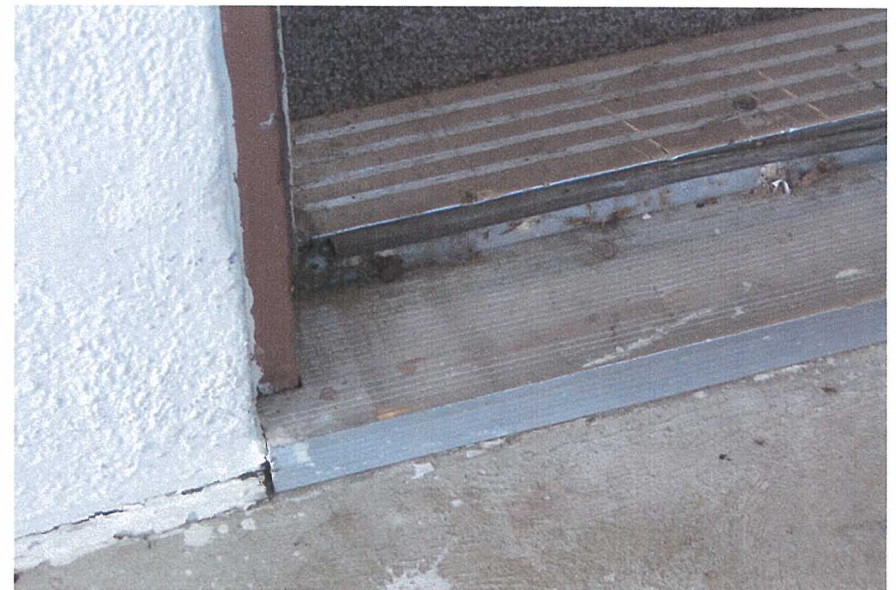
Building - Photo # 20

2" threshold is not compliant.

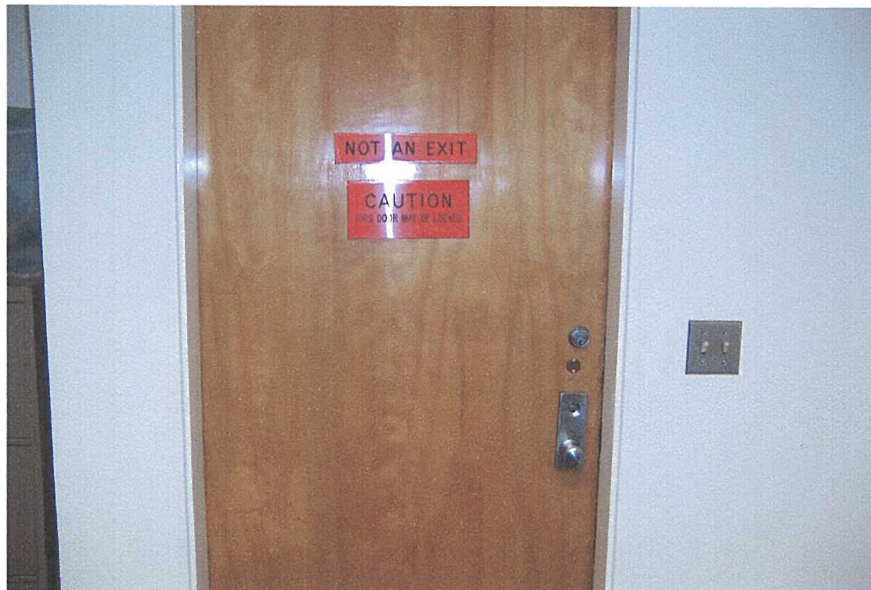
Building - Photo # 21

Hardware is not accessible type. No tactile/Braille room identification sign.

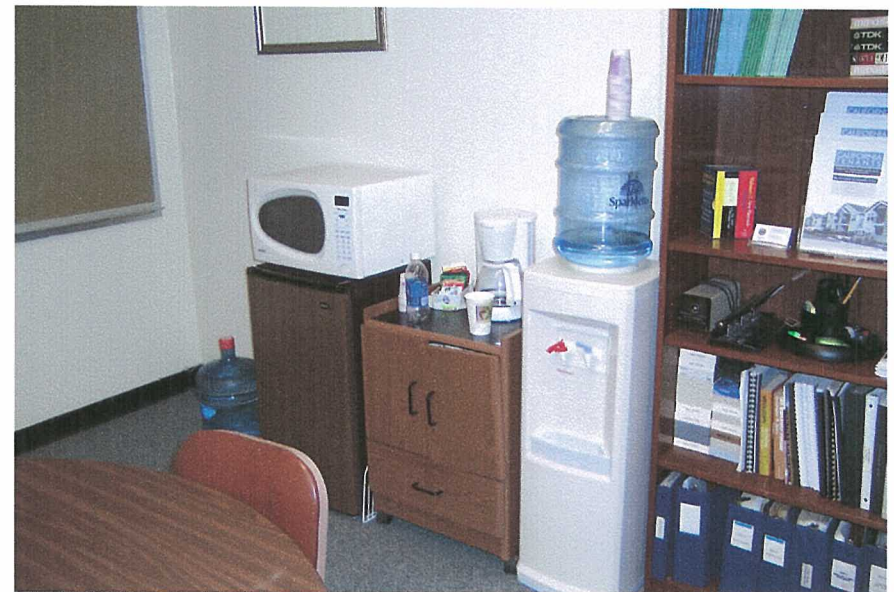
Building - Photo # 22

Table does not have the require knee clearance - 26 1/4" high.

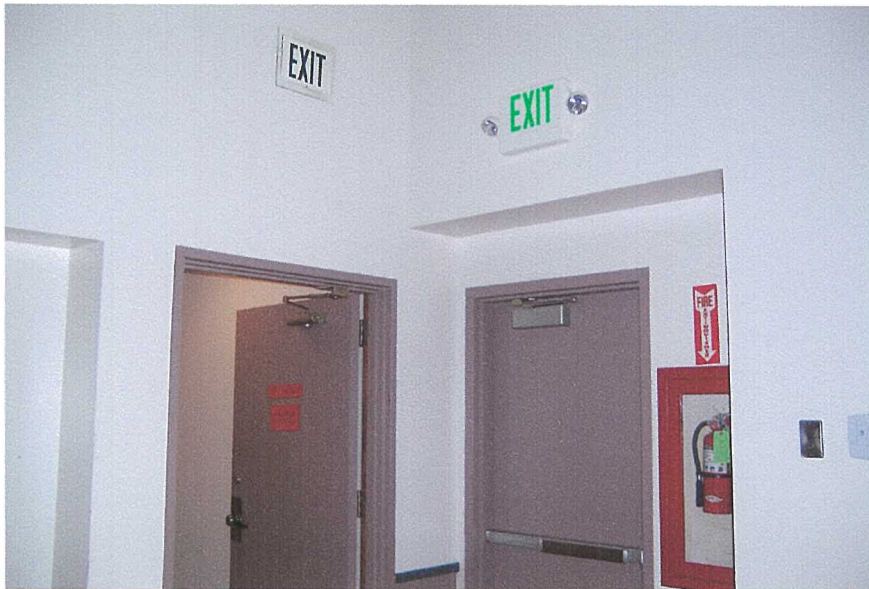
Building - Photo # 23

*No fire tactile and Braille "EXIT" sign provided.
Hardware is not accessible type. No tactile/Braille room
identification sign.*

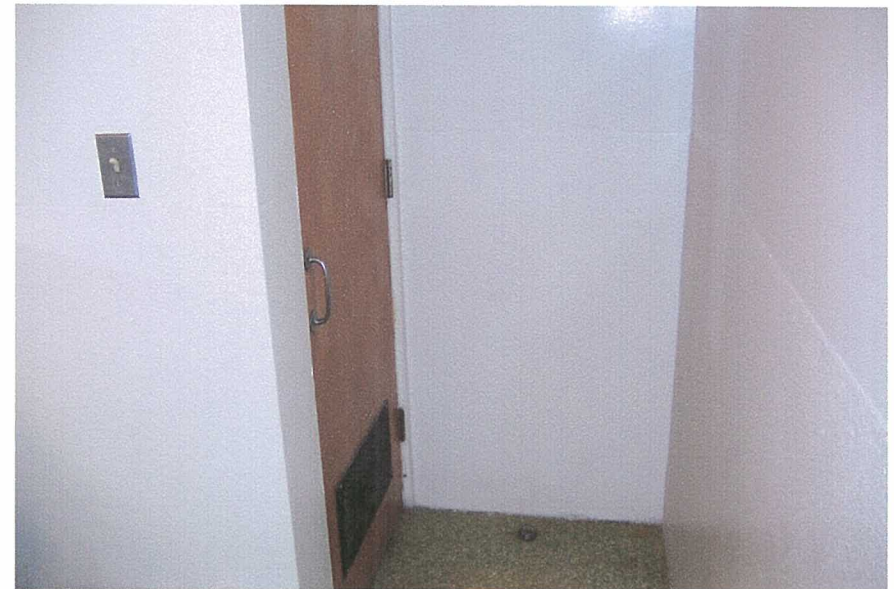
Building - Photo # 24

*Restroom vestibule is small and not compliant, without
the required minimum 60" from door to wall.*

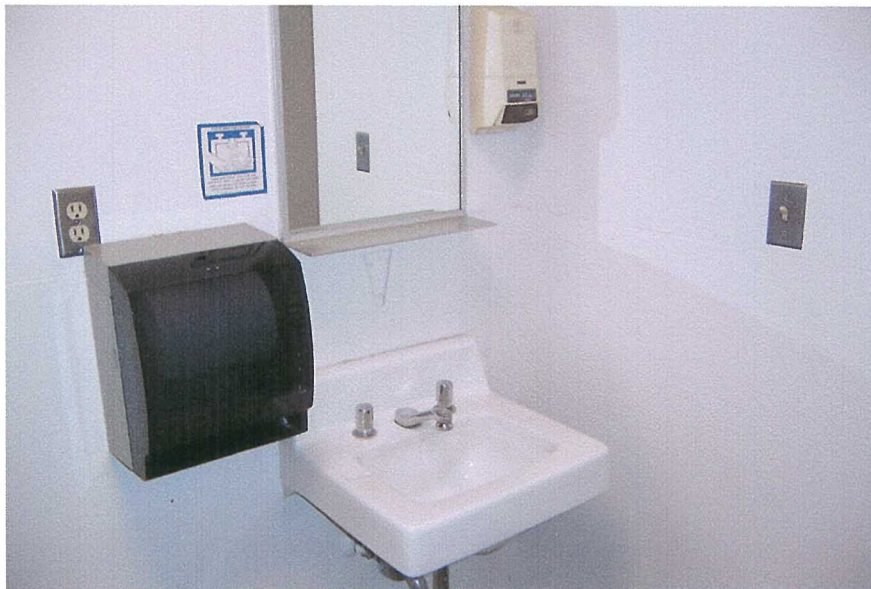
Building - Photo # 25

Sink is too low and does not have the required knee clearance - 24" high and 32" to the top. Mirror mounted too high.

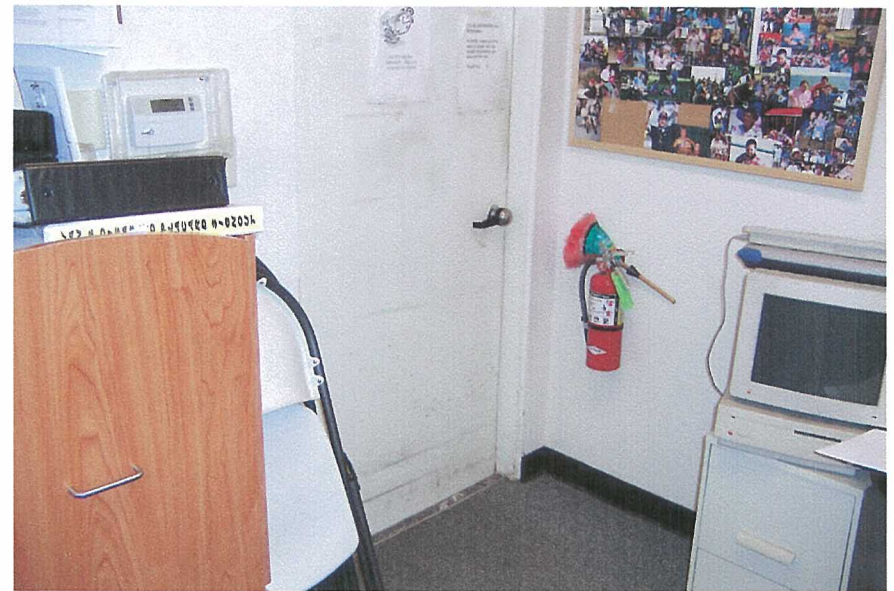
Building - Photo # 26

6" interior strike push side clearance to wall. There is not the required door maneuverable clearance due to the location of furniture and appliances.

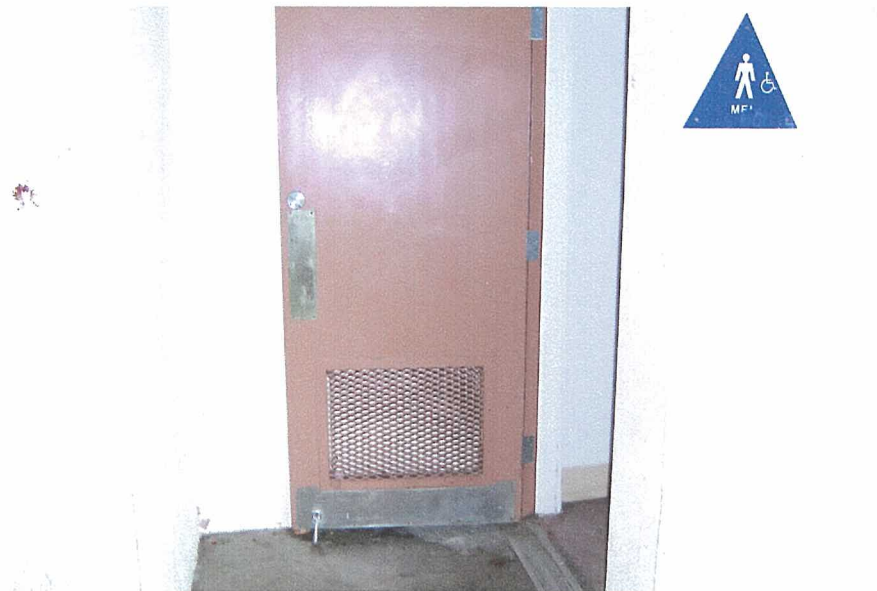
Building - Photo # 1

Triangle sign mounted on wall instead of door. Doorstop mounted at kick plate area.

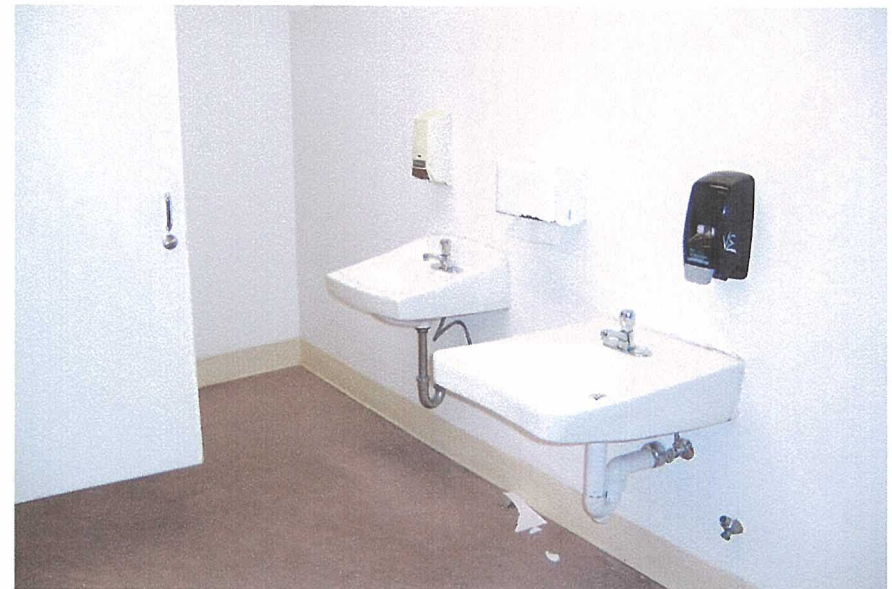
Building - Photo # 2

Sink does not have the required knee clearance - 25 1/2" high and 31 1/2" to the top.

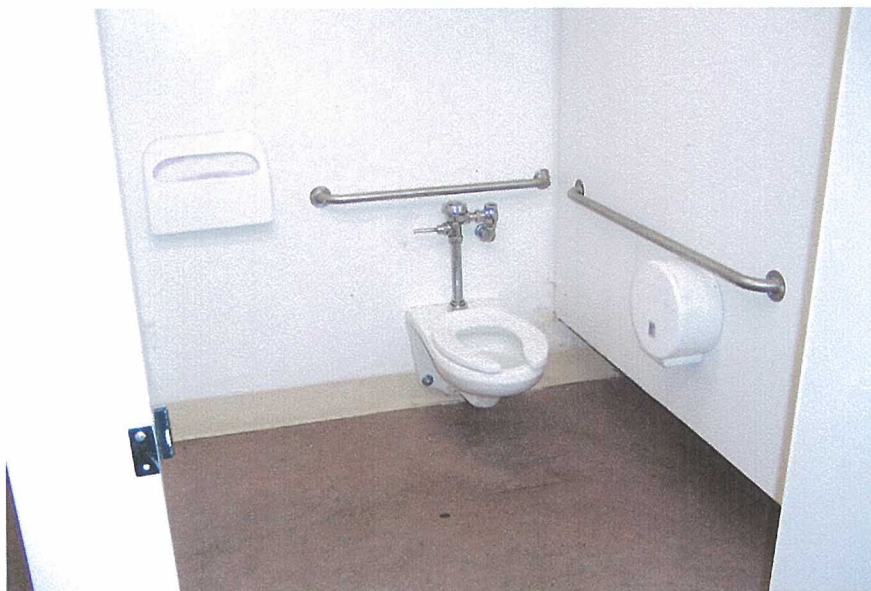
Building - Photo # 3

Toilet paper dispenser is mounted at 1/2" below grab bar instead of having 12" clear minimum.

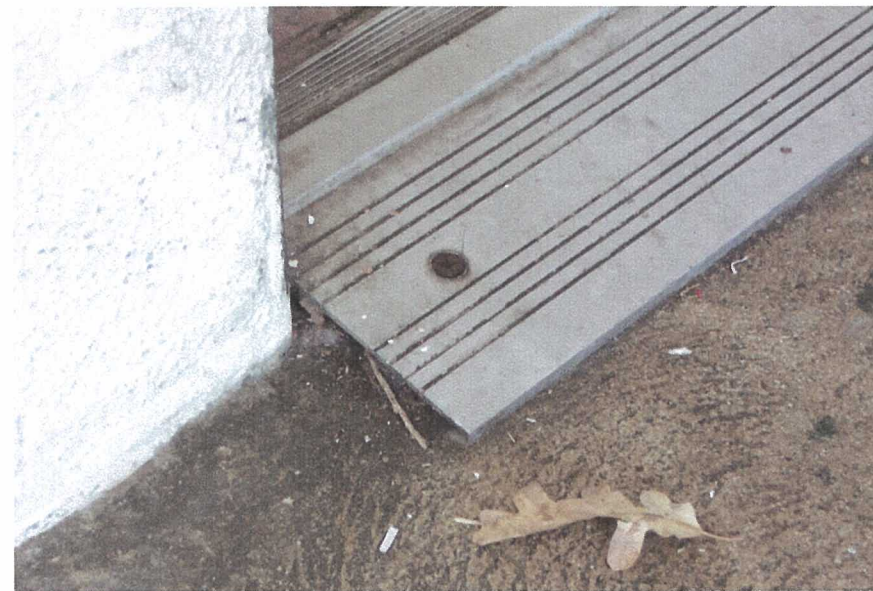
Building - Photo # 4

1" threshold, is not compliant.

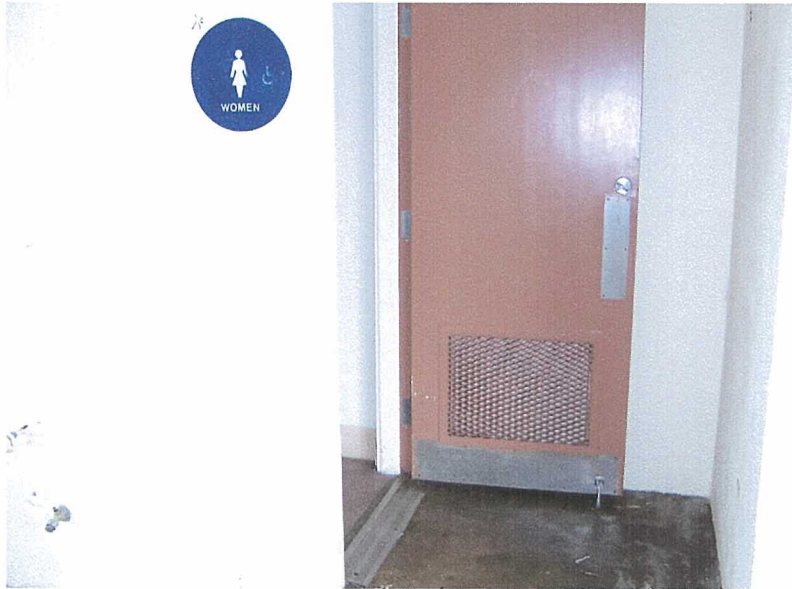
Building - Photo # 5

Women's restroom sign is mounted on the wall.
