GILDA PUENTE-PETERS
ARCHITECTS

**WESTSIDE COMMUNITY
CENTER**
ACCESSIBILITY SURVEY

June, 2007

**CITY OF SANTA
BARBARA**

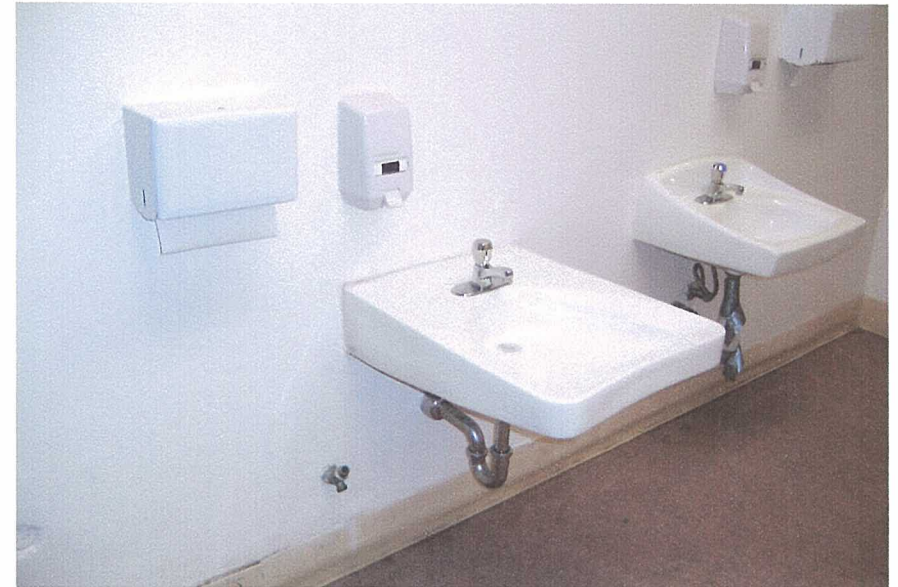
Building - Photo # 6

Sink does not have the required knee clearance - 25" high and 31" to the top.

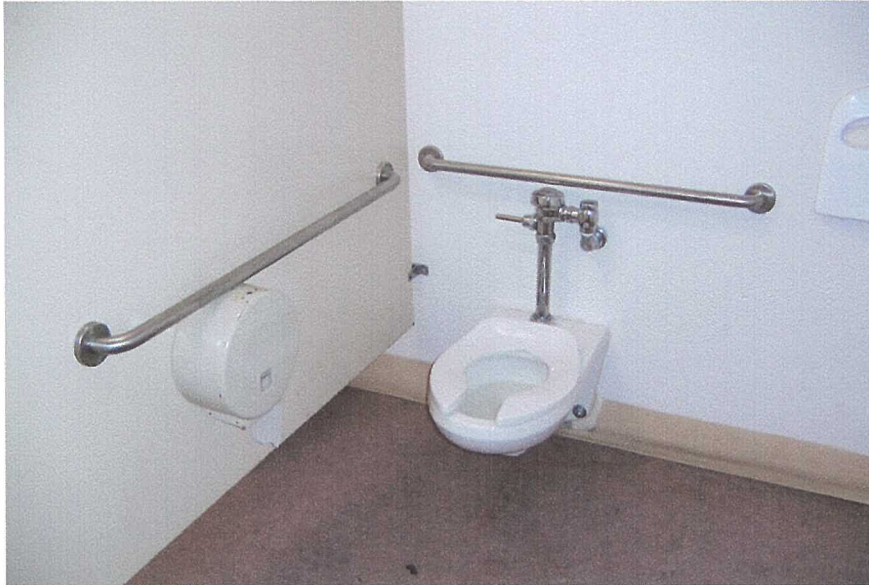
Building - Photo # 7

*Flush valve located at the narrow side of water closet.
Toilet paper dispenser accessible type but it is mounted at
1/2" below grab bar. 17" from centerline of water closet to
wall. Back & side grab bars are mounted too close to the
wall.*

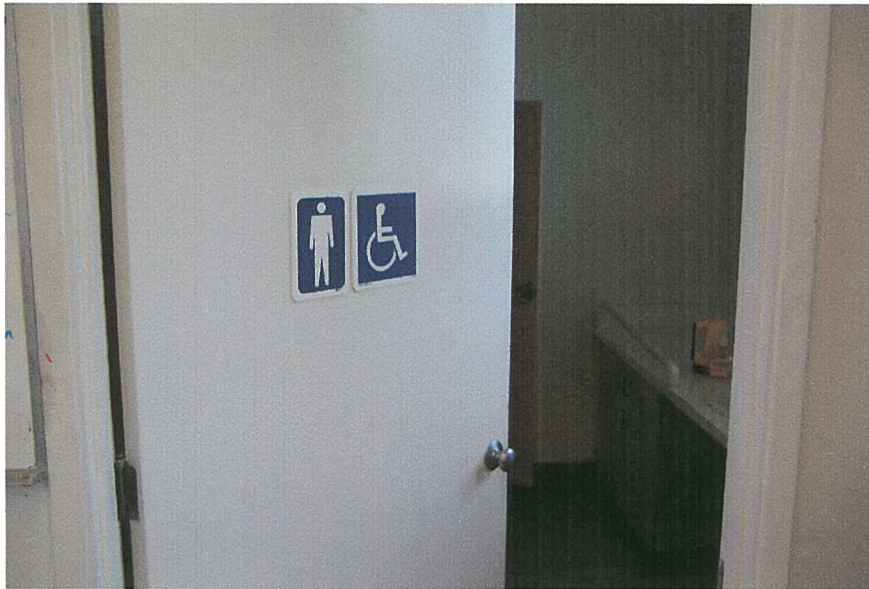
Building - Photo # 1

*Men's restroom door does not have a compliant sign.
Hardware is not accessible type.*

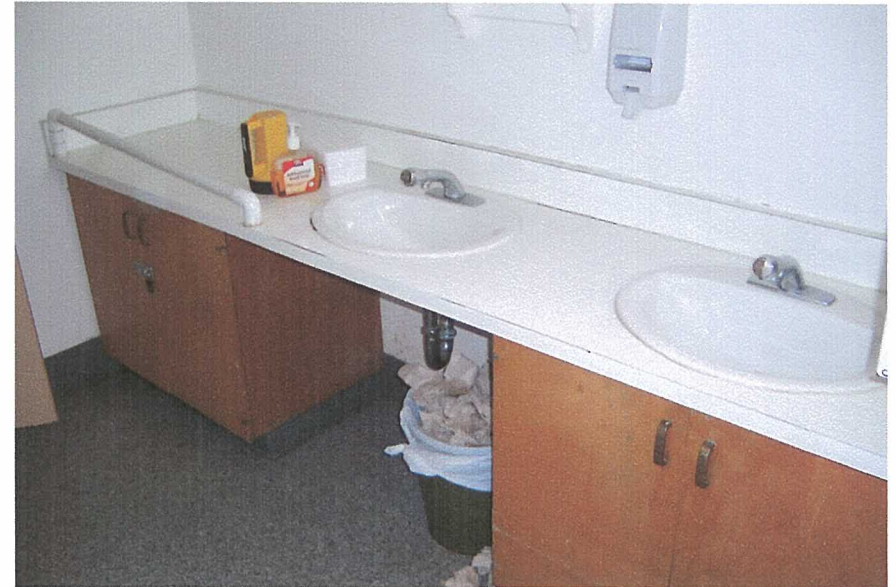
Building - Photo # 2

*Sink does not have the required knee clearance - 24"
high and 31" to the top. Soap dispenser accessible type,
mounted at 42" high.*

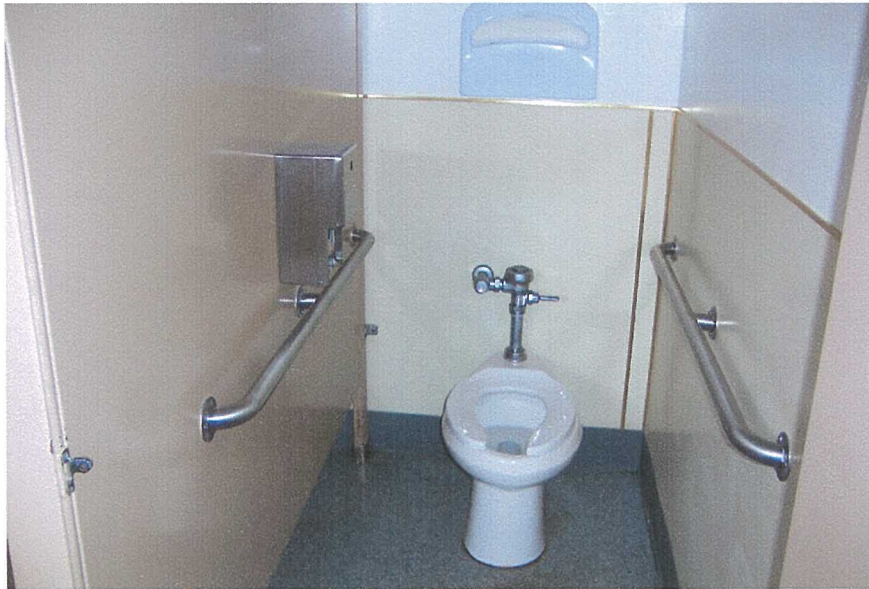
Building - Photo # 3

Narrow Men's semi-ambulatory stall is not compliant, since there is no other accessible restroom in this building.

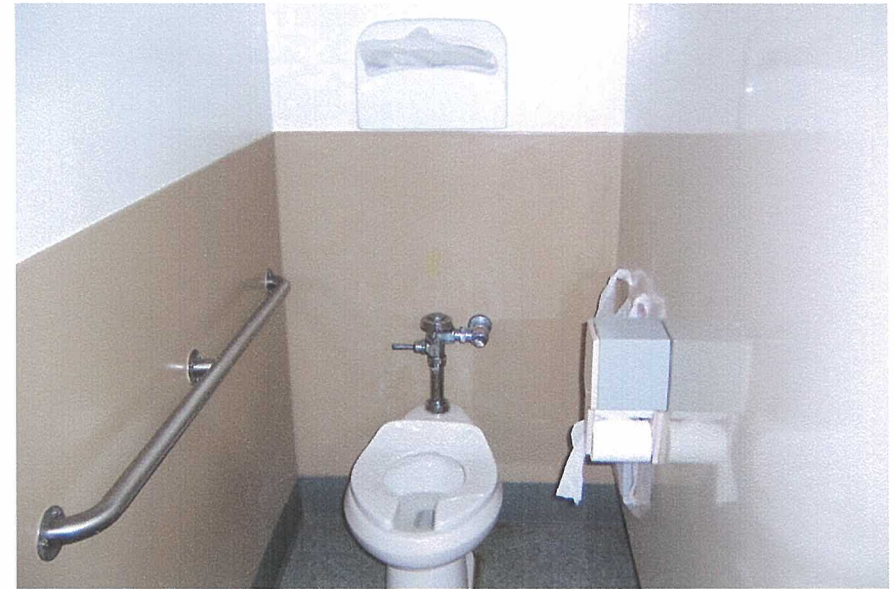
Building - Photo # 4

Narrow Women's semi-ambulatory stall is not compliant, since there is no other accessible restroom in this building.

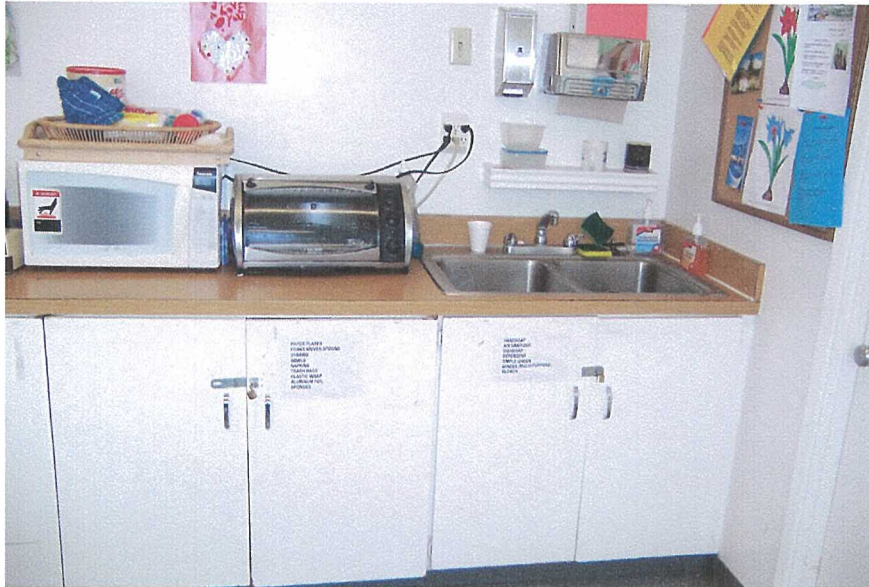
Building - Photo # 5

Sink does not have the required knee clearance. Soap dispenser accessible type, mounted at 57" high. Accessible type paper towel dispenser, mounted at 50" high.

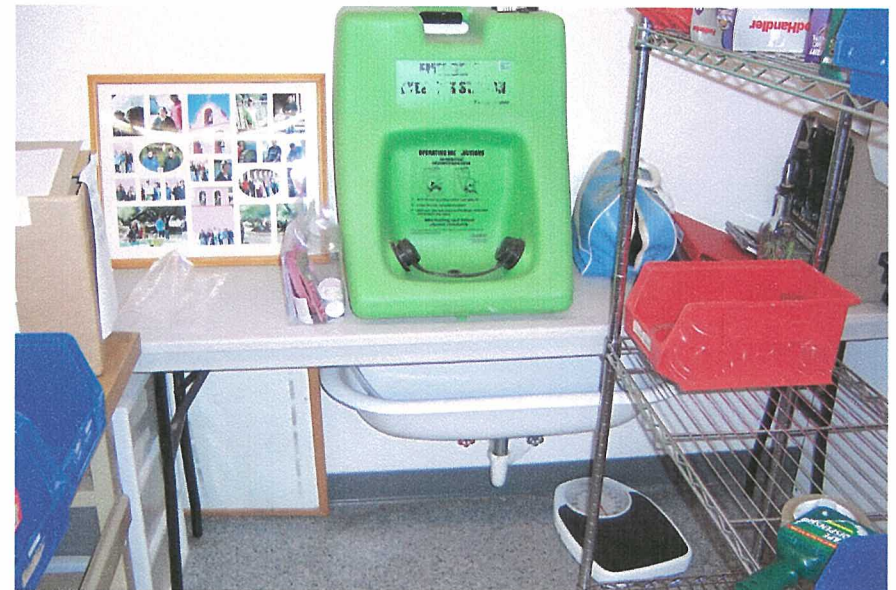
Building - Photo # 6

No knee clearance at eye wash, similar requirements as drinking fountains. Path of travel to eyewash is not compliant.

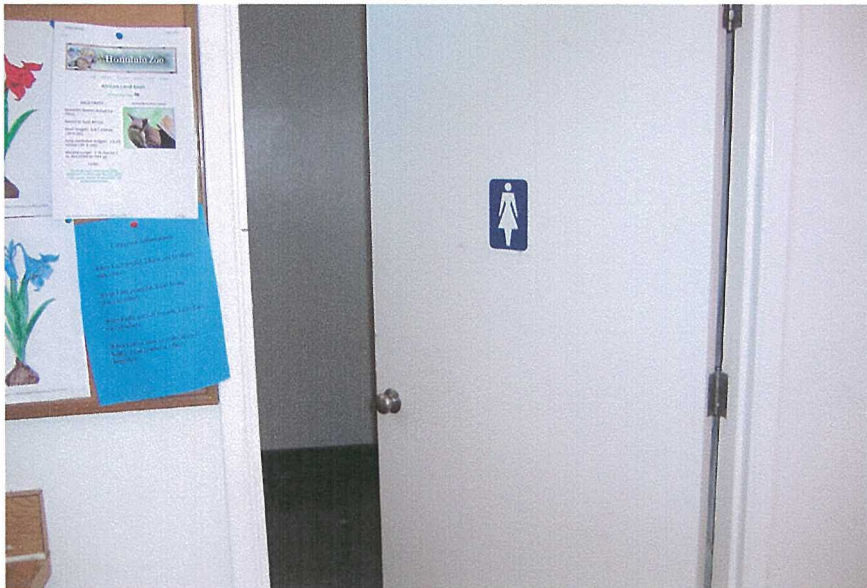
Building - Photo # 7

Doorknob not accessible type requires tight grasping and twisting of the wrist to operate. Women's restroom door does not have a compliant sign.

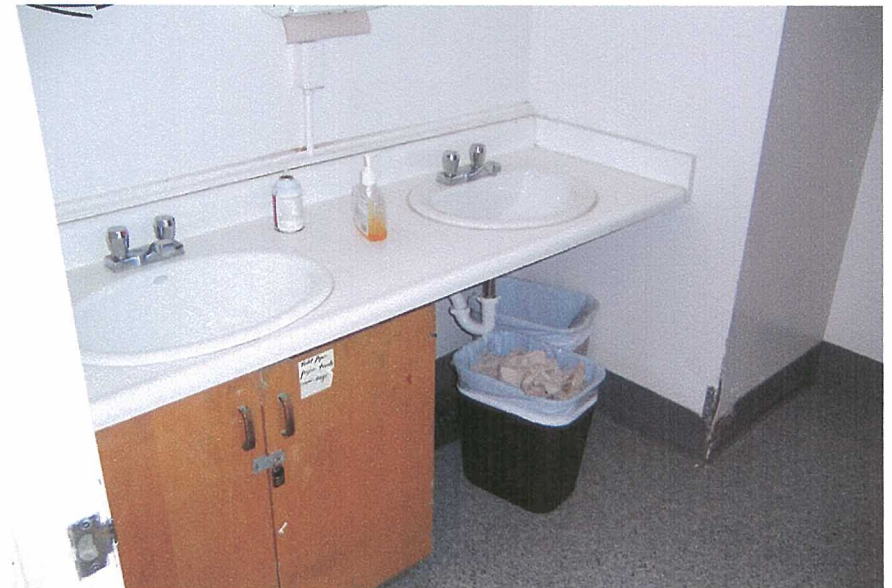
Building - Photo # 8

Sink does not have the required knee clearance - 24" high and 31" to the top. Relocate storage under sink.

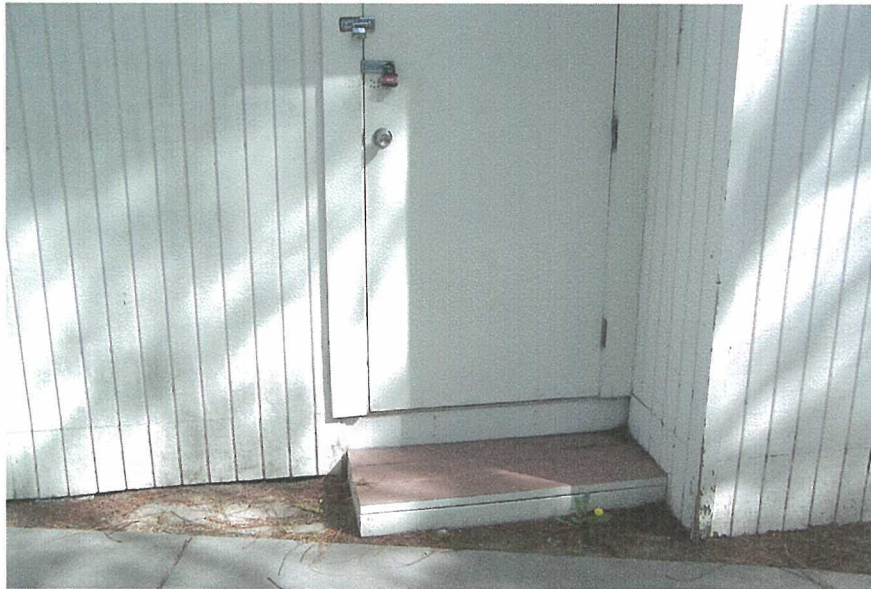
Building - Photo # 1

No door landing and sloped walk at exterior door. Not compliant hardware, no tactile/Braille room identification sign.
