**GILDA PUENTE-PETERS**  
**ARCHITECTS**

**MACKENZIE PARK**  
**ACCESSIBILITY SURVEY**

**February, 2006**

**CITY OF SANTA**  
**BARBARA**

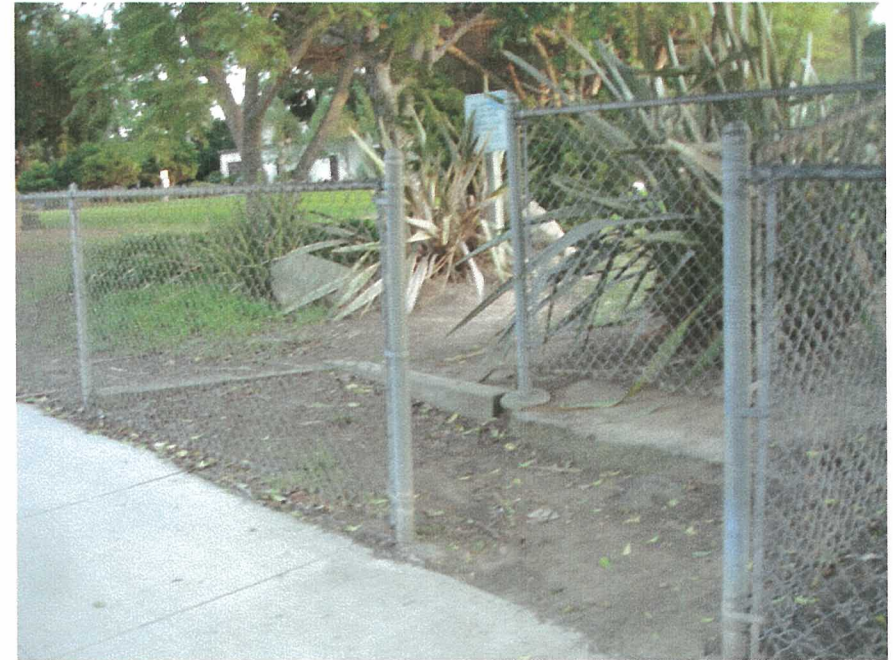
*Public Right-of-Way - Photo # 2*

*Gate path of travel is not accessible, surface is not firm, and stable. There is a step that makes this entrance inaccessible to wheelchair users.*

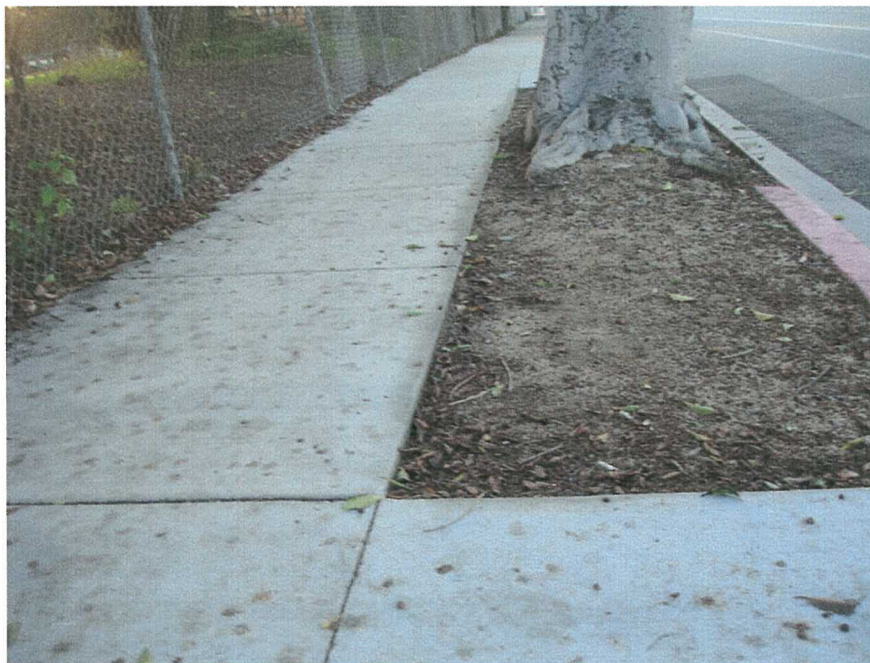
*Public Right-of-Way - Photo # 3*

*Tree well has 1" drop at several locations. Maintenance of dirt or bark is needed to avoid drops that can be a tripping hazard to pedestrians.*

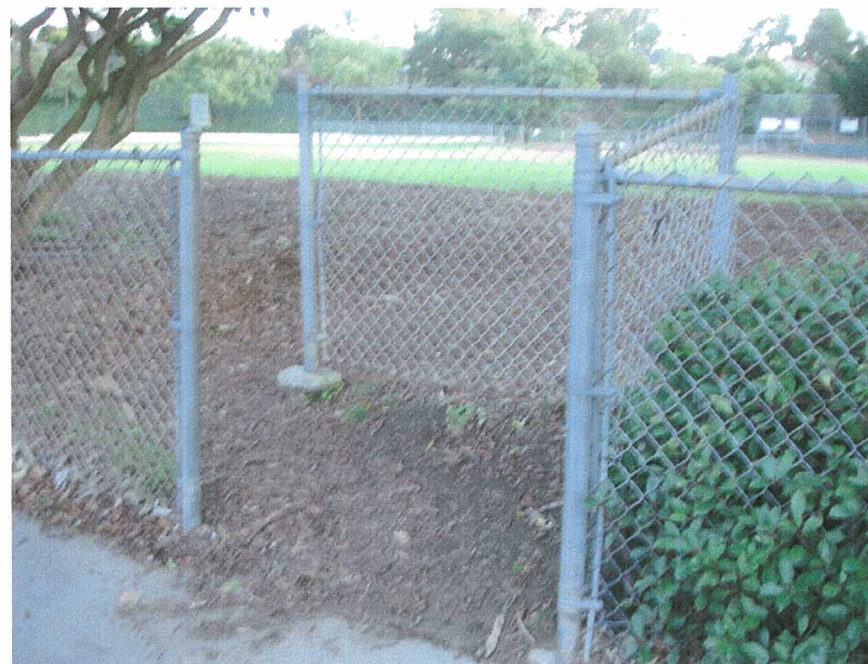
*Public Right-of-Way - Photo # 4*

*Gate path of travel to picnic tables is not accessible, surface is not firm and stable and there is a steep slope.*

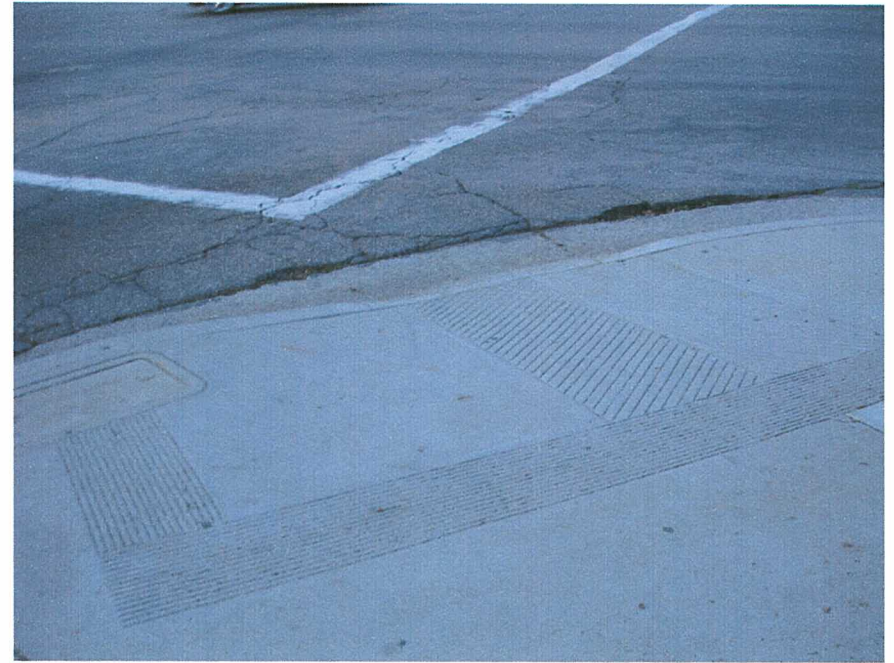
*Public Right-of-Way - Photo # 6*

*There are no detectable warnings at the curb ramp, and  
no contrasting color with adjacent surfaces. The gutter  
slope is 10% instead of the maximum allowed 5% slope.  
Broken concrete needs to be repaired.*

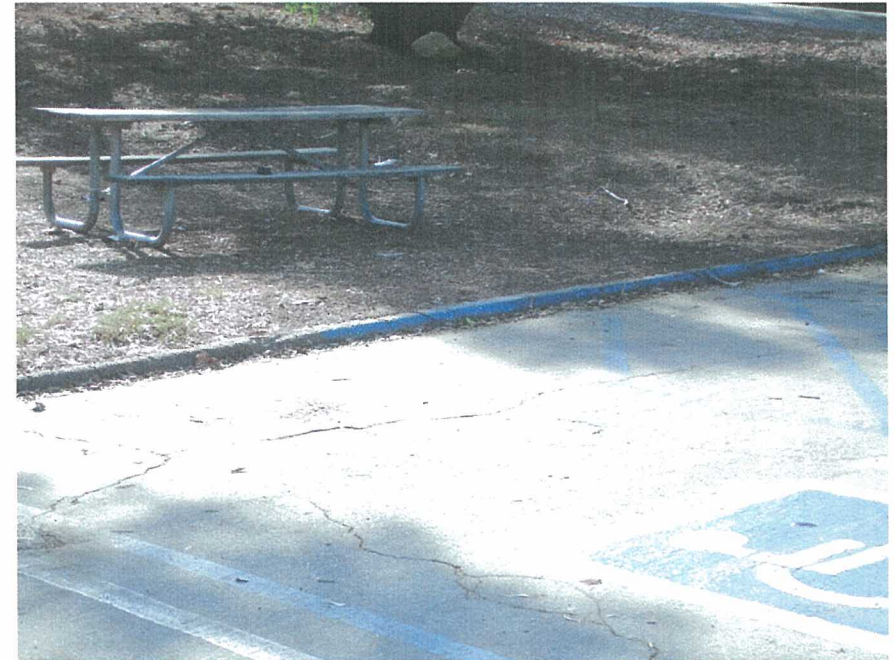
Site - Photo # 2

*Path of travel and area around picnic table are not accessible due to its surface and curb from parking stalls. Picnic table does not have the required knee clearance.*

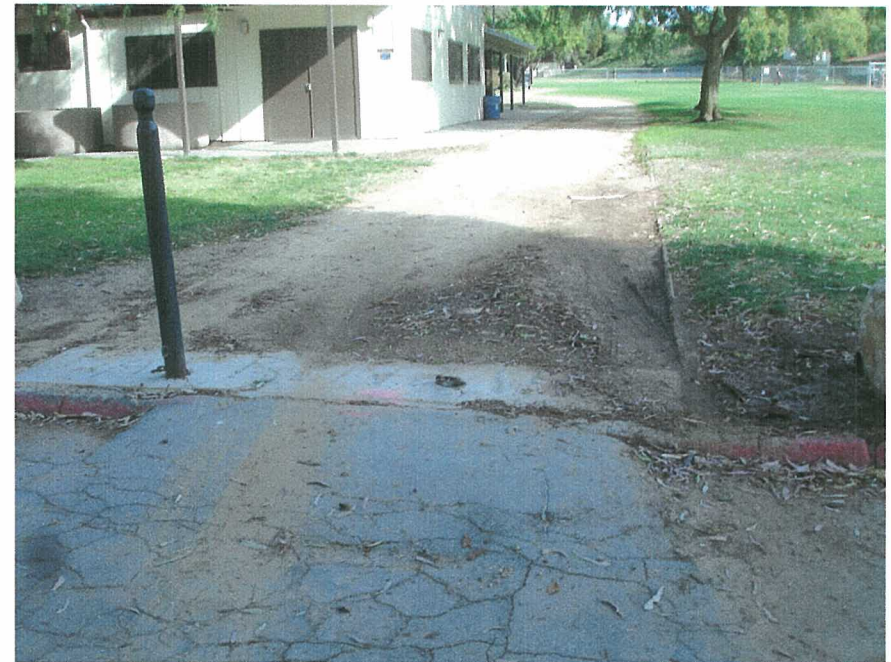
Site - Photo # 4

*Path of travel from parking to Adult Center – Building E does not have a firm, stable and slip resistant surface.*

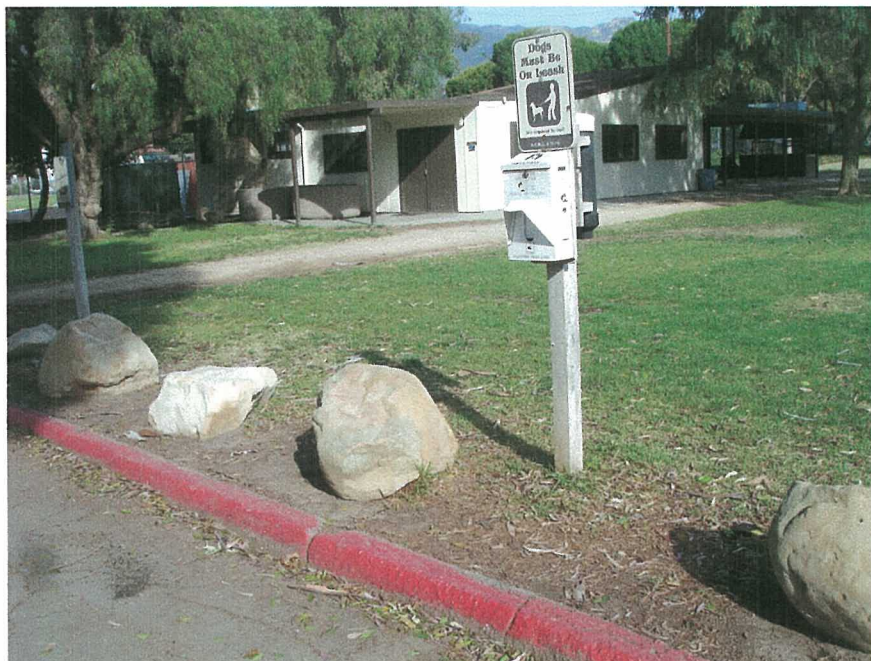
Site - Photo # 5

*Path of travel to pet's trash bag dispenser is not accessible.*

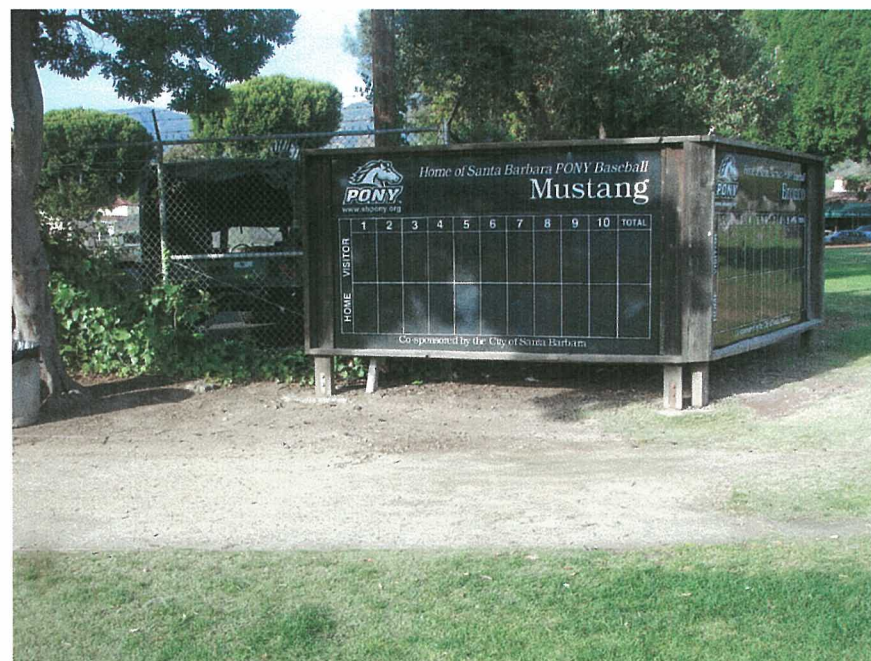
Site - Photo # 6

*Path of travel to score board is not accessible and scoreboard usable area is as high as 62" high.*

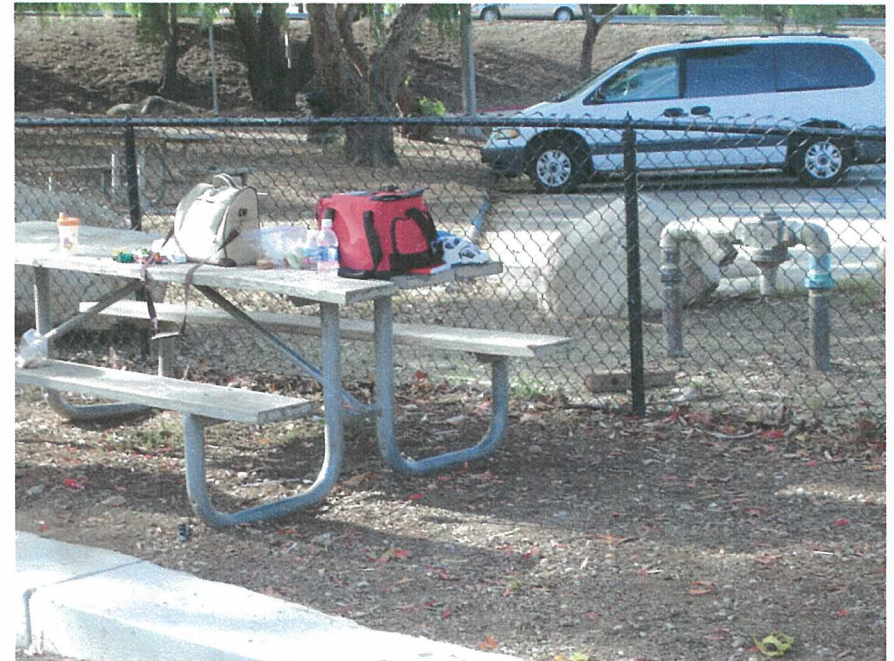
Site - Photo # 8

*Path of travel and area around to picnic table are not accessible due to its surface and curb from children's playground. Picnic table does not have the required knee clearance for wheelchair users.*

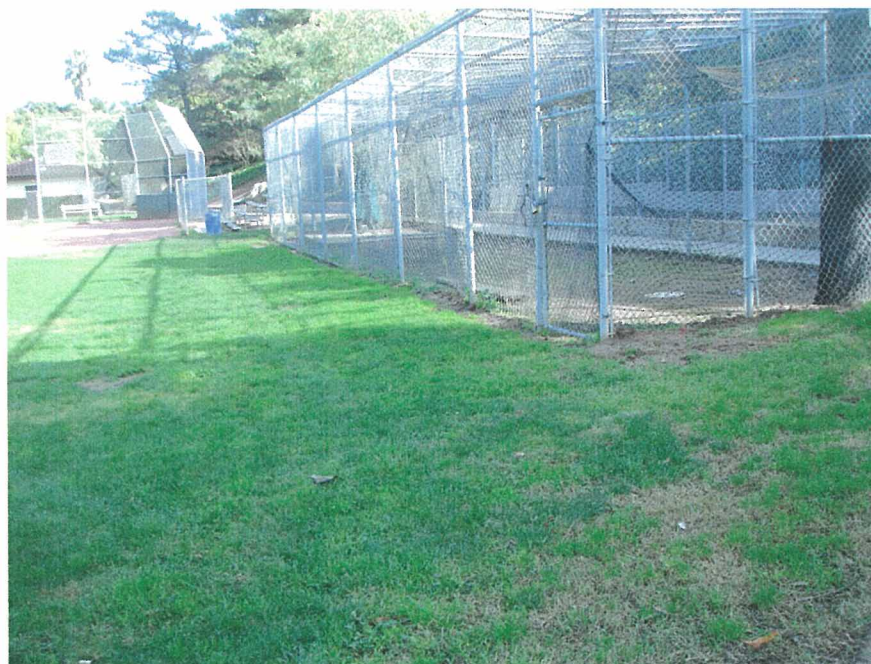
*Site - Photo # 9*

*Path of travel to batting cage gate is not firm, stable and slip resistant. Gate does not have the required 10" smooth kick plate and accessible hardware.*

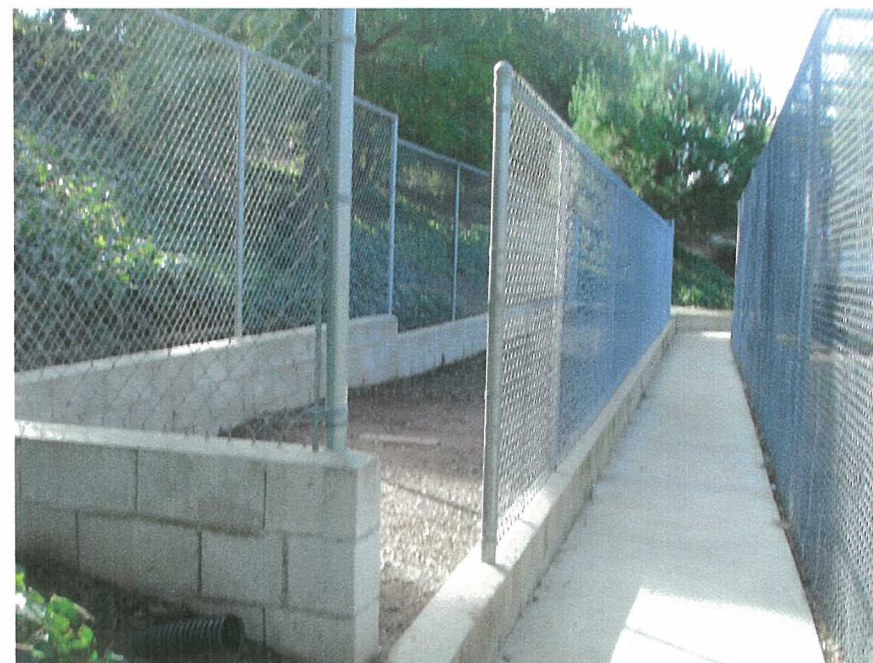
*Site - Photo # 10*

*Path of travel between batting cages has an excessive cross slope ranging from 3.2% to 5.3% slope.*

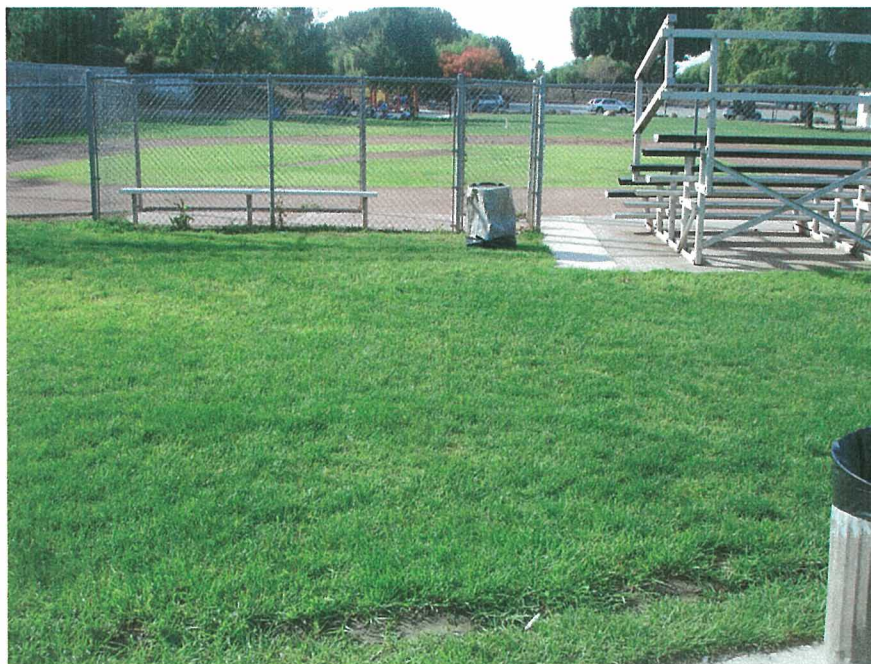
*Site - Photo # 11*

*Path of travel to bleachers is not firm stable and slip resistant.*

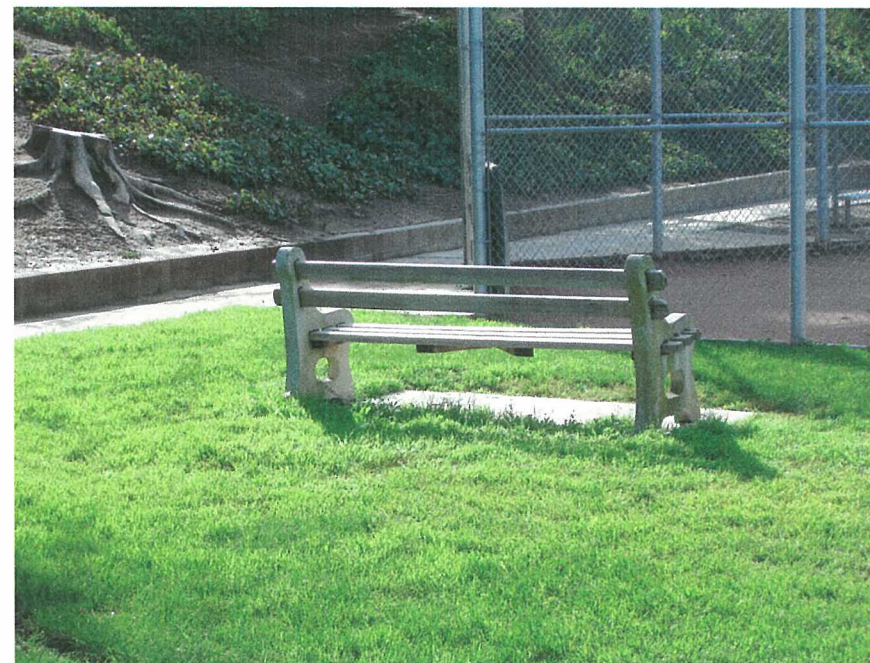
*Site - Photo # 12*

*Path of travel to bench and wheelchair maneuverable and usable space adjacent to bench is not firm stable and slip resistant.*

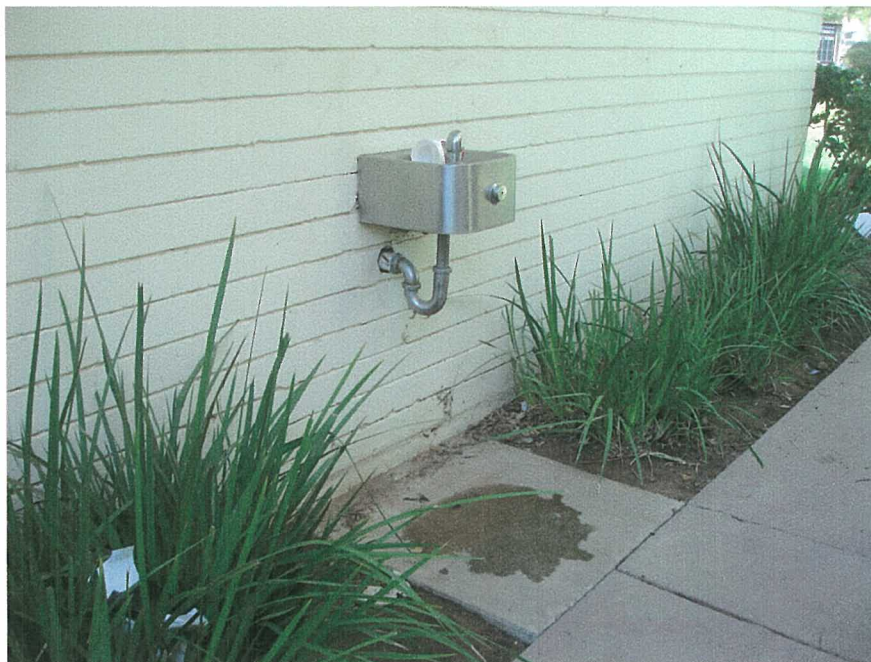
Site - Photo # 13

*Path of travel to drinking fountain is not wide enough.  
Bubbler mounted too high at 39" instead of 36"  
maximum. There is not a compliant knee clearance, 12"  
deep.*

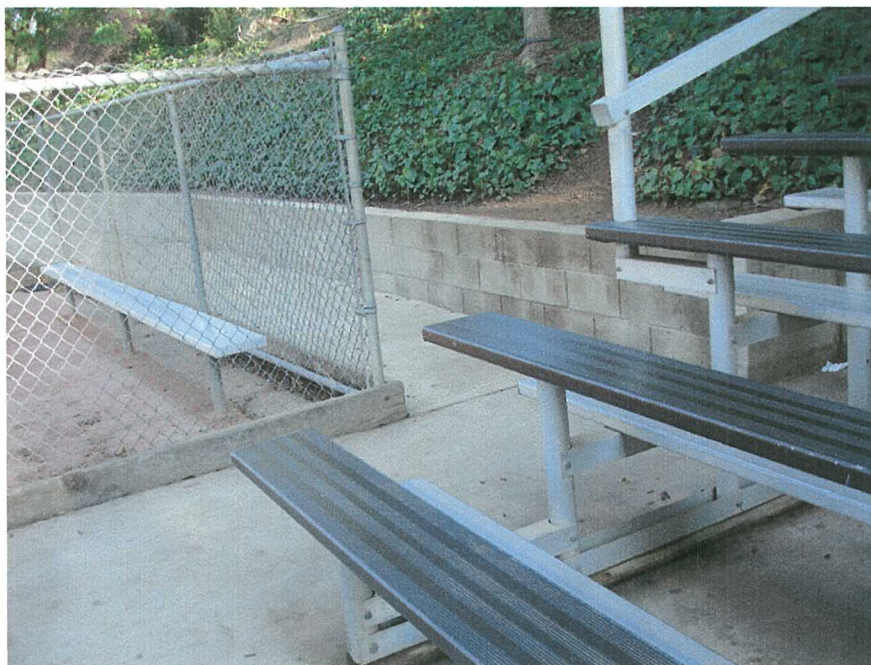
*Site - Photo # 15*

*Bleachers do not have a designated wheelchair and companion seating within or adjacent to the bleachers with compliant signage – ISA International Symbol of Accessibility.*

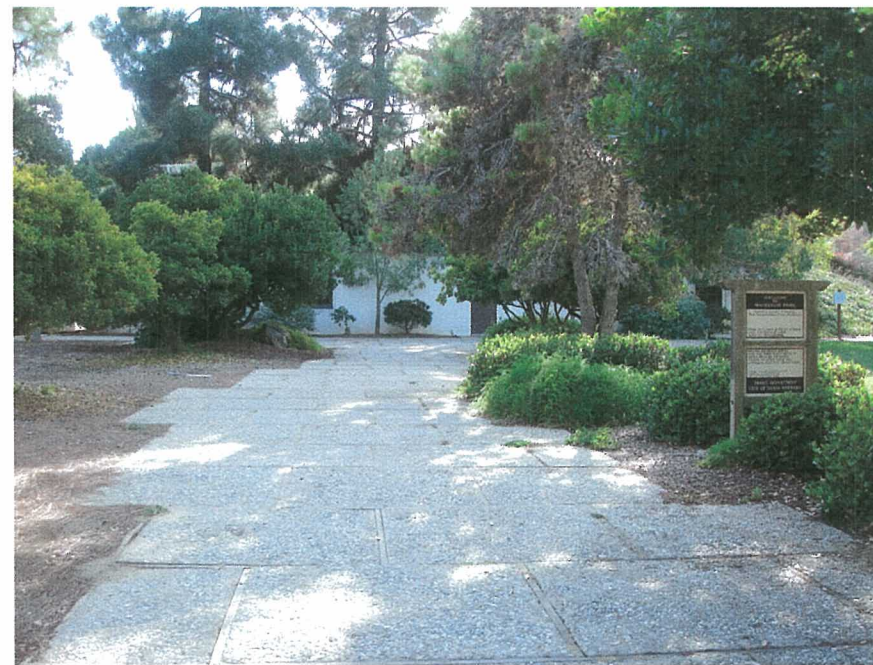
*Site - Photo # 16*

*Path of travel to Building A-Youth Activities Center has sections with pavement dislocations that exceed ½" vertical drop. Surface is not vibration free.*

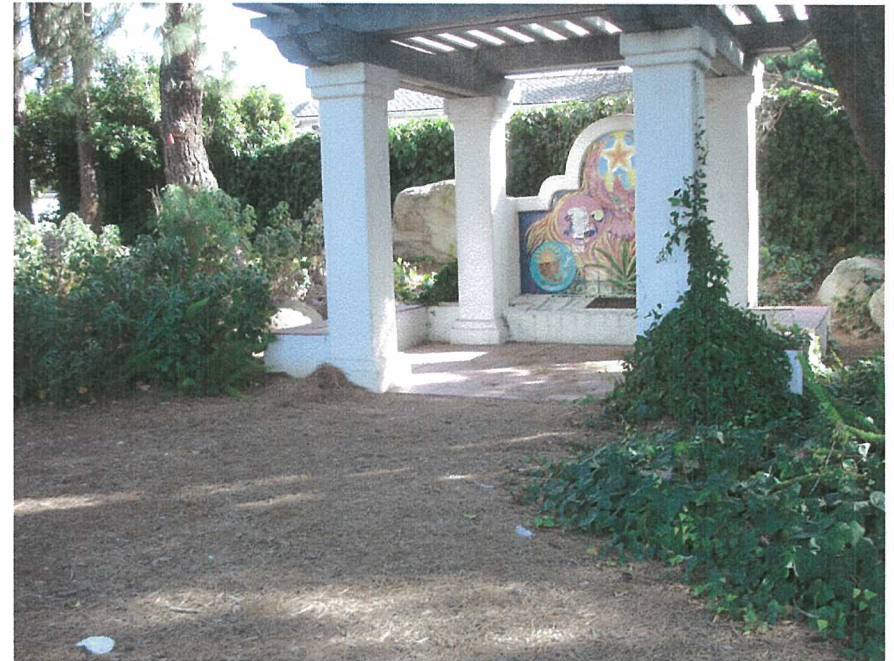
*Site - Photo # 18*

*Path of travel to Pillars of the Piece is not firm, stable and slip resistant.*

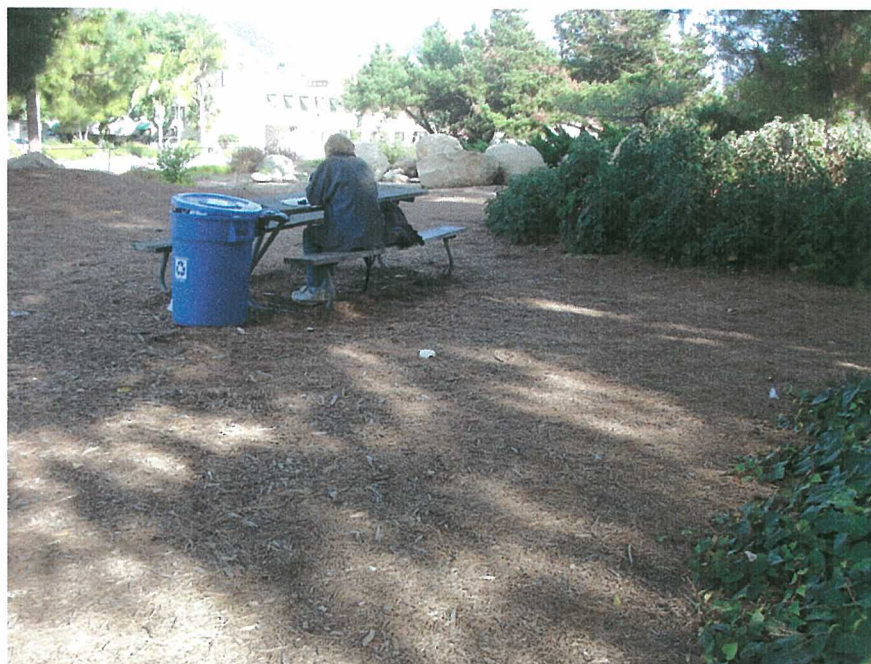
*Site - Photo # 19*

*Path of travel and area around picnic table are not accessible due to its surface that is not firm, stable and slip resistant. Picnic table does not have the required knee clearance for wheelchair users.*

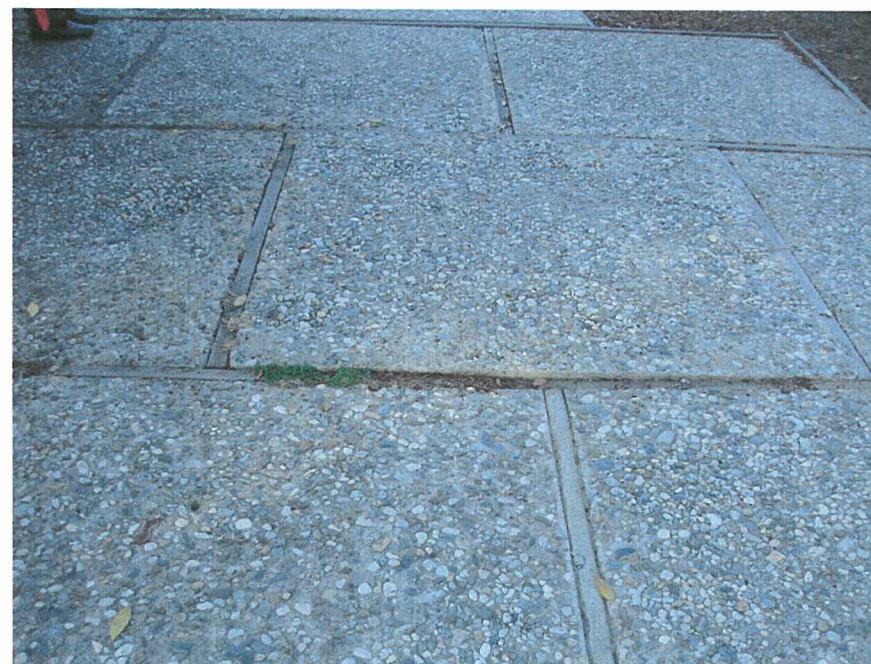
*Site - Photo # 20*

*Path of travel at main entrance to Building A-Youth Activities Center has sections with pavement dislocations that exceed ½" vertical drop. Surface is not vibration free.*

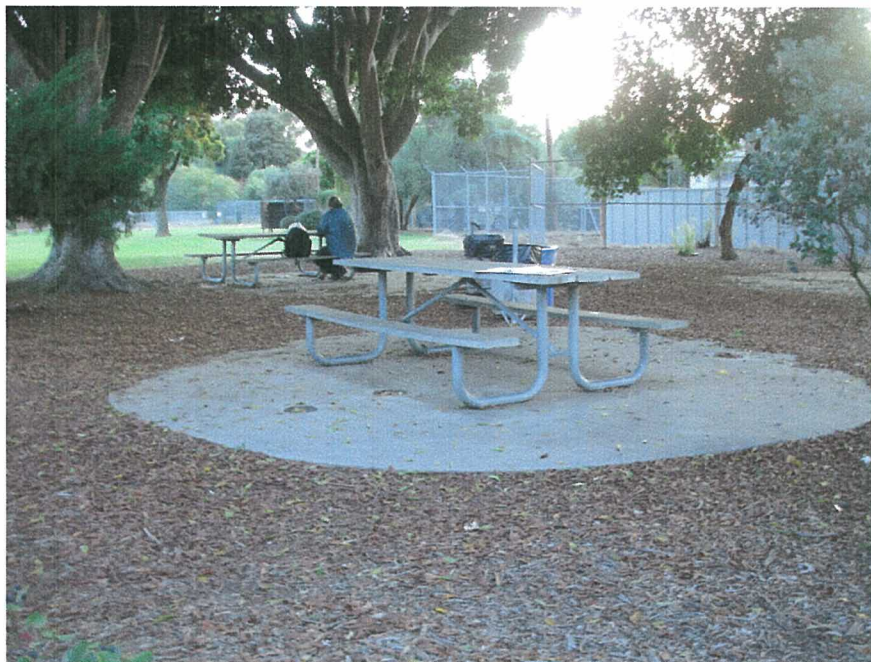
Site - Photo # 21

*Path of travel to picnic area is not firm, stable and slip resistant. Picnic table does not have the required knee clearance.*

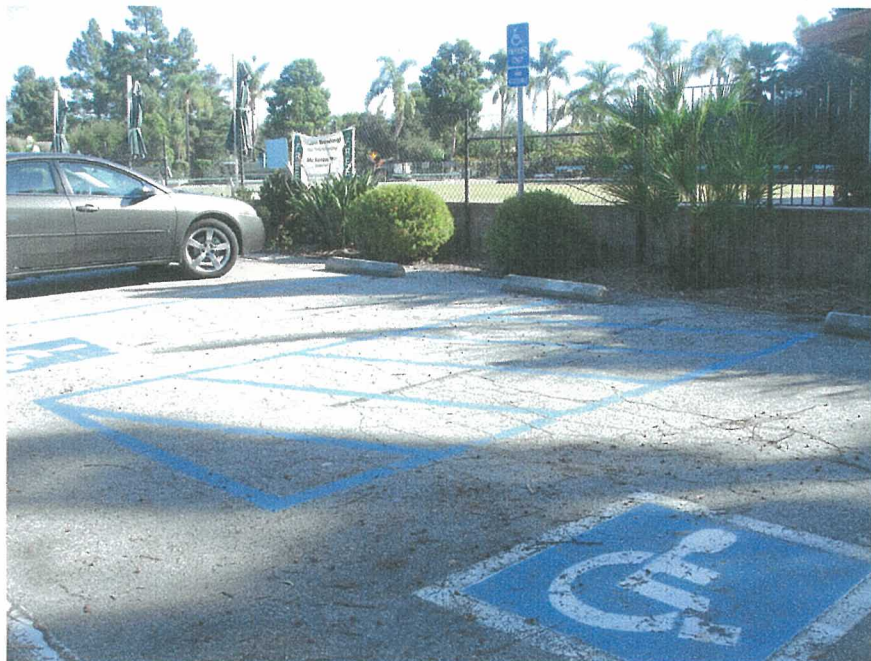
*Site - Photo # 23*

*The stalls and aisles spaces are 15' long, instead of the required 18'. There are no "NO PARKING" painted on the access aisles.*

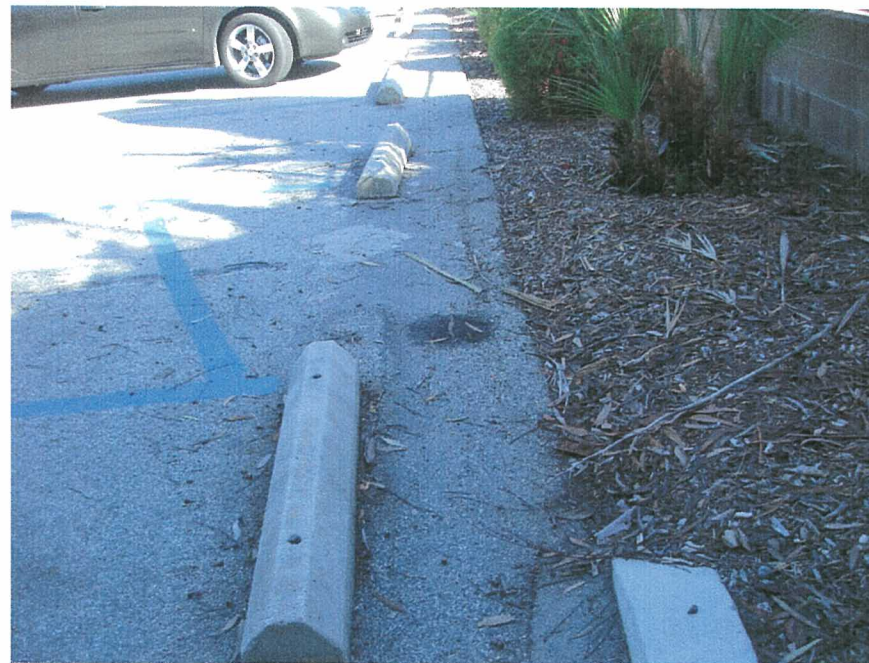
*Site - Photo # 24*

*There is no direct path of travel other than going behind parked cars from access aisles.*

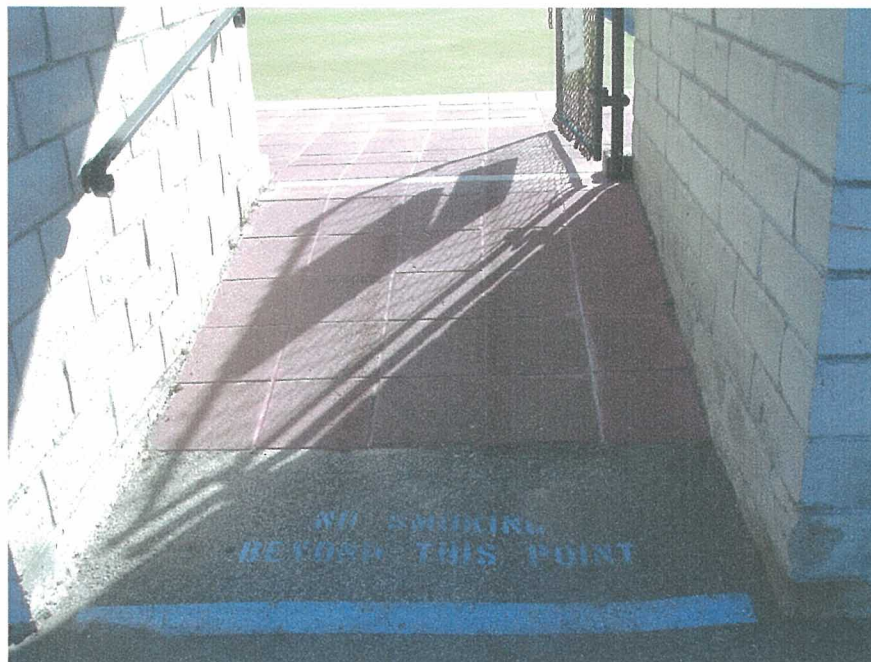
Site - Photo # 25

*Ramp slope 18.4%, with a 5% cross slope, handrail on one side only without extension. No top landing before gate.*

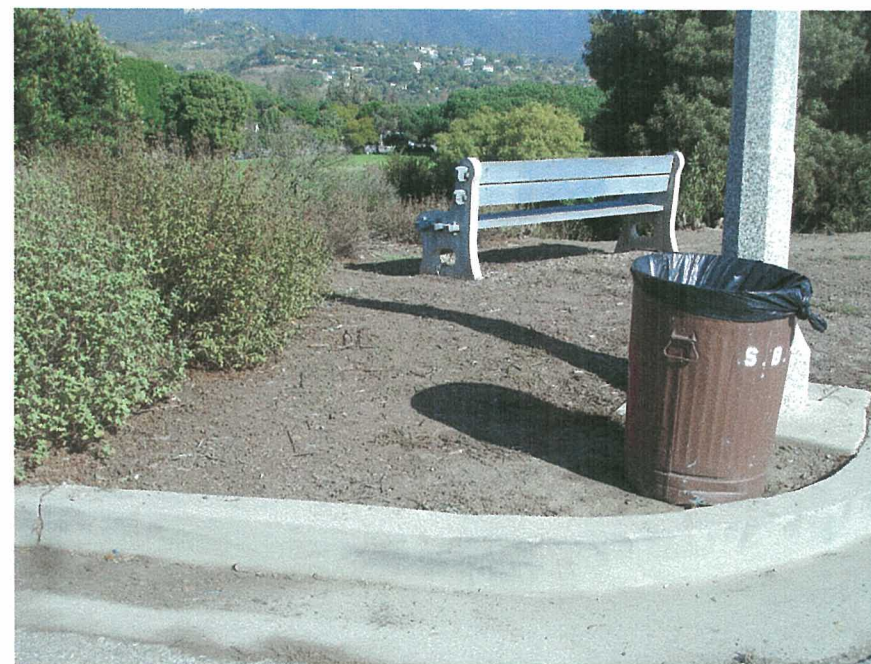
Site - Photo # 26

*There is no accessible path of travel to bench - path of travel through parking and a curb without curb cut.*

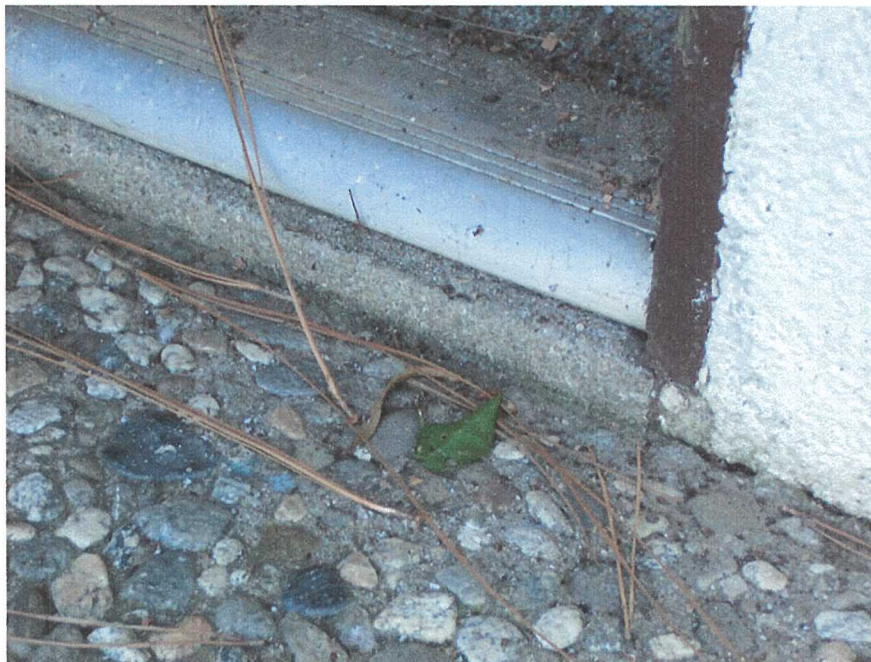
*Building - Photo # 3*

*Door threshold is 1 3/4" high and path of travel to it is not vibration free.*

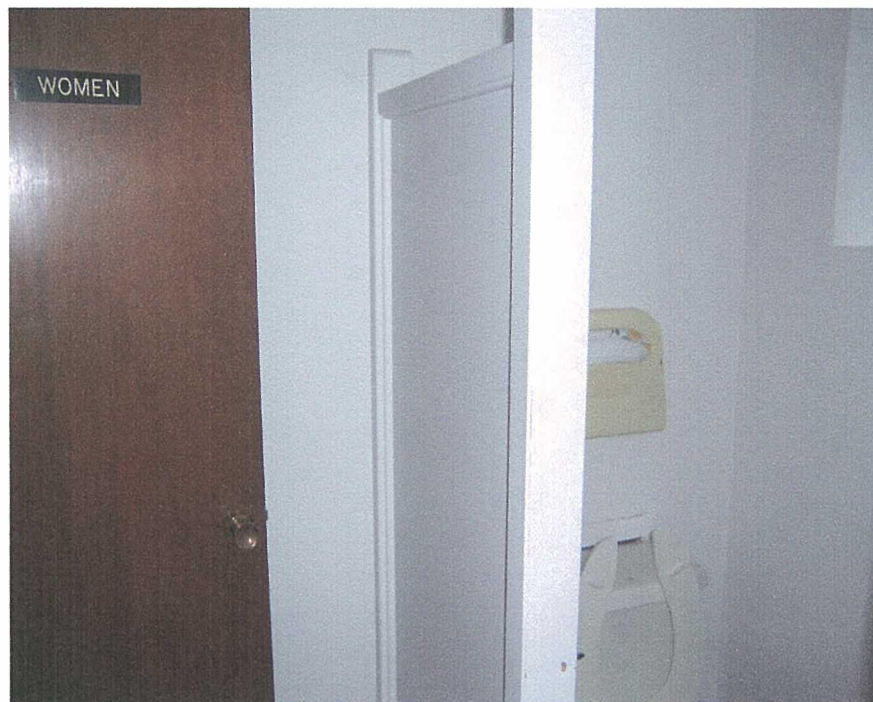
*Building - Photo # 11*

*Door too narrow not accessible – 22” wide. There are not tactile and Braille room identification and California 12” diameter circle signs. Door hardware requires tight grasping to operate.*

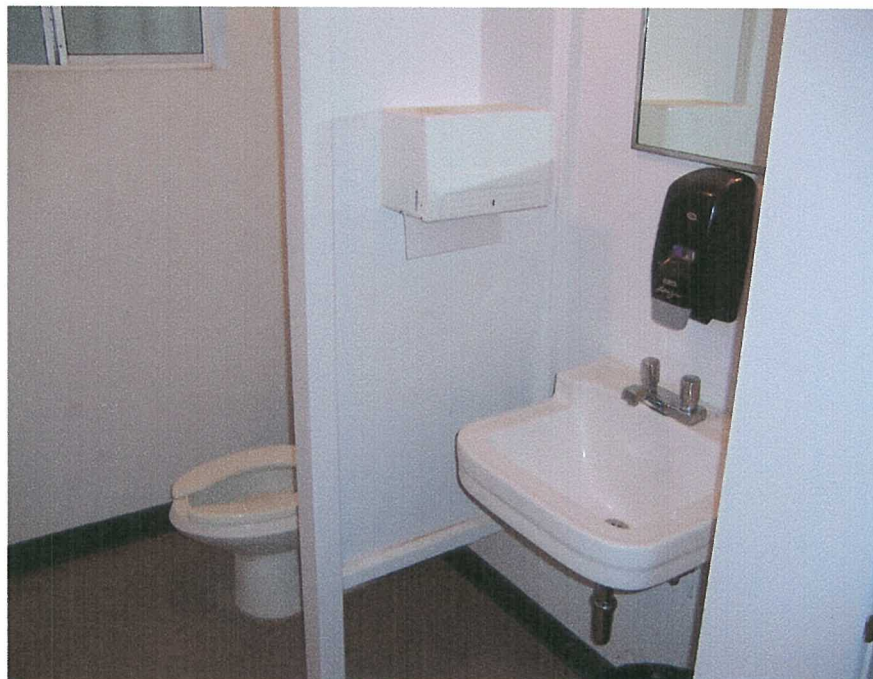
*Building - Photo # 13*

*Sink does not have insulation, mirror, paper towel and soap dispensers are mounted too high. Stall too narrow, not wheelchair accessible*

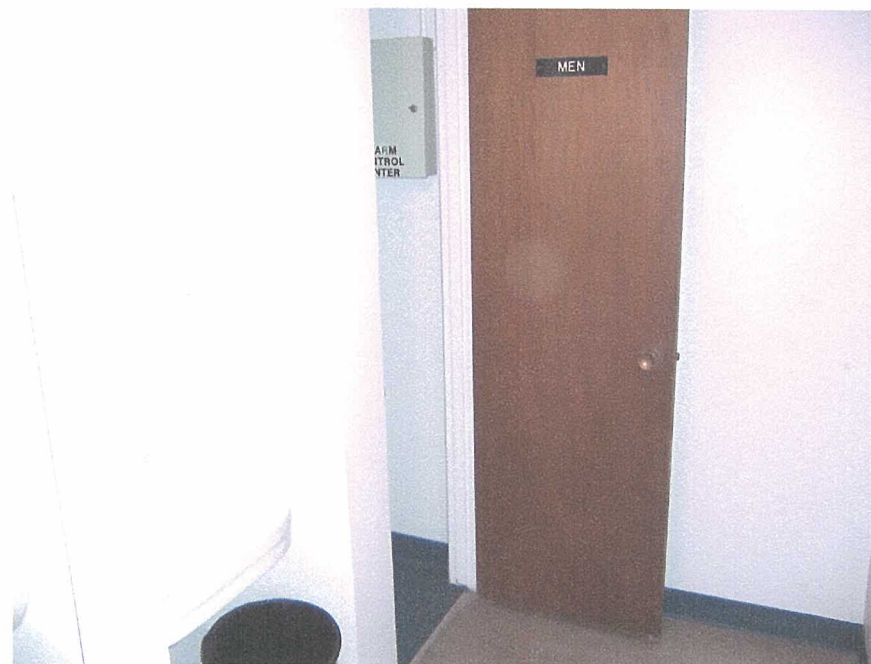
*Building - Photo # 14*

*Door too narrow not accessible – 21 ½" wide. There are not tactile and Braille room identification and California 12" triangle signs. Door hardware requires tight grasping to operate.*

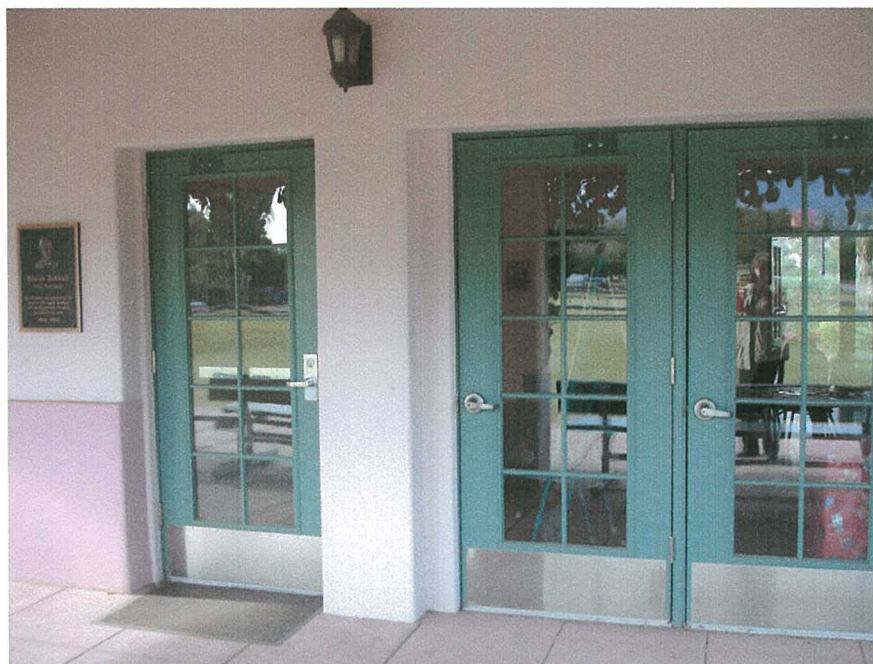
*Building - Photo # 1*

*Loose doormat needs to be secured. There is not an international symbol of accessibility indicating the accessible entrance.*

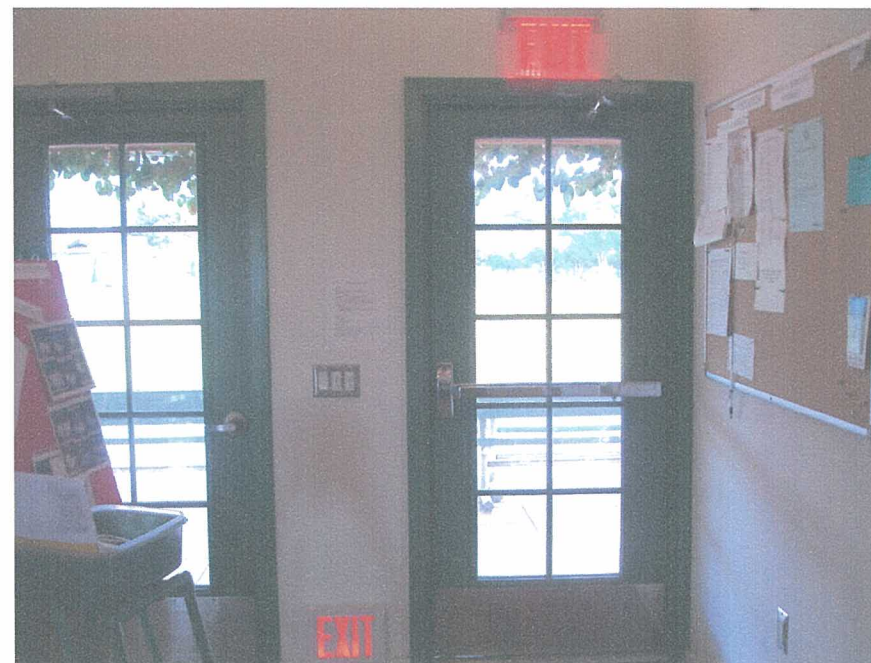
*Building - Photo # 2*

*There is no tactile and Braille "EXIT" sign. Bulletin board lower edge is mounted at 43" high.*

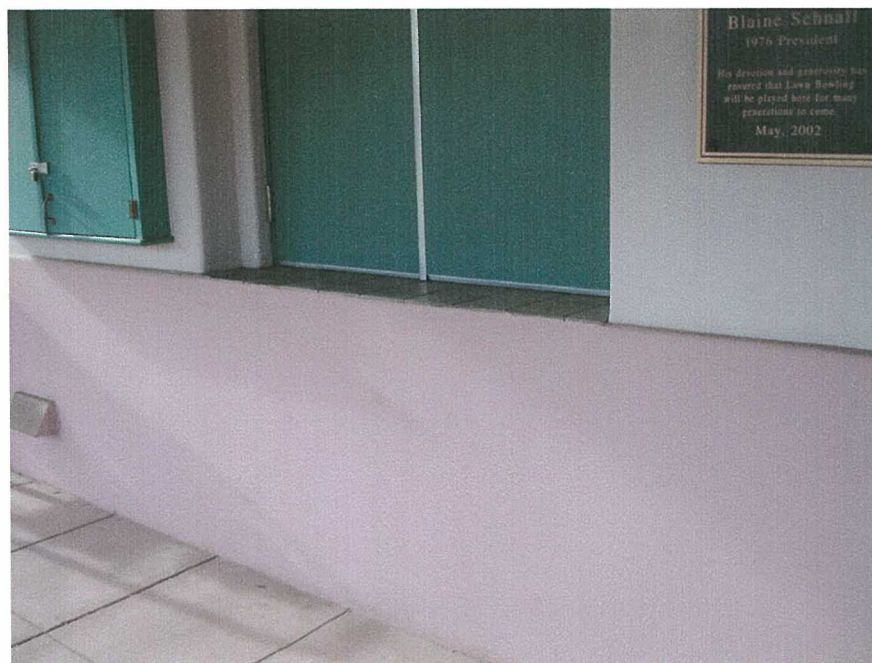
*Building - Photo # 3*

*Counter does not have a 34" maximum height, 36" wide section for wheelchair users – 36" high provided.*

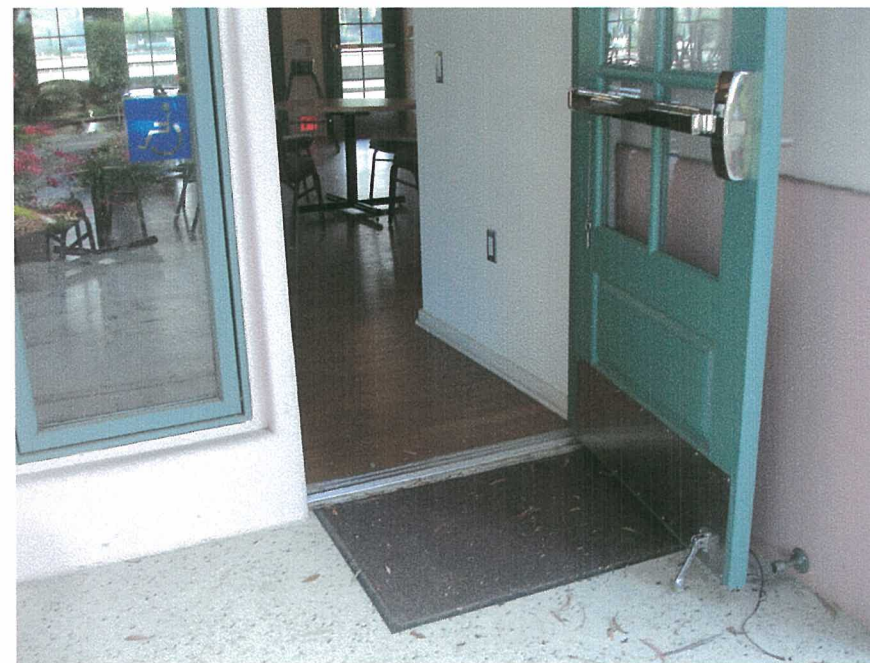
*Building - Photo # 4*

*Loose doormat needs to be secured. Doorstop mounted at lower 10" kick plate area is not compliant, this area is required to be smooth.*

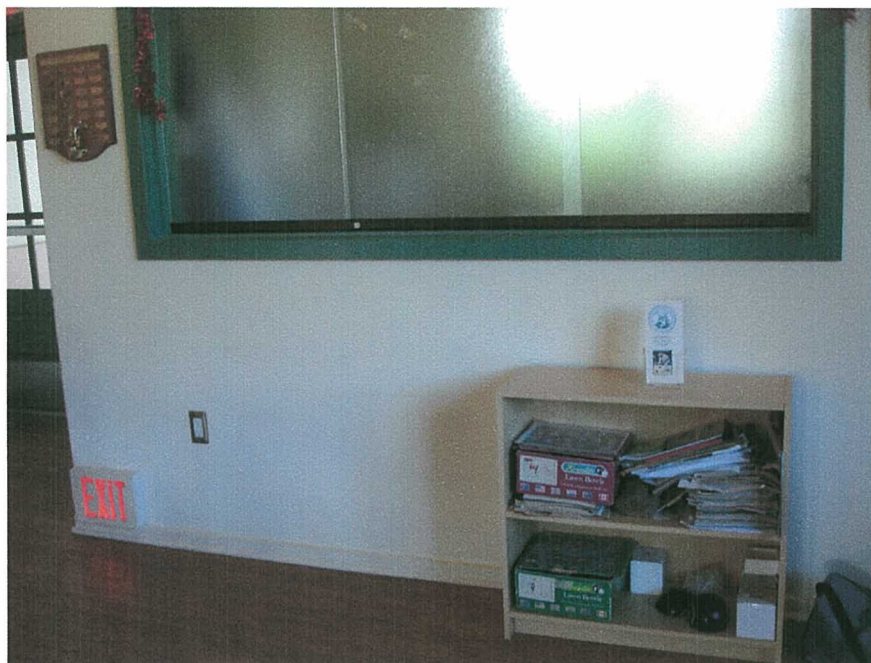
*Building - Photo # 5*

*Pass through window is mounted at 43" high instead of the required 34" high maximum.*

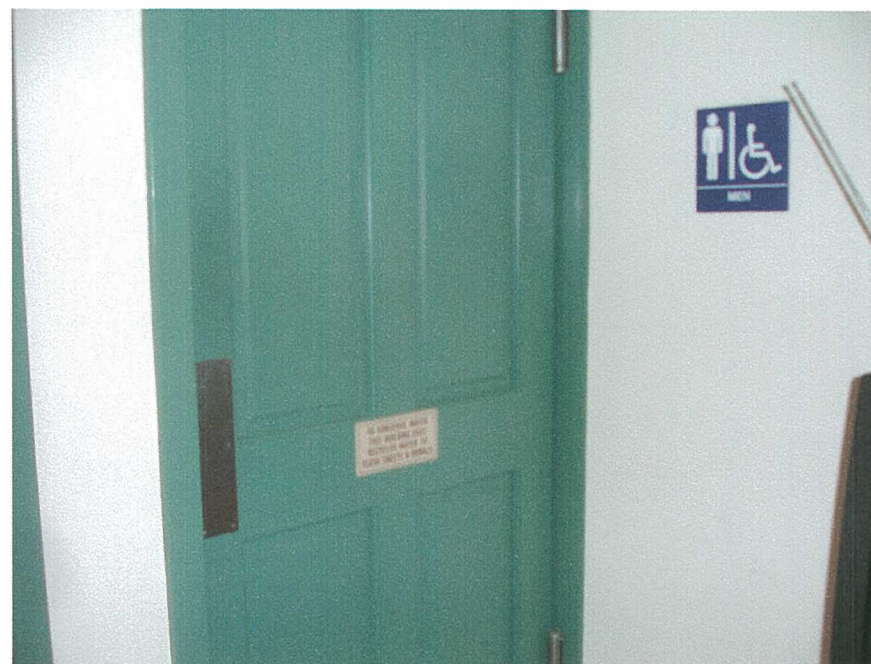
*Building - Photo # 6*

*There is not a triangular California required sign mounted at the door.*

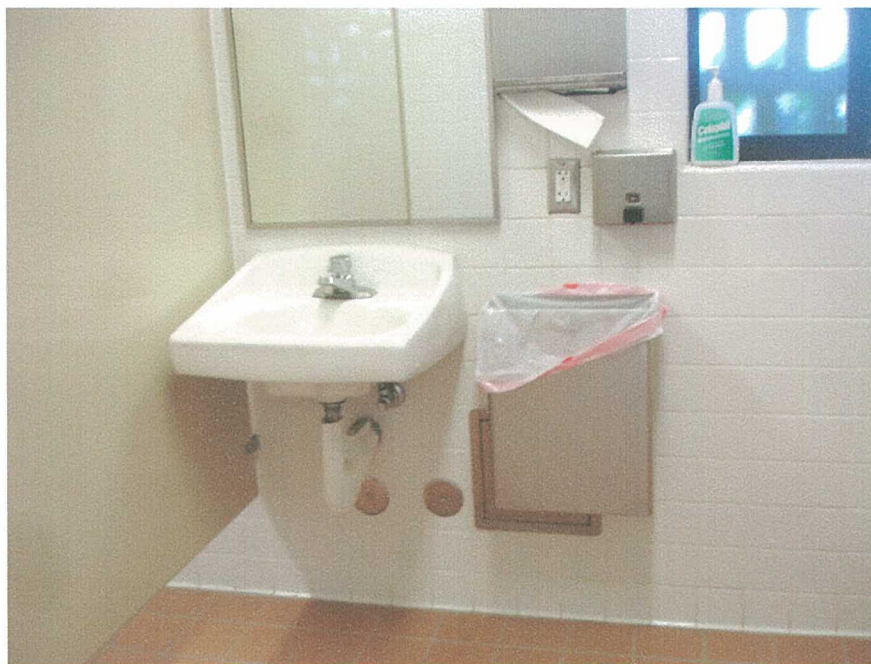
*Building - Photo # 7*

*Lavatory is mounted 11 ½" from partition instead of 18" minimum. Paper towel dispenser is mounted too high.*

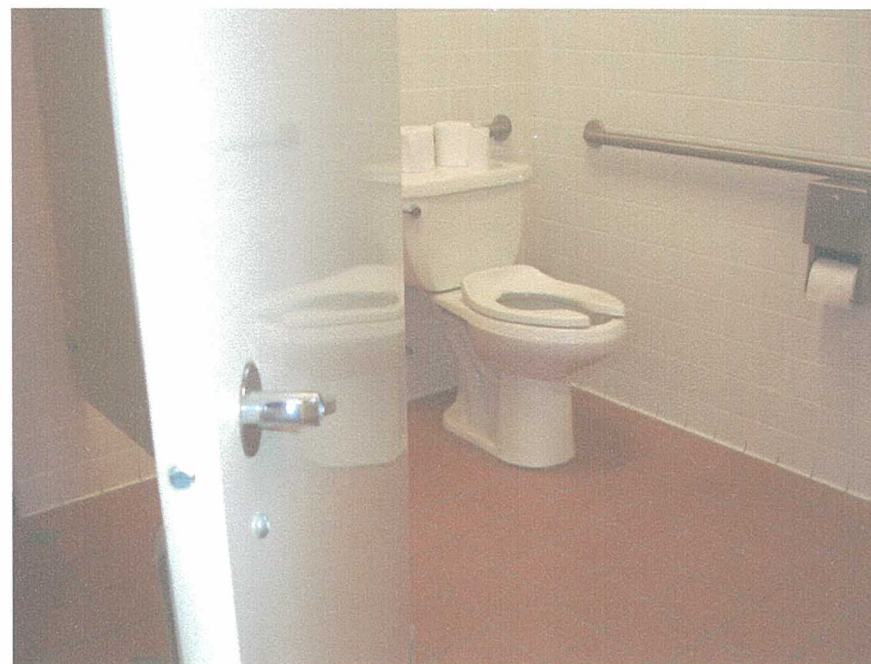
*Building - Photo # 8*

*There is no "U-pull" at interior accessible water closet compartment door. Toilet paper dispenser is mounted to close to grab bar.*

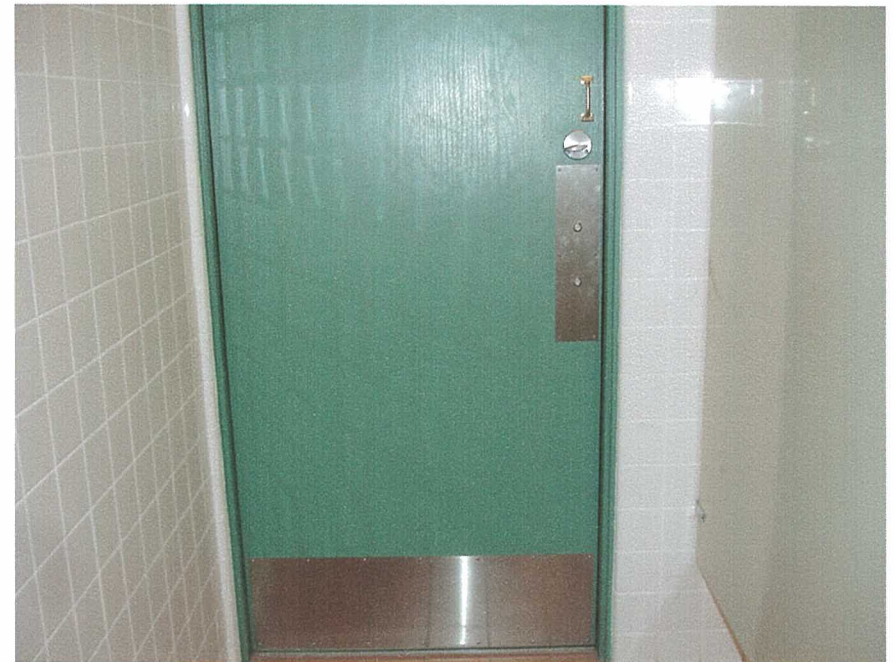
*Building - Photo # 10*

*Deadbolt is mounted too high at 49 ½" high. Narrow door strike side clearance has 8 ½" instead of 12" minimum.*
