**GILDA PUENTE-PETERS**  
**ARCHITECTS**

**MACKENZIE PARK**  
**ACCESSIBILITY SURVEY**

**February, 2006**

**CITY OF SANTA**  
**BARBARA**

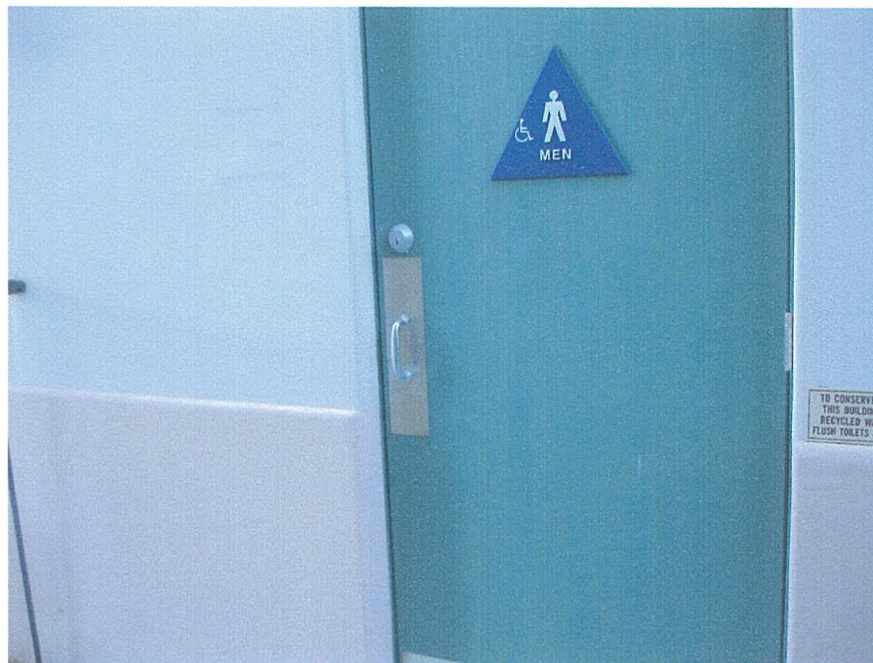
*Building - Photo # 11*

*Room identification tactile and Braille sign is missing.*

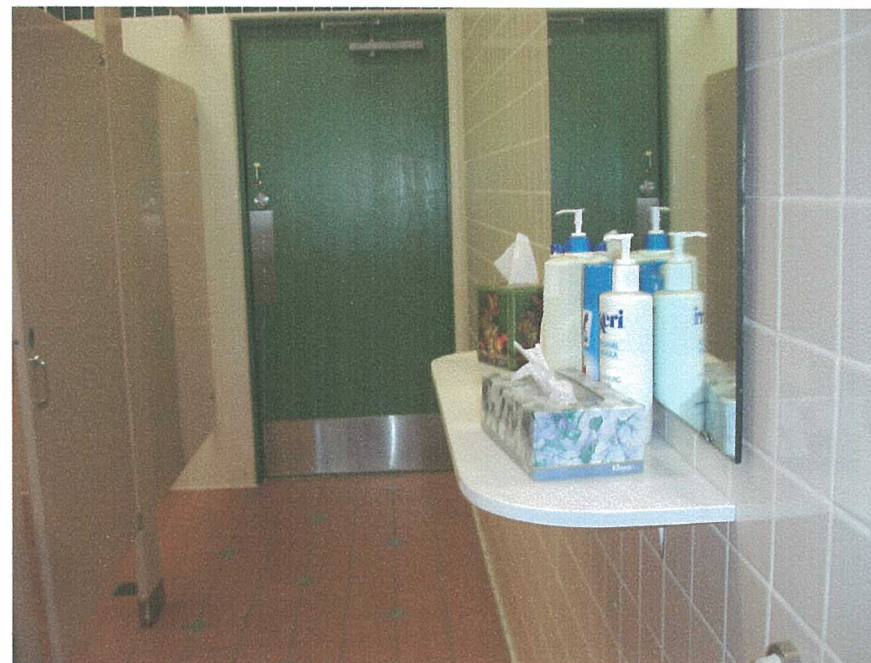
*Building - Photo # 12*

*Shelf protrudes into the path of travel 10" at 40 ½" high, without any cane detectable element at 27" high.*

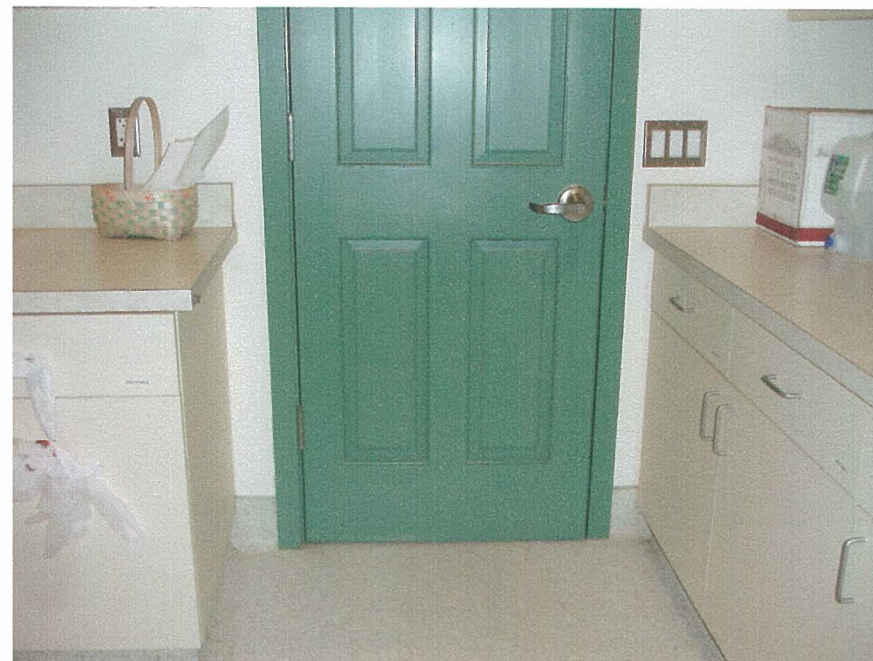
*Building - Photo # 14*

*Door strike side clearance at the pull side of door is 4 1/2" instead of the required 18" minimum.*

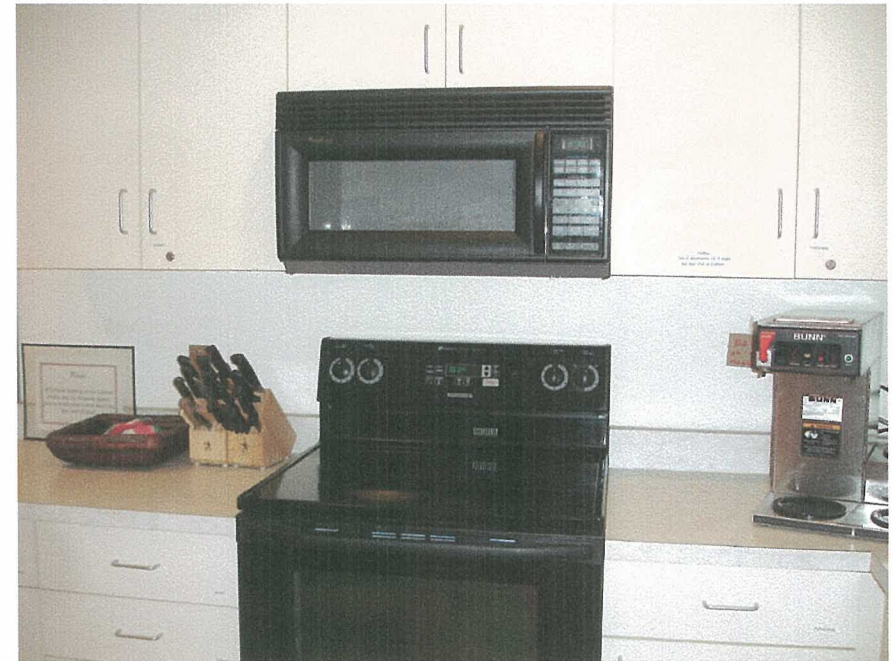
*Building - Photo # 16*

*Stove controls are mounted on the back of the stove and microwave controls are out of reach for wheelchair users.*

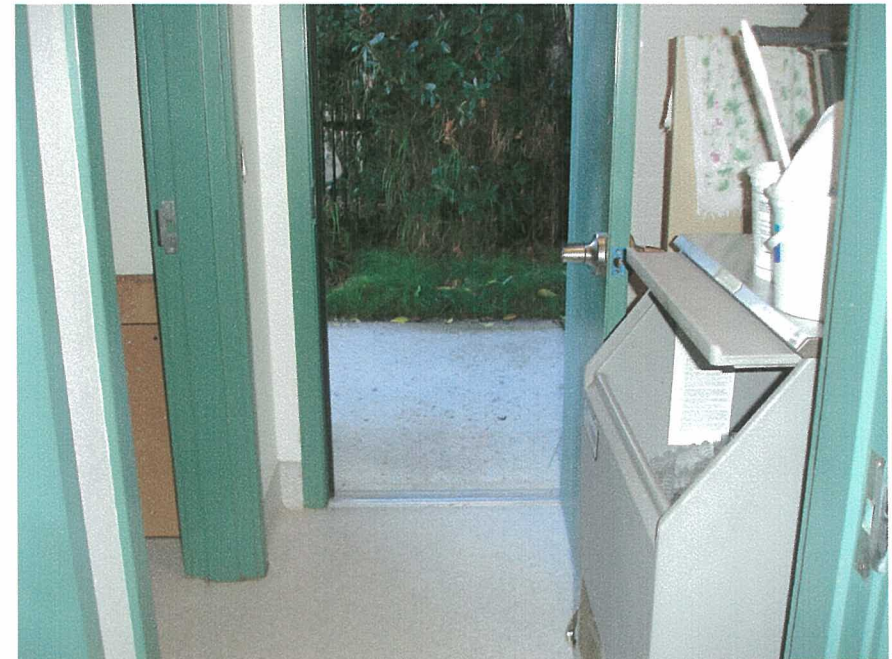
*Building - Photo # 18*

*Door strike side clearance at the pull side of door is 5 ½" instead of the required 18" minimum. Door is too narrow – 27" wide and not wheelchair accessible.*

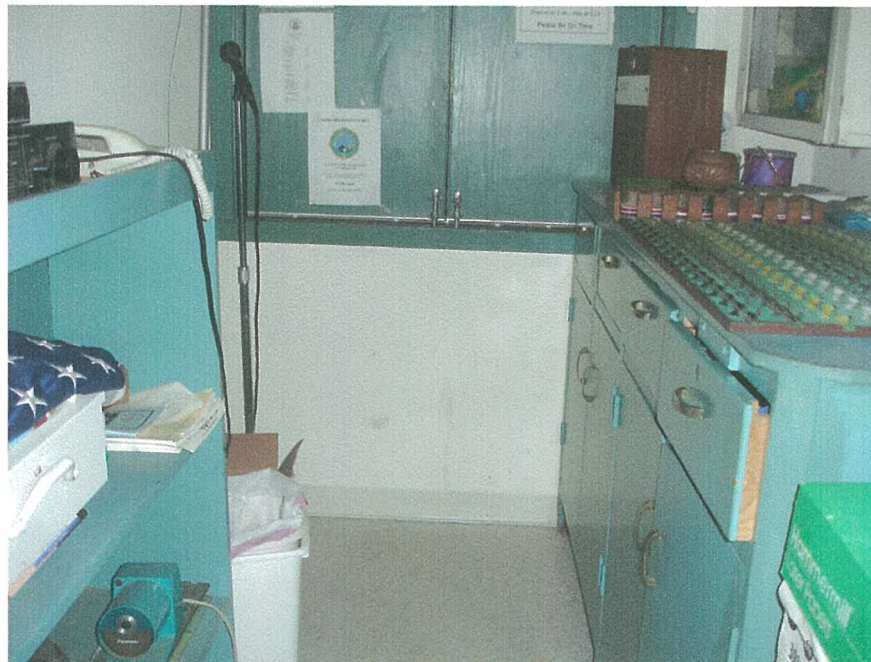
*Building - Photo # 19*

*Scoreboard room pass through window is 36" high instead of 34" high maximum. There is no wheelchair maneuverable clearance, passage between cabinets is 27" wide.*

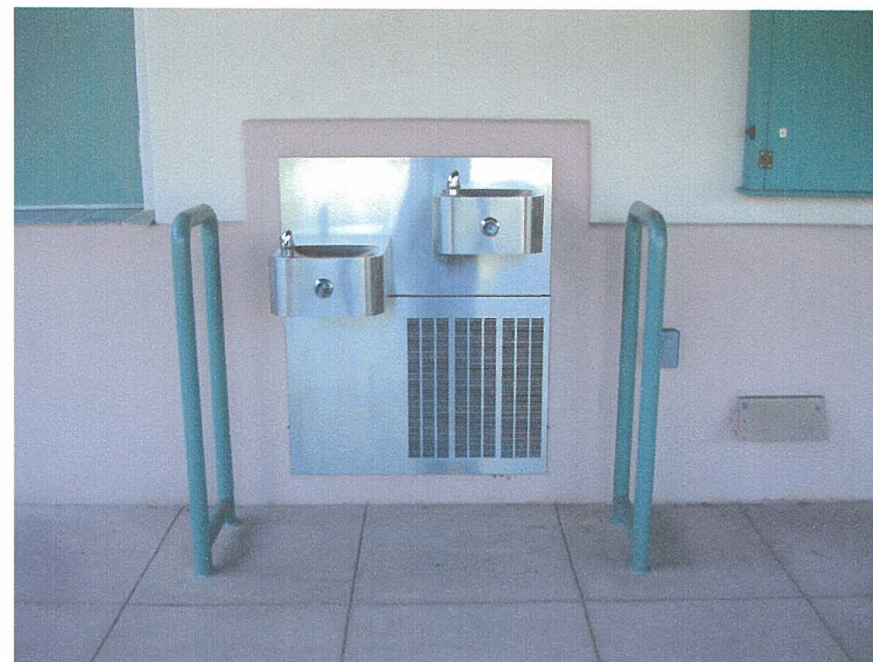
*Building - Photo # 20*

*Accessible drinking fountain distance from the rail to the centerline of drinking fountain is 13 1/2" instead of the required 15" minimum. Effort to operate drinking fountain push button is 7 lbf, instead of the maximum required 5 lbf.*

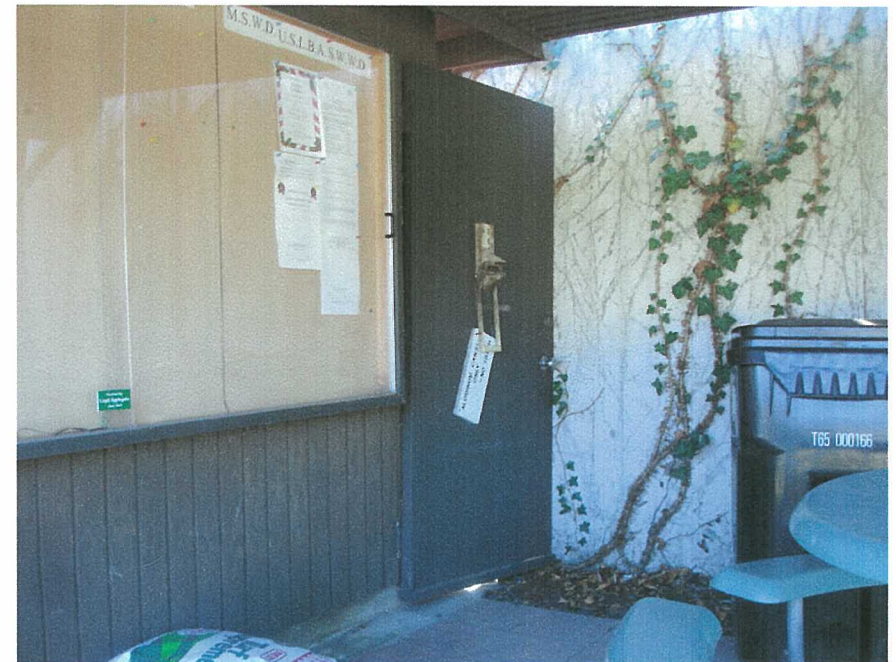
*Building - Photo # 2*

*Door hardware requires tight grasping and twisting of the wrist to operate. There is not a tactile and Braille room identification sign.*

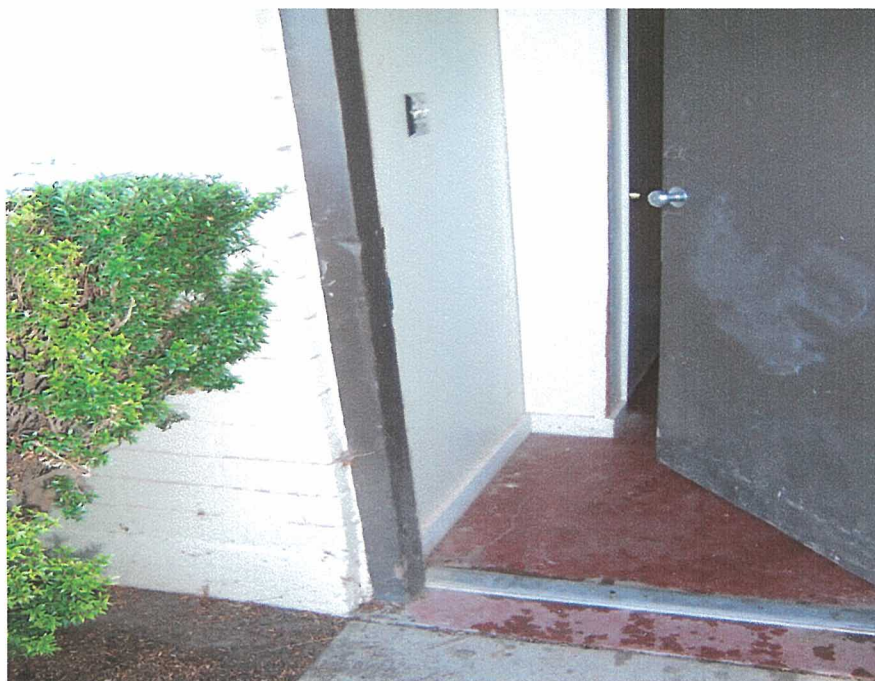
*Building - Photo # 1*

*Door hardware requires tight grasping to operate and twisting of the wrist to operate. Threshold is 1" high instead of ½" beveled maximum. There is 36" to the wall in front of the door and 0" strike clearance on the pull side of door. A recommendation is to change the door swing.*

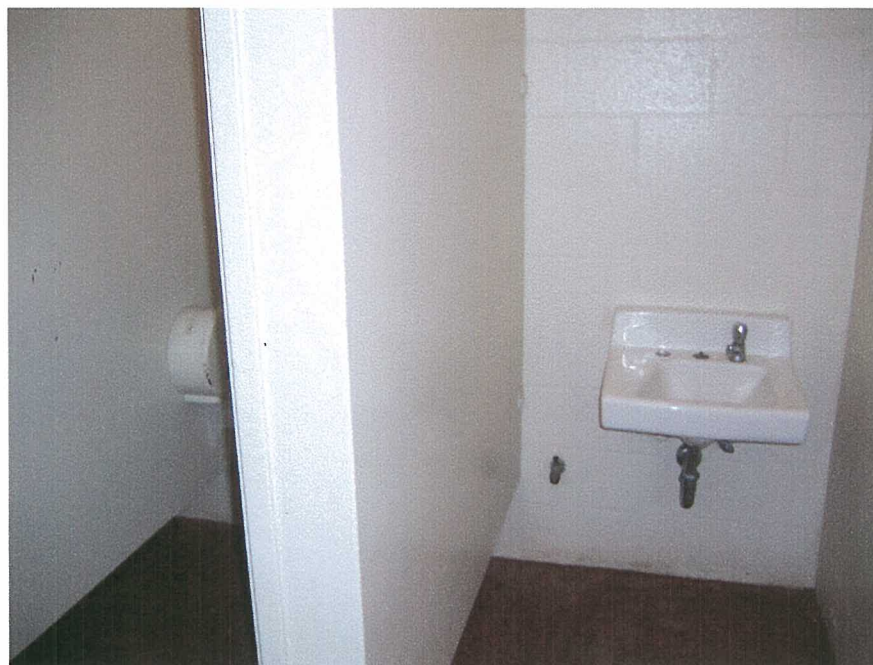
*Building - Photo # 7*

*Narrow stalls are not accessible. Sink does not have pipe insulation. Soap dispenser is compliant type but paper towel and soap dispenser are mounted too high.*

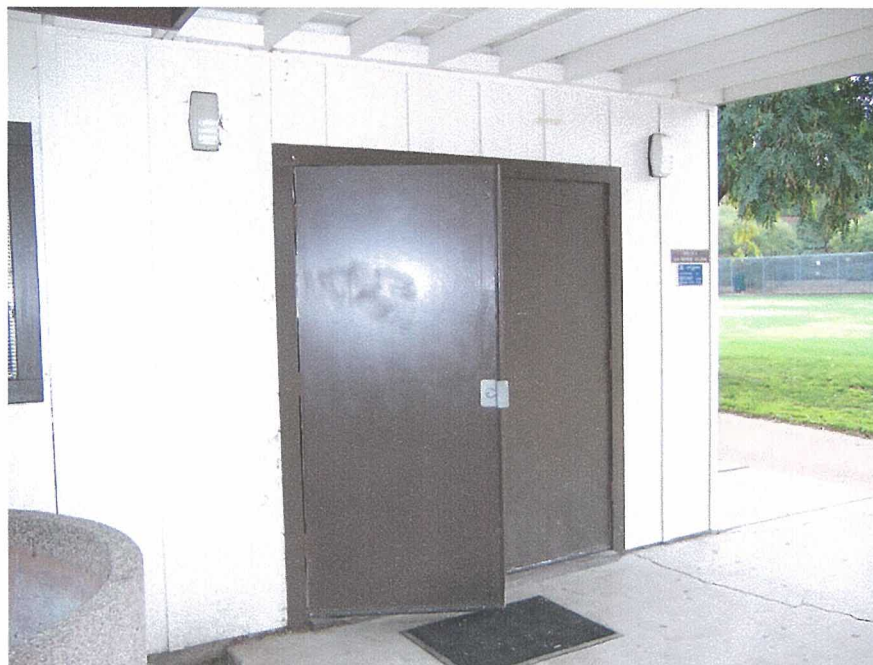
*Building - Photo # 1*

*Door hardware requires tight grasping to operate. Loose doormat needs to be secured. There is not a tactile and Braille room identification signs.*

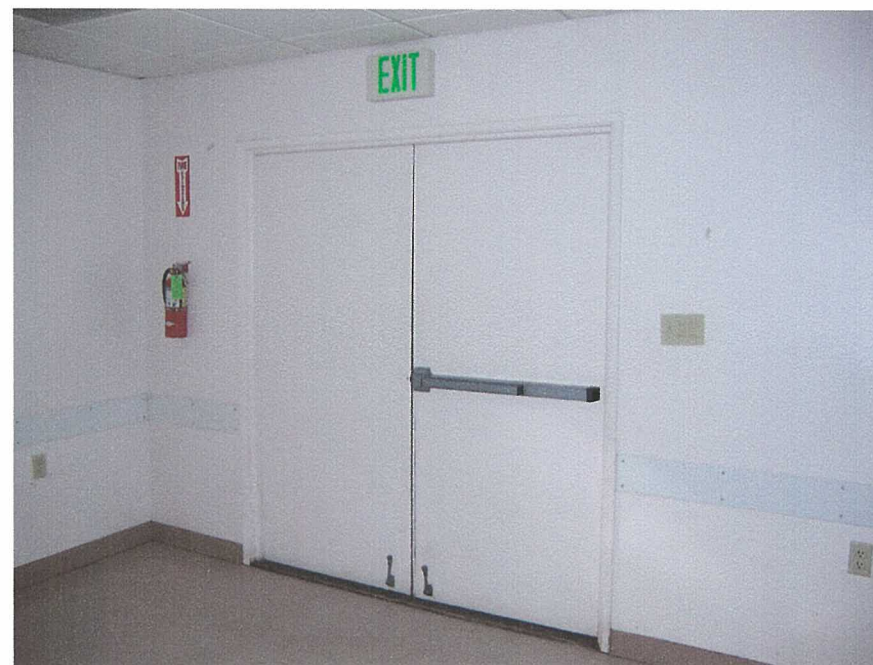
*Building - Photo # 2*

*There is not a tactile and Braille "EXIT" sign. Doorstops are mounted at the lower area of the door, which is required to be smooth. Fire extinguisher mounted too high.*

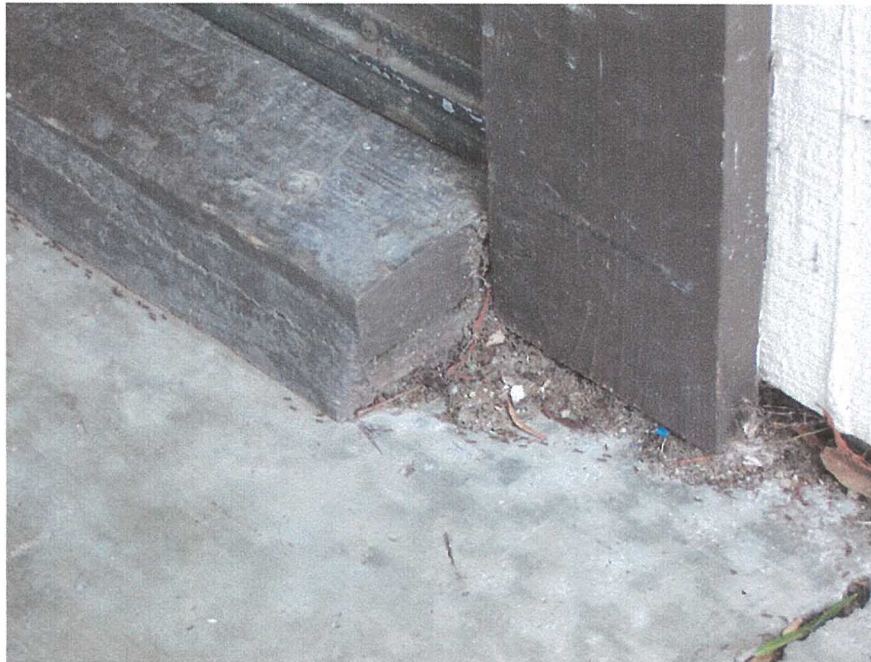
*Building - Photo # 3*

*Threshold is 2" high, not accessible.*

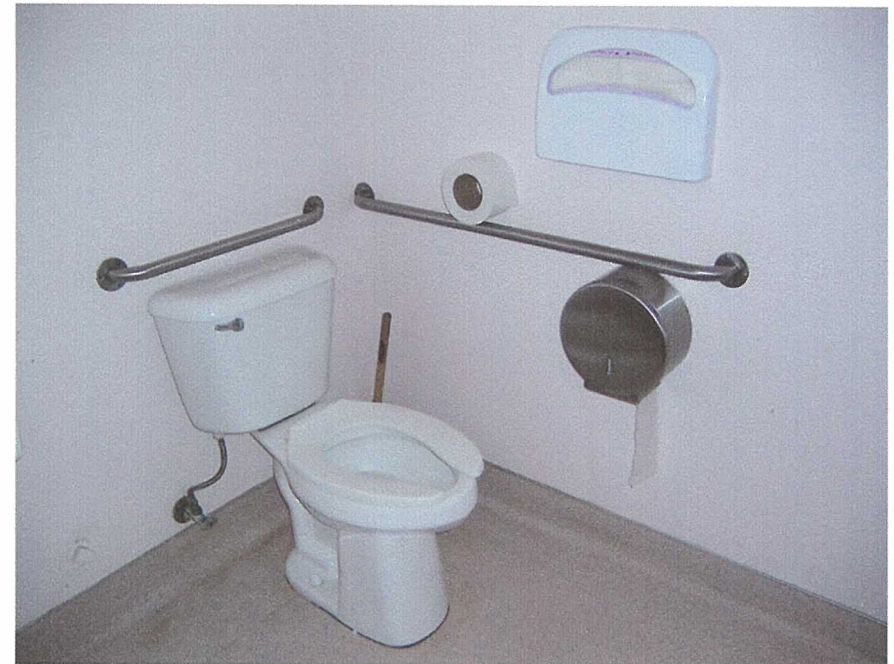
*Building - Photo # 12*

*Back grab bar is too small 24" long, side grab bar mounted 1 1/2" from the back wall instead of the required 12" minimum. Seat cover dispenser mounted too high. Toilet paper dispenser is mounted leaving only 3/4" clearance from grab bar.*

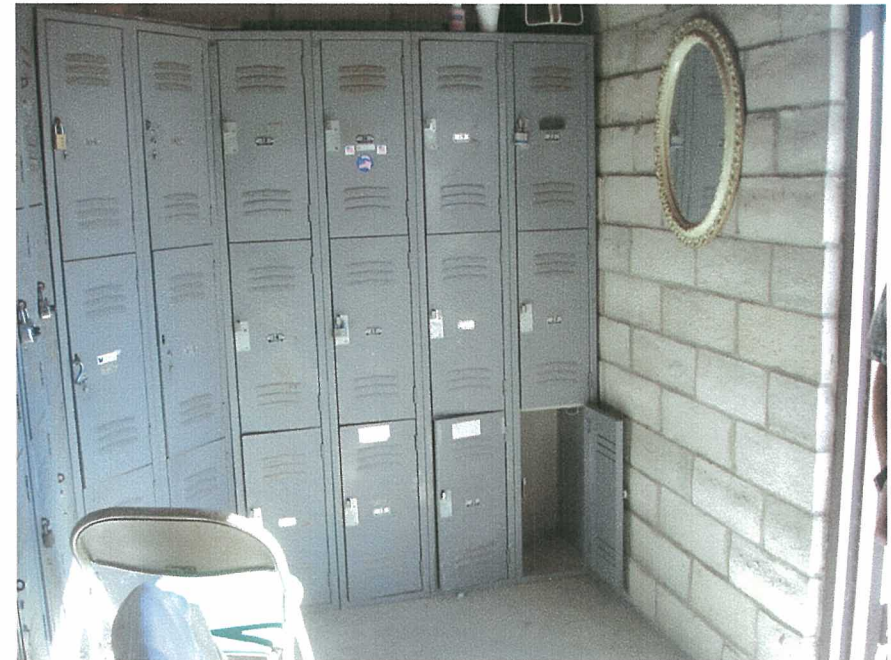
*Building - Photo # 4*

*There is not a designated accessible locker with door hardware that does not require tight grasping, pinching and twisting of the wrist to operate. An ISA International Symbol of Accessibility sign should be placed at the accessible locker. Mirror is mounted too high.*

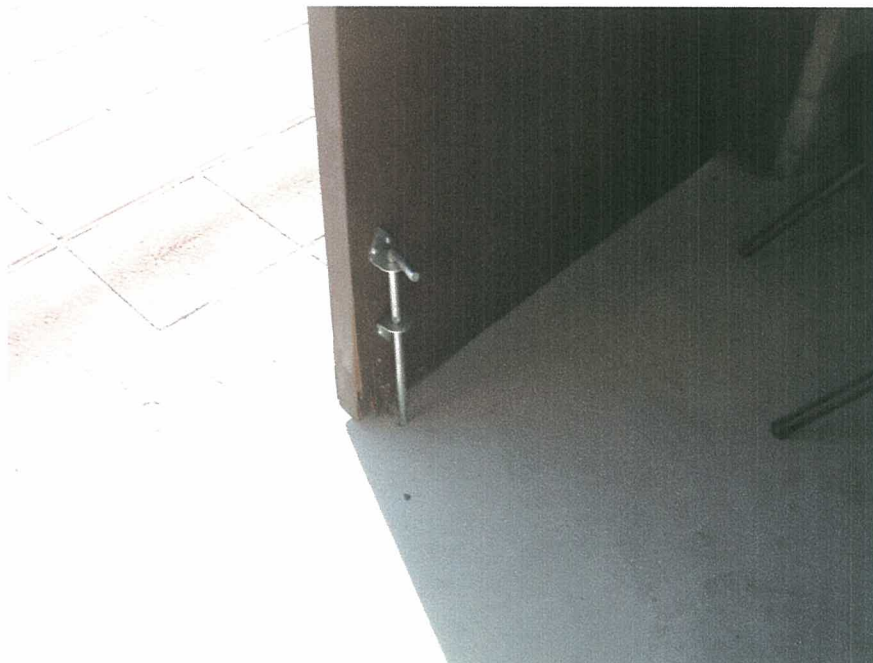
*Building - Photo # 5*

*Garage deadbolt mounted on the lower Kick plate area required being smooth. Step makes this locker room inaccessible. There is no contrasting color striping at step.*

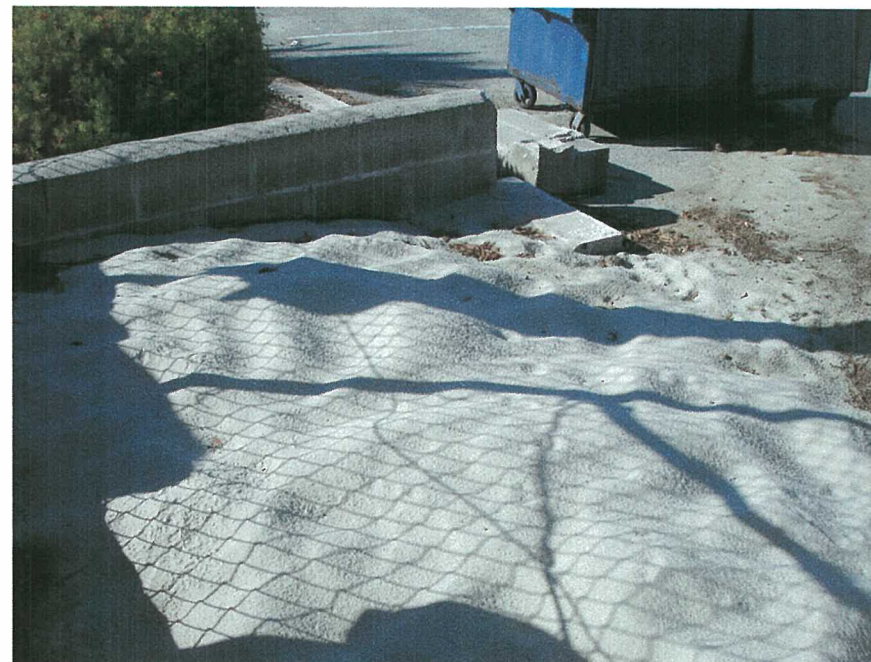
*Building - Photo # 6*

*Open sand pit does not have a high area that can be used to take the sand by wheelchair users.*
