**ALICE KECK PARK MEMORIAL
GARDENS
ACCESSIBILITY SURVEY**

June, 2007

CITY OF SANTA BARBARA

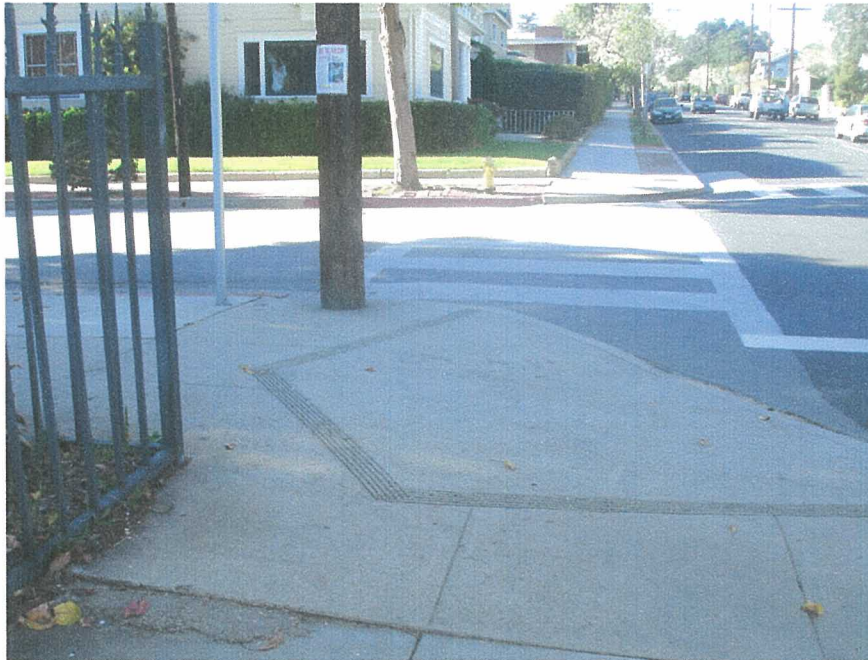
Public Right-of-Way - Photo # 1

Curb ramp is non-conforming, with running slope of 9.5% and flar side of 11.5%. The top landing is 24" deep instead of the required 48". There are no detectable warnings and contrasting color with the adjacent surfaces. Grooves 4" instead of 12" wide.

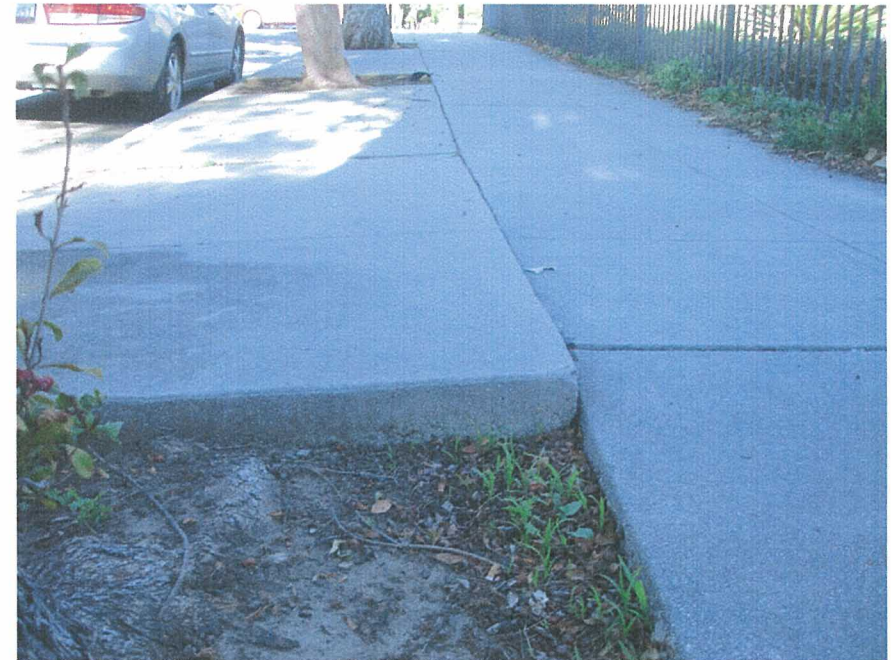
Public Right-of-Way - Photo # 2

Pavement dislocation is a tripping hazard. Tree well dirt level has a 1"-3" drop from the adjacent walk.

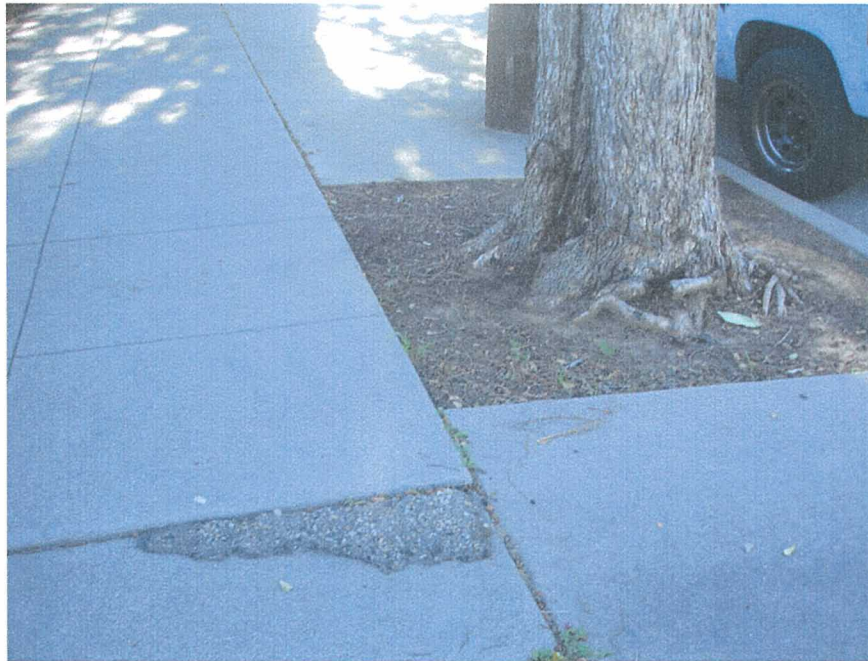
Public Right-of-Way - Photo # 3

Tree well has uneven surfaces and pavement dislocations that need repair.

Pavement dislocations.	Beveled edge 1:2 max. (between 1/4" and 1/2")	Pavement dislocation. Photo #: 3	ADAAG: 4.5.2 T24: 1133B.7.4	Remove, replace or repair surface area to correct abrupt change in level.	80	SF	\$22	\$1,760	2
Pavement dislocations.	Beveled edge 1:2 max. (between 1/4" and 1/2")	Patched concrete at pavement dislocation need to be repaired. Photo #: 2	ADAAG: 4.5.2 T24: 1133B.7.4	Grind or repair pavement dislocation to create beveled transition 1:2 max.	2	JOB	\$200	\$400	2

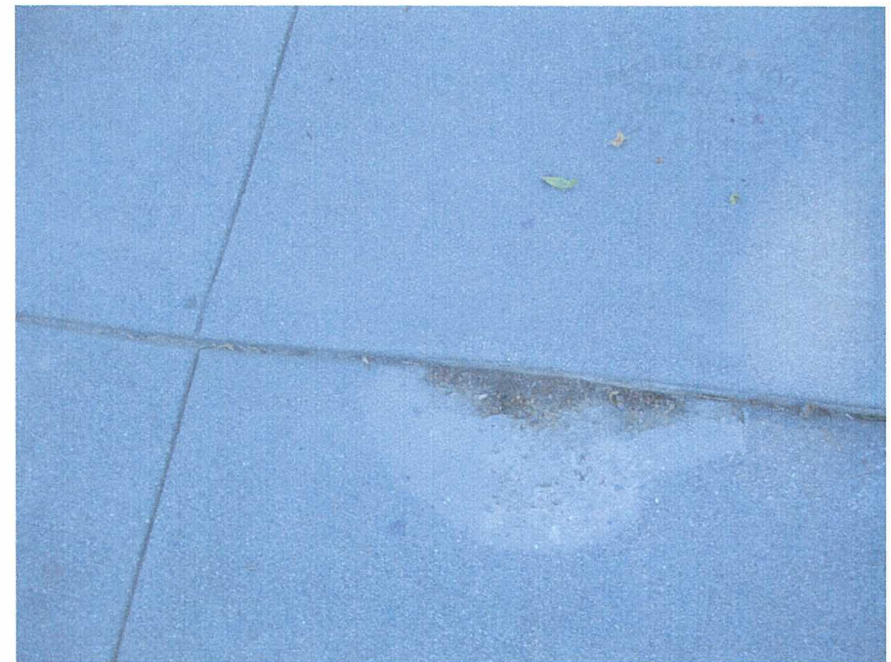
Public Right-of-Way - Photo # 4

Uneven surface in the path of travel needs to be repaired.

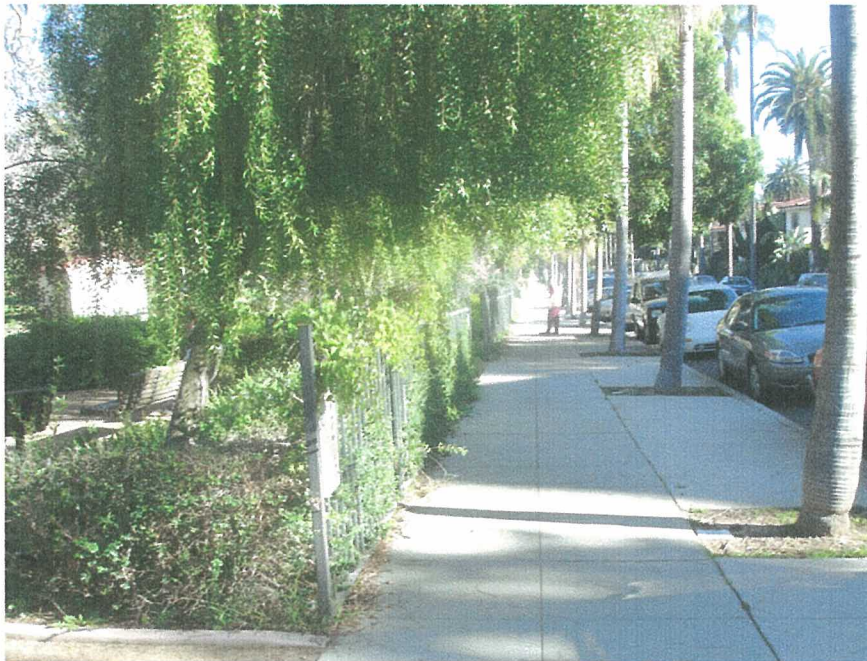
Public Right-of-Way - Photo # 5

Tree leaves are an overhead obstruction at 62" high instead of the required minimum clearance of 80" high.

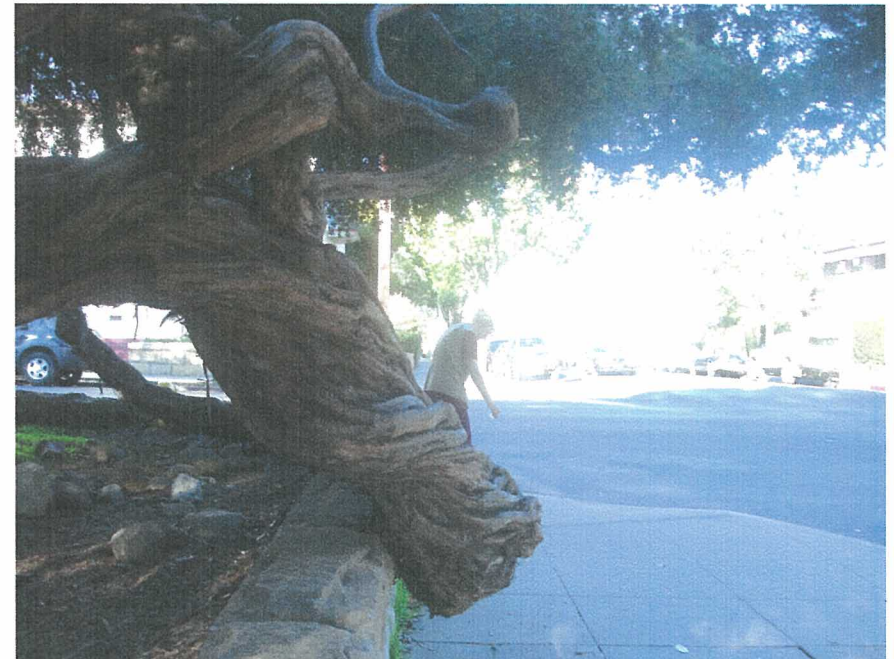
Public Right-of-Way - Photo # 6

Tree branch protrudes 7" into the path of travel at 72" high. Branch needs to be trimmed.

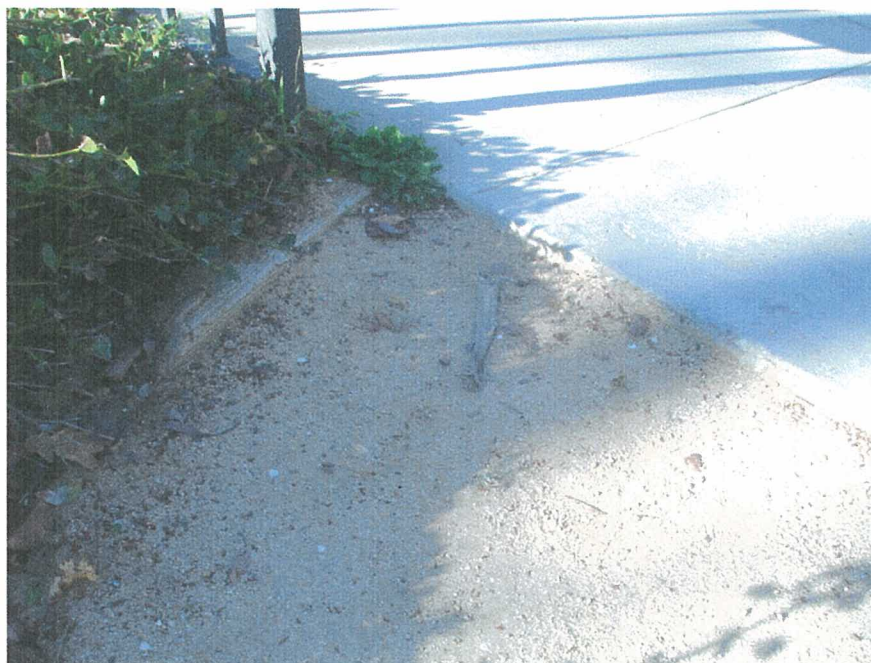
Site - Photo # 1

1" drop from sidewalk to decomposed granite surface, is a tripping hazard.

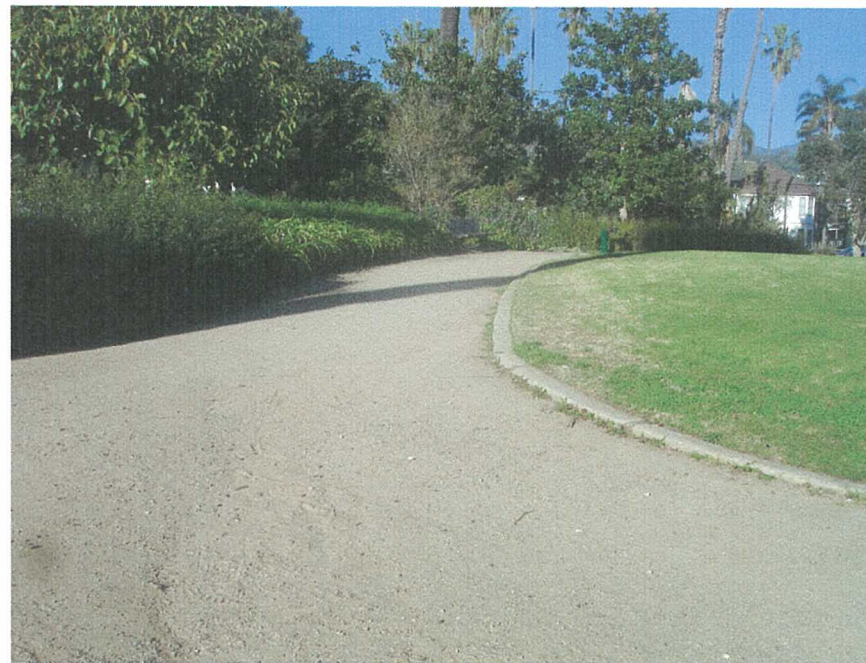
Site - Photo # 2

Path of travel has uneven surfaces and excessive cross slopes that are not considered an accessible surface.

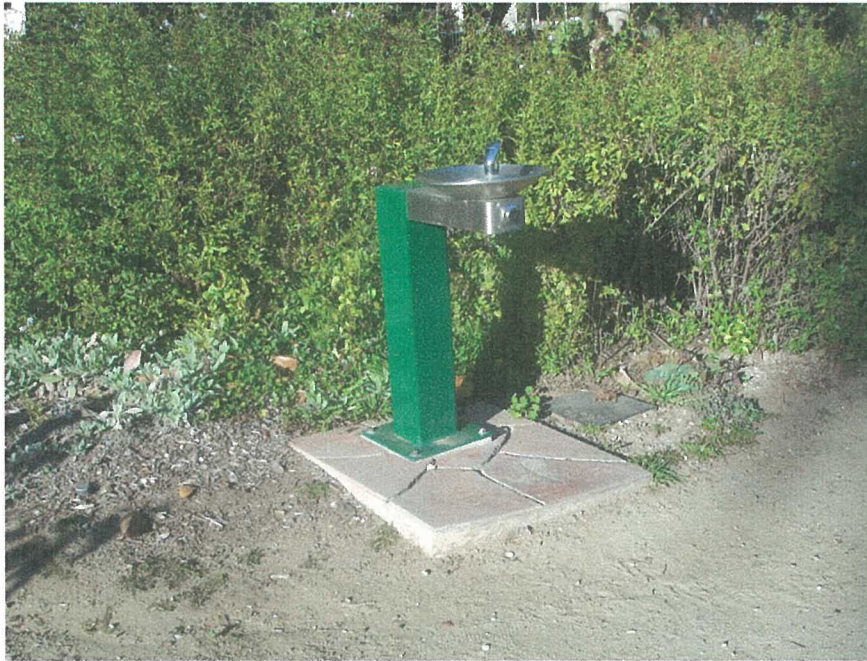
Site - Photo # 3

Landing at drinking fountain has 2" to 3" drop from concrete platform to decomposed granite level.

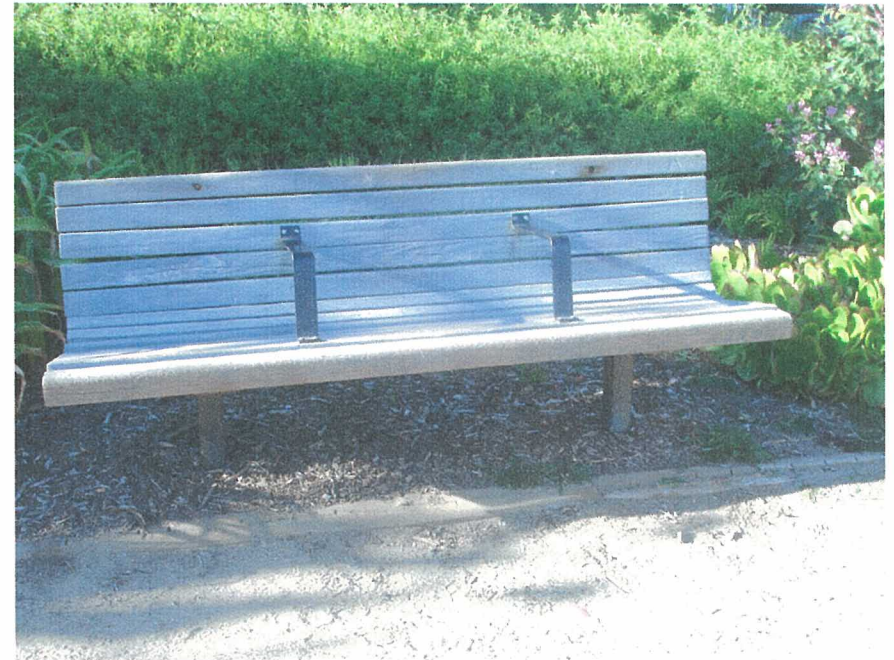
Site - Photo # 4

There is no 30" by 48" space adjacent to bench for a wheelchair user to be seated shoulder to shoulder with a person seated on the bench.

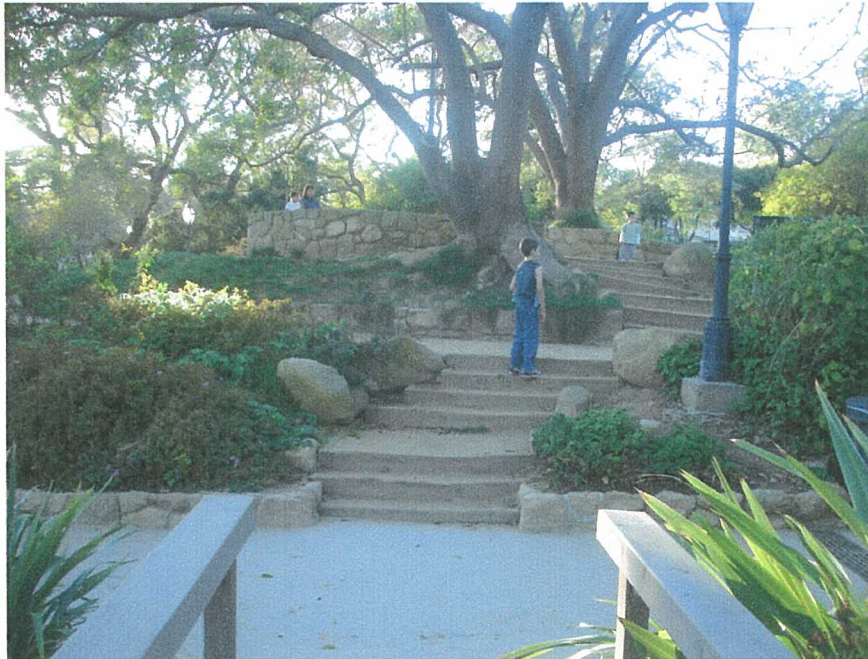
Site - Photo # 5

Stair has uneven raisers, no handrails and contrasting color striping.

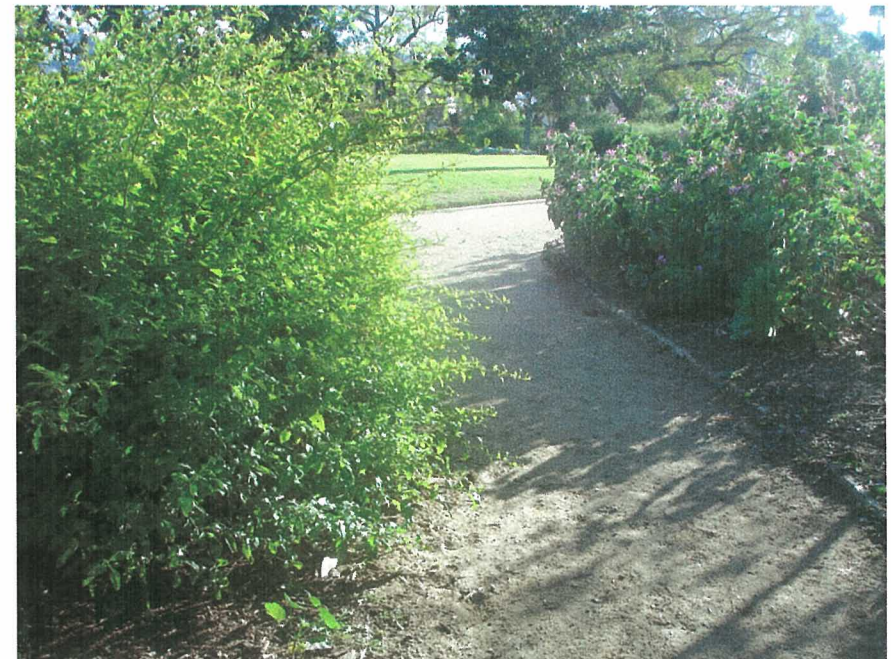
Site - Photo # 6

Walk width 38" due to vegetation protruding into the path of travel.

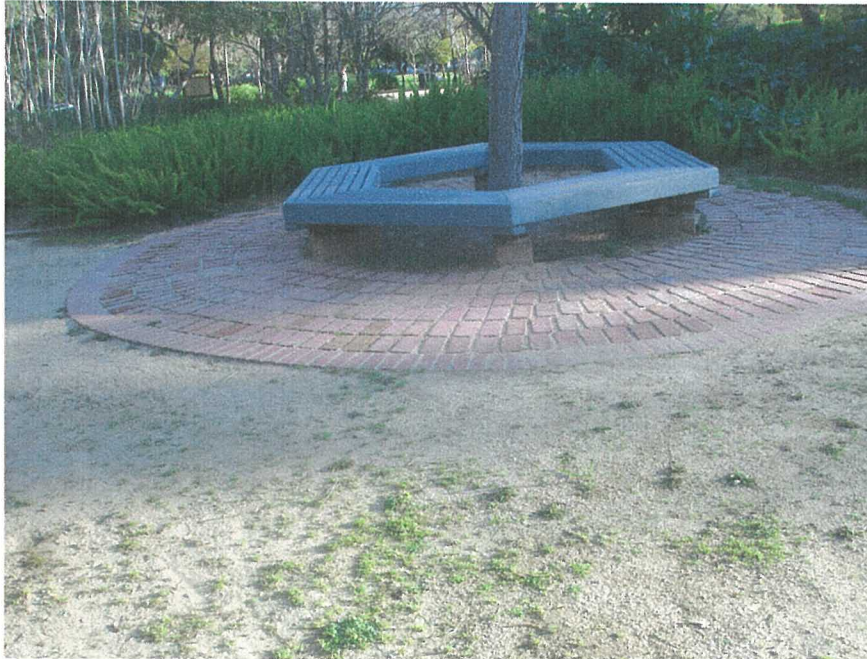
Site - Photo # 7

There is no 30" by 48" space adjacent to bench for a wheelchair user to be seated shoulder to shoulder with a person seated on the bench. 1" drop with adjacent surface.

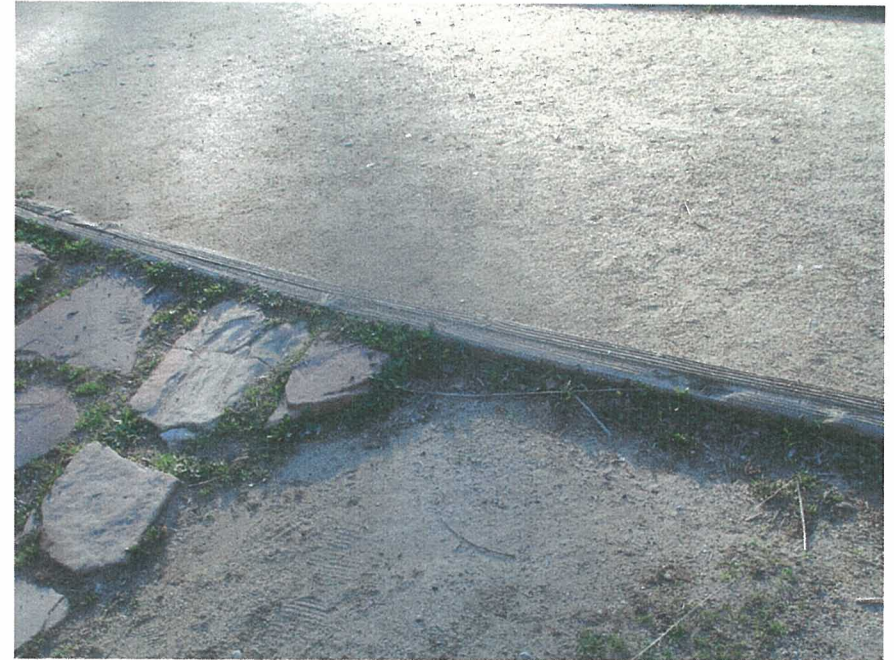
Site - Photo # 8

Path of travel has 1" drop with adjacent surface.

Walks and Sidewalks										
Pavement dislocations.	Beveled edge 1:2 max. (between 1/4" and 1/2")	Path of travel has 1" drop with adjacent surface. Photo #: 8	ADAAG: 4.5.2 T24: 1133B.7.4	Remove, replace or repair surface area to correct abrupt change in level.	10 SF	\$22	\$220	2

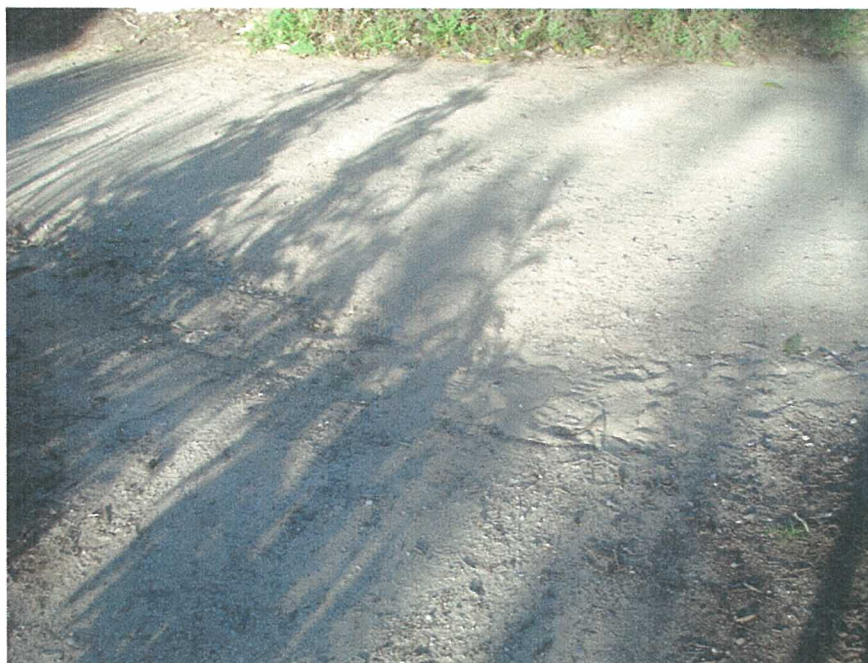
Site - Photo # 9

Path of travel has uneven surfaces – not compliant.

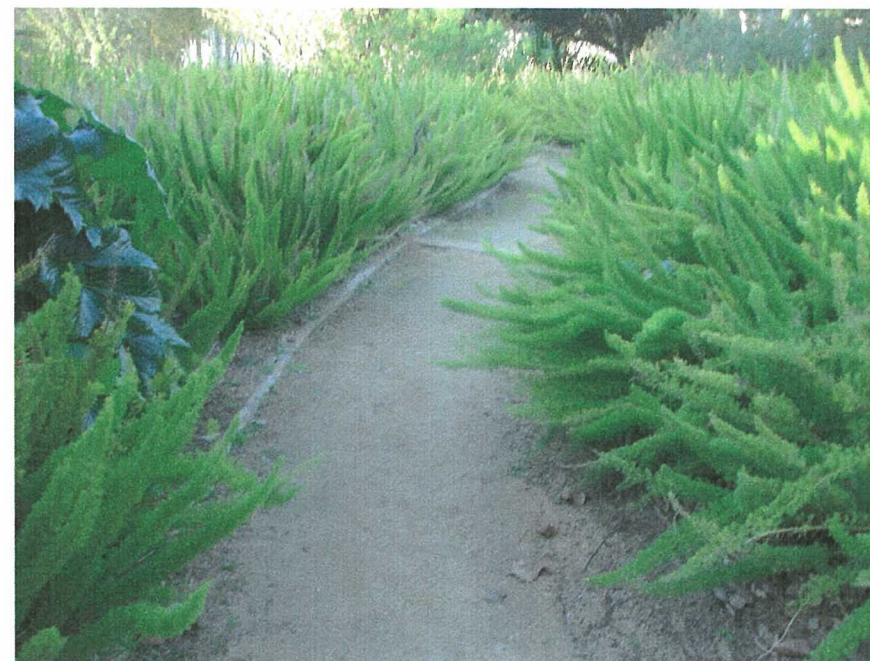
Site - Photo # 10

Path of travel between batting cages has an excessive cross slope ranging from 3.2% to 5.3% slope.

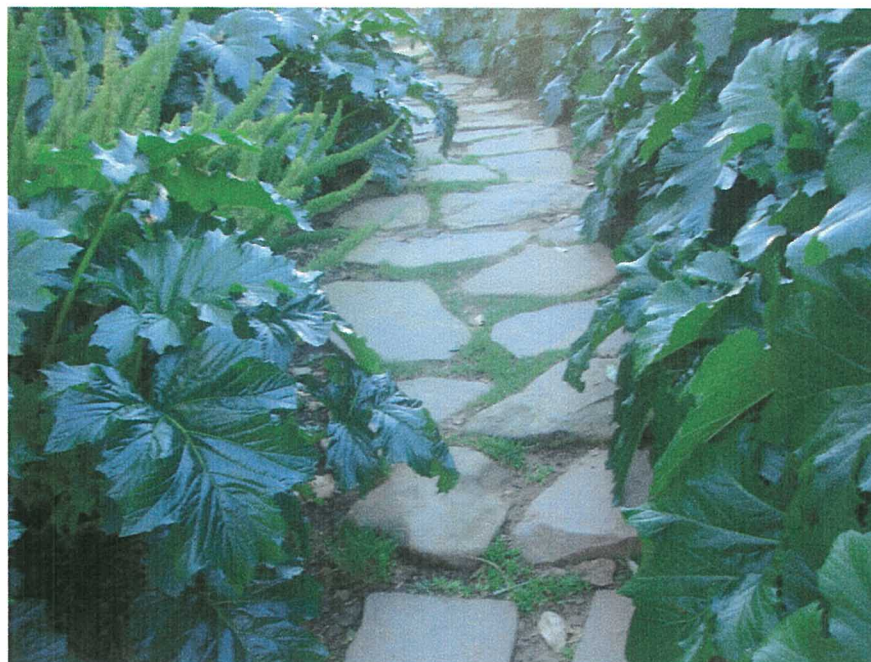
Site - Photo # 11

*Path of travel not accessible through narrow stone walk
with planting - natural walk not accessible.
Informational-directional signage needed.*

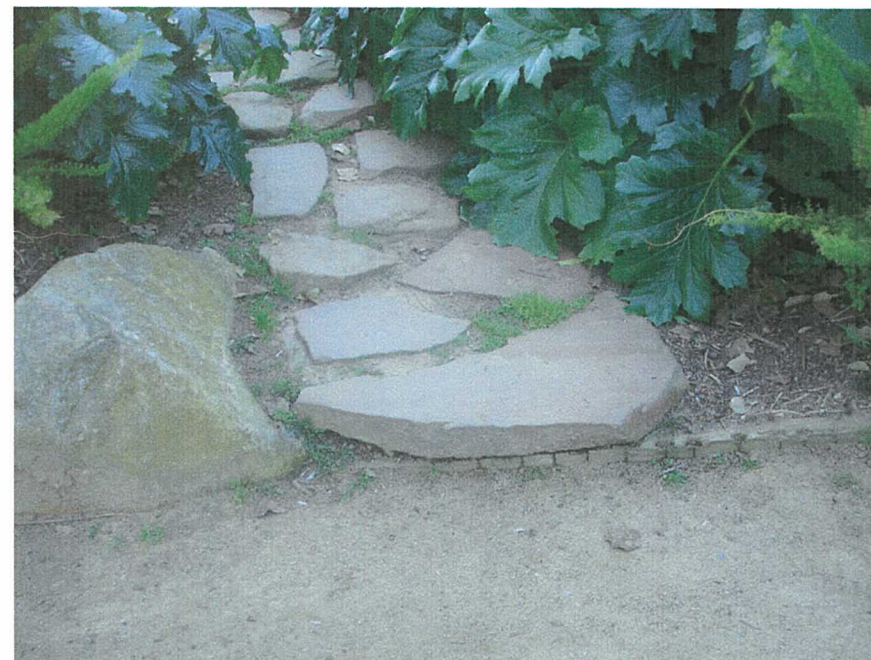
Site - Photo # 12

*Path of travel not accessible due to 2" step and narrow
stone walk with planting - natural walk not accessible.
Informational-directional signage needed.*

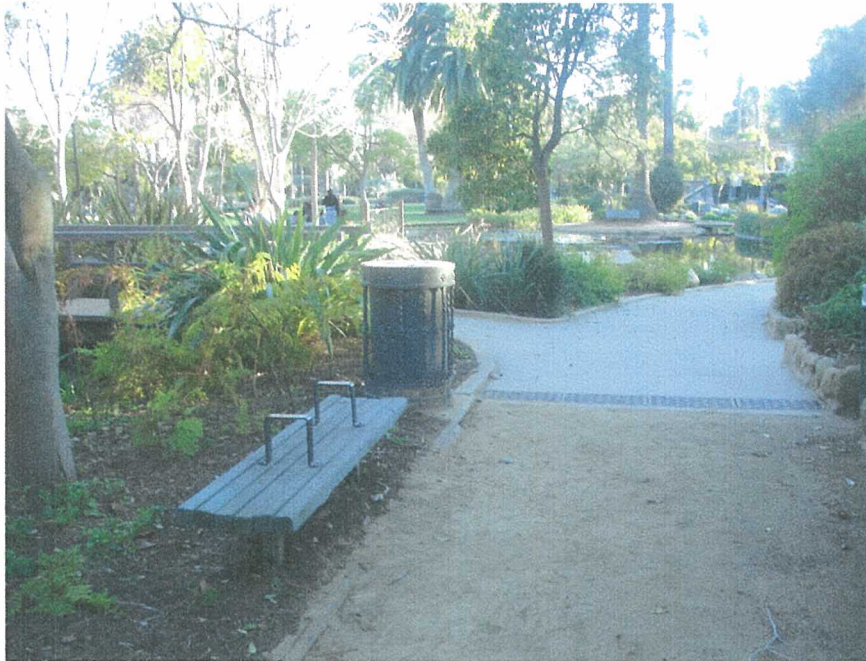
Site - Photo # 13

There is no 30" by 48" space adjacent to bench for a wheelchair user to be seated shoulder to shoulder with a person seated on the bench. No backrest provided.

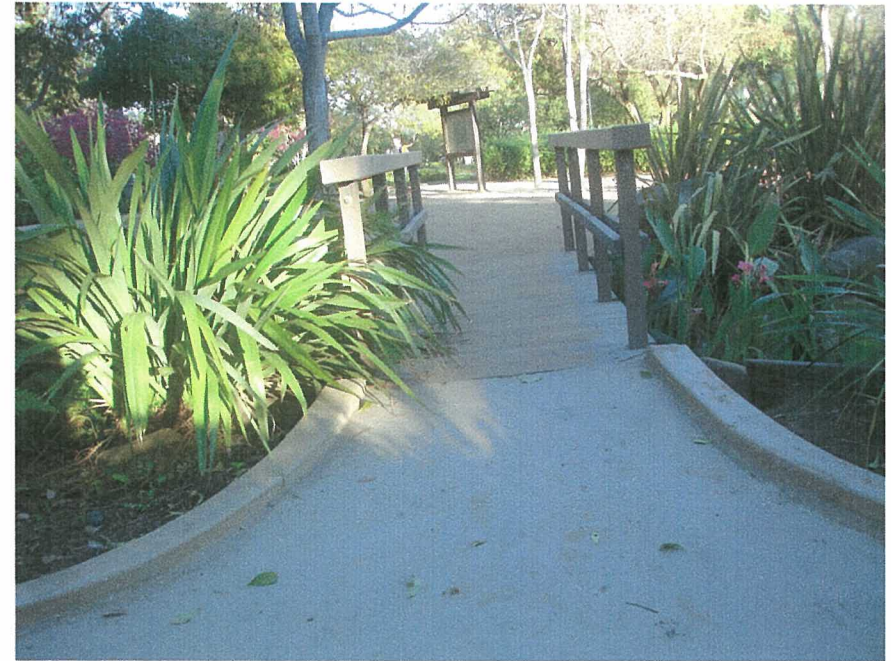
Site - Photo # 14

*Bridge has non-compliant path of travel width - 36 1/2".
Guardrail with 14" gaps between rails instead of 4" sphere max. Running slope at access to it is 11.1%-14.2%. 2" drop to path of travel.*

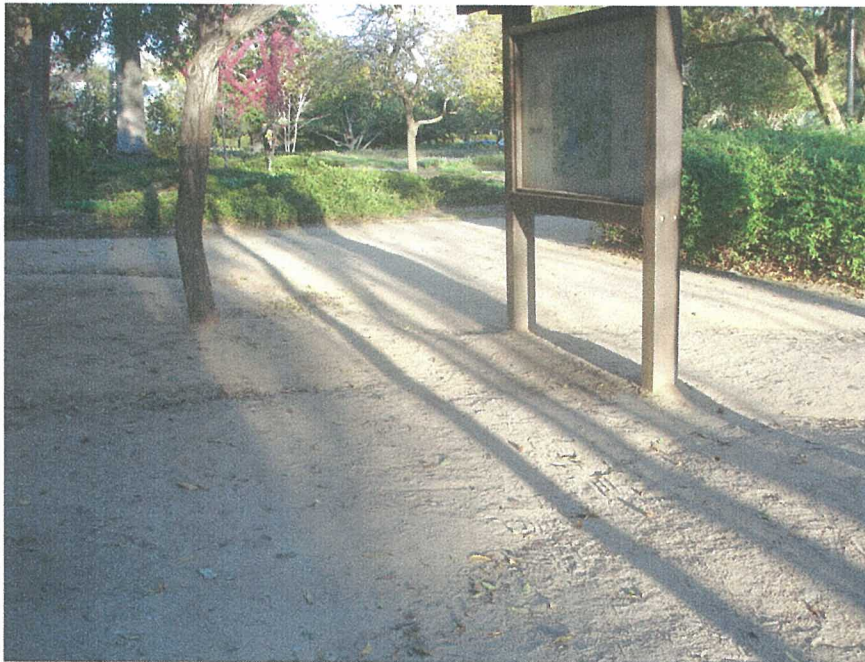
Site - Photo # 15

Path of travel has uneven surfaces. Tree branches and leaves at 70" high.

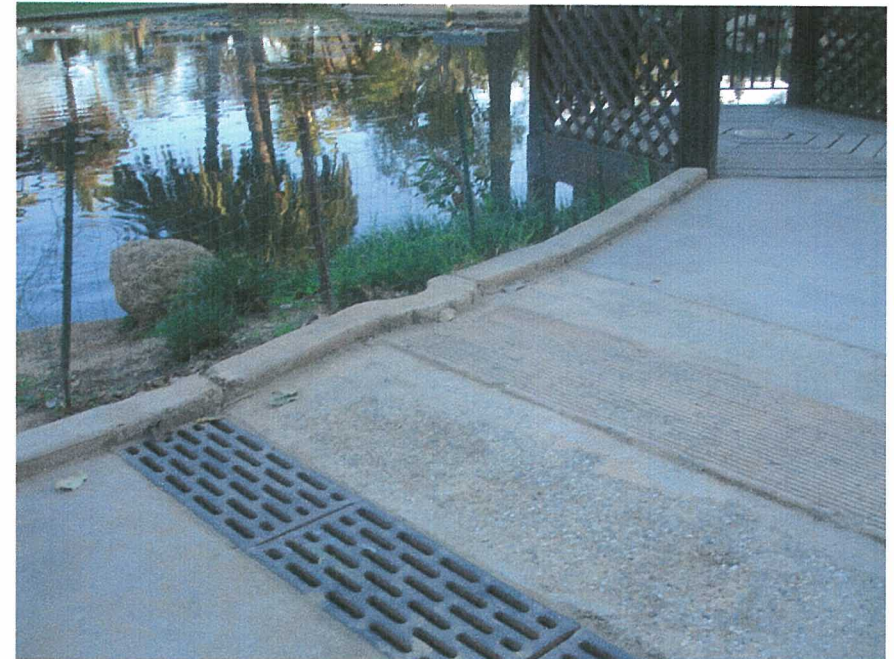
Site - Photo # 16

Path of travel has grates with 3/4" wide gaps in the direction of travel (1'x8').

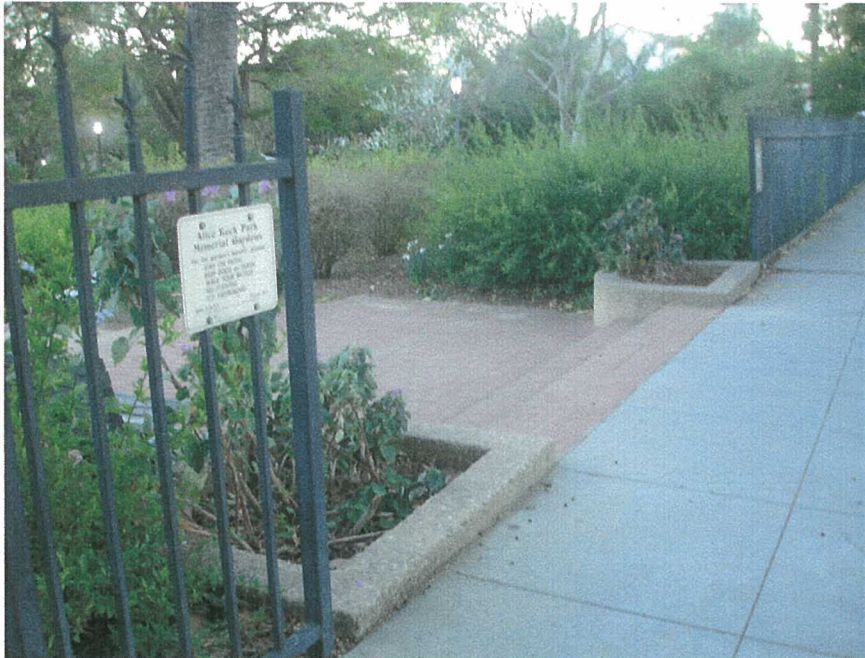
Site - Photo # 17

Stair has uneven bottom raisers 5 1/2" to 6", uneven intermediate stair raisers 4 1/2" to 6", uneven raisers at top stairs 5 1/2" to 5 3/4". No handrails and contrasting color striping.

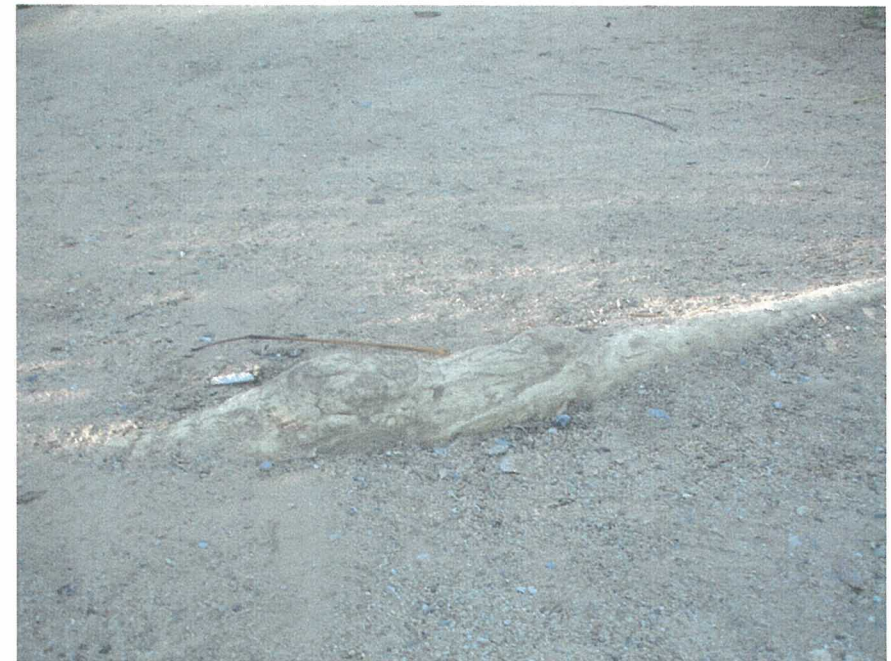
Site - Photo # 18

Path of travel to tree has uneven surface due to tree root, dislocations range from 1 1/2" to 2".

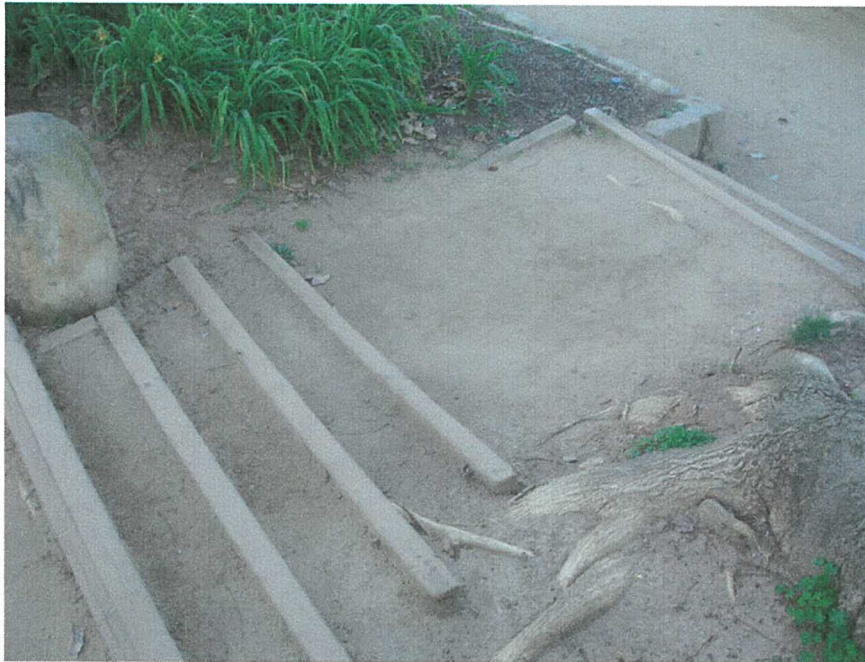
Site - Photo # 19

Stair does not have compliant landing. Uneven raisers 4" to 6 1/2", non-compliant extensions, no compliant contrasting color striping.

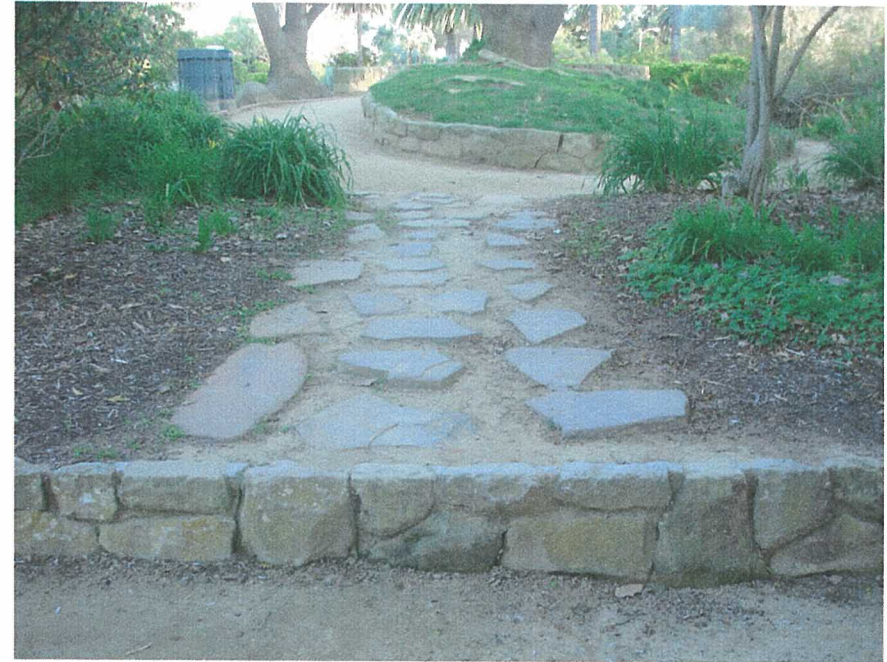
Site - Photo # 20

Path of travel has uneven surfaces leading to a 12" drop. Path of travel is not accessible. Provide informational and directional sign at this location.

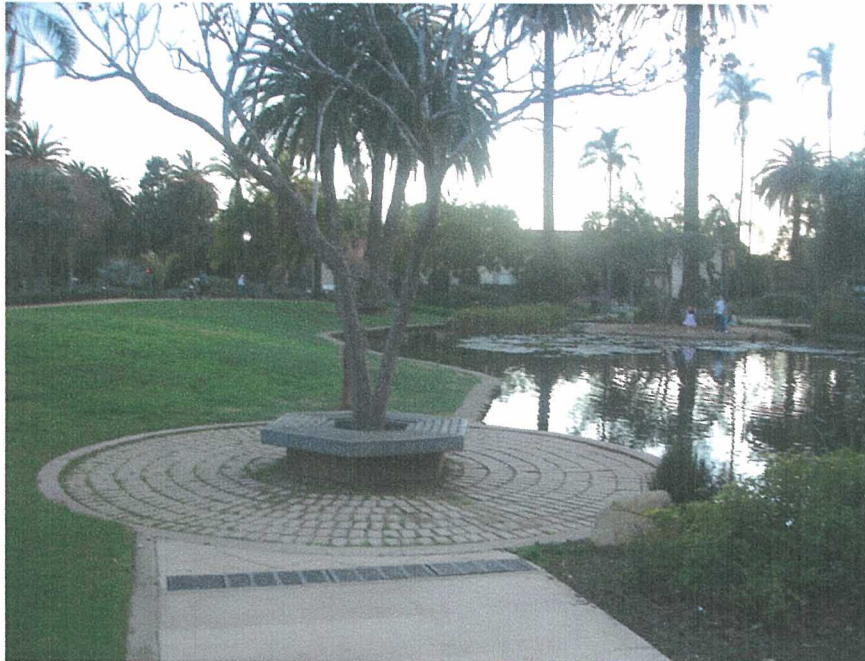
Site - Photo # 23

Walk adjacent to pond has a 16" drop to water without a 6" curb.

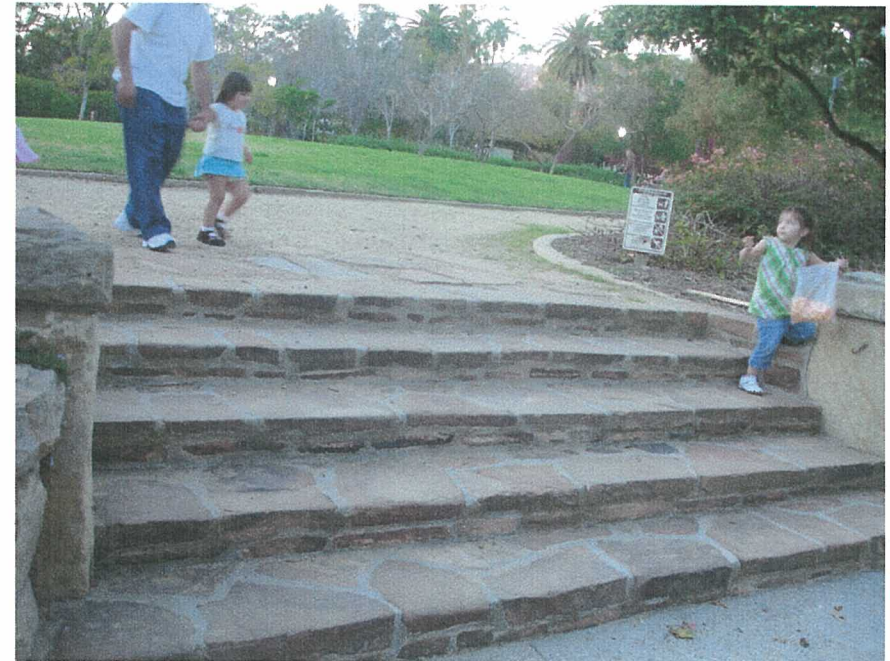
Site - Photo # 24

Stair does not have compliant raisers 5" bottom to 6", non-compliant treads 16 1/2" to 17 1/2". No handrails and contrasting color striping. No directional sign to accessible entrances.

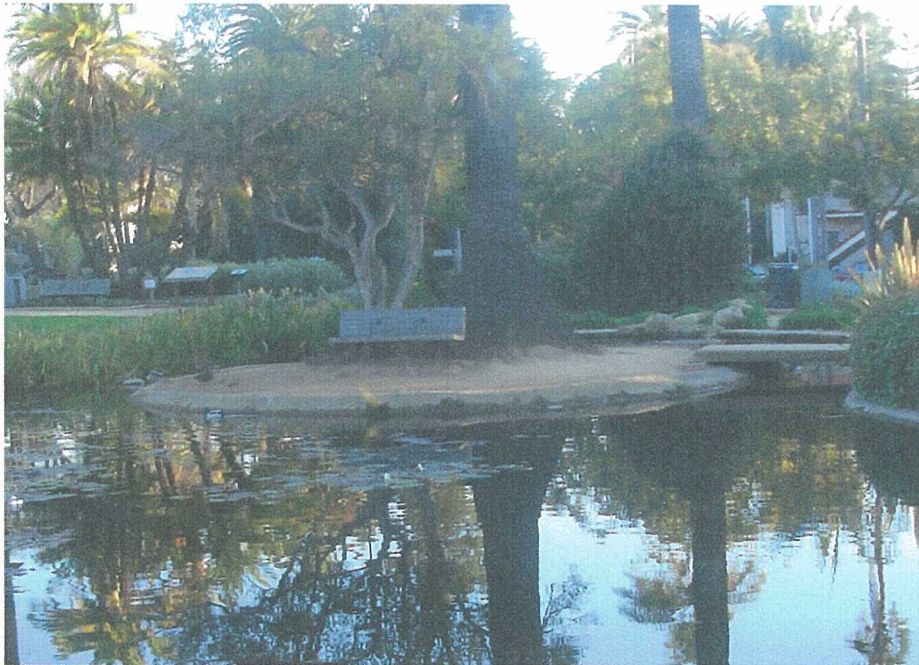
Site - Photo # 25

Bridge adjacent to pond does not have a guardrail. The bridge surface has 1" gaps in the direction of travel, and a step at both ends to the adjacent walks. Bench is located on an accessible path of travel with uneven surfaces.
