**CONEJO
AREA CITY
DOCUMENTS**

2005 PRELIMINARY GEOLOGY OBSERVATIONS

SUBJECT: Preliminary Geologic Observations, January 13 and February 1, 2005, of the Conejo Road Landslide Area, City of Santa Barbara, California

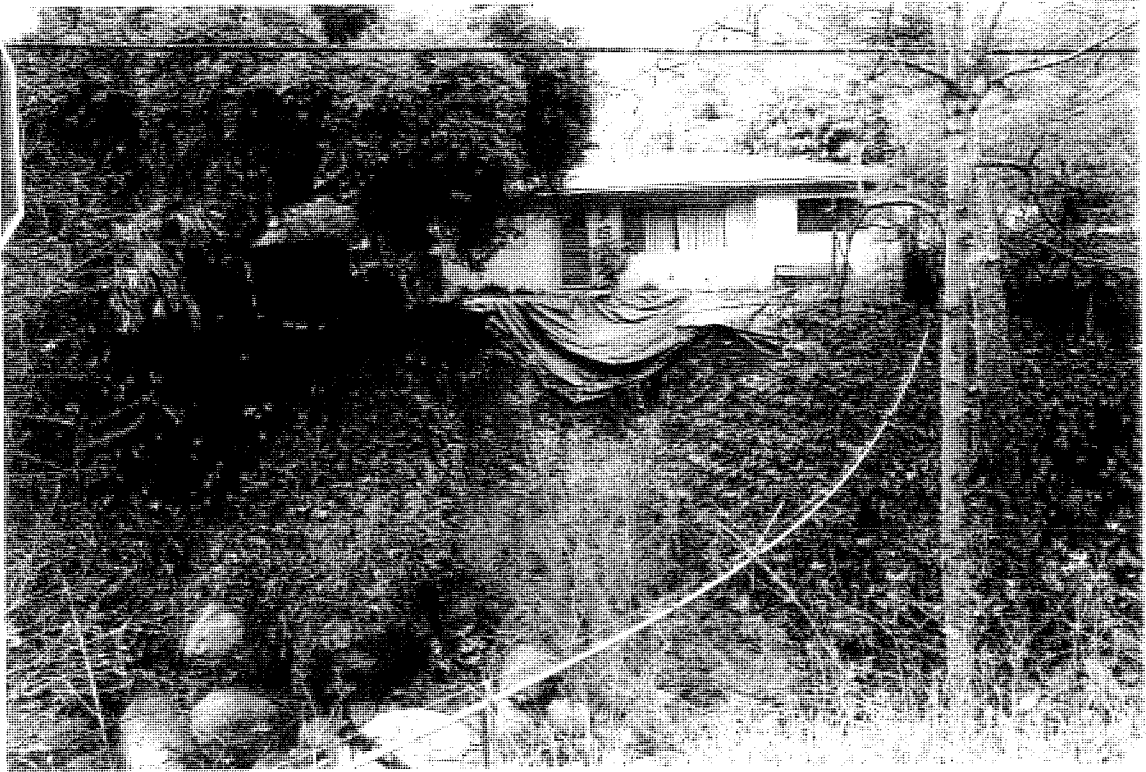
The January 2005 rainstorms caused erosion along Sycamore Creek at the toe of the old landslide (Qlso). This erosion caused creek bank retreat. The residence at 1815 Stanwood Drive was adversely impacted. Erosion and bank slippage resulted in the undermining of an area being used for storage and the yard between the house and the creek. Photographs 1 and 2 in Appendix A illustrate these conditions.

Photo 1 Sycamore Creek erosion near 1815 Stanwood Drive, 1/13/05.

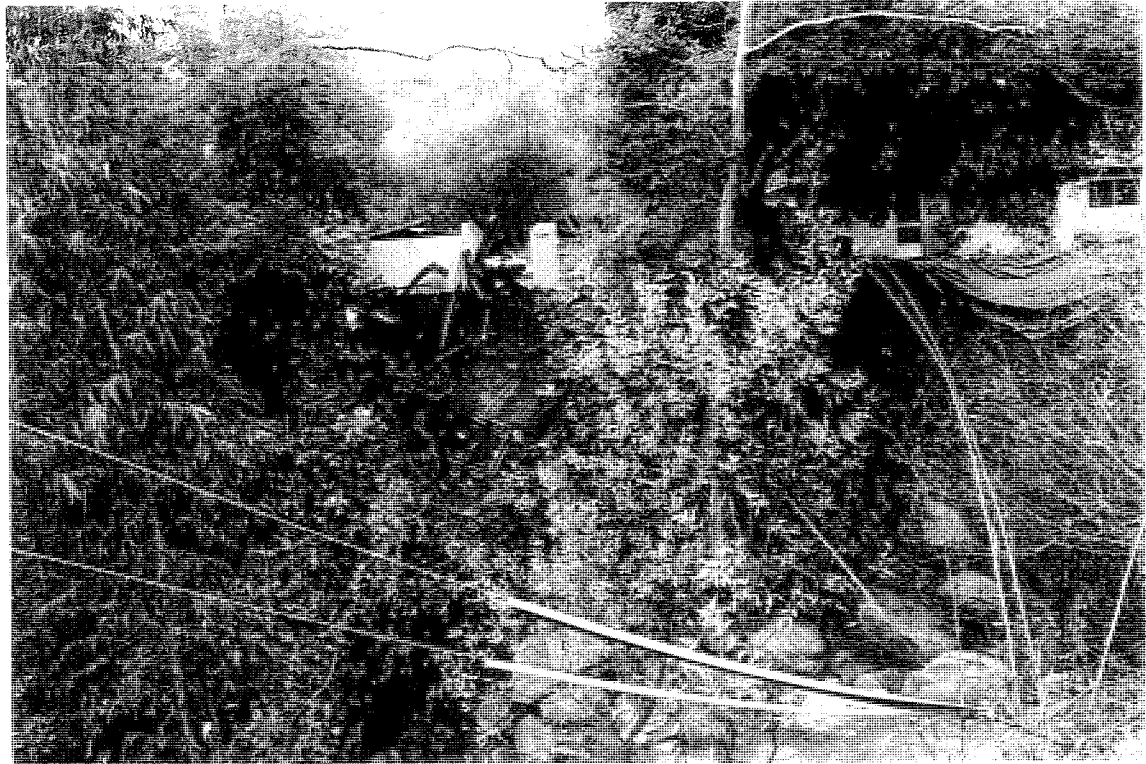
Photo 2 Sycamore Creek erosion near 1815 Stanwood Drive, 1/13/05.

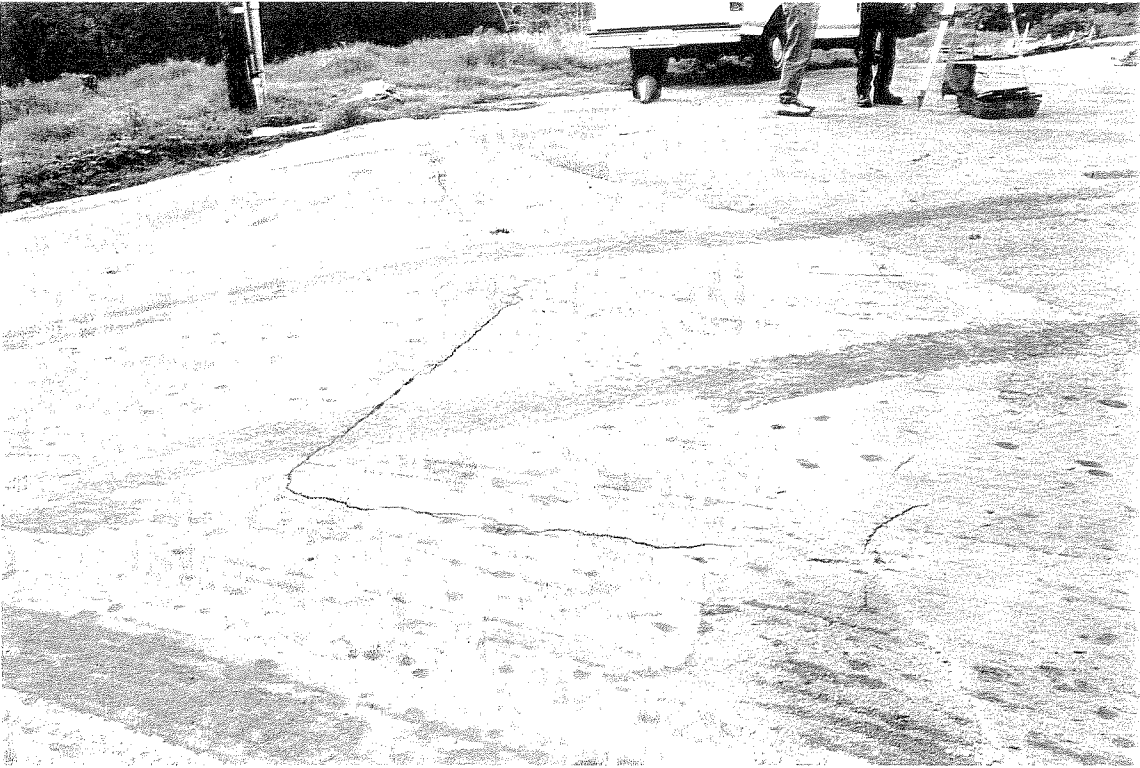
Asphalt cracking near the head and lateral scarps of Slide Mass A was observed. This cracking appeared to be relatively fresh and is occurring in an area with historic and significant earth movement. An extension crack was forming downslope from survey monitoring point 5043. Several other less defined pavement cracks were also observed on Conejo Road near its intersection with Conejo Lane. The crack trend lines up with a ground crack in the soil. These cracks appear to be extension in movement. Soil cracking may represent an old lateral slide scarp. Creep appears to be occurring. Photographs 3, 4, 5, and 6 in Appendix A illustrate the observed conditions.

Photo 3 Pavement cracking Conejo Road Slide Mass A near survey monitoring point 5043, 1/13/05.

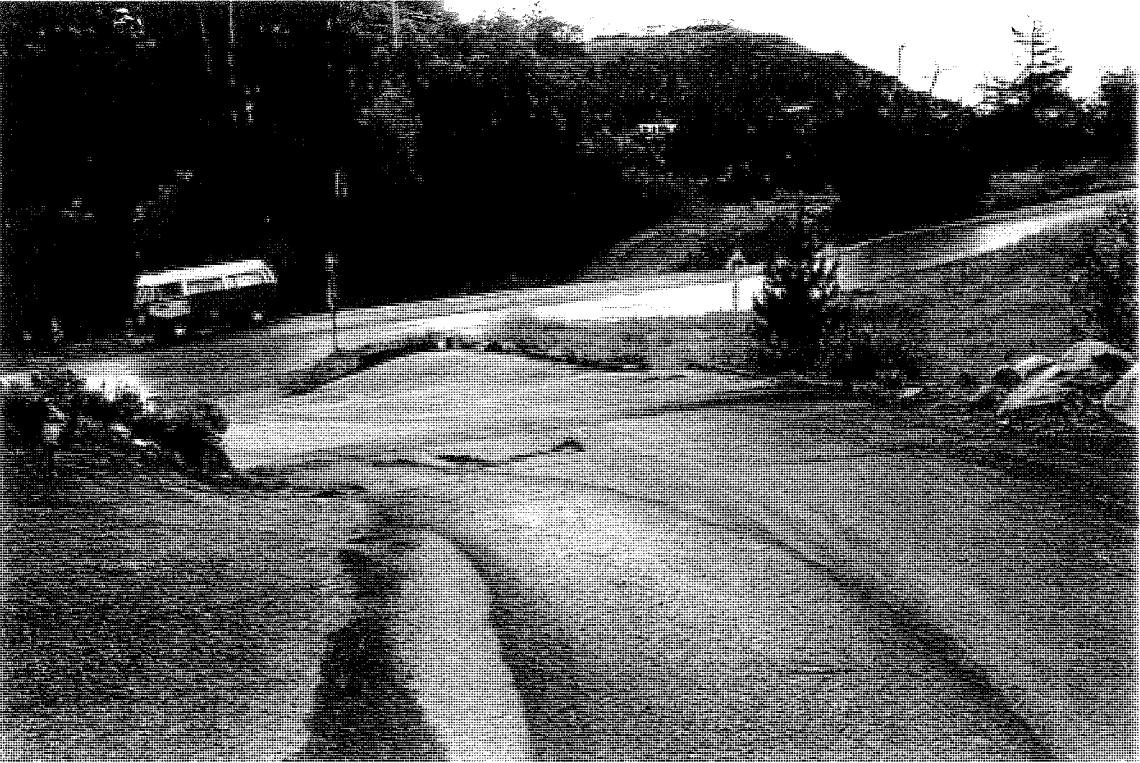
Photo 4 Slide Mass A scarp viewed from Conejo Lane, 1/13/05.

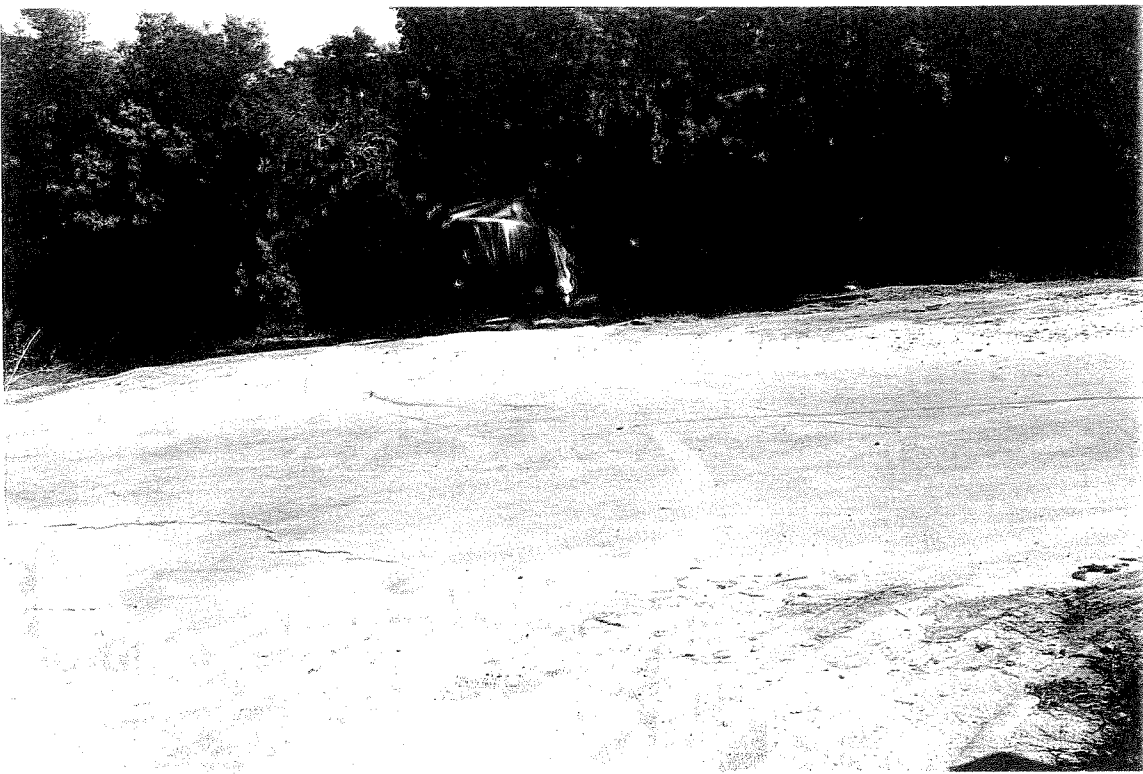
Photo 5 Pavement cracks Conejo Road slide Mass A near the Conejo Road / Conejo Lane intersection, 2/1/05.

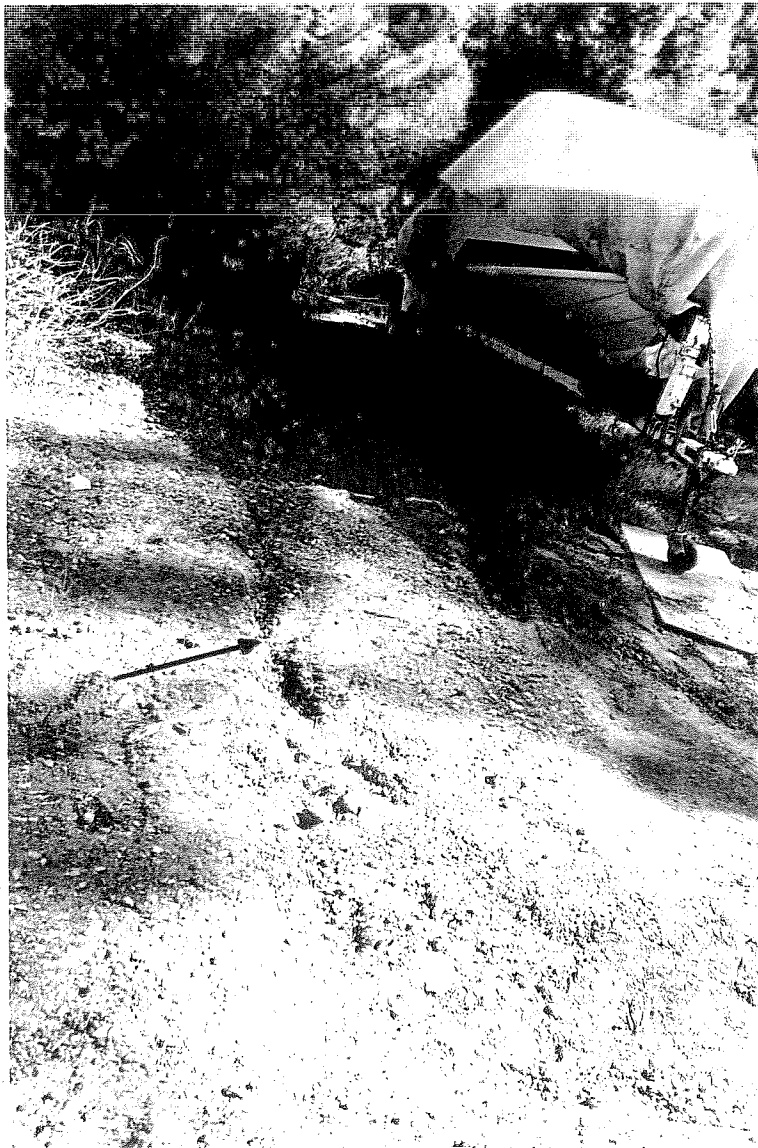
Photo 6 Ground crack that correlates with pavement cracks in Photo 5, 2/1/05.

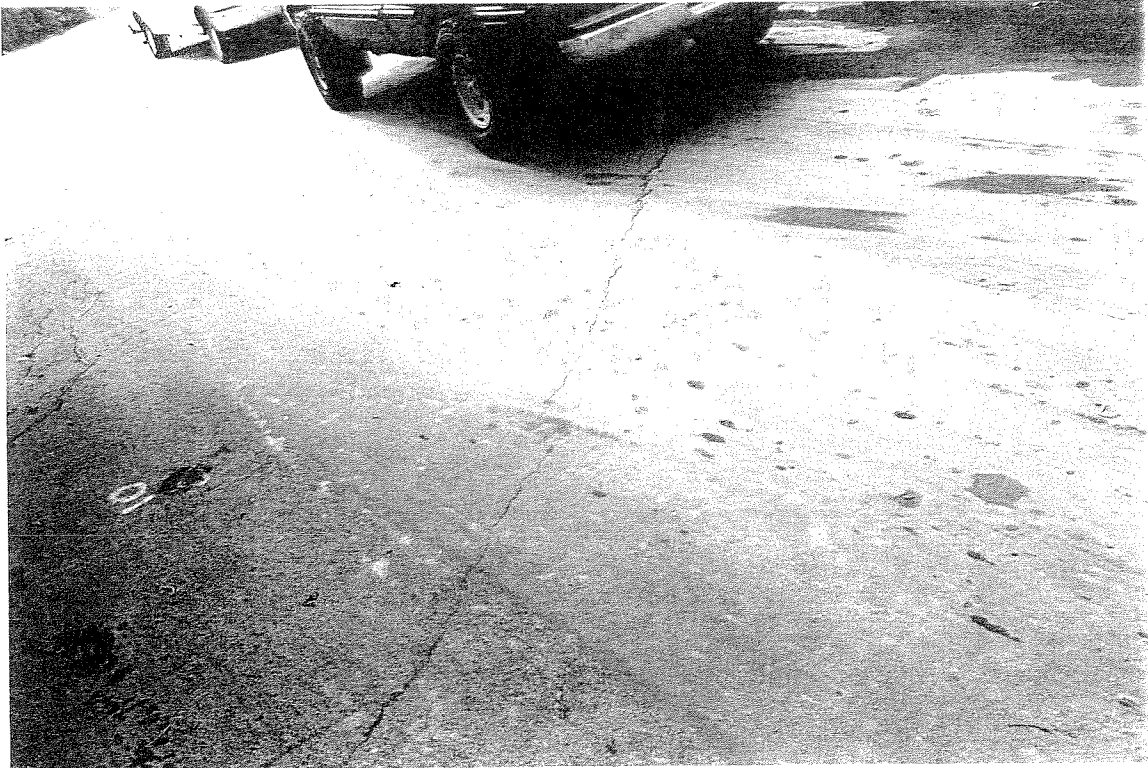
Several areas of recent pavement cracking were observed outside of active Slide Mass A, Slide Mass B and Slide Mass C. A pavement crack that cuts diagonally across Conejo

Road was observed near 444 Conejo Road. Hardscaped areas visible from the road appeared to be relatively new and showed no obvious signs of cracking. This crack did not fit other road crack patterns. The cause of the crack is unknown and could be attributed to settlement or earth movement. Photograph 7 in Appendix A illustrates this crack.

Photo 7 Pavement crack near 444 Conejo Road, 1/13/05.

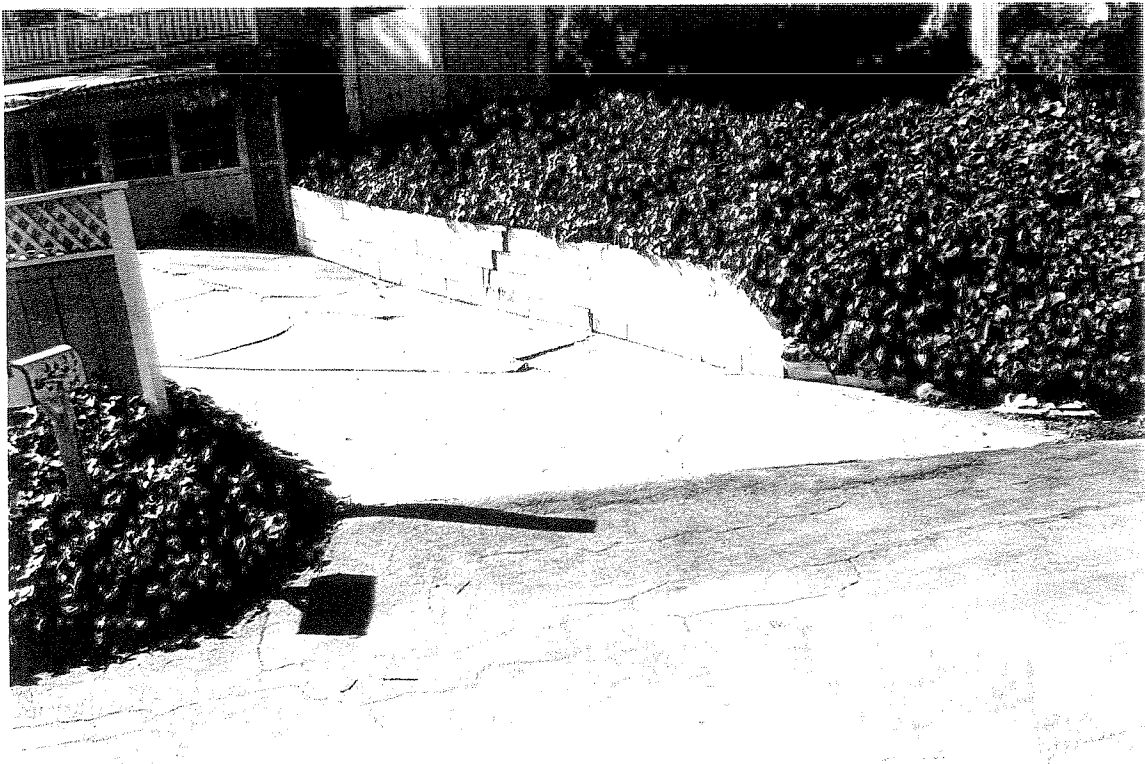
The next adjacent residence is 450 Conejo Road. Survey monitoring point 5017 is located in front of the home. Pavement and block walls are showing signs of distress. The survey point is showing uplift. Plastic sheeting was observed covering a slope descending to the backyard of another nearby residence. That residence showed signs of distress. Preliminary observations suggest that other landslide movement may be occurring outside Slide Mass A, Slide Mass B and Slide Mass C. All features observed from the road may not be related. However, there is enough data to suggest incipient earth movement. This earth movement would involve the descending slope and homes located there. Photograph 8 in Appendix A illustrates the survey monitoring point in relation to 450 Conejo Road.

Photo 8 Survey monitoring point 5017 near 450 Conejo Road, 2/1/05.

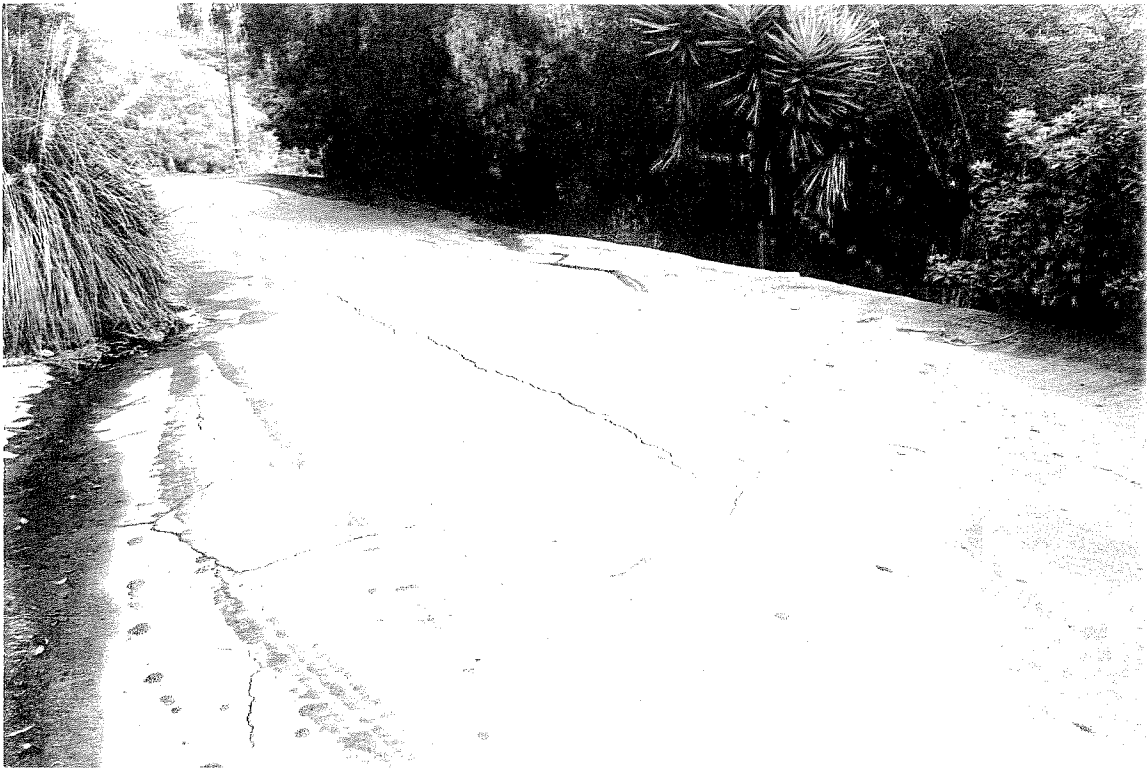
Pavement cracks were also observed in the road near 428 and 434 Conejo Road. These cracks are open and appear active. The cracks are roughly parallel to the outside edge of the road. Material underlying the road in this area appears to be creeping downslope. Conejo Lane residences may be located downslope in some areas. No obvious indication of slope movement on the descending slopes could be observed from the edge of Conejo Road. Continued expansion or enlargement of creep in this area may require the walking of these slopes and geologic observations. Photographs 9 and 10 in Appendix A illustrate this area.

Photo 9 Pavement cracks near 428 Conejo Road, 1/13/05.

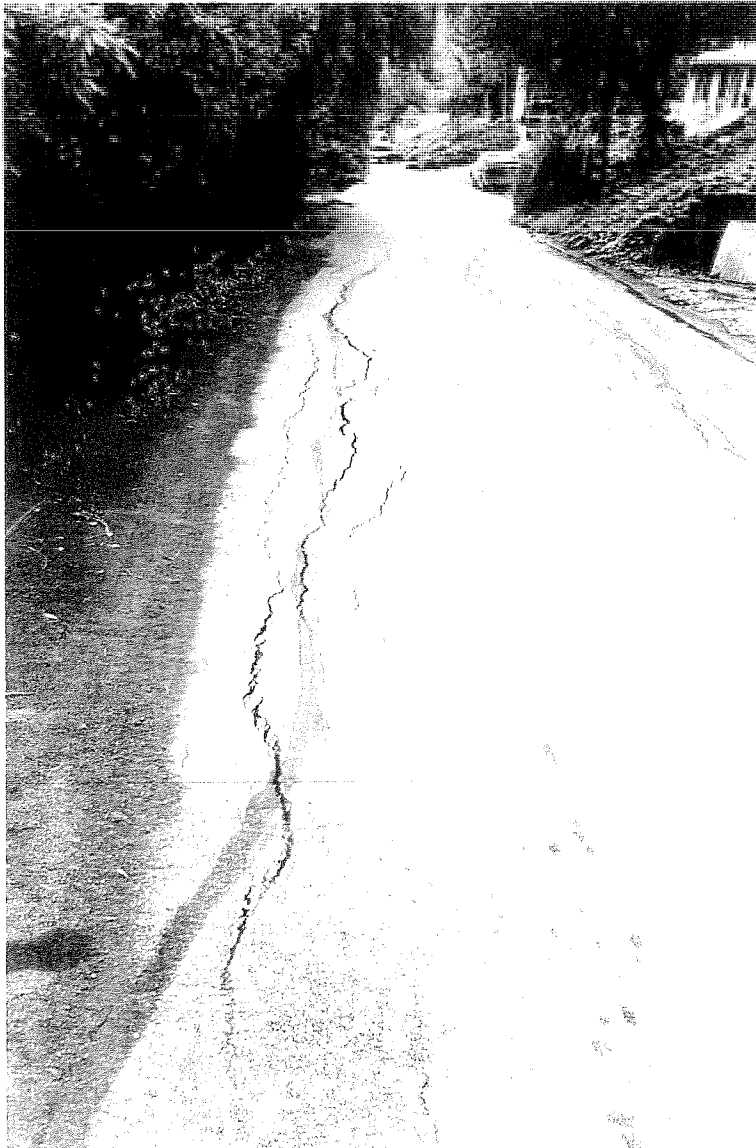
Photo 10 Pavement cracks near 434 Conejo Road, 1/13/05.

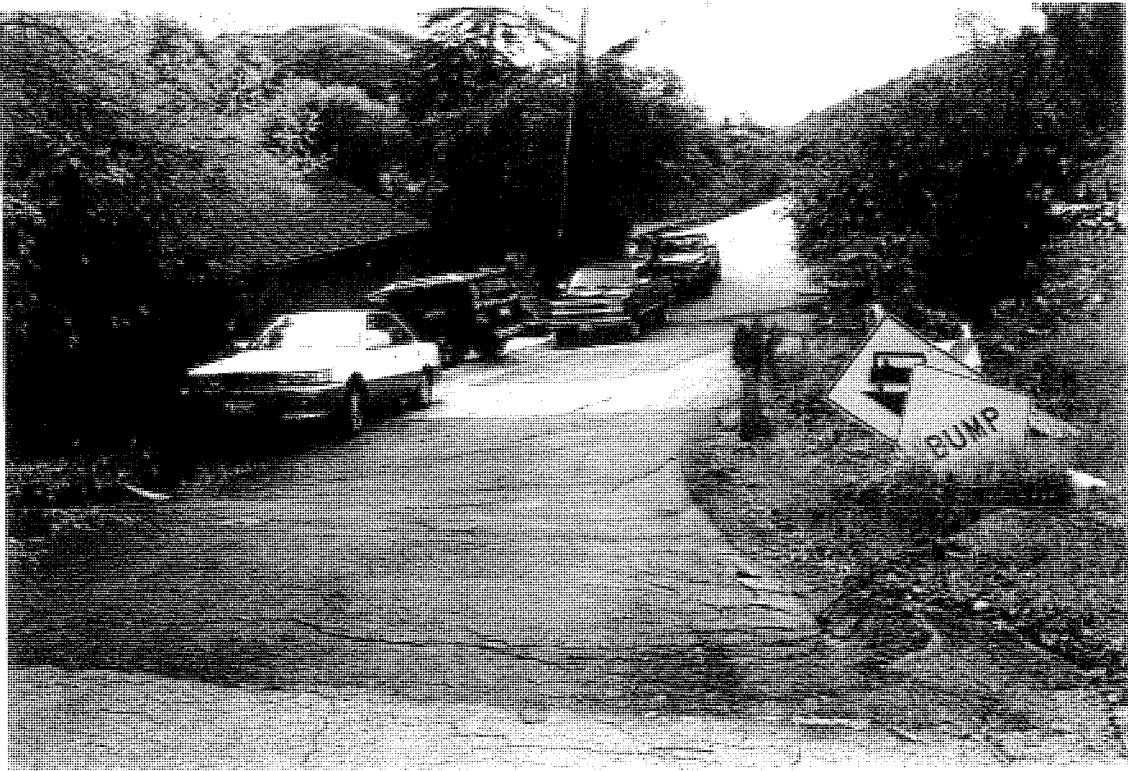
The pavement in Ealand Place underlain by Slide Mass C was down dropped but did not show obvious signs of recent pavement cracking. However, the driveway to 16 Ealand Place was covered with plastic sheeting. Some slippage in the head scarp area may be occurring. This slippage is upslope from the Ealand Place survey monitoring point. Earth movement may not be immediately reflected at the survey point. Photographs 11 and 12 in Appendix A illustrate this area.

Photo 11 Looking south near 10 Ealand Place across Slide Mass C lateral scarp, 1/13/05.
