## ORTEGA PARK MURAL EVALUATION REPORT

JULY 13, 2021

Prepared by:  
**Site & Studio Conservation, LLC.**  
Kiernan Graves  
Evelynn Bird  
Abigail Rodriguez  
Magdalena Solano

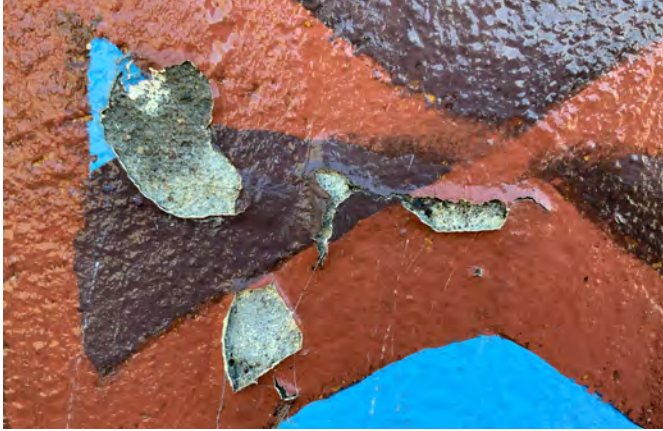
Overall, the Ortega Park murals are in fairly good condition except the *Codex Cospi*. This mural exhibits widespread and severe condition issues such as salt activity leading to flaking paint (Figure 1) and structural cracking of the stucco layer. Other murals that exhibit similar structural cracking are the underwater scenes found inside the wall around the pool— particularly *Dolphins* (Figure 2) found on the opposite side of the *Codex Cospi* wall. *Campeños* has relatively minor vertical structural cracks that run almost the full height and divide the mural into thirds. This condition may affect the stability of stucco if these particular murals are relocated and more robust protection materials may be necessary, especially in the case of *Codex Cospi* and *Dolphins*.

Figure 1. Detail from *Codex Cospi* (2020), showing damage to painted surface from salt activity. This is found throughout most of the painted surface of this particular mural.

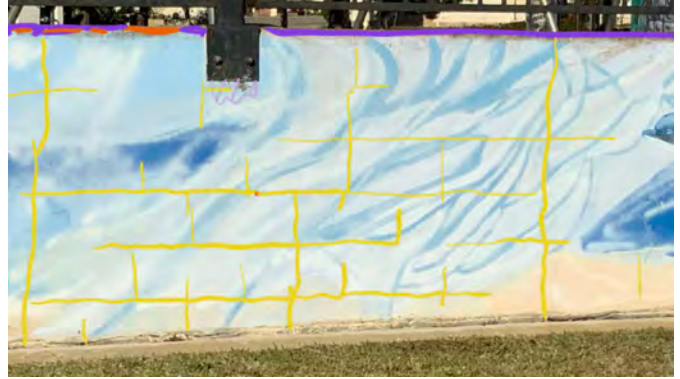
Figure 2. Example of the extensive cracking (drawn in yellow) in the shape of the CMUs found in *Dolphins* and *Codex Cospi*. This type and extent of cracking is what would make these murals extremely difficult to relocate without significant damage.

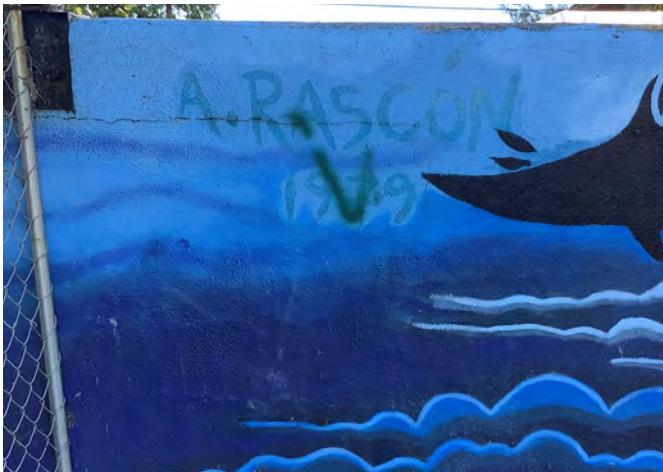
Figure 3. Example of the graffiti found on the murals currently. All incidences are done with the same green paint.

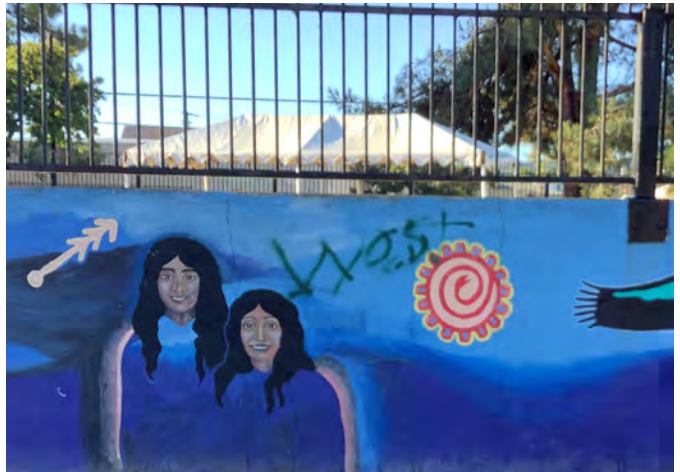
Figure 4. Example of the graffiti found on the murals currently. All incidences are done with the same green paint.

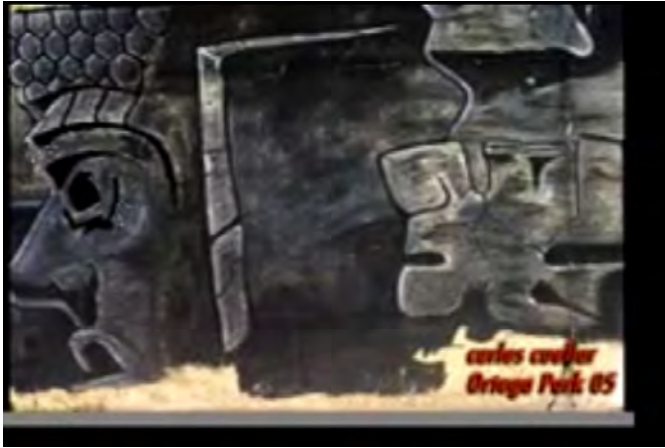
Figure 11. *Underwater Atlantes/Toltecas* before restoration, note the very muted and monotone palette. (Image is taken from a video put together with archive images by Cuellar.)

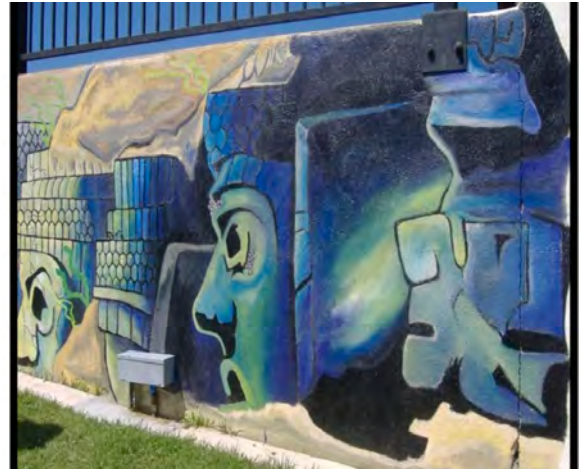
Figure 12. *Underwater Atlantes/Toltecas* after restoration, note the much changed and vibrant palette though the lines and composition are the same. (Image from Venegas 2020.)

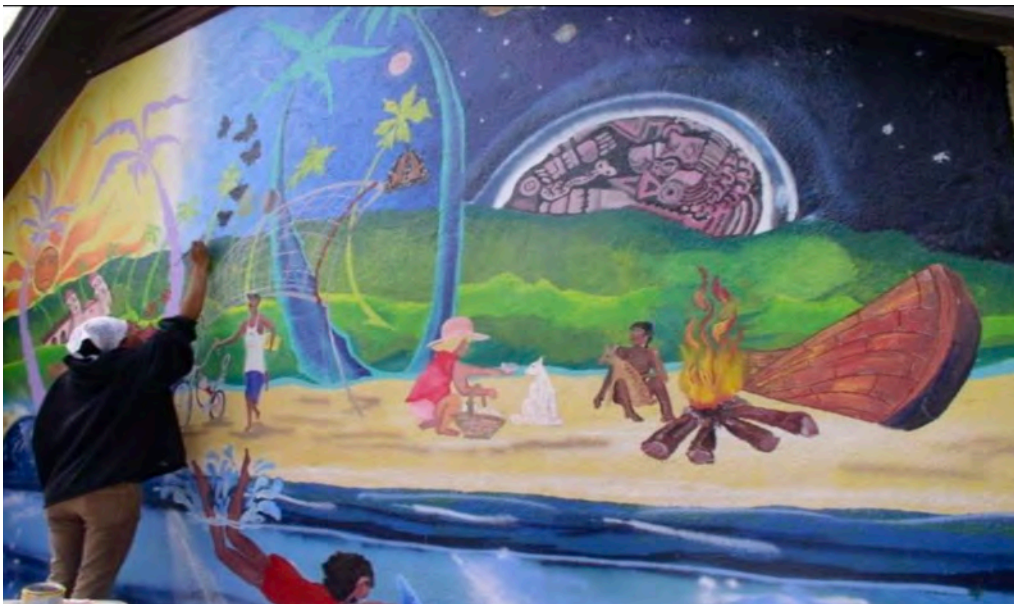
Figure 24. The painting of *La Playa* in 2005, notice the fading of the colors between the original and the current image.  
(Image from Venegas 2020)

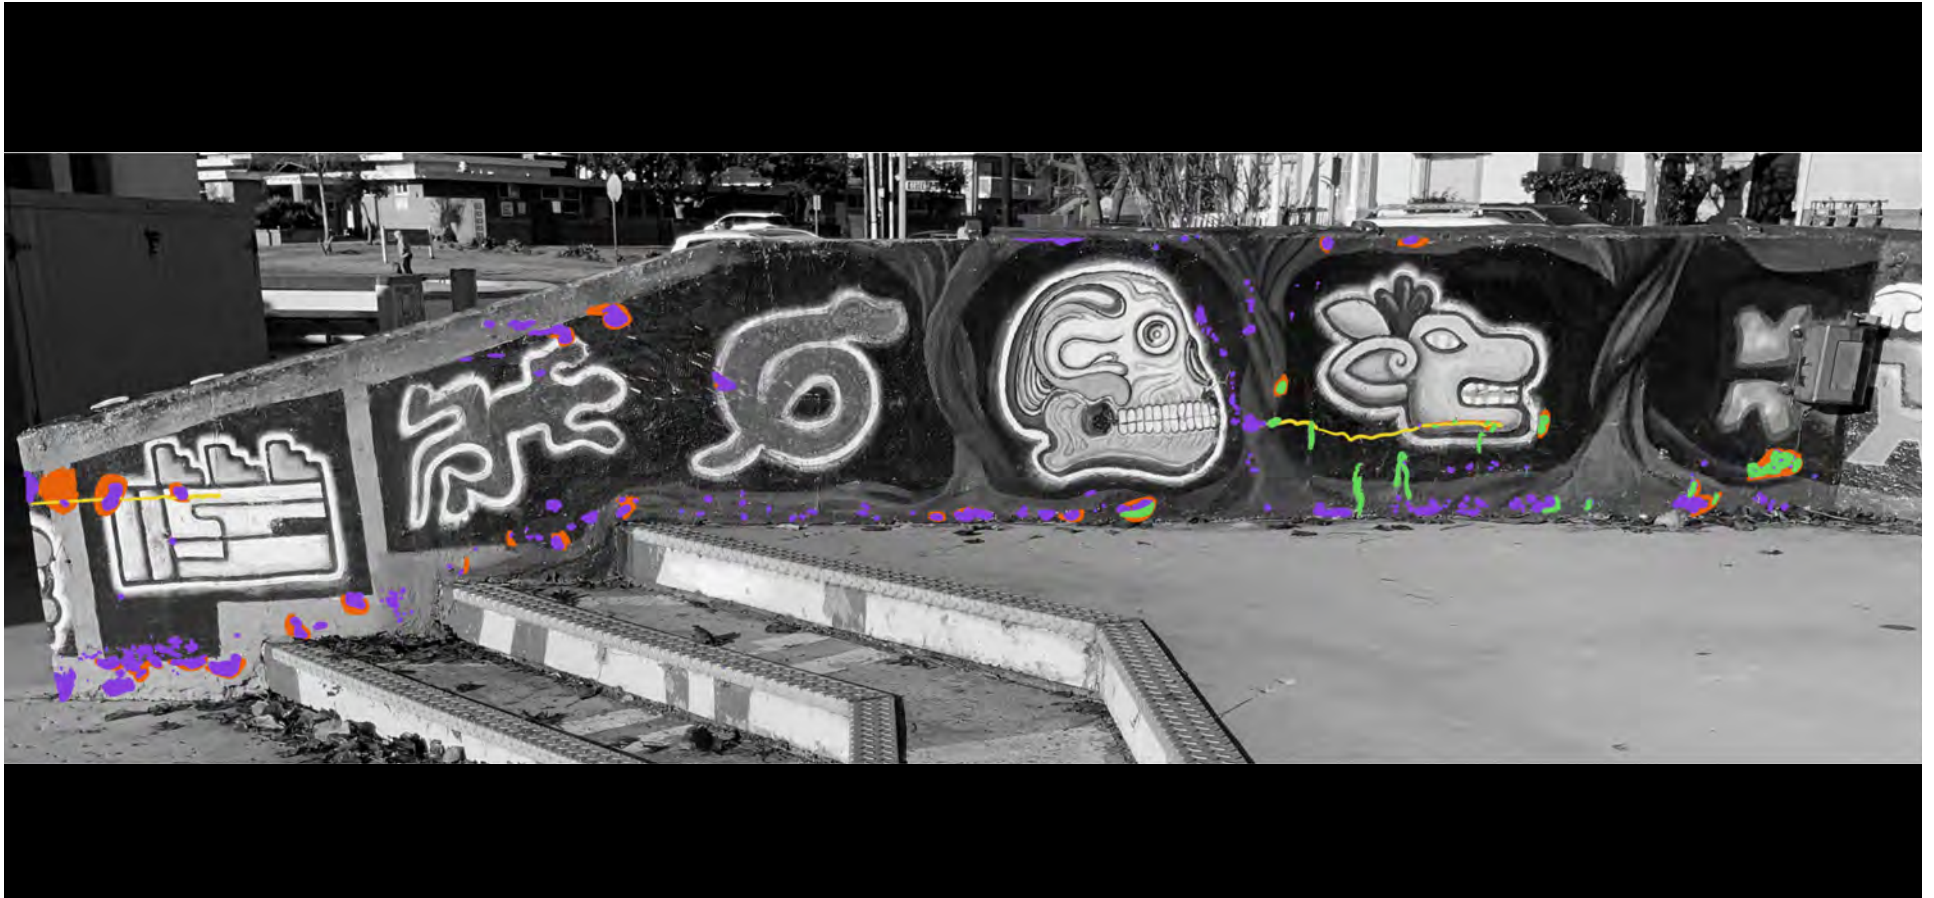
## Aztec Symbols (1 of 2)

As is typical with murals painted on retaining walls, *Aztec Symbols*, *Green Serpent*, the lower edge of *Coatlicue*, and part of the *Rainbow Quetzal* exhibit a significant amount salt activity, flaking and loss due to water and other contaminants contained within the dirt behind the wall and percolating out through the exposed surface as the environment fluctuates. The murals on the south-southeastern facing walls of the pool house and surrounding walls, which support *La Playa* and *Dolphins*, exhibit the most severe fading and deterioration of paint binder. These condition phenomena are most often seen in blue exterior house paints and are exacerbated by the intense and direct sunlight they receive given their orientation. *Underwater Atlantes/Toltecas* and *Blue Whale* both show the same deterioration, but to a lesser degree.

Aztec Symbols	Considered temporary training space for youth artists.	Document and deaccession	Recommended by the Mural Working Group to document and deaccession.	\$2,500
