Site Accessibility Evaluation

Alice Keck Park
219 E Micheltorena St
Santa Barbara, CA 93101
Accessibility Evaluation
Inspection Date: 08/24/2023
Inspectors: Scott Saddlemire

SALLY SWANSON
ARCHITECTS, INC.

Report Date: 11/03/2023

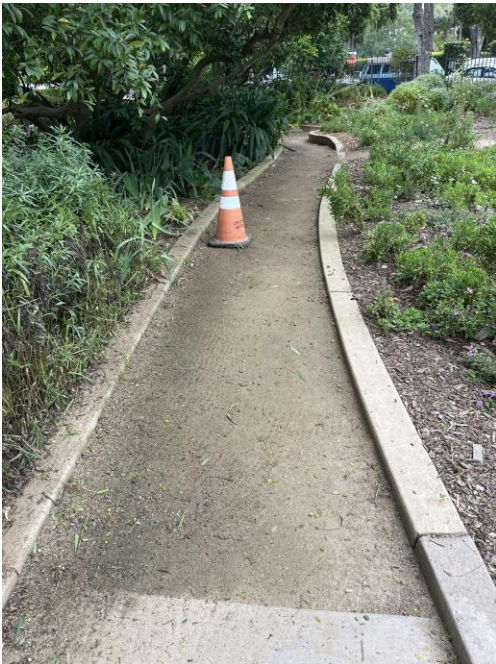
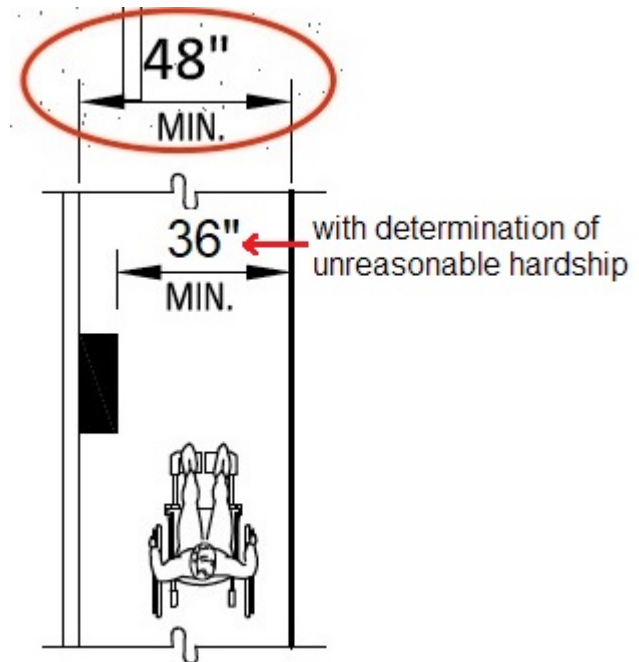
Finding: 1

The route of travel does not provide the required minimum width.

The minimum clear width for sidewalks and walks is 48 inches.

When, because of right-of-way restrictions, natural barriers or other existing conditions, the enforcing agency determines that compliance with the 48-inch clear sidewalk width would create an unreasonable hardship, the clear width may be reduced to 36 inches.

See exception 3 in the findings section

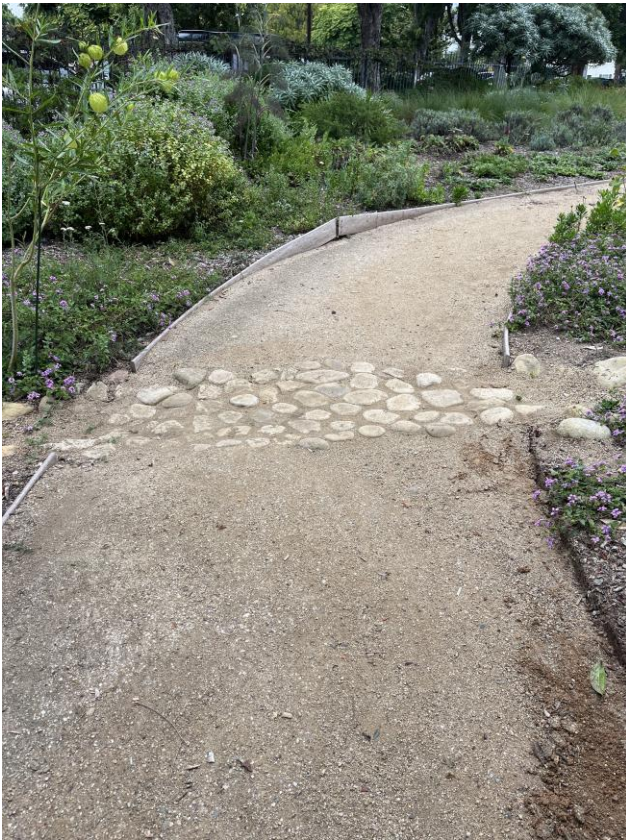
Finding: 2 (Continued)

The walkway contains abrupt vertical edges and/or variations over 1/4 inch.

1/4 inch is the maximum vertical rise. Changes in level between 1/4 inch and 1/2 inch must be beveled at 1:2 or less.

Changes in level greater than 1/2 inch must be by way of a ramp.

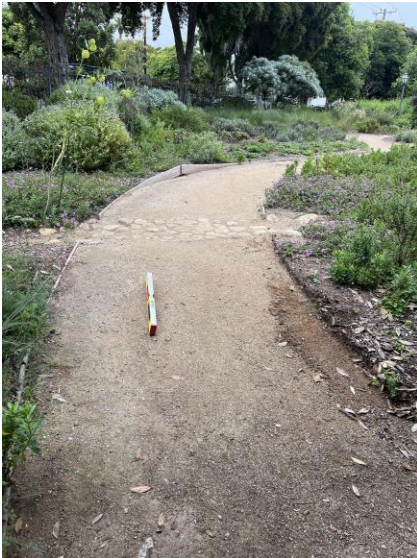
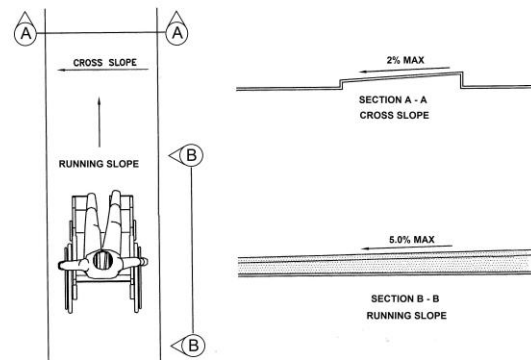
Finding: 3

The accessible route has running slopes greater than 5% and has not been constructed as a ramp (i.e. handrails, edge protection, etc.). Cross slopes are greater than 2% across the width of the walk.

When the slope in the direction of travel of any walk exceeds 1 unit vertical in 20 units horizontal (5-percent slope), it must be constructed as a ramp. Surface cross slopes must not exceed 1 unit vertical in 48 units horizontal (2-percent slope).

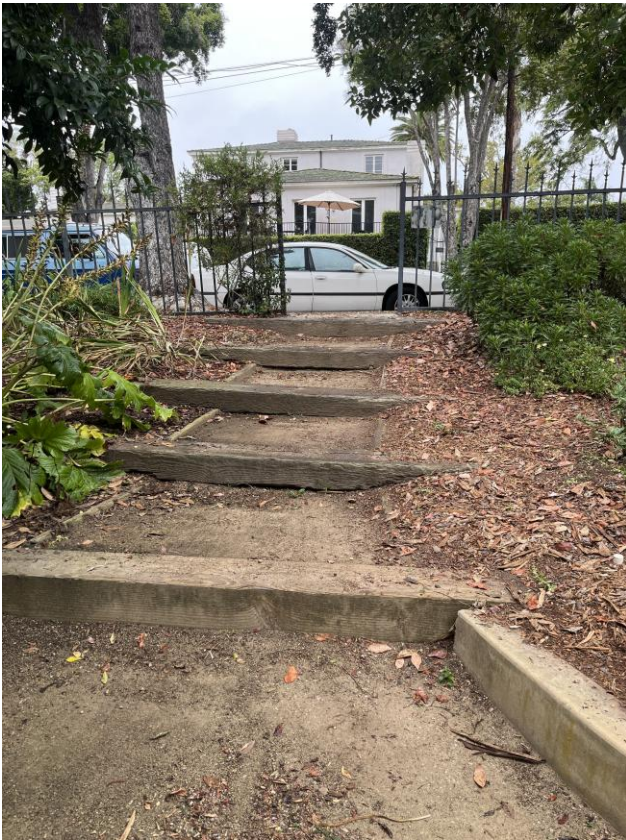
Finding: 4 (Continued)

The entrance is not accessible and is missing signage. An identification sign identifying that this entrance is not accessible and directional signage pointing to the accessible entrance is required.

When a directional sign is required, it should be located to minimize backtracking. In some cases, this could mean locating a sign at the beginning of a route, not just at the inaccessible entrances to a building.

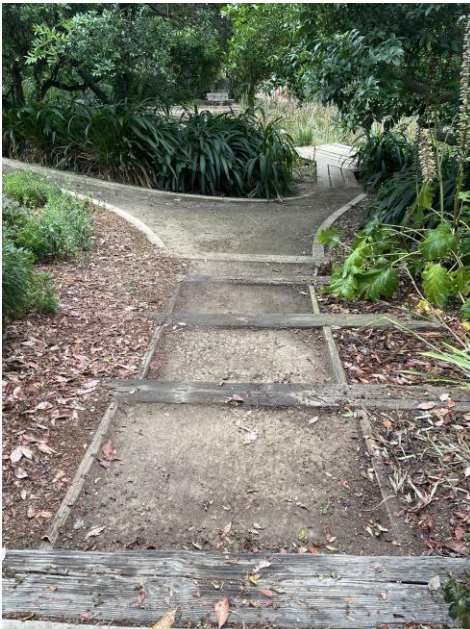
Finding: 5

The stairway is not nearly compliant.

The stairway treads and risers are not uniform and are not within the required height.

The stairway contains open risers. The tread surface contains slopes exceeding 2% and or changes in level.

The stairway is missing or contains contrasting stripes that are not on the required treads.

The tread nosings projects beyond the riser more than 1 1/4 inch. The nosing curvature is greater than 1/2 inch maximum.

The stairway does not have compliant handrails on both sides of the stairway.

The stairway tread and/or landing accumulates water.

The required floor identification sign is not provided.

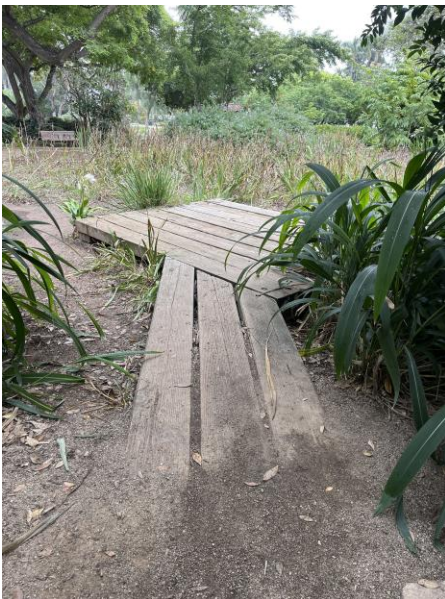
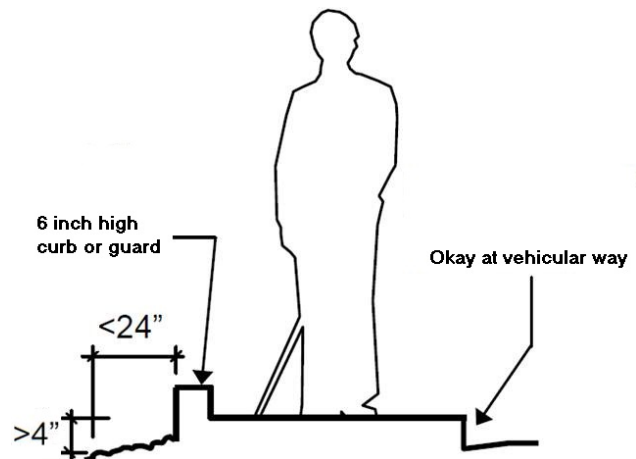
Finding: 6

There is an abrupt change in level greater than 4 inches.

Abrupt changes in level exceeding 4 inches in a vertical dimension between walks, sidewalks or other pedestrian ways and adjacent surfaces or features shall be identified by warning curbs at least 6 inches in height above the walk or sidewalk surface.

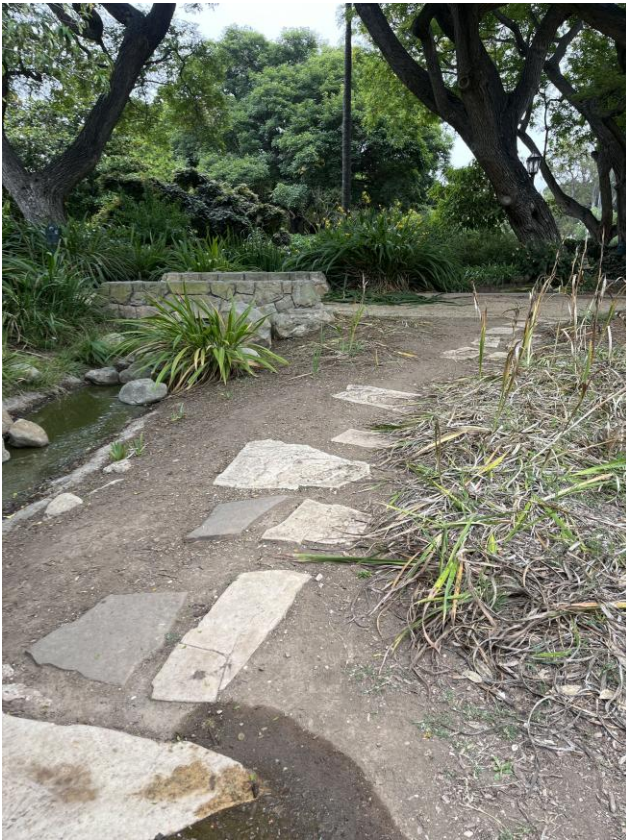
Finding: 7 (Continued)

The walkway contains abrupt vertical edges and/or variations over 1/4 inch.

1/4 inch is the maximum vertical rise. Changes in level between 1/4 inch and 1/2 inch must be beveled at 1:2 or less.

Changes in level greater than 1/2 inch must be by way of a ramp.

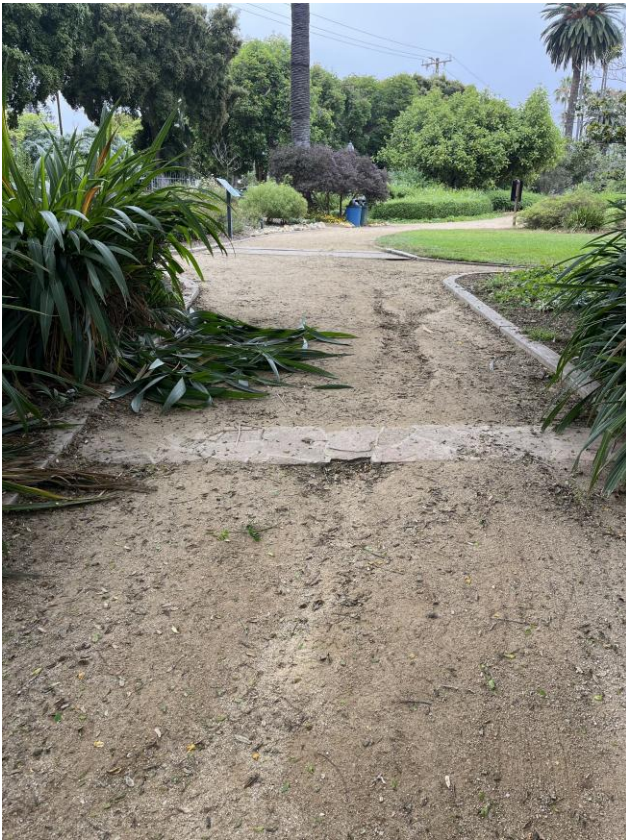
Finding: 8 (Continued)

The walkway contains abrupt vertical edges and/or variations over 1/4 inch.

1/4 inch is the maximum vertical rise. Changes in level between 1/4 inch and 1/2 inch must be beveled at 1:2 or less.

Changes in level greater than 1/2 inch must be by way of a ramp.

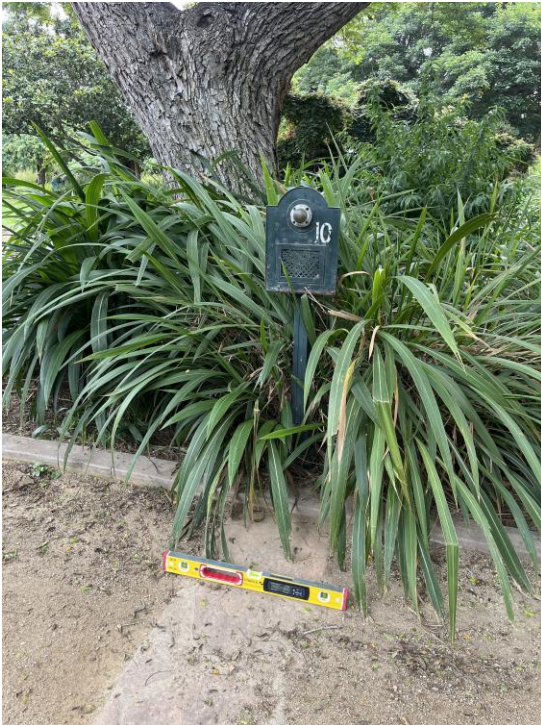
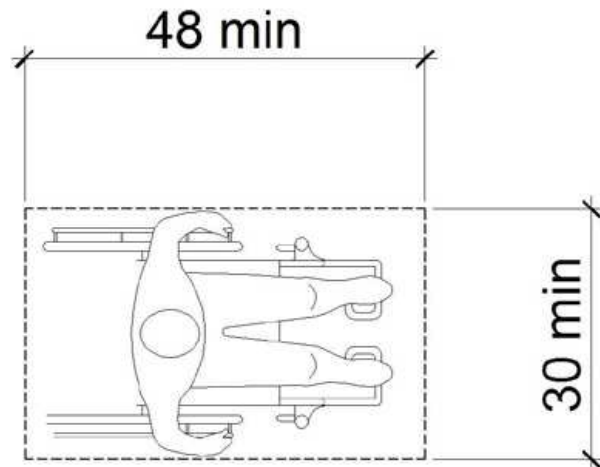
Finding: 9

The element is not accessible because there is not adequate clear floor space for an approach.

The clear floor or ground space shall be 30 inches minimum by 48 inches minimum.

Provide level floor space at all of the audio stations

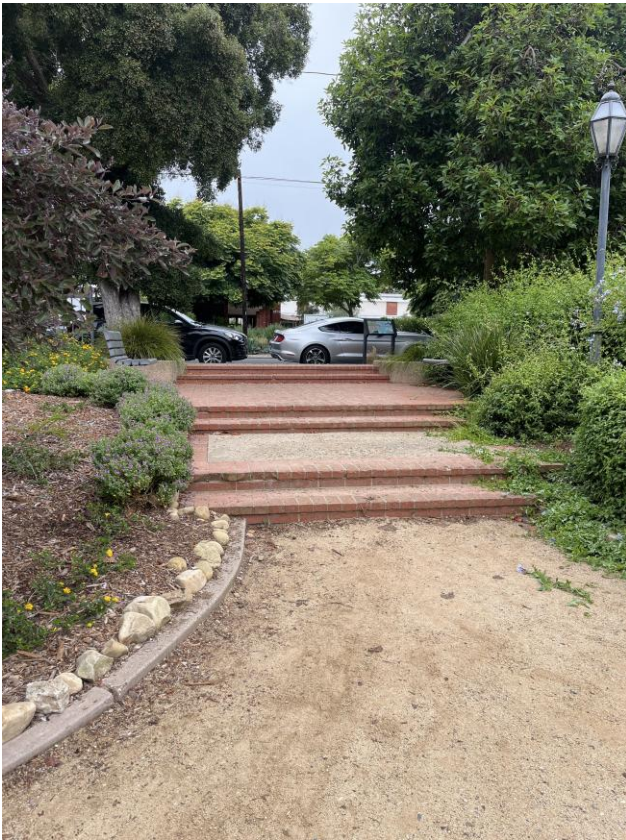
Finding: 10 *(Continued)*

The entrance is not accessible and is missing signage. An identification sign identifying that this entrance is not accessible and directional signage pointing to the accessible entrance is required.

And stairs

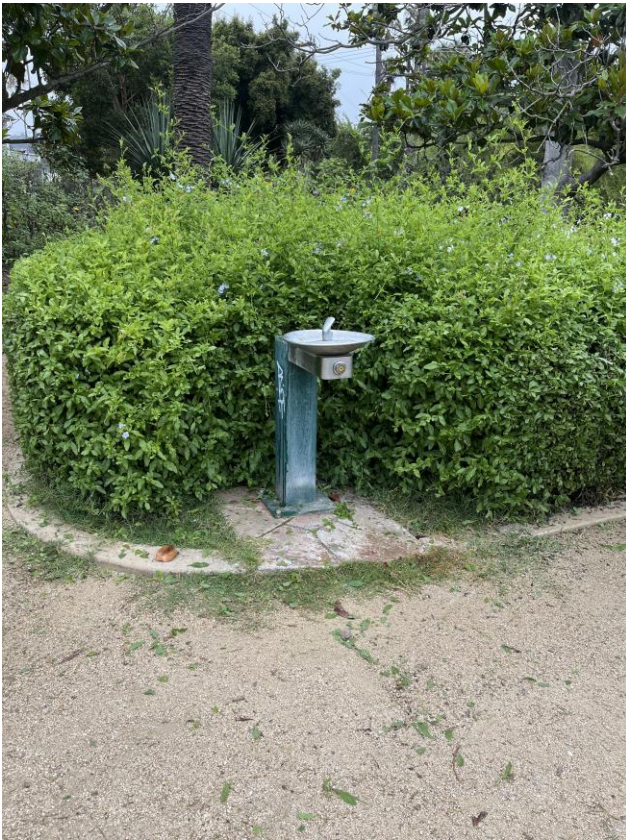
Finding: 11 (Continued)

There is no drinking fountain for standing persons.

No fewer than two drinking fountains shall be provided. One drinking fountain shall meet requirements for wheelchair accessibility and one drinking fountain shall meet requirements for standing persons.

2010 ADAS Section: 602.7, 211.2 plus clear floor space,

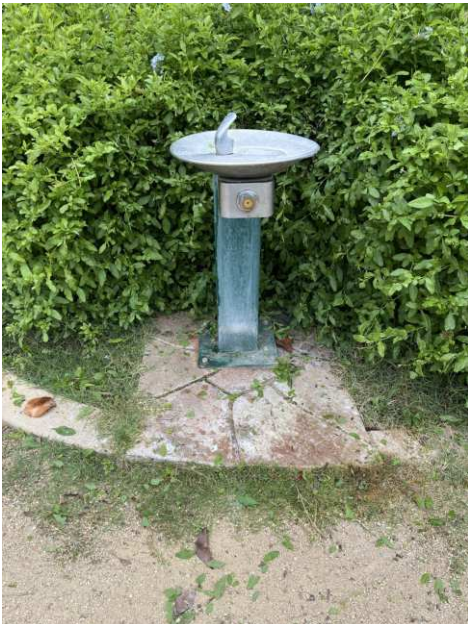
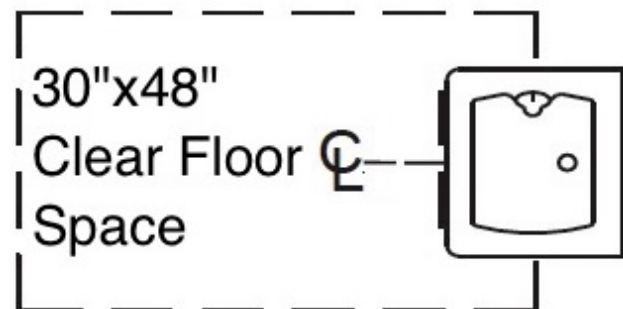
Finding: 12

The clear floor space required at accessible drinking fountains is not positioned for a forward approach.

Units shall have a clear floor or ground space positioned for a forward approach and centered on the unit.

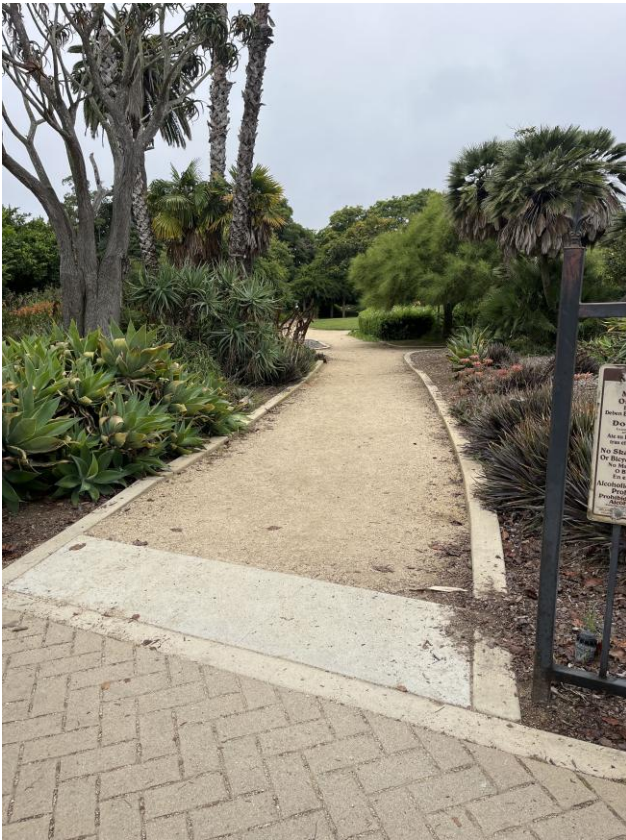
Finding: 13 *(Continued)*

The entrance is not accessible and is missing signage. An identification sign identifying that this entrance is not accessible and directional signage pointing to the accessible entrance is required.

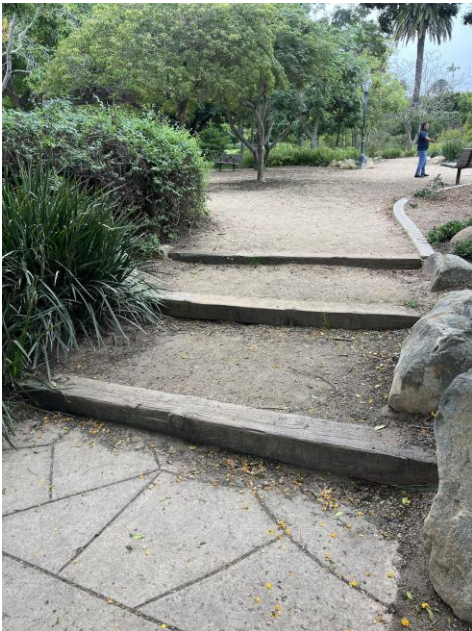
Finding: 16

The stairway is missing or contains contrasting stripes that are not on the required treads.

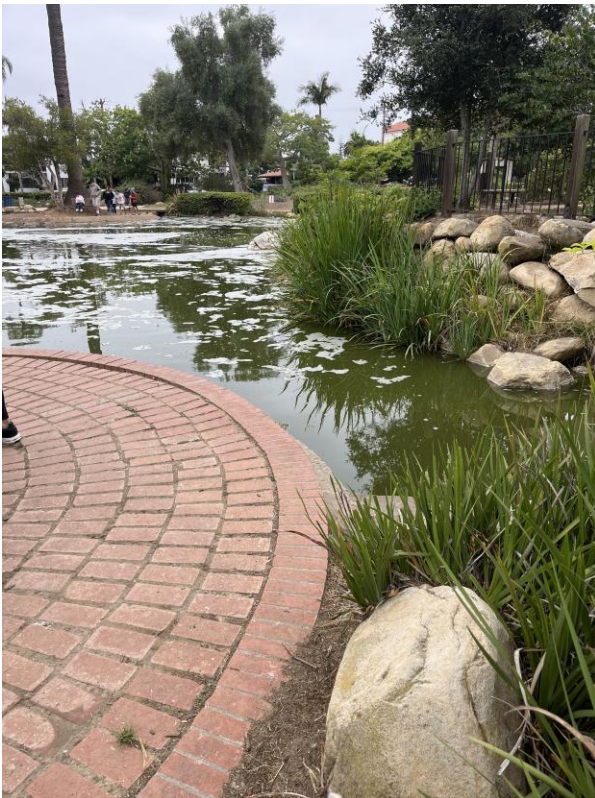
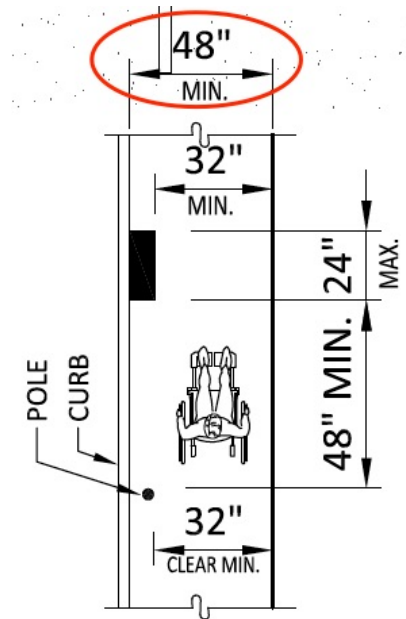
Finding: 21

The clear width for sidewalks and walks shall be 48 inches (1219 mm) minimum. When, because of right-of-way restrictions, natural barriers or other existing conditions, the enforcing agency determines that compliance with the 48-inch (1219 mm) clear sidewalk width would create an unreasonable hardship, the clear width may be reduced to 36 inches (914 mm).

Ensure accessible path of travel is not blocked by trash cans, POP displays, ect.

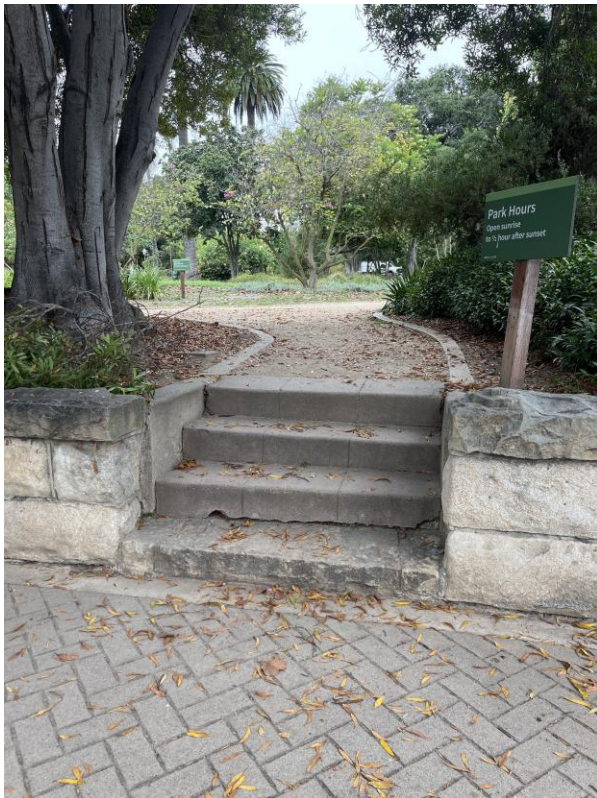
Finding: 23

The stairway is missing or contains contrasting stripes that are not on the required treads.

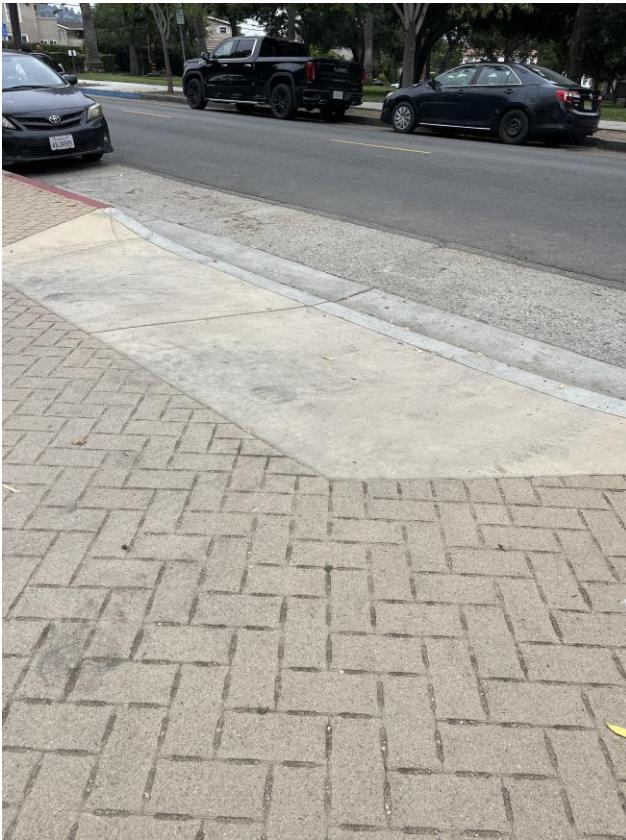
Finding: 27 (Continued)

The detectable warning is missing at the curb ramp.

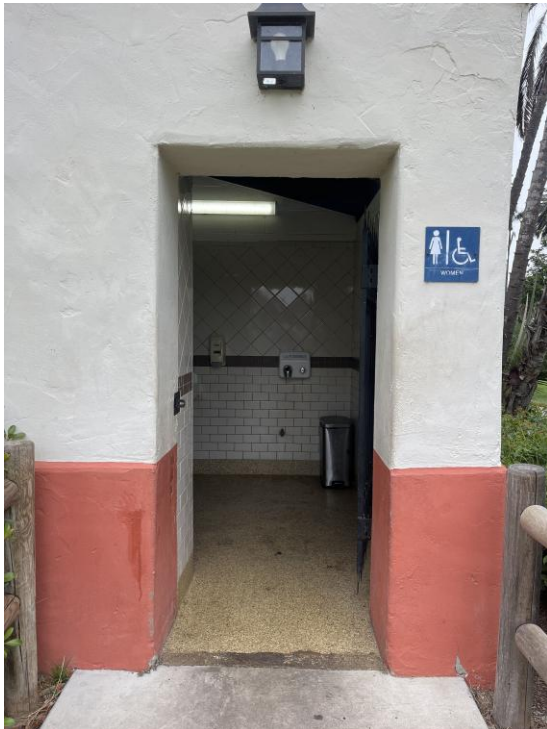
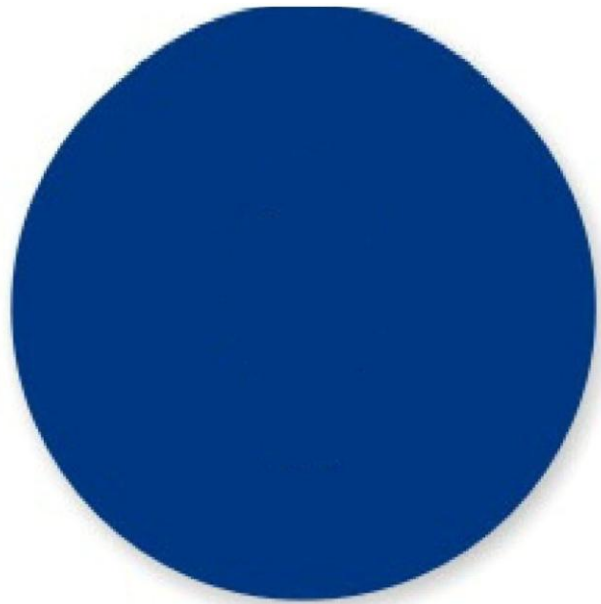
The geometric sign for the women's room is missing.

missing

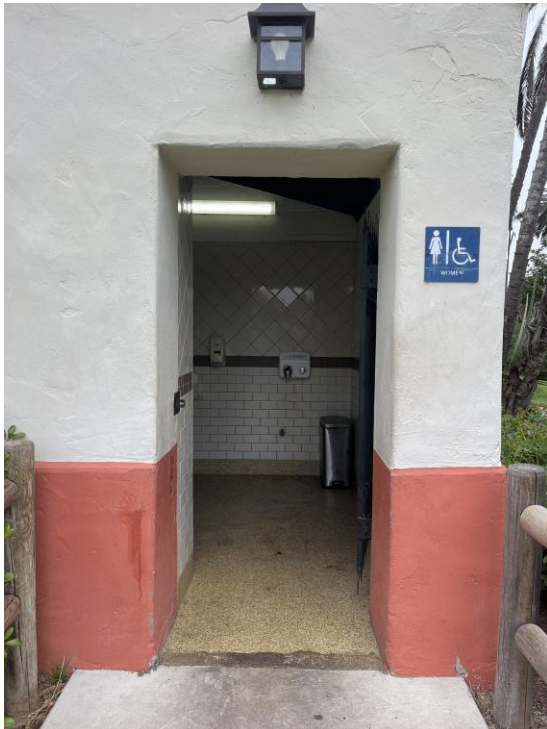
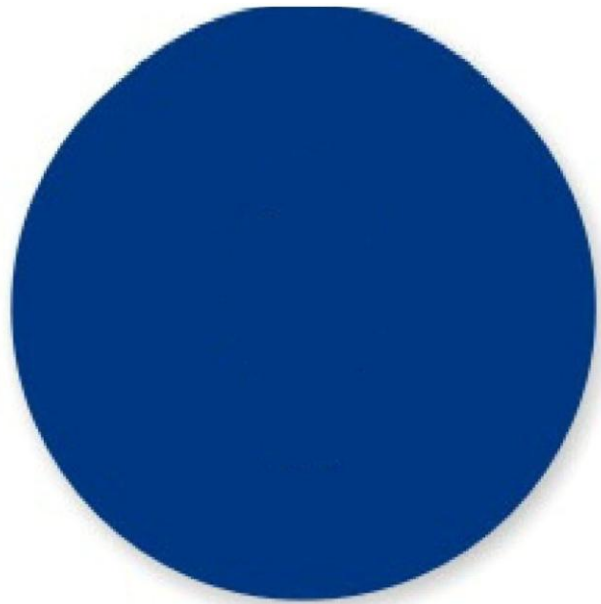
Finding: 35

The geometric sign for the women's room is missing.

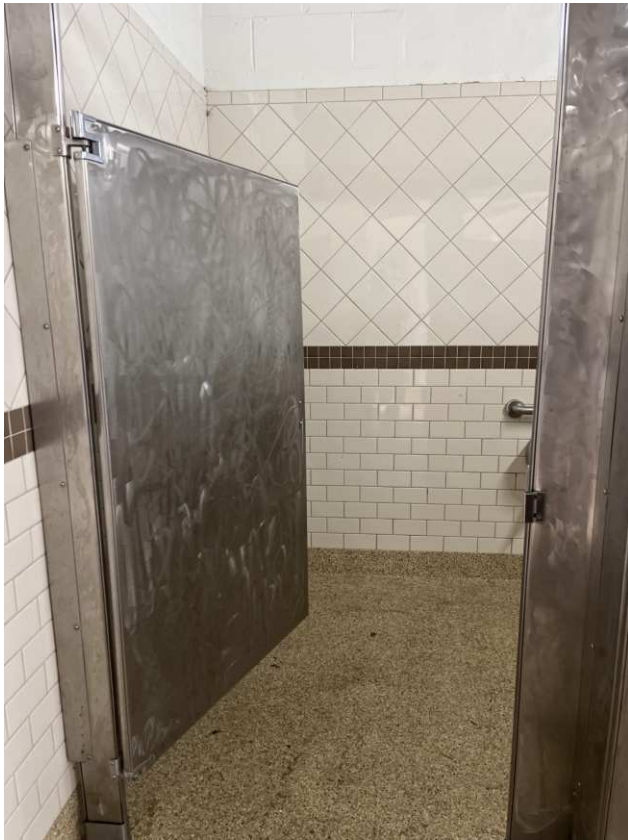
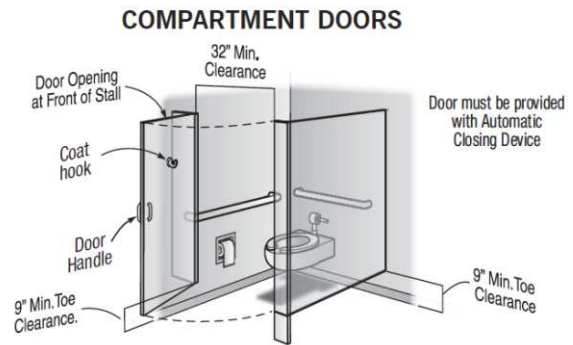
Finding: 38 (Continued)

The compartment door is not self closing.

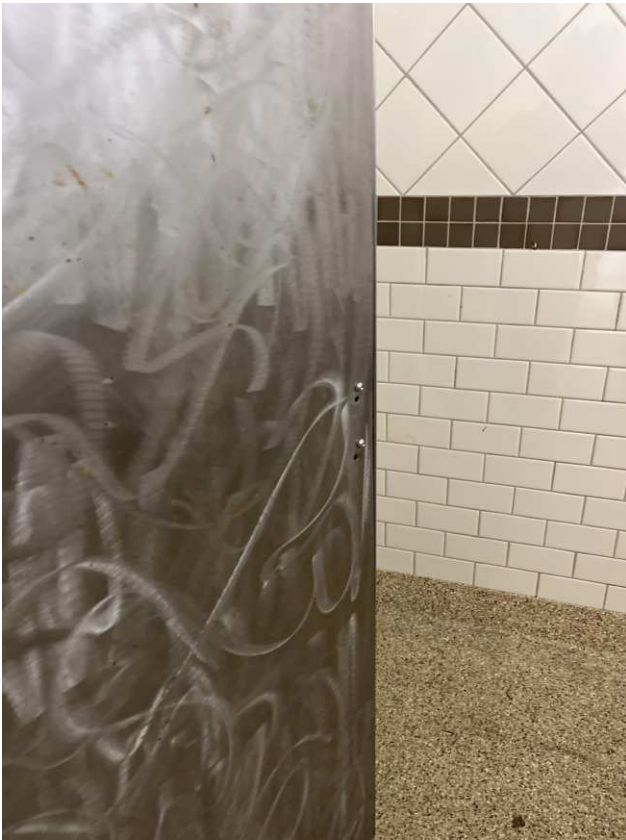
Finding: 39 (Continued)

The water closet compartment is missing a loop handle on both sides of the door.

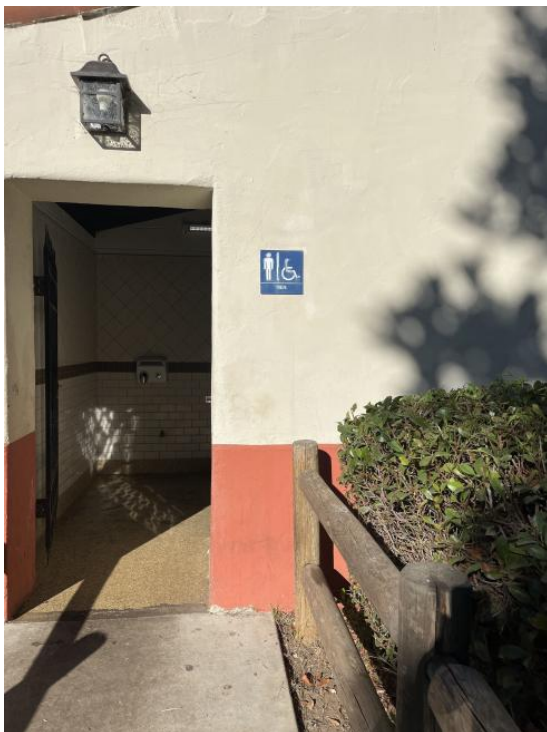
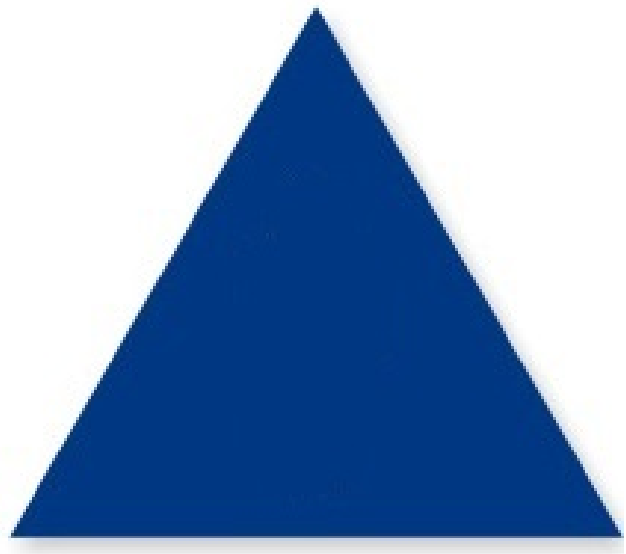
Finding: 44

The geometric sign for the men's room is missing.
