Bellosguardo Foundation (Clark estate)

July 10, 2022

ARBORIST FIELD REPORT for Clark Estate

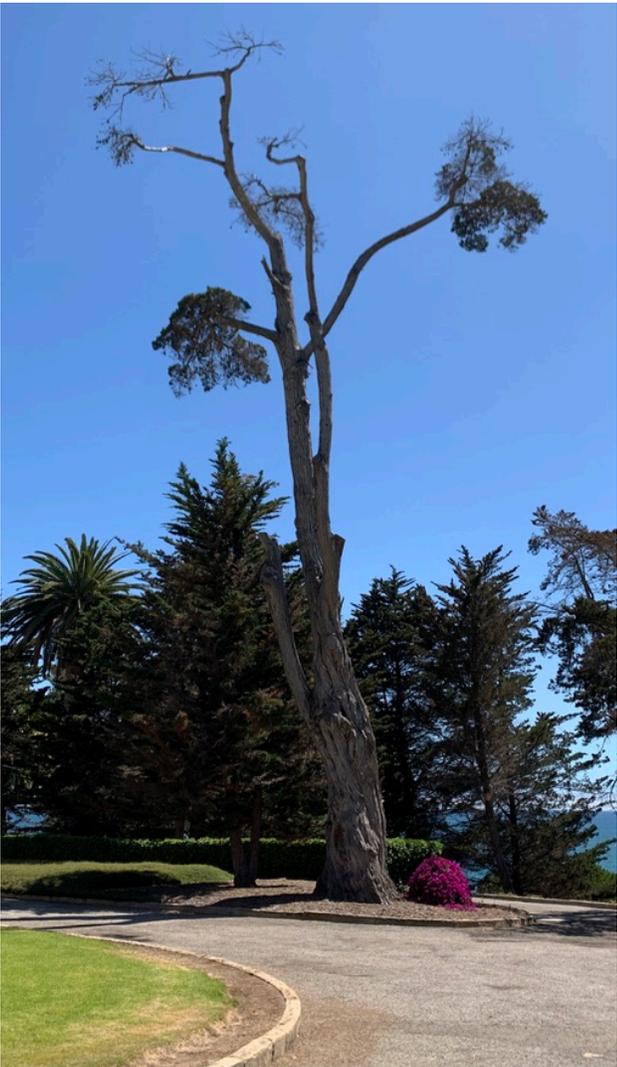
This old tree is close to death and will not recover. As the tree declines, so does the root system. Although the remaining tree is primarily a trunk, degrading roots predispose the tree to failure. Any person or vehicle would likely be crushed if the tree were to contact them.

Below left: Looking slightly southwesterly at the declining tree with the adjacent young cypress to the left.

- This tree will not recover and should be removed.
- Although it is statistically unlikely to fall at the exact moment that a person or vehicle is beneath it, there are no significant benefits to retaining the tree. There are multiple other habitat trees nearby on the site.

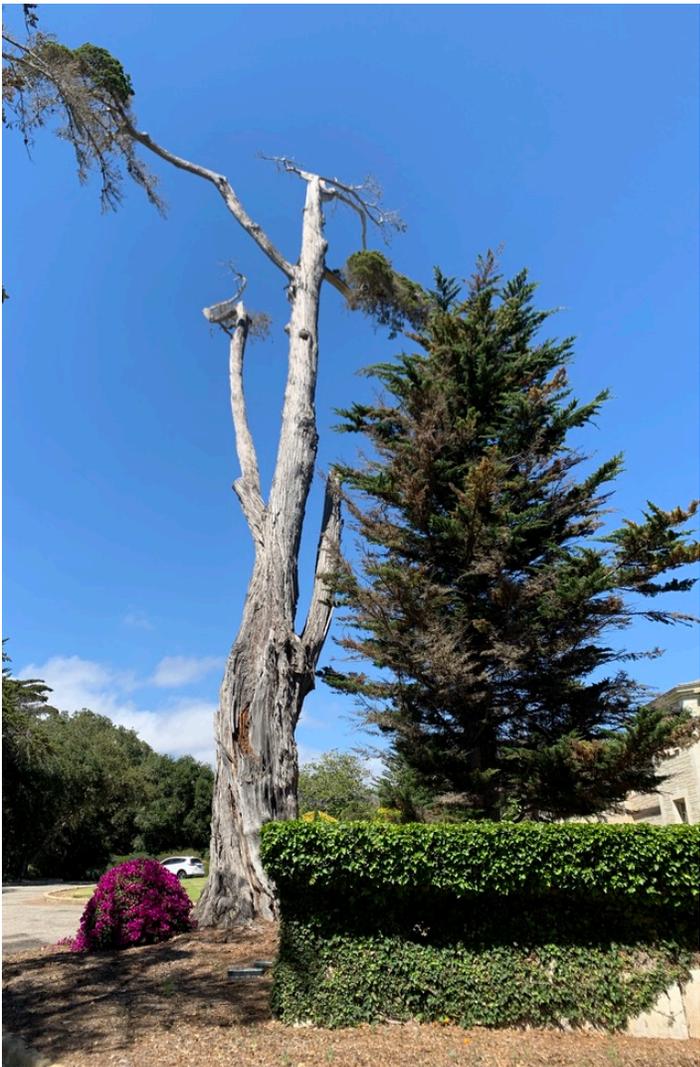
Below right: Looking easterly at the declining cypress tree with the adjacent young cypress to the right.

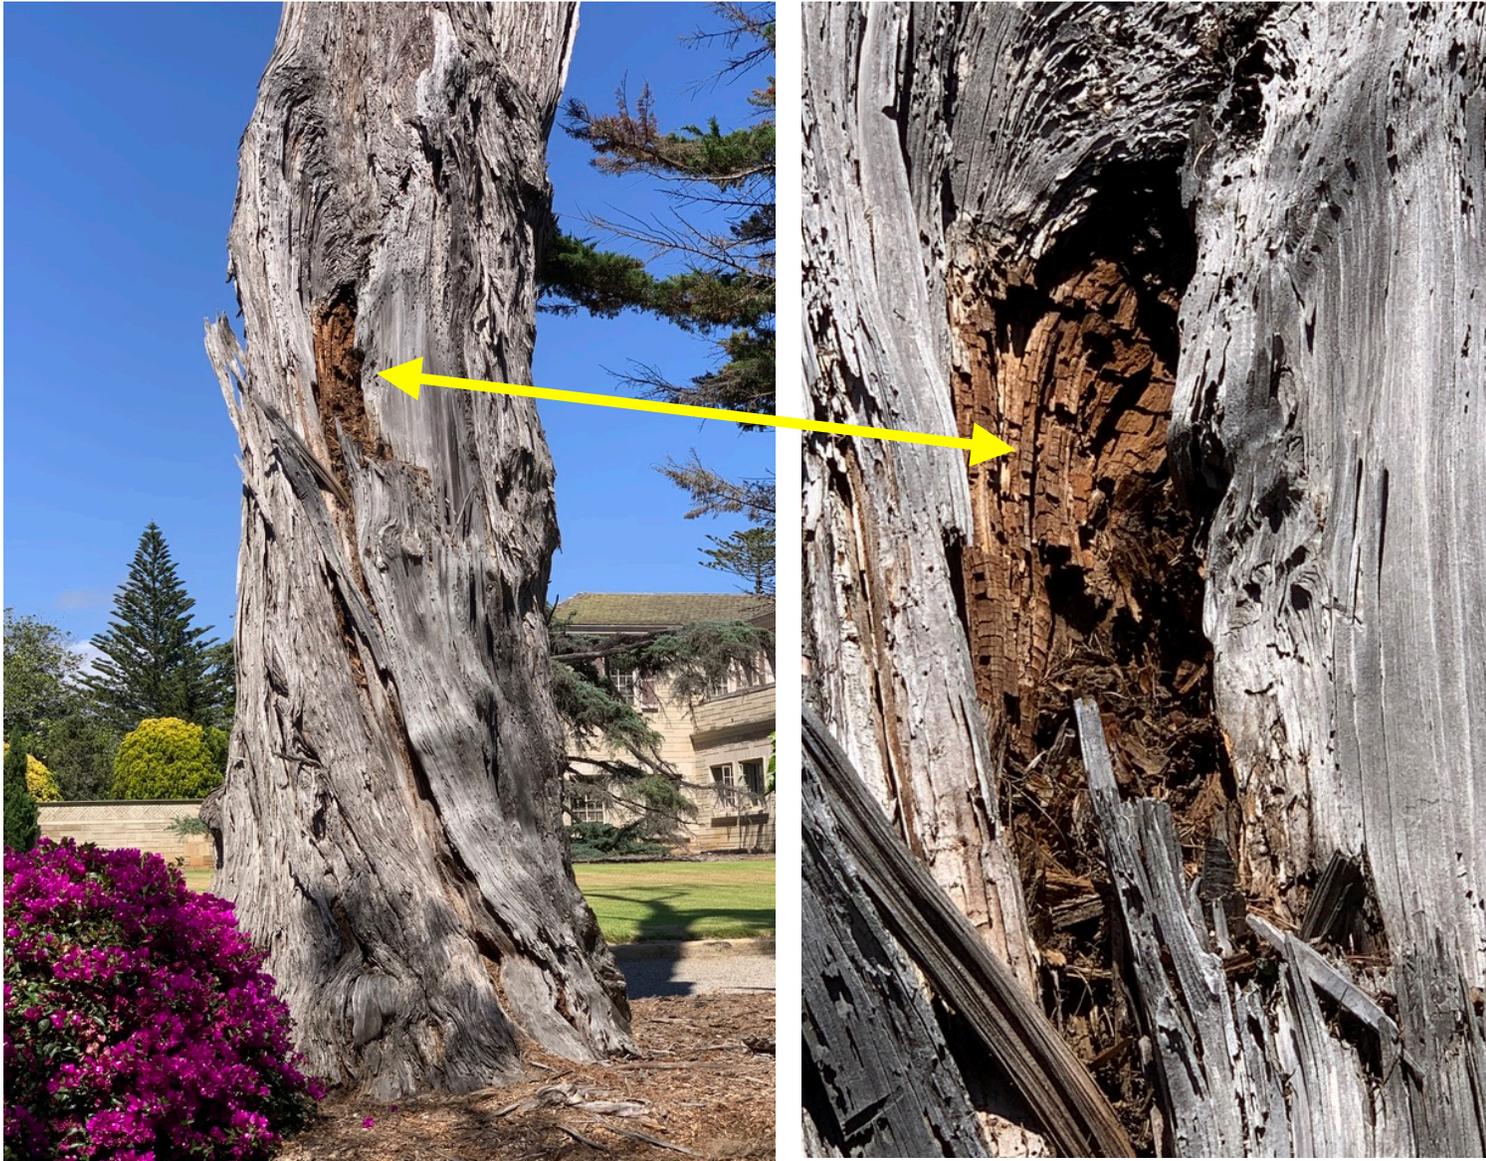
Looking easterly at the cypress and the brown rot in the trunk that is at the stage where termites are decomposing the wood. Note the ends of the young cypress tree to the right (in the upper left photo) spreading to the north.
