PHASE 1
HISTORIC STRUCTURES/SITES
REPORT

For 1250 Cliff Drive

Santa Barbara, California

October 17, 2022

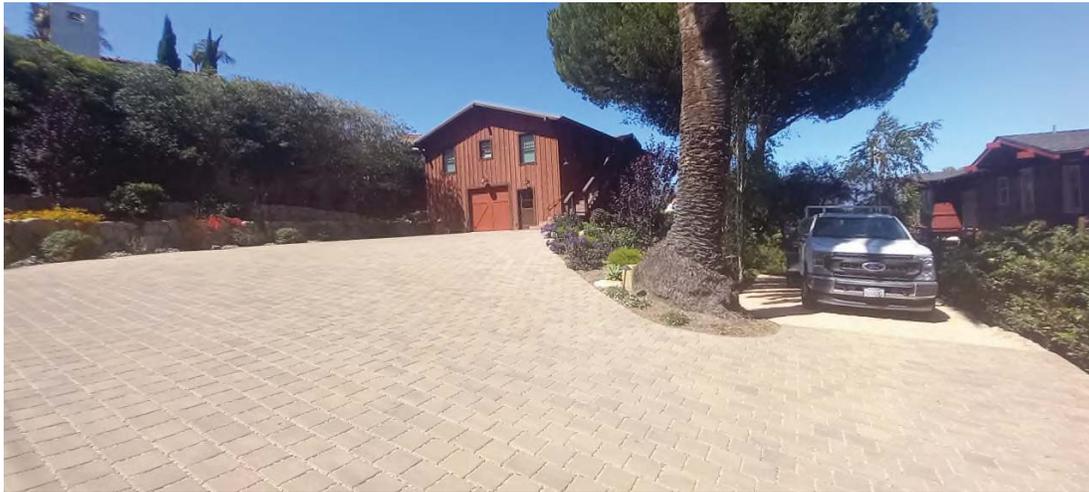
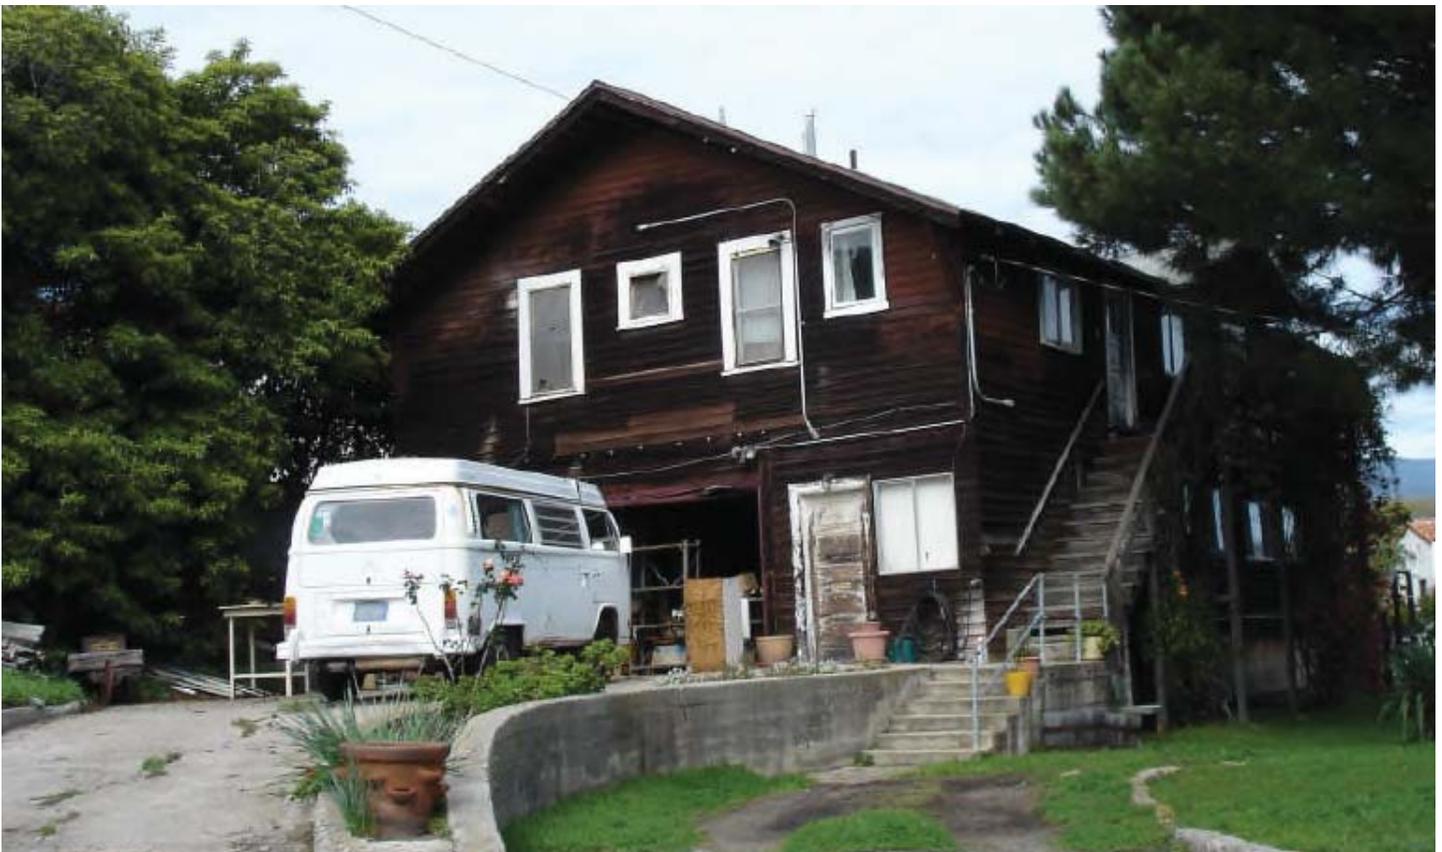
Figure 17, Former Barn, West Elevation, looking east

a mix of wood frame and metal frame windows units. Alterations completed under **Permit #XXXX**, included the replacement of the original clapboard siding with board-and-batten style siding, replacement of the fenestration and new doors. The placement of fenestration was altered. On the west elevation, which is the primary façade, the location of a person door was altered and the original five panel door was replaced with a four-light panel door, a small window flanking the door was removed, bay doors were installed and the second fenestration was altered with the original one-over-one wood sash replaced with nine-over-one wood sash windows. The location of the west elevation's second floor fenestration was altered and the centrally placed square window was replaced with a window with a rectangular orientation.

Extensive modifications completed since 2015 have substantially diminished the building's ability to convey its historic appearance and vernacular style architecture. Alterations include replacement of the original wood clapboard style siding with board-and-batten style siding, the replacement of

surviving original doors and windows with new units with different glazing pattern and the re-arrangement of fenestration. Because of these changes the former barn no longer retains integrity of design.

Extensive modifications carried out since 2015 have removed almost all of the building's original exterior construction materials. Moreover, the replacement materials including the cladding do not match the originals. Therefore, the former barn does not retain integrity of materials.

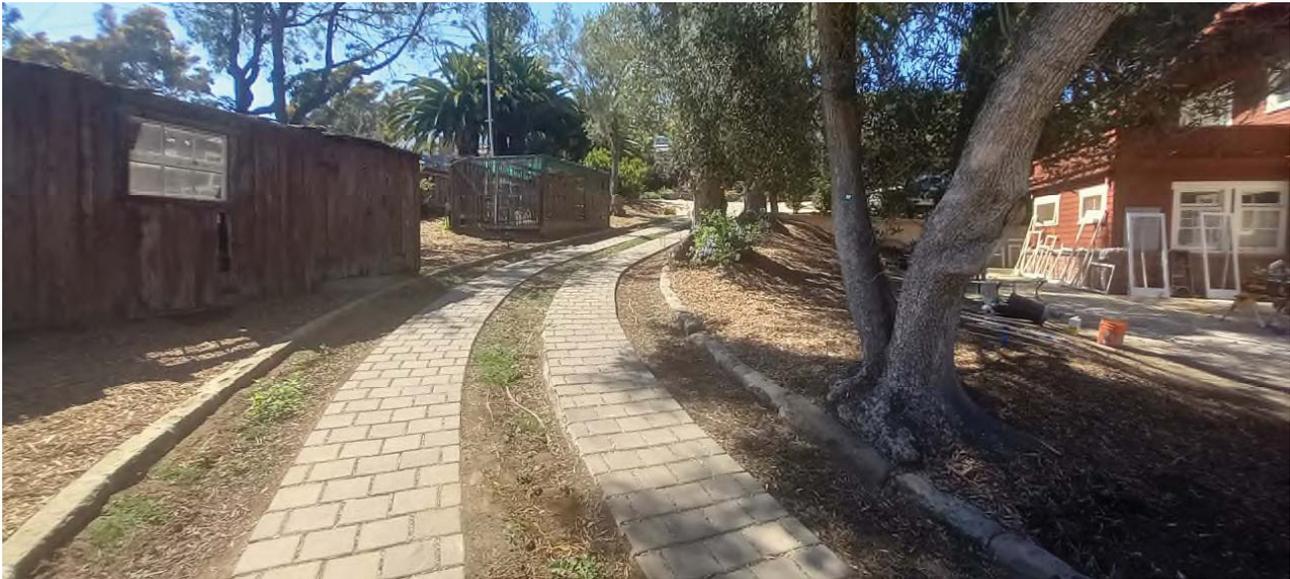
Figure 18, Shed and Lath House, looking north

The shed was most likely built when the rest of the property was developed in circa-1920. It is in poor physical condition.

The lath house was most likely built sometime between circa 1920 and 1945. It is in fair physical condition.
