TREE INVENTORY AND ASSESSMENT

Project location: Garden Street Hotel, 101 Garden St., Santa Barbara 93101

February 22, 2022

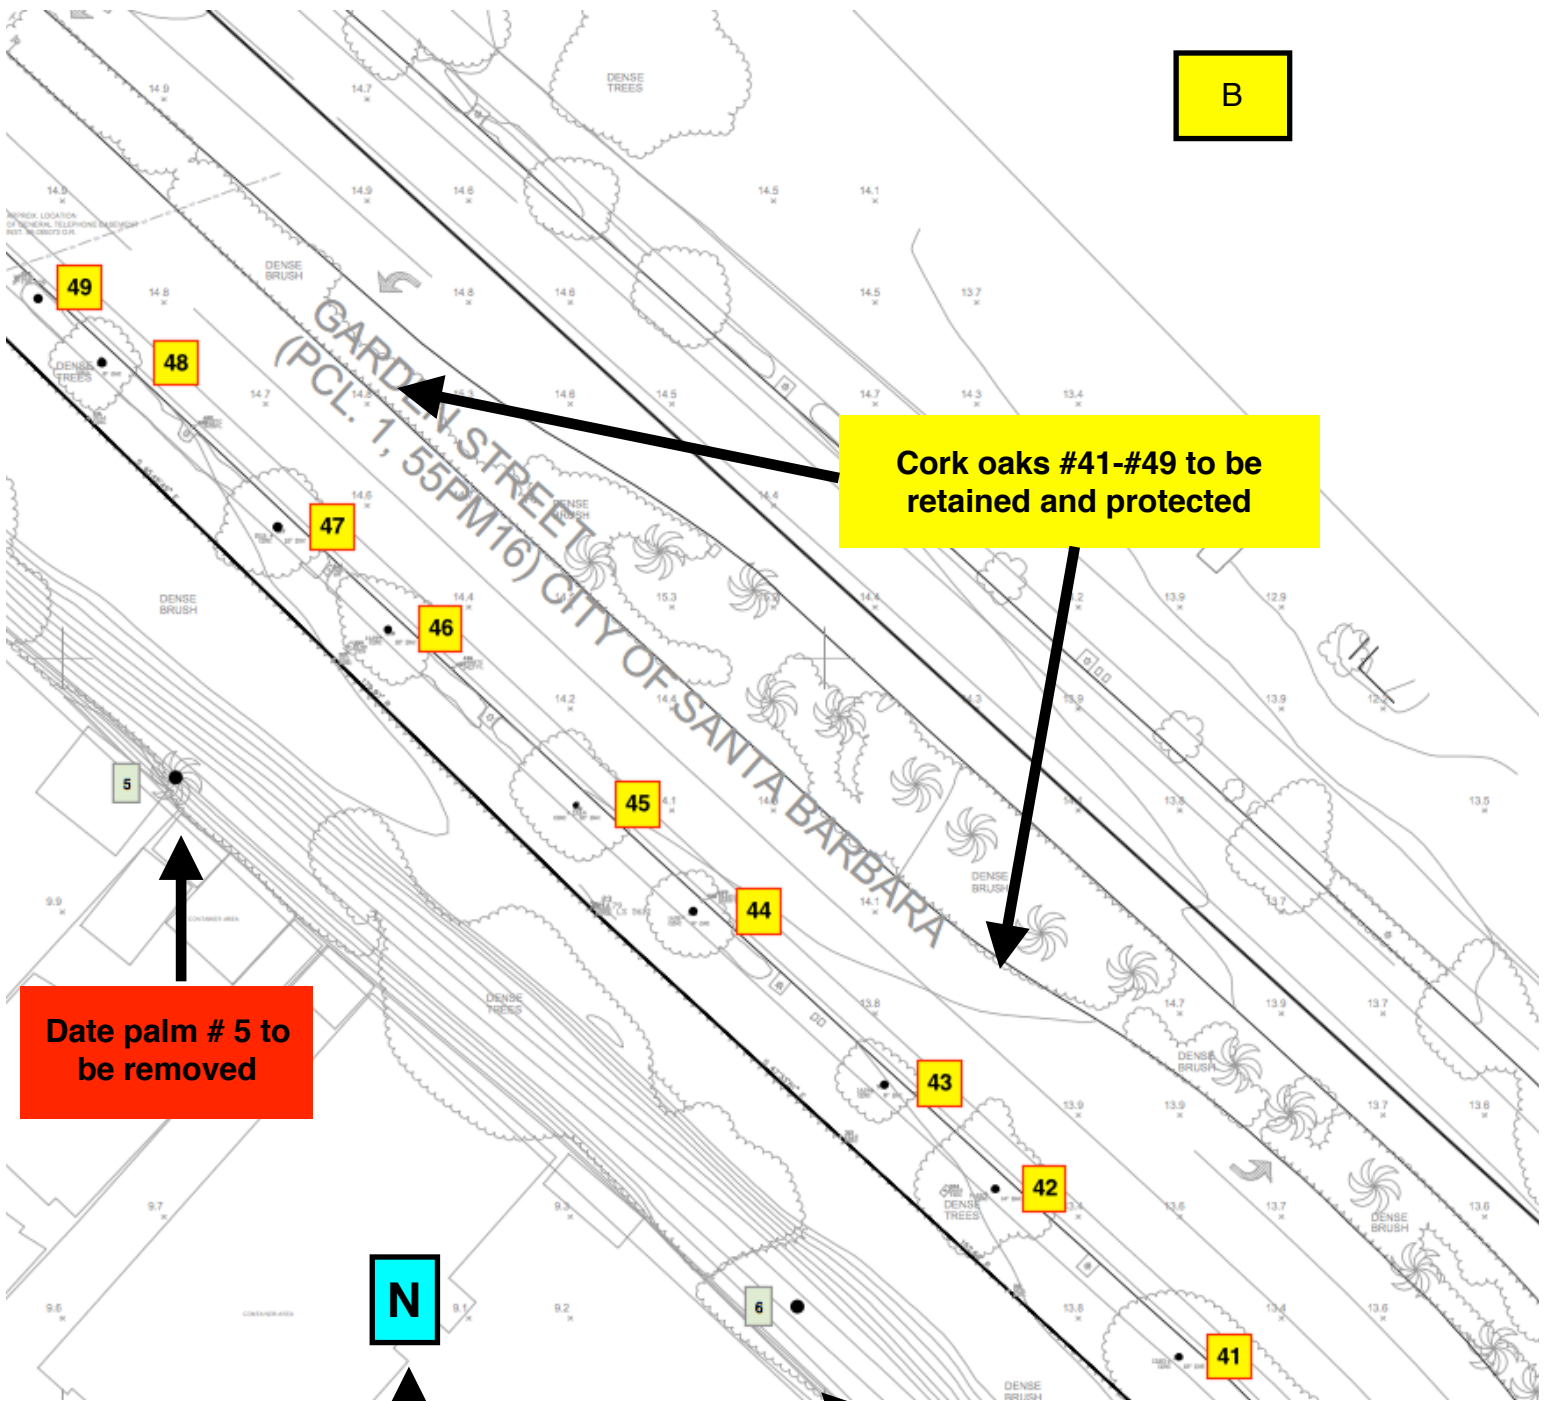
Cork oaks #41-#49 to be retained and protected

Date palm # 5 to be removed

CA Live oak #6 to be retained and protected

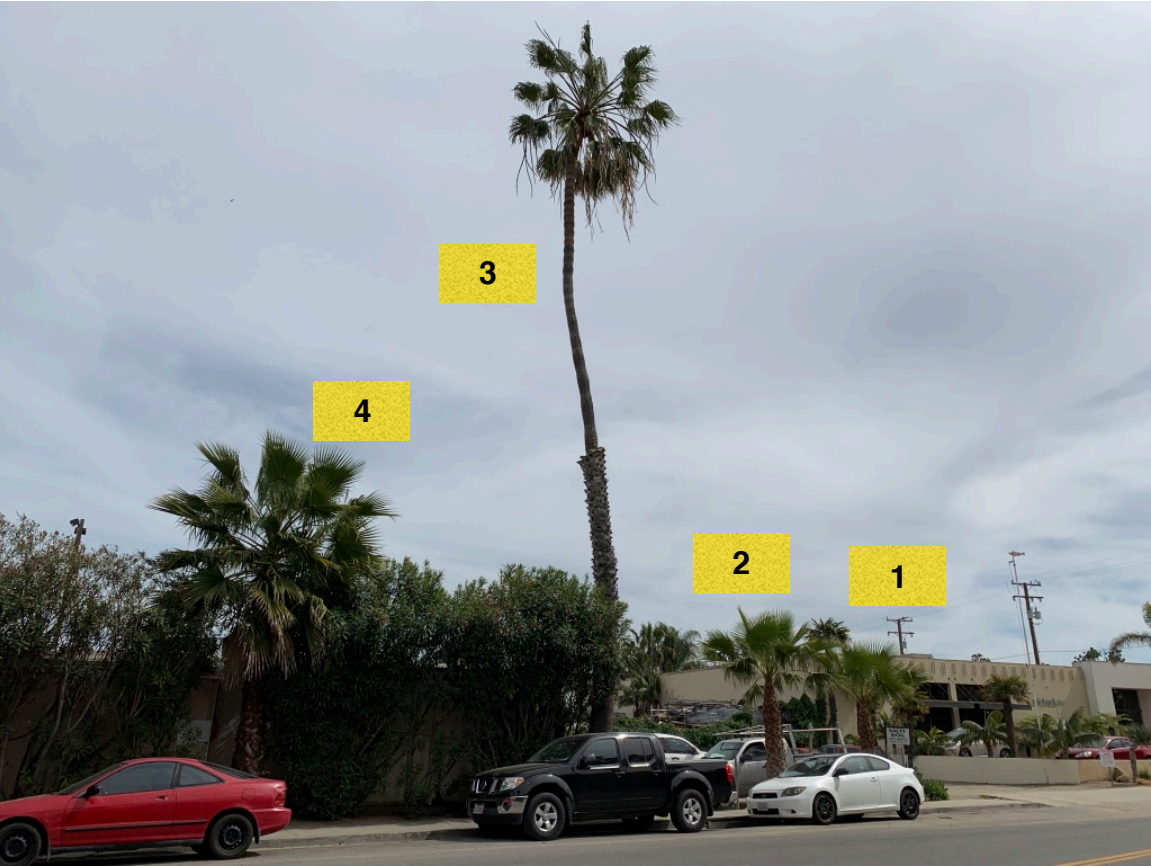
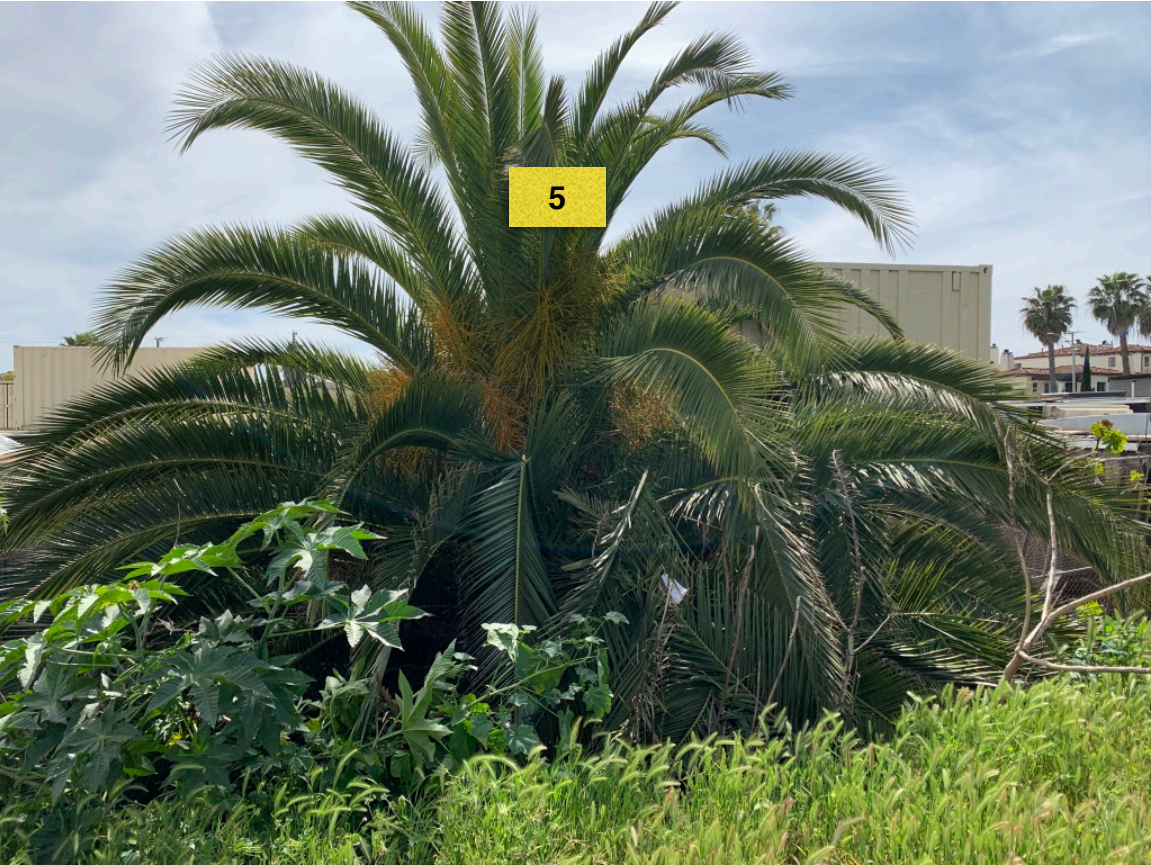
Above along Yanonali St. / Below along Garden St.

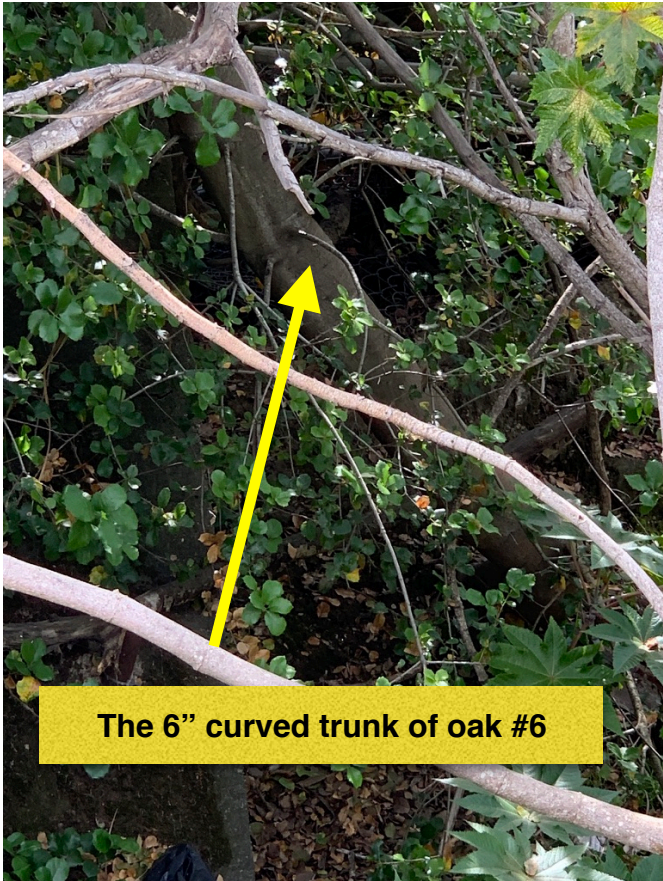
4. There is one small 8" DBH oak tree in this channel among the overgrowth. This curved trunk tree, appears to working its way through the competitive vegetation.

The 6" curved trunk of oak #6

- The only native tree is the one oak (#6) in the drainage channel that will not conflict with development if the channel is to be retained. Protect this tree with fencing around the trunk, in a circle with a 6' radius.
- The Date palm tree is non-native and invasive. It will be removed since it may pose a threat to the restoration area.
- All palms at the southern end of the city, and the three Kentia palms will be retained and protected. All other palms will be removed including the four off-site palms #1-#4.
- Most protected palms are outside of the work zone and already protected with chain link fence. The three Kentia palms will require protection chain link fencing.
- All off site non-native Cork oaks will be retained and protected except for #39, which will be removed. Chain link fence already is enclosing the project area.

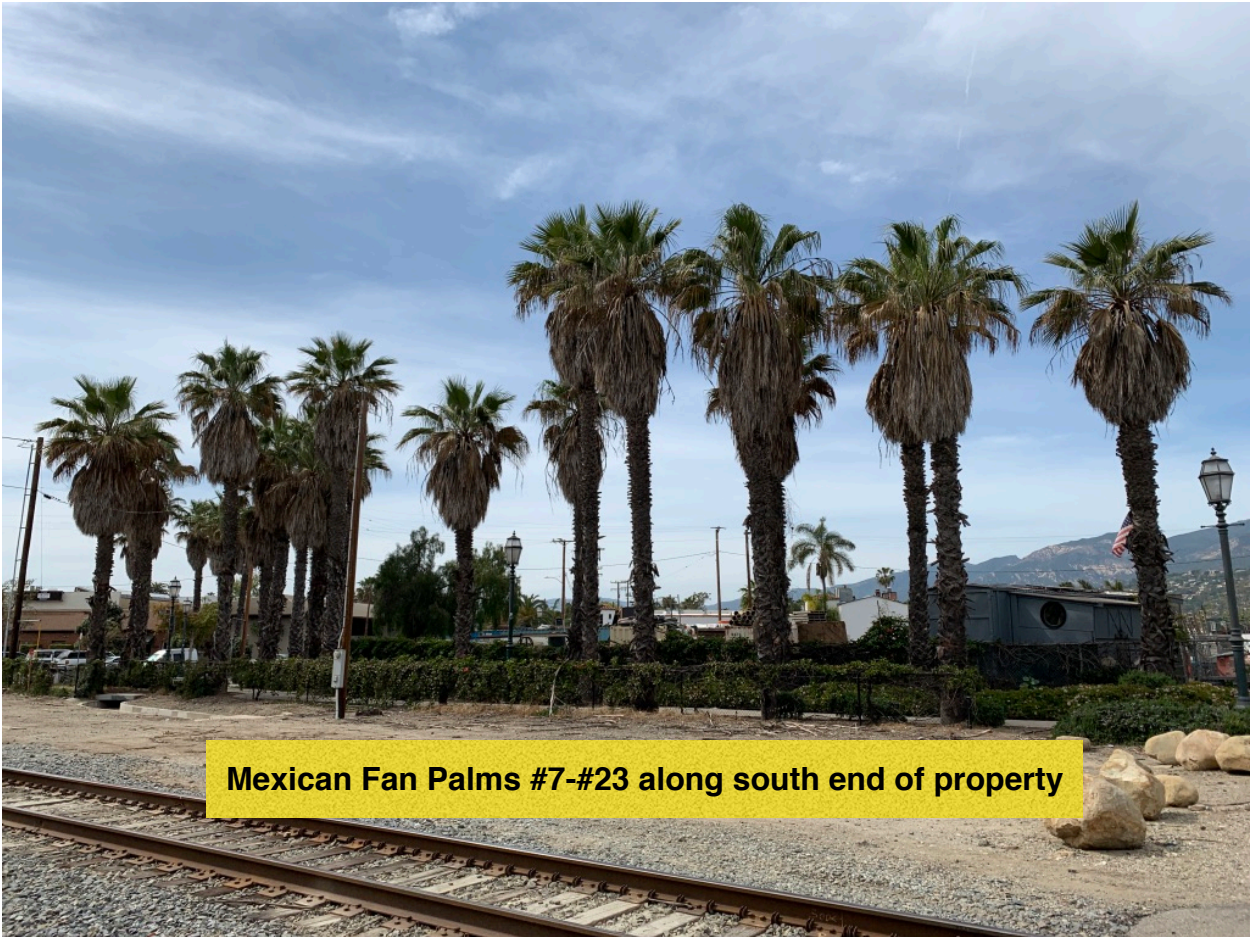
7. Along the southern portion of the property, are a cluster of 17 Mexican Fan Palms. These palms line the two sides of a walkway (south of Mason St.) with some of the palms on the subject property. Chain-link fence protects trees from the construction provided the fence remains in place.

Mexican Fan Palms #7-#23 along south end of property

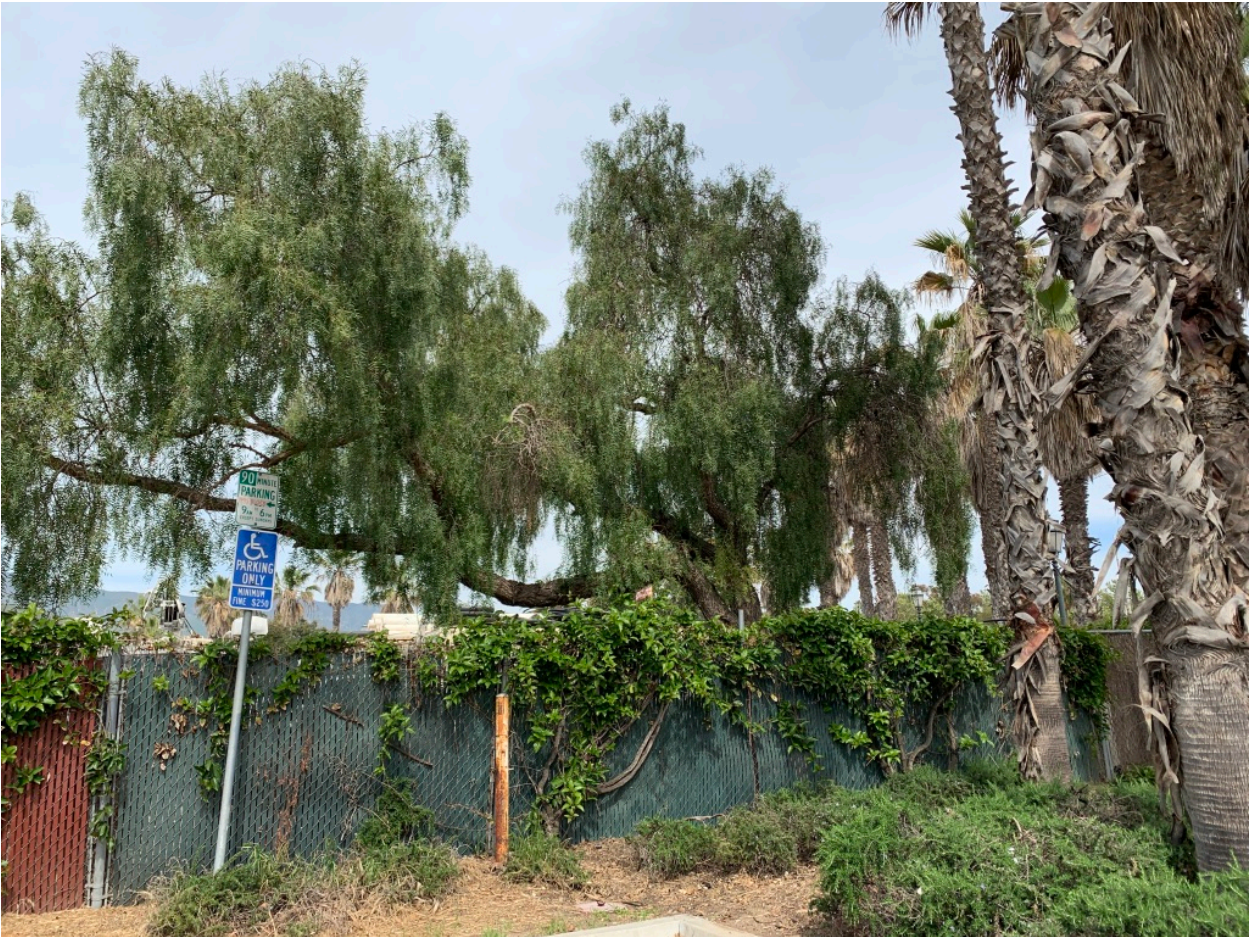
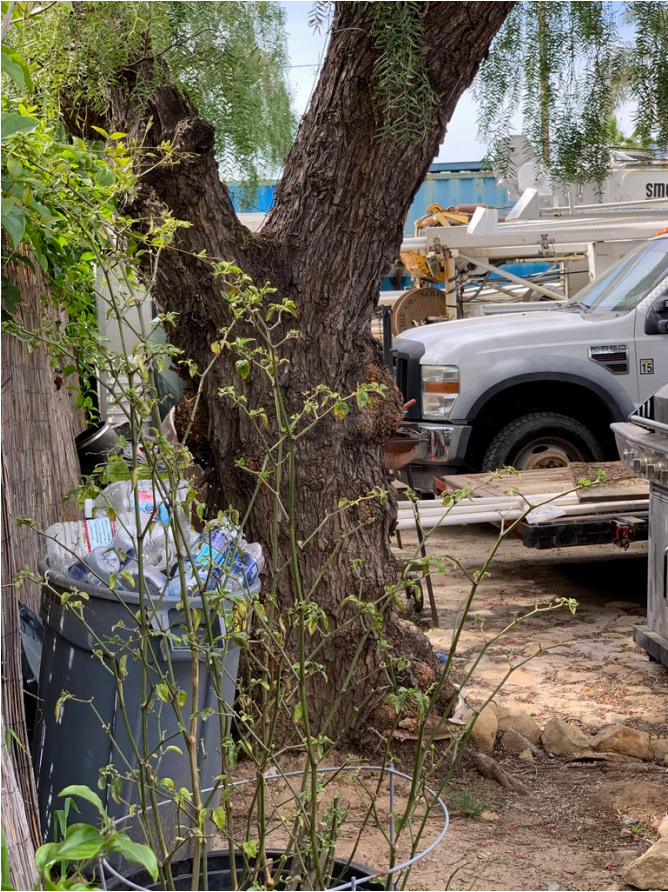
5. A small Date Palm, Castor Bean, Fig, and Pampas grass are in the channel.
6. At the southwest corner of the property, adjacent to Santa Barbara Street, is one non-native California Pepper in fair condition.

**Above: California pepper #24
Left: with 26" trunk**

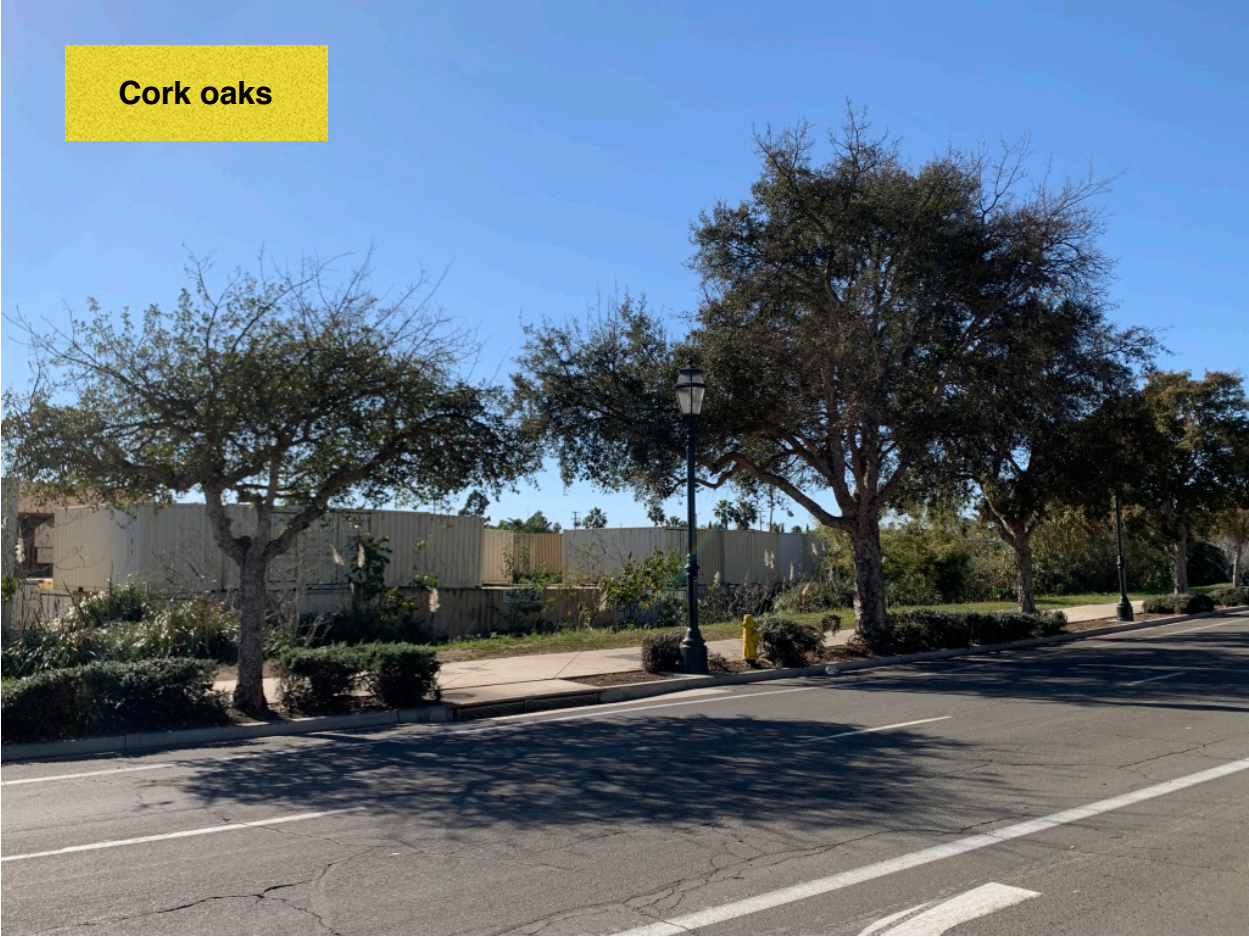
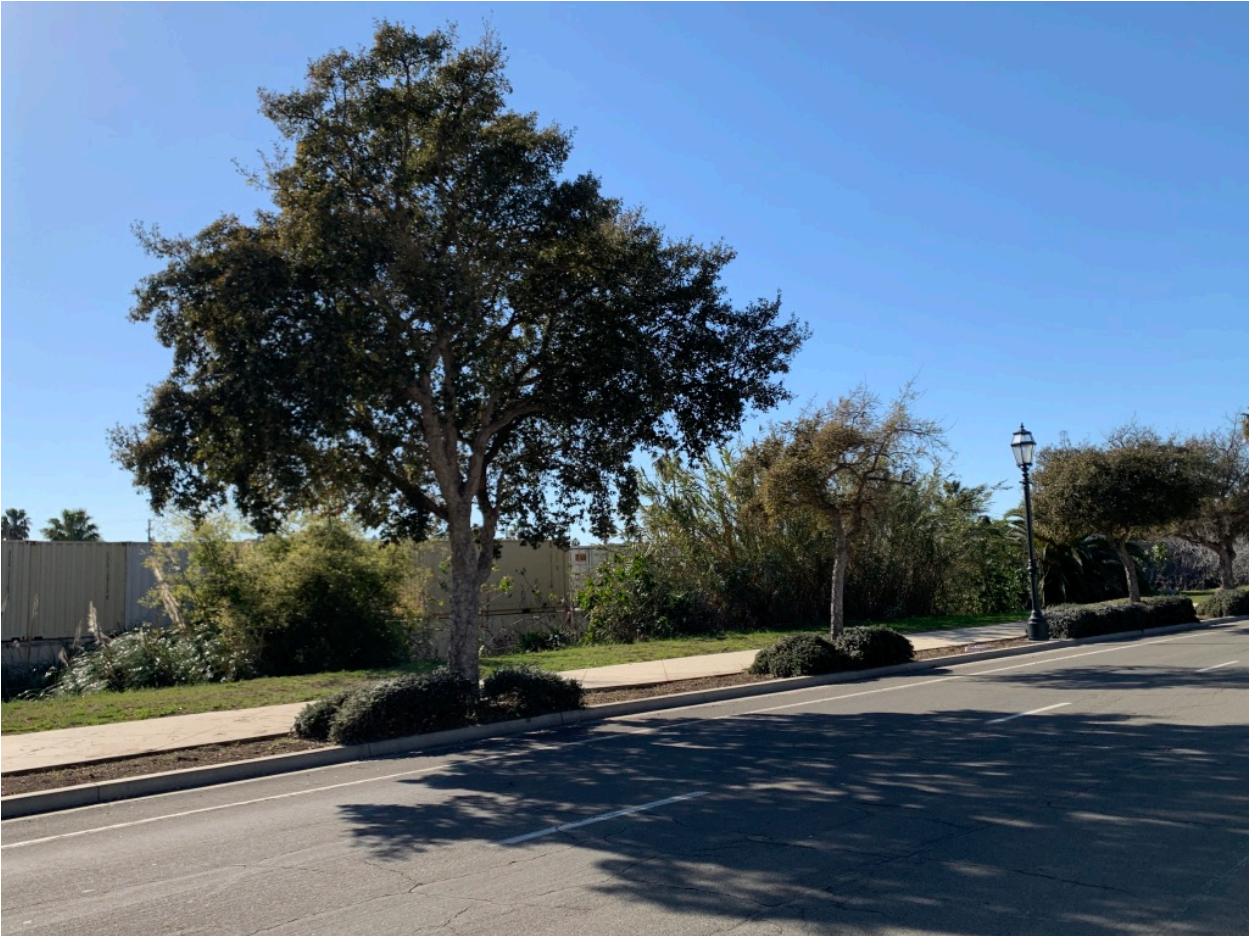
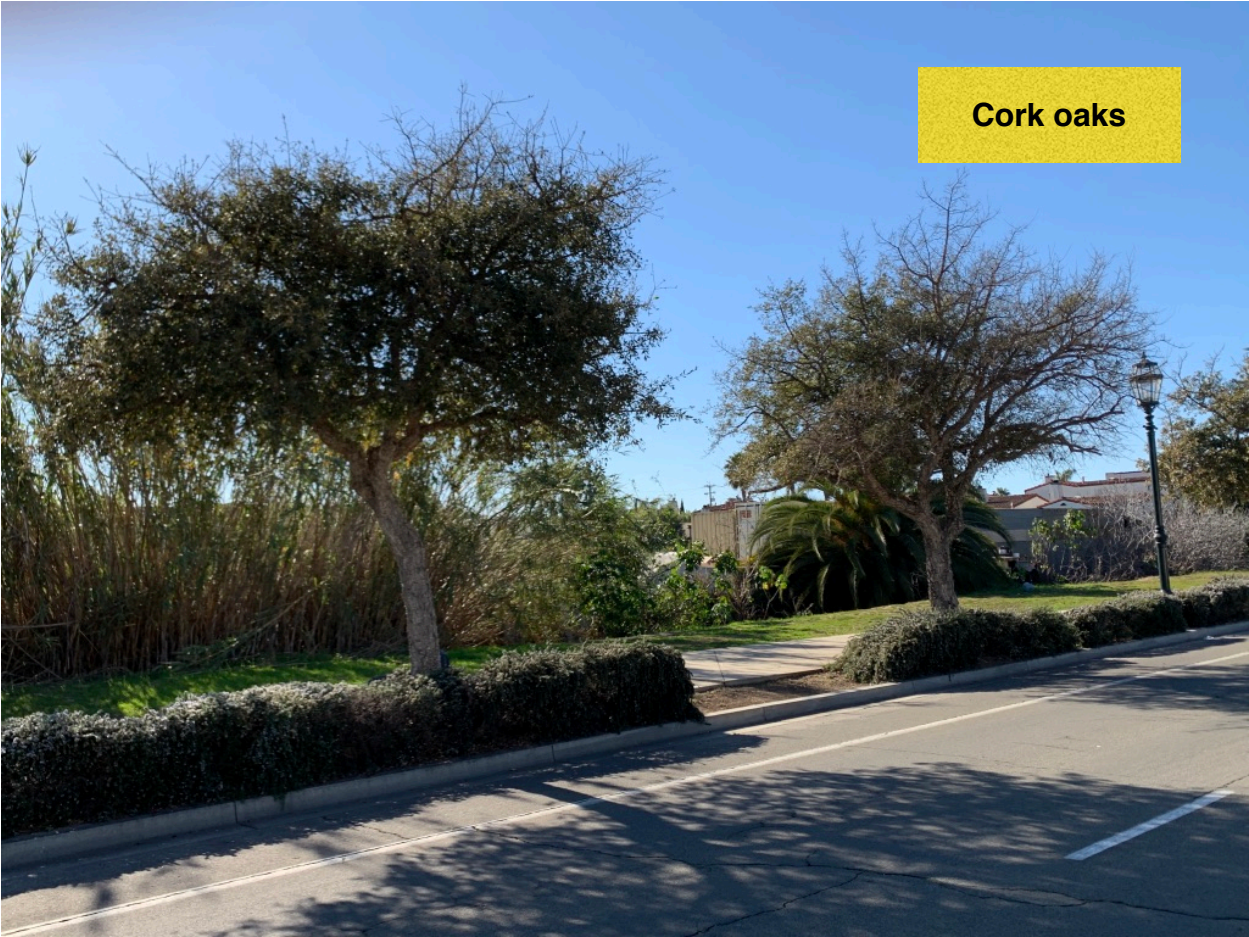
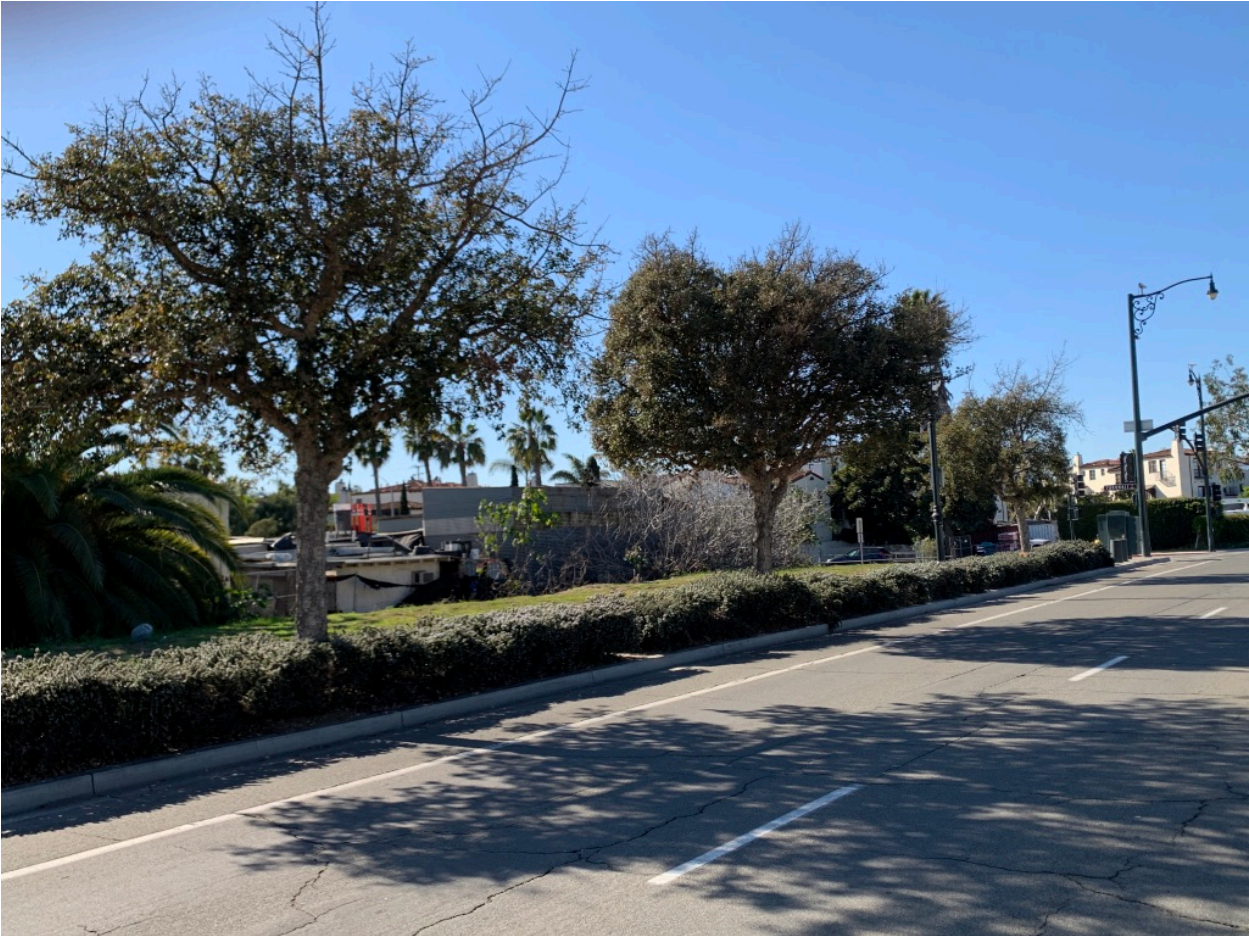
Cork oaks

9. The City has planted 19 Cork Oak trees along Garden Street that are mostly in fair condition after a significant infestation of oak worms. Most appear to be recovering fairly well and should survive.
