City of Santa Barbara FORESTRY DIVISION

PRONT YARD SET BACK TREE REMOVAL REQUEST

Arborist Report/Tree Protection Plan

Regarding: 650 Rockwood Drive, City of Santa Barbara, California

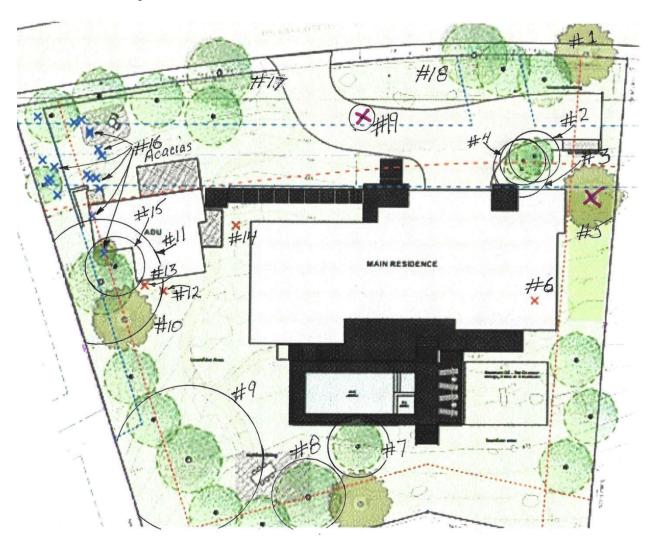
Site Plan Showing All Trees

The CRZ's of two specimens (#'s 11 and 15) were found to be affected by over 20% due to the construction of an Accessory Dwelling Unit (ADU).

Figure 1. The proposed removals are shown with red X's. I determined that the CRZ of two trees, # 11 and 15, would be encroached upon by construction. Five native and one mature specimen non-native (# 5) are proposed for removal. Tree representations shown with solid centers were initially proposed locations for new mitigation oaks. Graphic taken from a site plan drawn up by Blackbird Architects at a 1/8"=1' scale.

Tree Number	Name	Reason for Removal or Mitigation	Size: Trunk diameter at 4.5' up - DBH	Mitigation Tree Replacements, Size and Number
			(Critical Root Zone)	
6	Coast Live Oak	To be removed for residence construction.	11" DBH (11')	One 24" boxed specimen.
11	Coast Live Oak	ADU construction encroaching over 20% of CRZ	Four 10" DBH trunks. (20')	One 36" boxed specimen.
12	Coast Live Oak	ADU construction is too close to the tree to preserve it.	16" DBH (16')	One 36" boxed specimen.
13	Coast Live Oak	ADU construction is too close to the tree to preserve it.	8" + 12" DBH (14')	One 36" boxed specimen.
14	Coast Live Oak	House construction is too close to the tree to preserve it.	9" + 10" DBH (13')	One 36" boxed specimen.
15	Coast Live Oak	Over 20% CRZ encroachment from ADU construction.	10" (10')	One 24" box.
19	Coast Live Oak	To be removed for driveway construction.	A small multi trunk specimen.	One 15 gallon nursery oak.

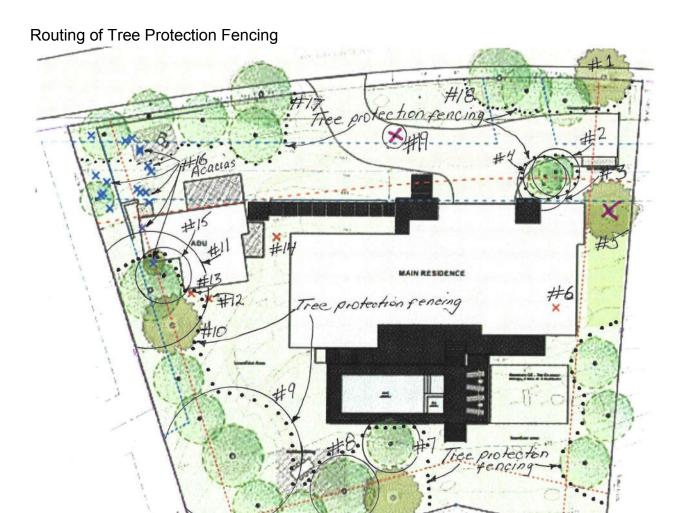
Figure 2. The graphic shows five locations for the routing of tree protection fencing shown with lines of black dots.

- 1. It will be imperative to place strongly staked tree protection fencing as outlined in the graphic shown on page 9. The project arborist is to be on hand to supervise the installation.
- 2. All heavy equipment must be prevented from entering protected areas.
- 3. No storage of materials of any kind is to occur within tree CRZ's.
- 4. The locations for portable tool washout basins are to be supervised by the project arborist to insure no liquid material spills into root zones.
- 5. No ditching for utility lines is to occur within protected tree root zones without the project arborist present.
- 6. Any tree roots cut during construction operations are to be cut even to help prevent decay.

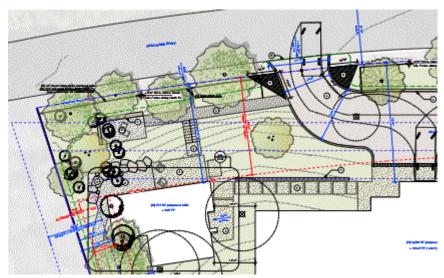
Plan Section

I did not consider the fact that some of the removals are located within the setback zone that the City of Santa Barbara has jurisdiction over. Specifically, there are 16 young Acacia specimens in a group in the northwest corner of the property which the architects and owners would like to replace with native oak trees (Refer to a site plan section on page 2). Just as important, the area has been set aside for new outdoor living infrastructure.

Figure 1. A plan section of the site shows existing and proposed new trees. The subject trees can be seen at the left side of the plan as small black circles. The red dashed line paralleling Rockwood Drive and running left to right represents the City's setback line.

I would like to request that the City of Santa Barbara grant the owners permission to remove the specified trees in order to develop the area for outdoor living.
