**July 2022**

*Location of Tree:* 624 E. De La Guerra Plaza/ 726 State St., Santa Barbara CA 93101

**Tree Species:** *Washingtonia robusta*, **Common Name:** Mexican Fan Palm

## **ARBORIST FIELD REPORT - Mexican Fan Palm at 726 State St.**

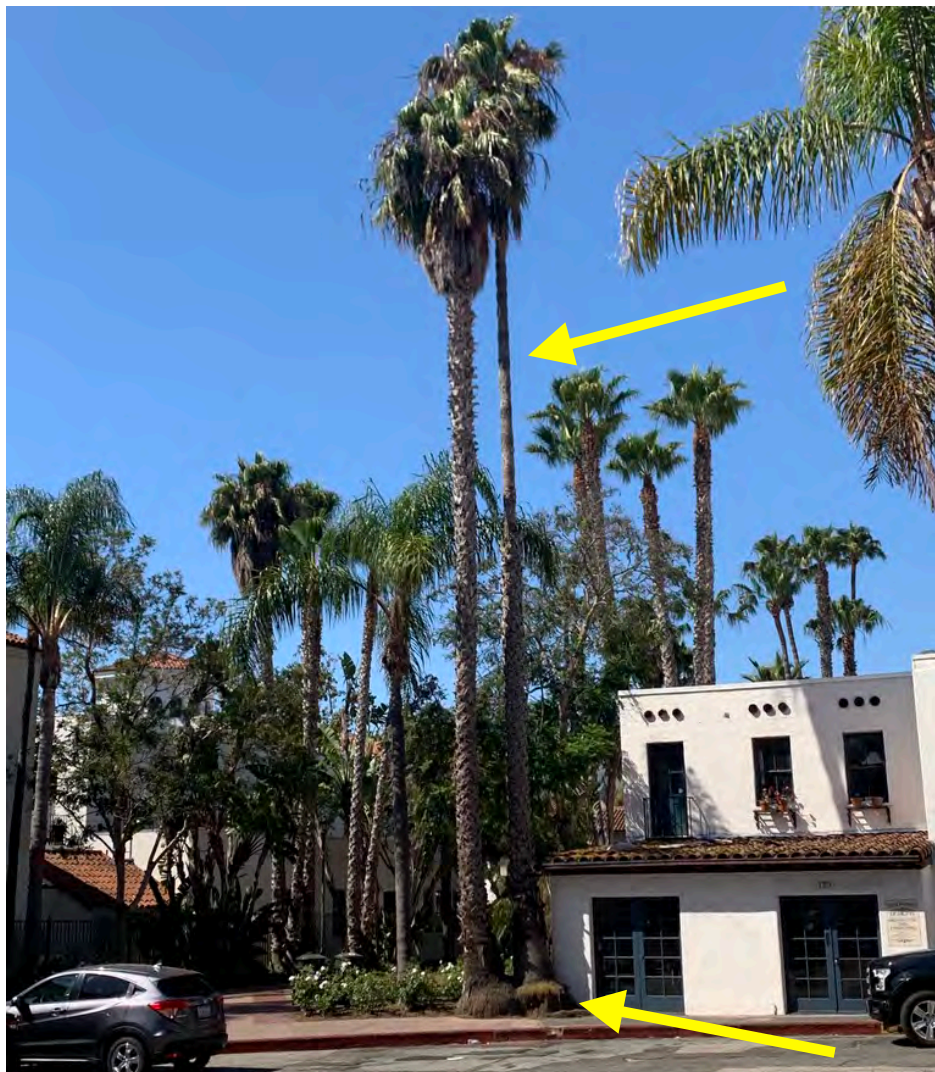
Looking west at the problematic fan palm (arrows)

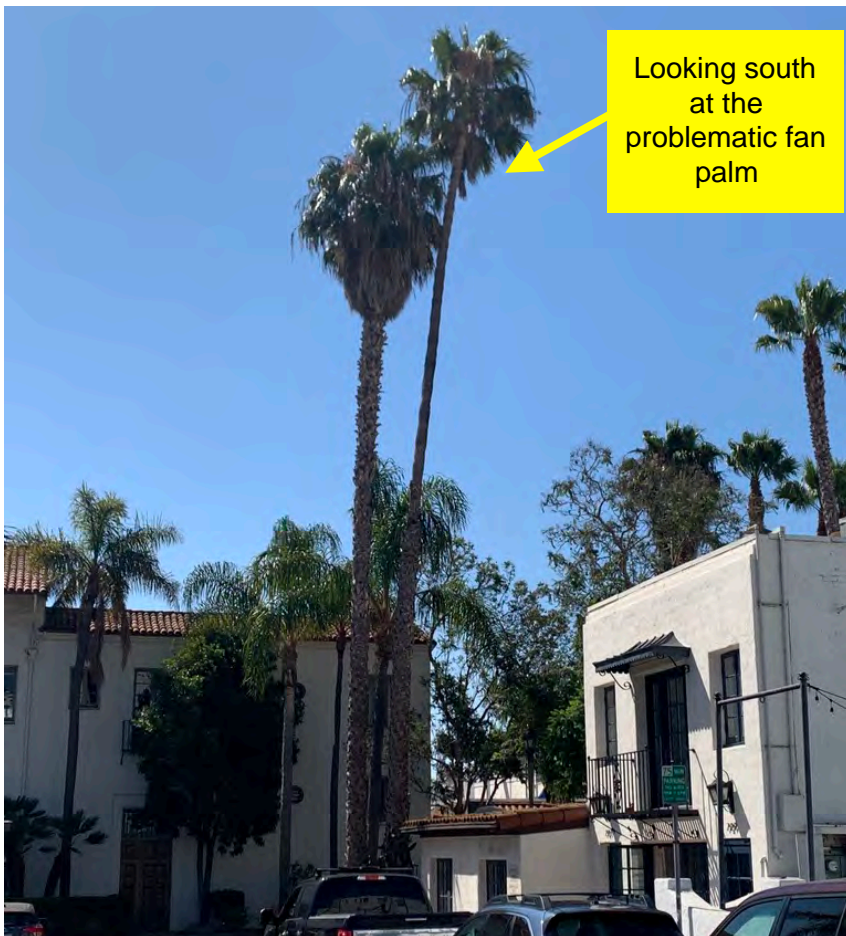
Looking south  
at the  
problematic fan  
palm

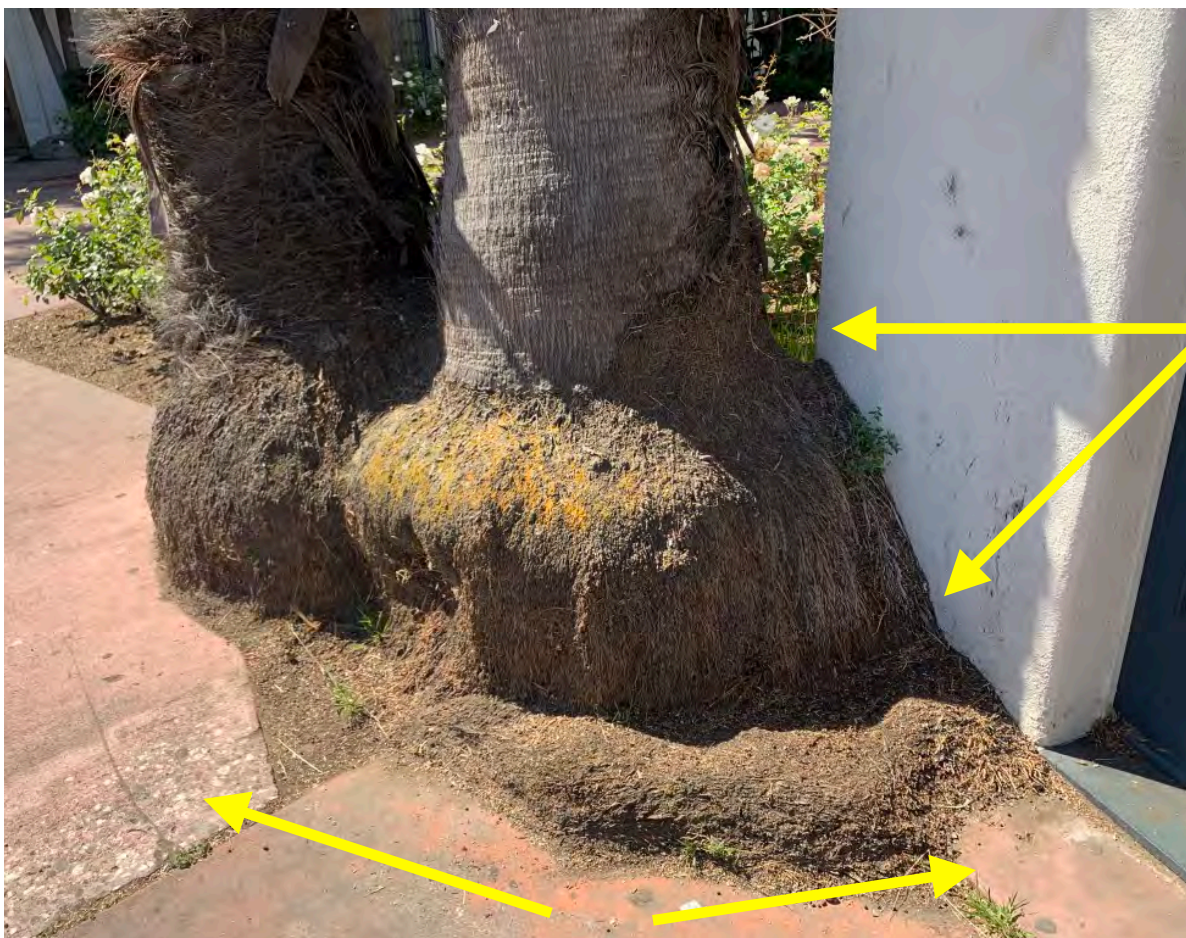
The RIZ extends  
more than 24" above  
the ground, blocks  
drainage and applies  
pressure to the  
building corner.

Also note damage to  
sidewalk (repaired  
with grinding)

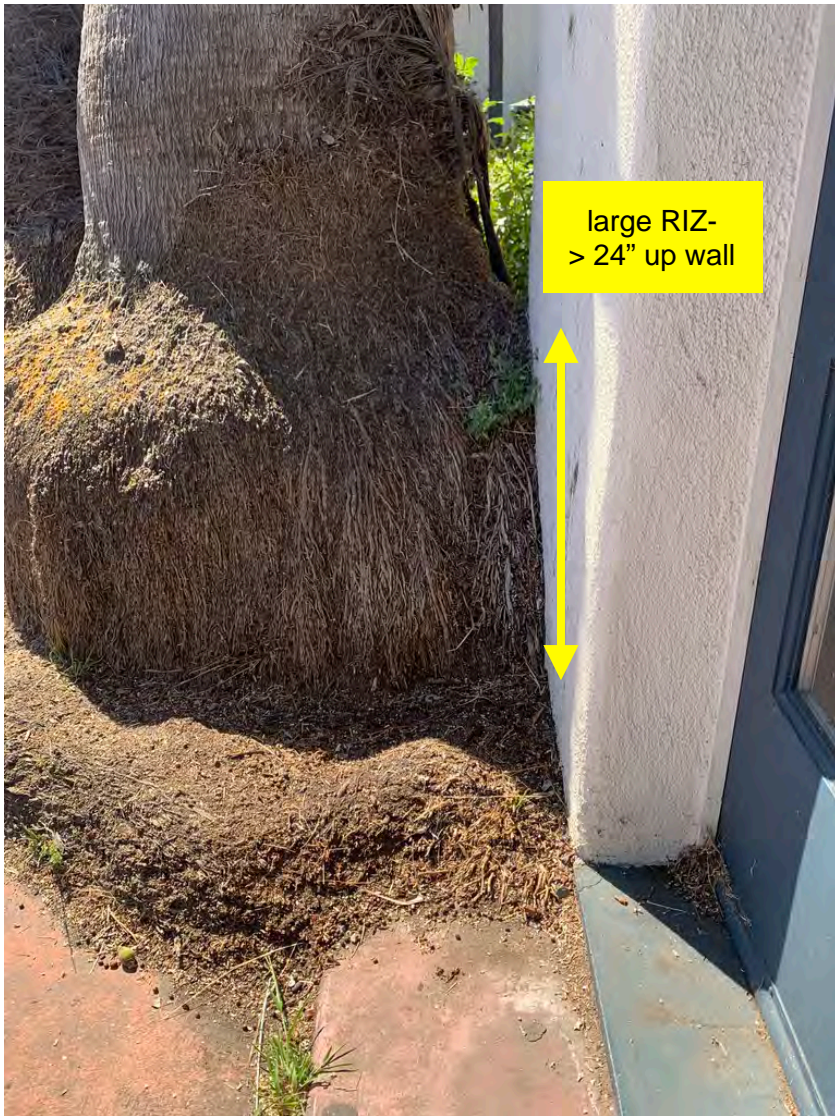
Above left: extended RIZ pushing wall and blocking drainage.

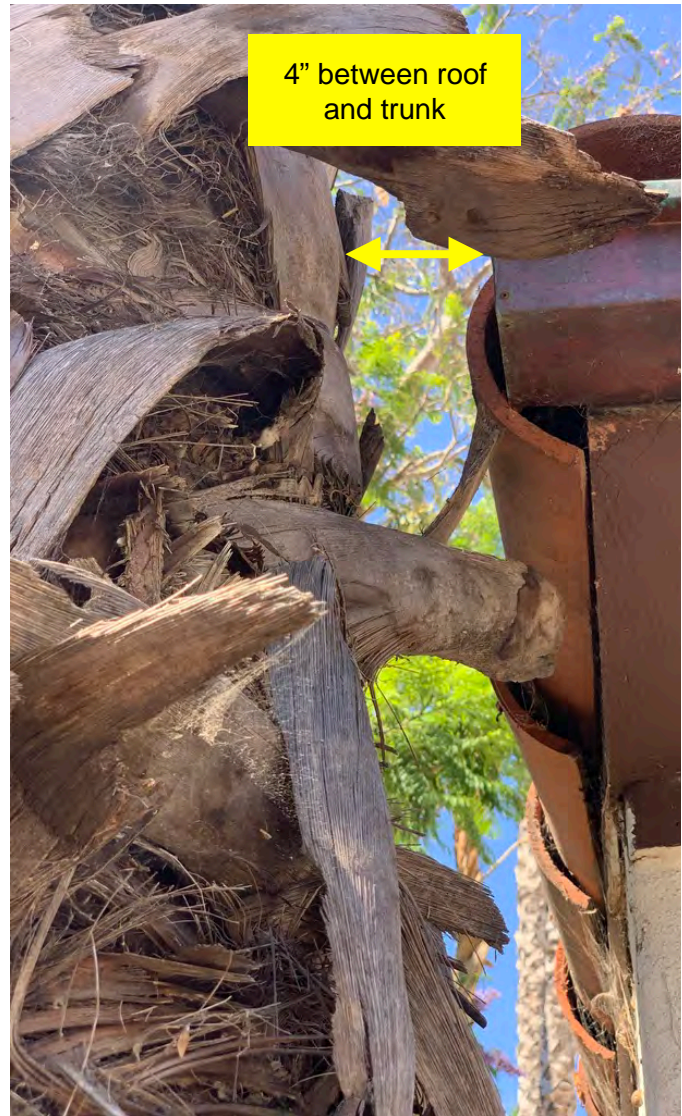
Above right: trunk is 4" from roof, likely to hit during extreme wind.
