**FRONT YARD SET BACK TREE REMOVAL  
REQUEST**

**September 2022**

VISTA DEL MONTE - TREE APPLICATION

**STREET TREE MASTER PLAN  
SPECIES DESIGNATION CHANGE  
FOR ADOPTION**

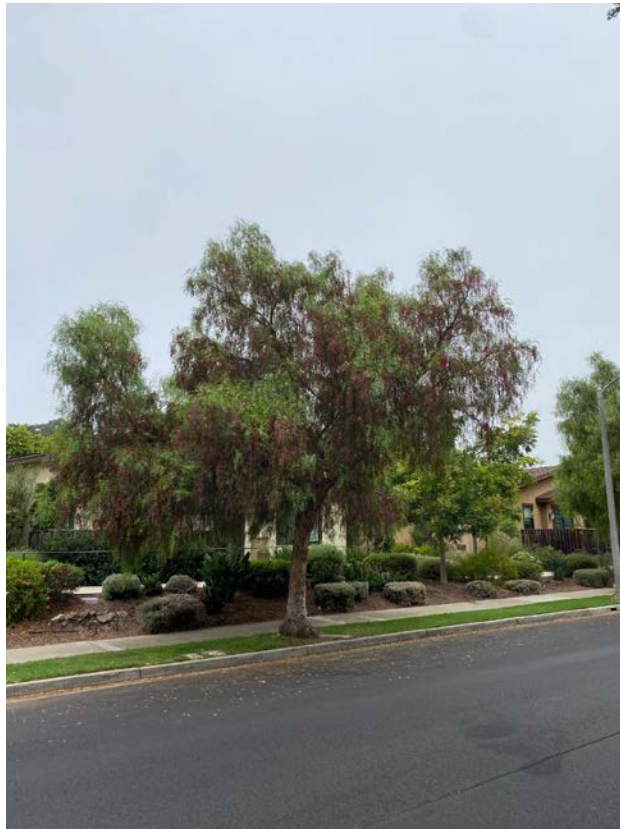
*Requested Reason for Removal:* A prolific pepper tree is a toxic species and is full of toxic red berries that permeate the air in our home. Family has allergies and is having difficulty breathing.

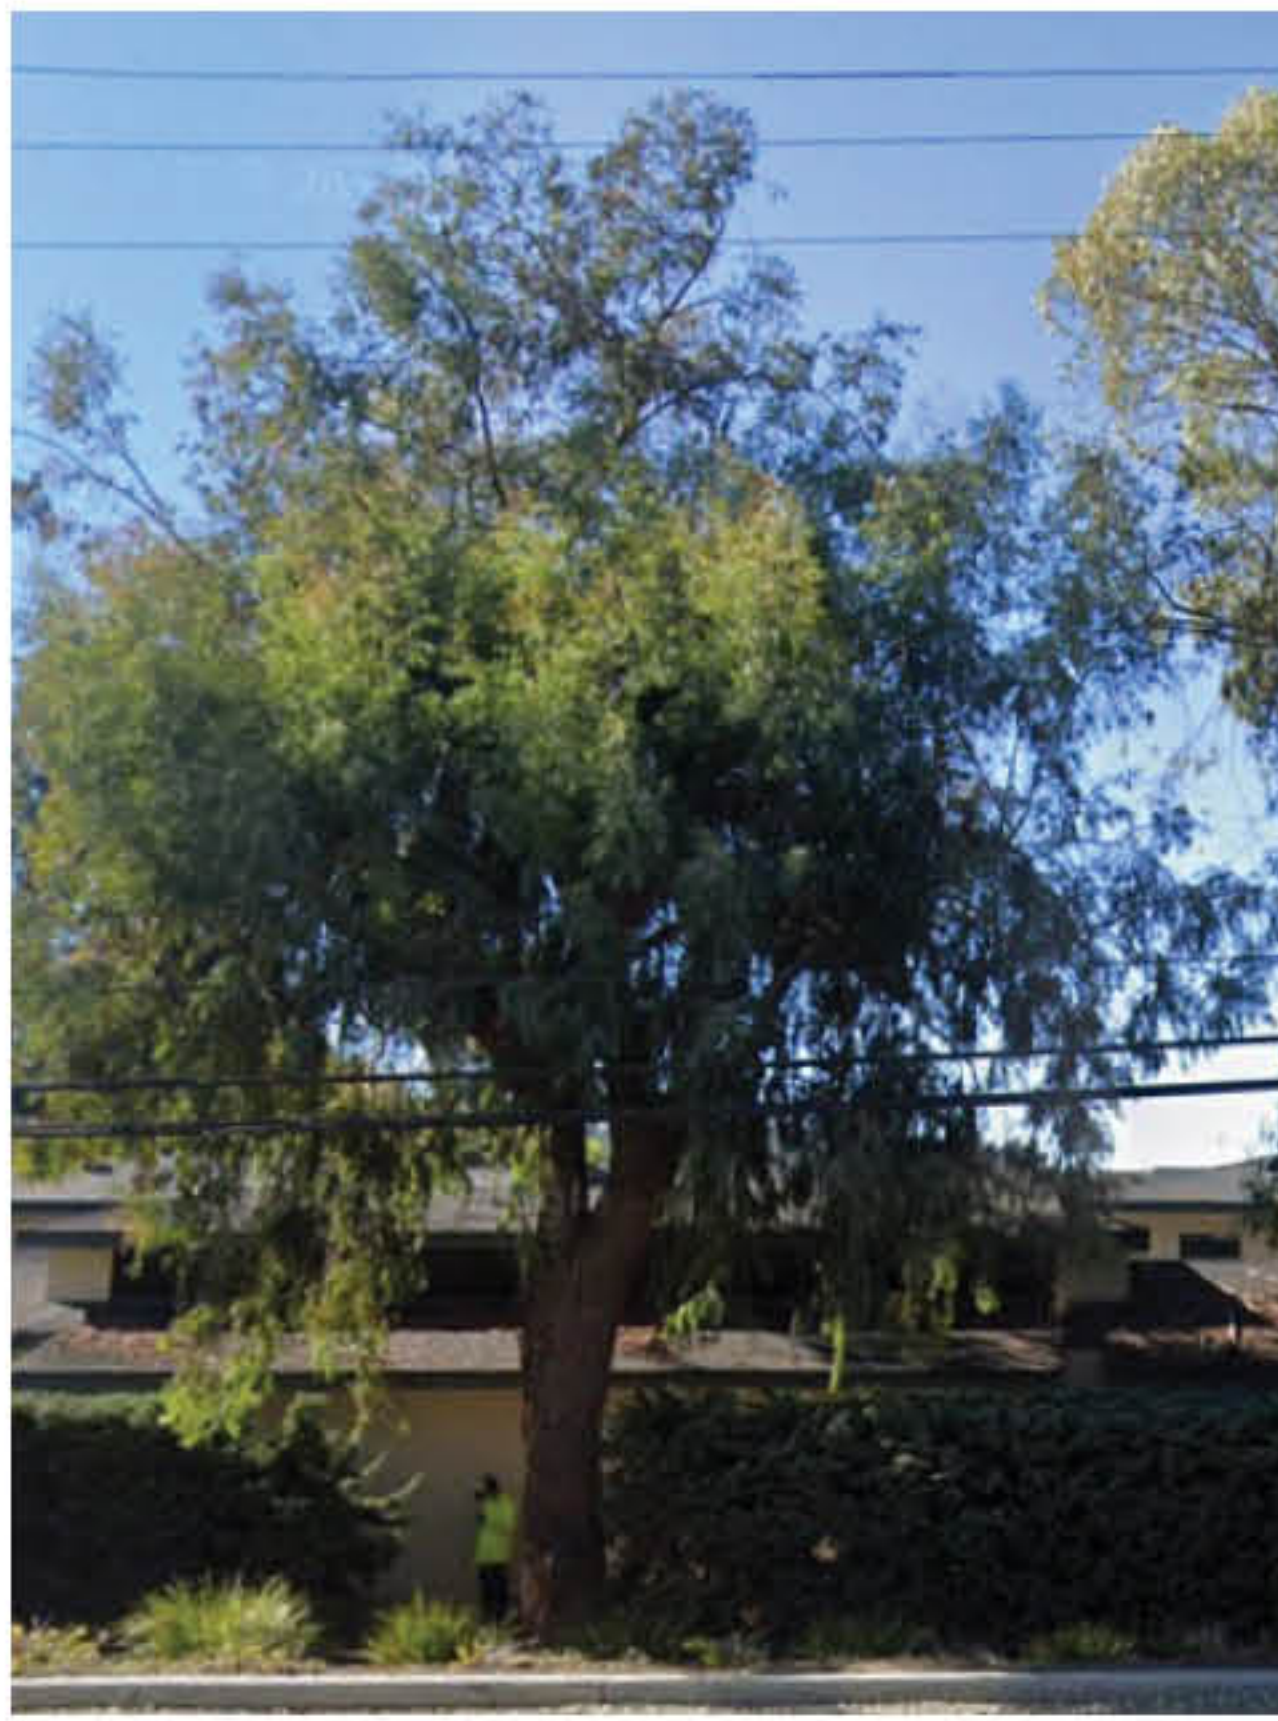
TREE 1 - *Eucalyptus sideroxylon*

TAG #	BOTANICAL NAME	TARGET DESCRIPTION	DBH	HEIGHT	STRUCTURE	NOTES	MITIGATION RECOMMENDATIONS
1	<i>Eucalyptus sideroxylon</i>	Garage, Drive Aisle, Sidewalk	27.5	50	2	Southern California Edison (SCE) has continually pruned northern portion of crown due to proximity to nearby overhead power lines. This has created an unbalanced crown weight distribution and places the cantilevered load over the adjacent row of garages on the Vista Del Monte (VDM) property. There are several instances of poor structure such as codominant leaders and included bark from years of utility pruning. Tree has developed a lean in the direction of the VDM garages and although the root collar indicates a stable root structure, the cantilevered weight of the crown combined with the uncorrected lean could lead to failure. Tree is in good health with slight indications of stress.	Southern portion of crown is oversized and will require consistent pruning to maintain a balanced shape and reduce the weight of the cantilevered limbs. Tree has outgrown its location and should be removed and replaced with a more suitable species in a location that does not conflict with overhead power distribution.

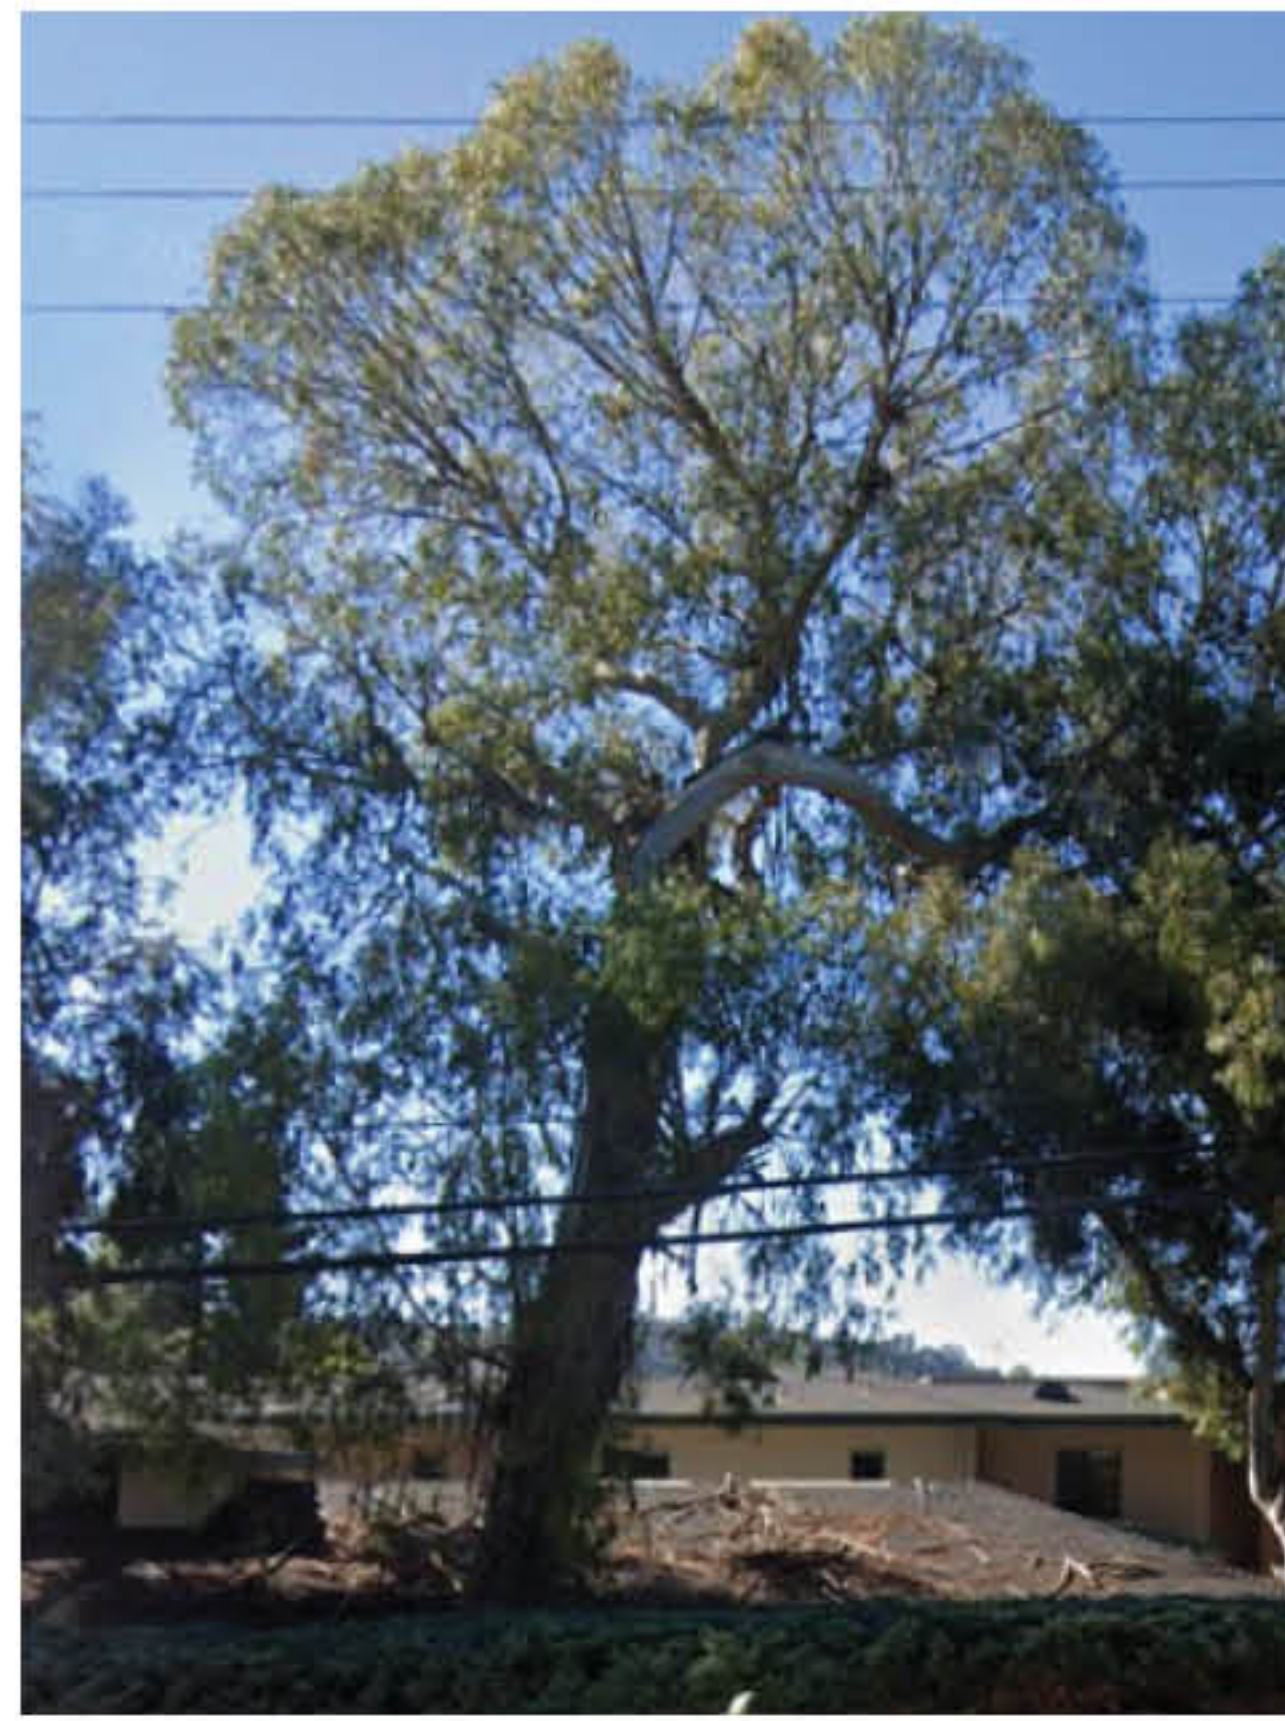
TREE 2 - *Eucalyptus viminalis*

COMMON NAME	TARGET PROXIMITY	OCC. RATE	HEALTH	DISPOSITION		
	red ironbark	10	2	4	R		
2	<i>Eucalyptus viminalis</i>	Garage, Drive Aisle, Sidewalk	38.0	50	2	SCE has continually pruned northern portion of crown due to proximity to nearby overhead power lines. This has created an unbalanced crown weight distribution and places the cantilevered load over the adjacent row of garages on the VDM property. There are several instances of poor structure such as codominant leaders and included bark from years of utility pruning. Tree has developed a lean in the direction of the VDM garages and although the root collar indicates a stable root structure, the cantilevered weight of the crown combined with the uncorrected lean could lead to failure. Tree is in poor health with indications of stress such as moderate evidence of psyllid infestation and tortoise beetle damage to the leaves.	Southern portion of crown is oversized and will require consistent pruning to maintain a balanced shape and reduce the weight of the cantilevered limbs. Tree has outgrown its location and should be removed and replaced with a more suitable species in a location that does not conflict with overhead power distribution.

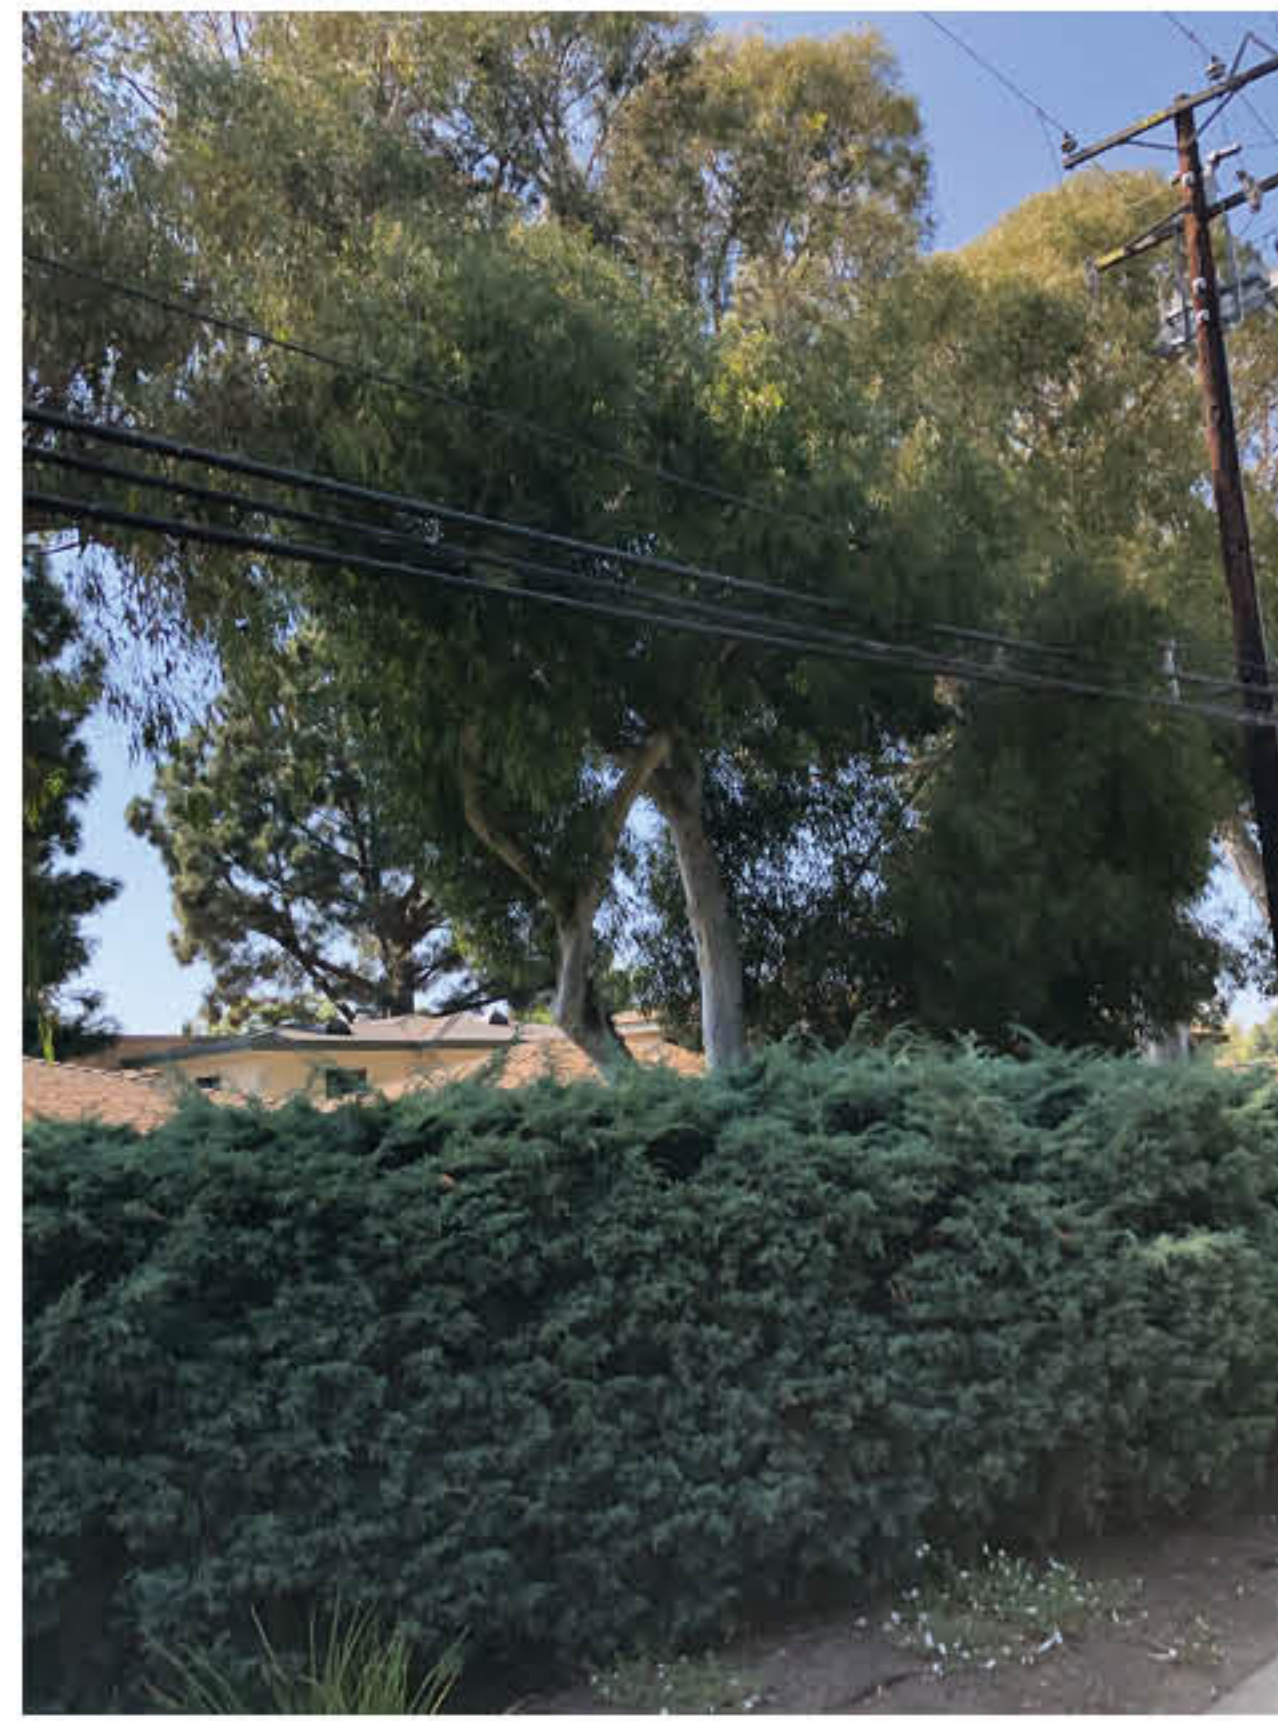
TREE 3 - *Eucalyptus viminalis*

COMMON NAME	TARGET PROXIMITY	OCC. RATE	HEALTH	DISPOSITION		
	manna gum	10	2	2	R		
3	<i>Eucalyptus viminalis</i>	Garage, Drive Aisle, Sidewalk	25.0	40	2	SCE has continually pruned northern portion of crown due to proximity to nearby overhead power lines. This has created an unbalanced crown weight distribution and places the cantilevered load over the adjacent row of garages on the VDM property. There are several instances of poor structure such as codominant leaders and included bark from years of utility pruning. Tree has developed a lean in the direction of the VDM garages and although the root collar indicates a stable root structure, the cantilevered weight of the crown combined with the uncorrected lean could lead to failure. Tree is in poor health with moderate indications of stress such as evidence of psyllid infestation and tortoise beetle damage to the leaves.	Southern portion of crown is oversized and will require consistent pruning to maintain a balanced shape and reduce the weight of the cantilevered limbs. Tree has outgrown its location and should be removed and replaced with a more suitable species in a location that does not conflict with overhead power distribution.

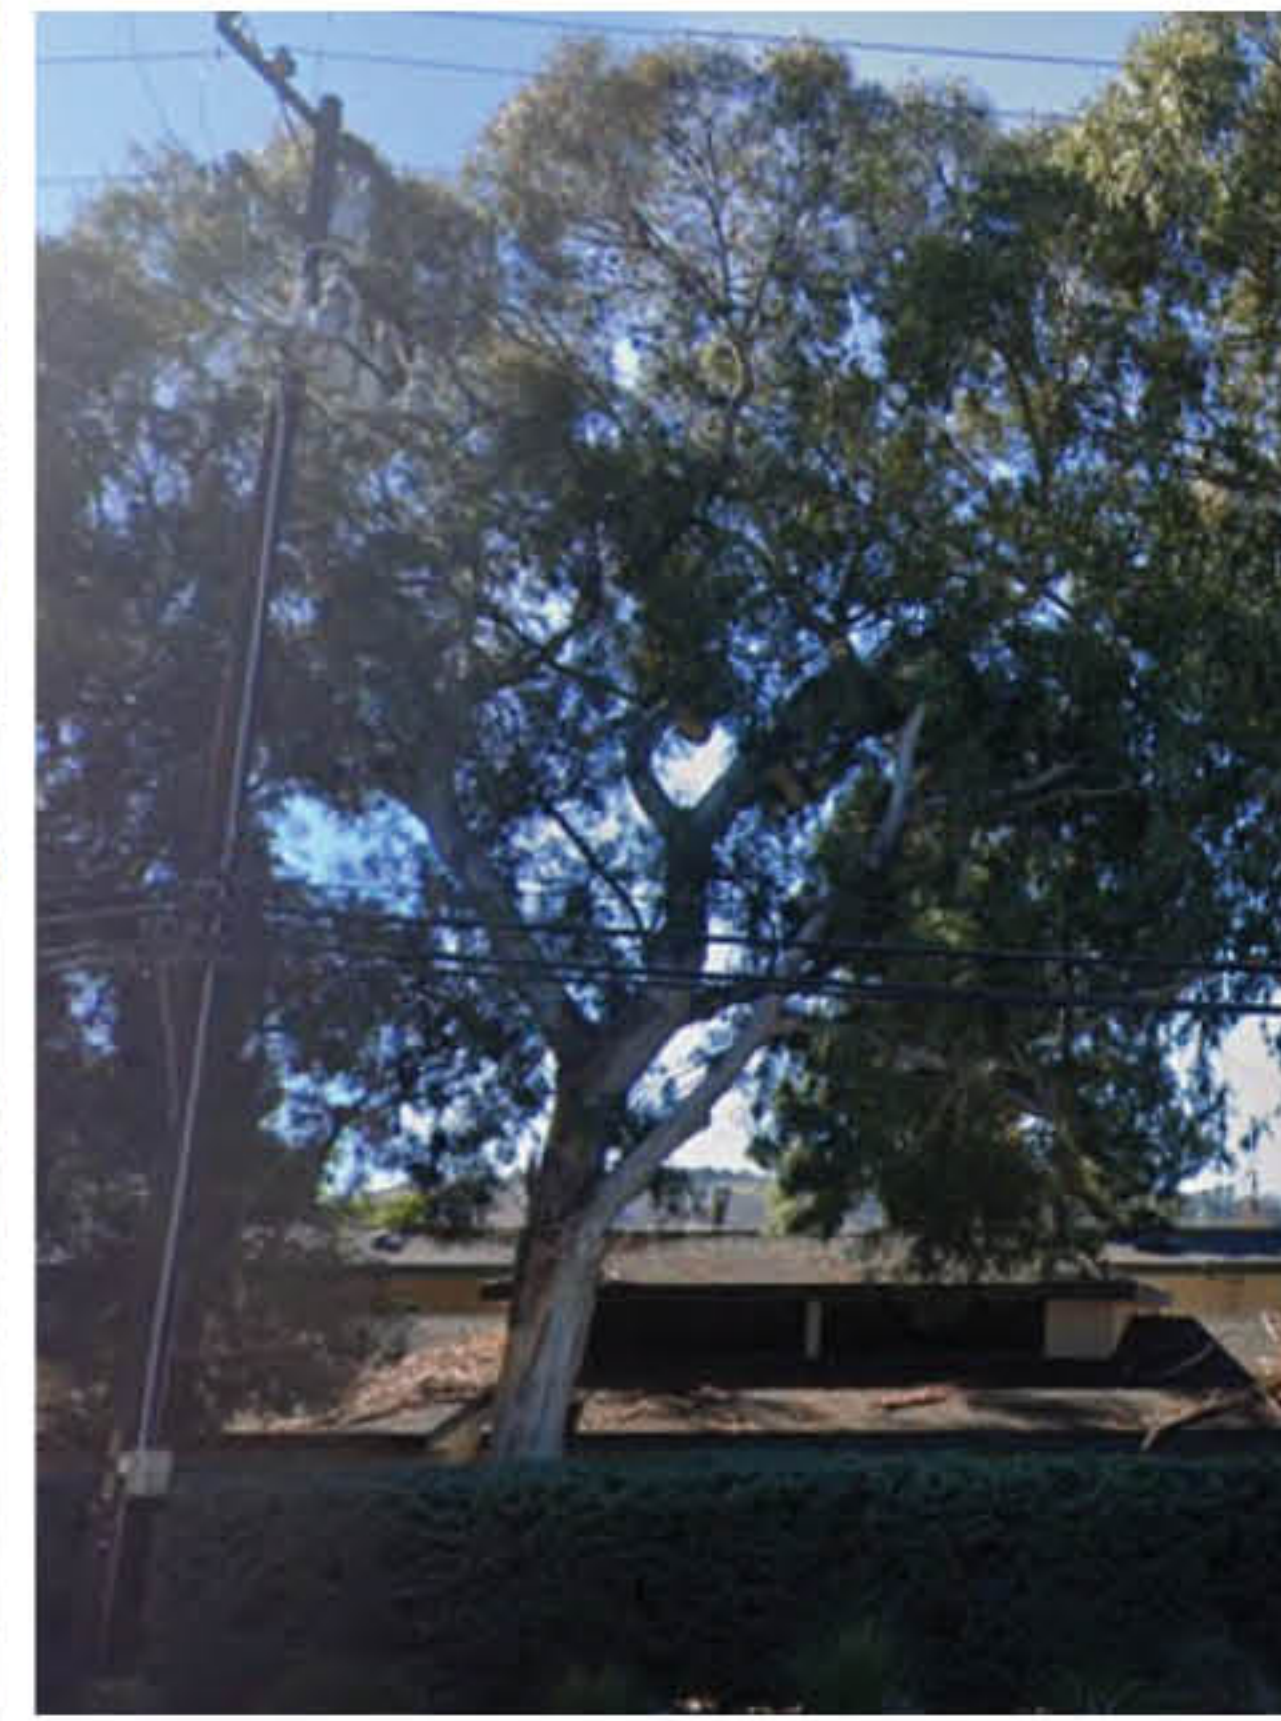
TREE 4 - *Eucalyptus viminalis*

COMMON NAME	TARGET PROXIMITY	OCC. RATE	HEALTH	DISPOSITION		
	manna gum	10	2	2	R		
4	<i>Eucalyptus viminalis</i>	Garage, Drive Aisle, R.O.W., Sidewalk	35.0	45	3	SCE has continually pruned northern portion of crown due to proximity to nearby overhead power lines. This has created an unbalanced crown weight distribution and places the cantilevered load over the adjacent row of garages on the VDM property. There are several instances of poor structure such as codominant leaders and included bark from years of utility pruning. Tree has developed a lean in the direction of the VDM garages and although the root collar indicates a stable root structure, the cantilevered weight of the crown combined with the uncorrected lean could lead to failure. Tree is in good health with slight indications of stress such as evidence of psyllid infestation and tortoise beetle damage to the leaves.	Southern portion of crown is oversized and will require consistent pruning to maintain a balanced shape and reduce the weight of the cantilevered limbs. Tree has outgrown its location and should be removed and replaced with a more suitable species in a location that does not conflict with overhead power distribution.

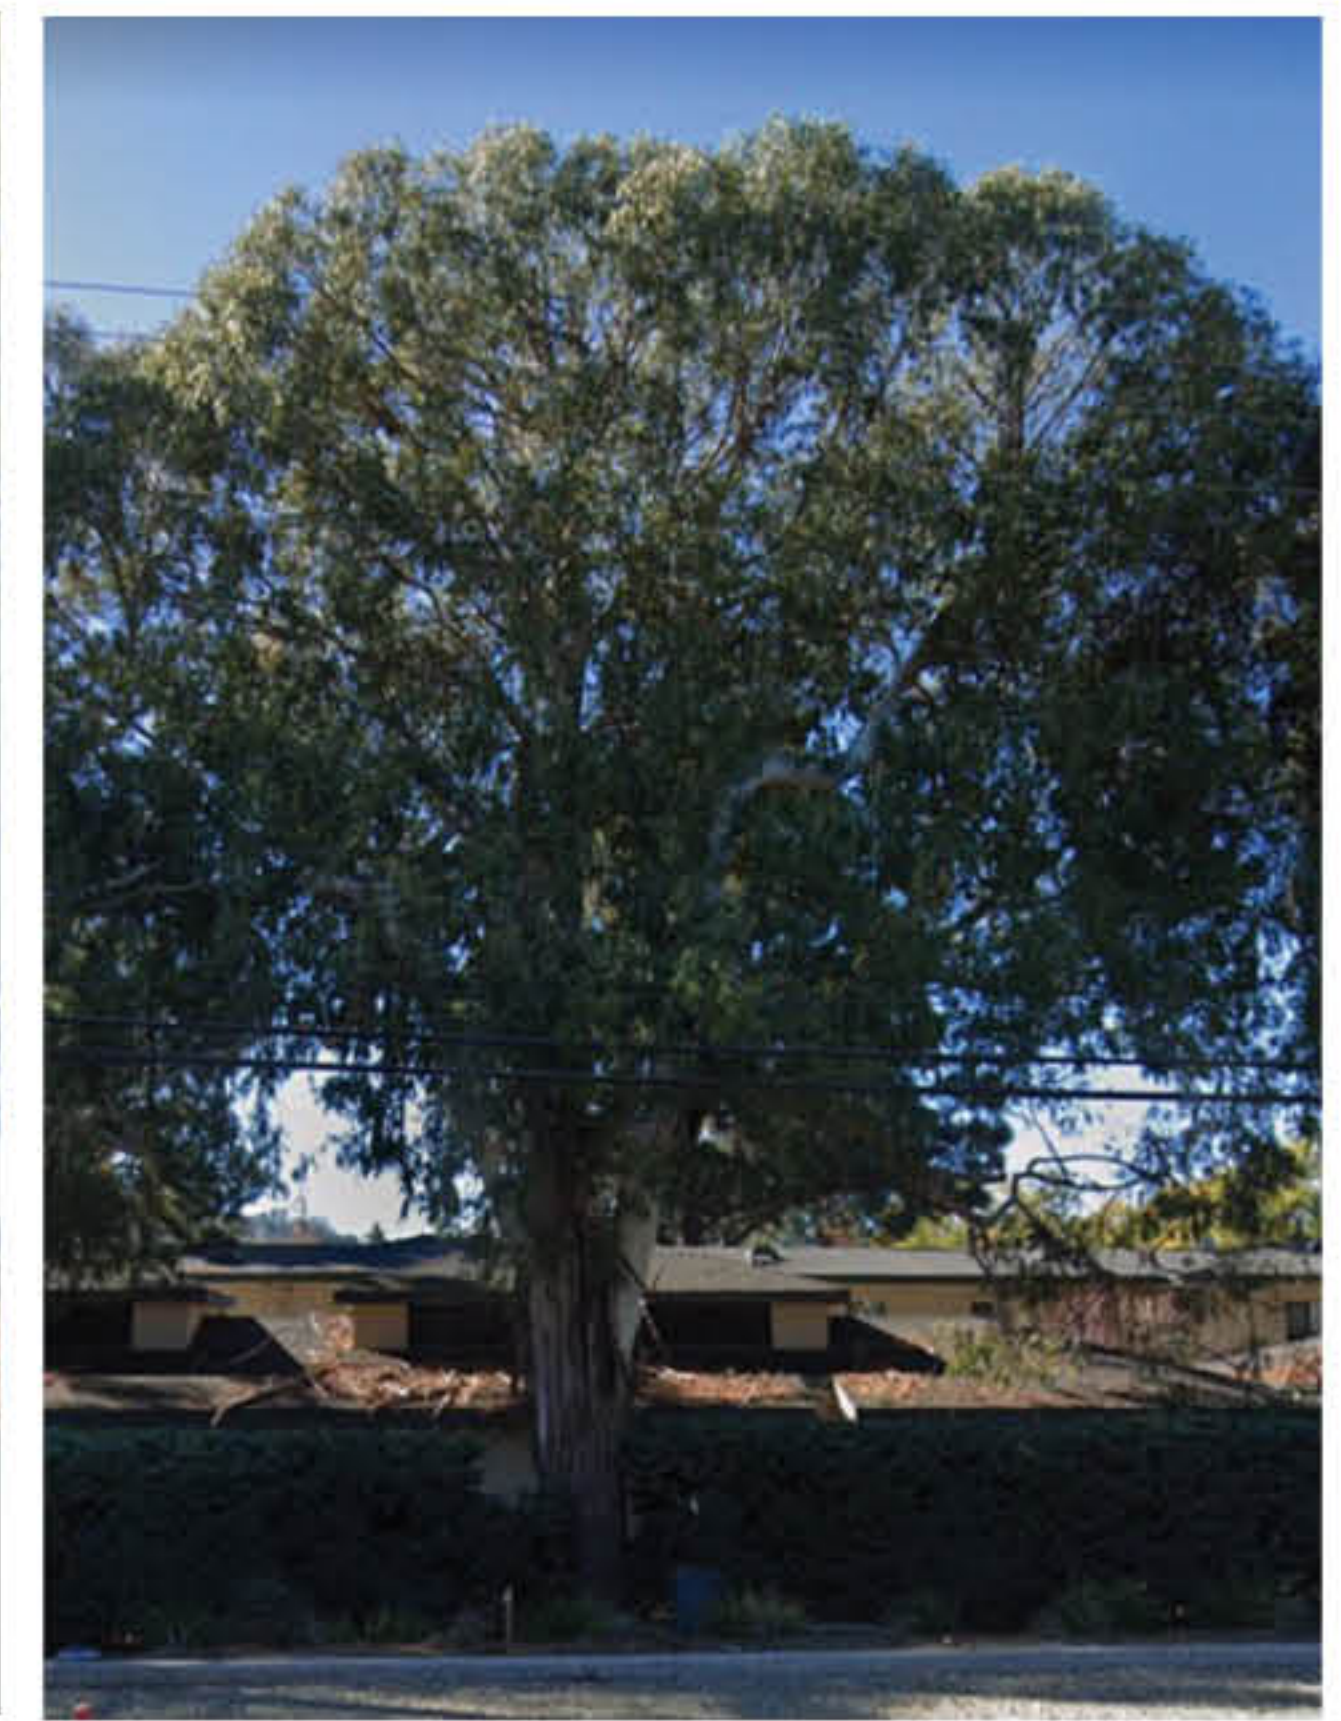
TREE 5 - *Eucalyptus viminalis*

COMMON NAME	TARGET PROXIMITY	OCC. RATE	HEALTH	DISPOSITION		
	manna gum	10	2	4	R		
5	<i>Eucalyptus viminalis</i>	Garage, Drive Aisle, Sidewalk	42.5	50	2	SCE has continually pruned northern portion of crown due to proximity to nearby overhead power lines. This has created an unbalanced crown weight distribution and places the cantilevered load over the adjacent row of garages on the VDM property. There are several instances of poor structure such as codominant leaders and included bark from years of utility pruning. Tree has developed a lean in the direction of the VDM garages and although the root collar indicates a stable root structure, the cantilevered weight of the crown combined with the uncorrected lean could lead to failure. Tree is in moderate health with slight indications of stress such as evidence of psyllid infestation and tortoise beetle damage to the leaves.	Southern portion of crown is oversized and will require consistent pruning to maintain a balanced shape and reduce the weight of the cantilevered limbs. Tree has outgrown its location and should be removed and replaced with a more suitable species in a location that does not conflict with overhead power distribution.

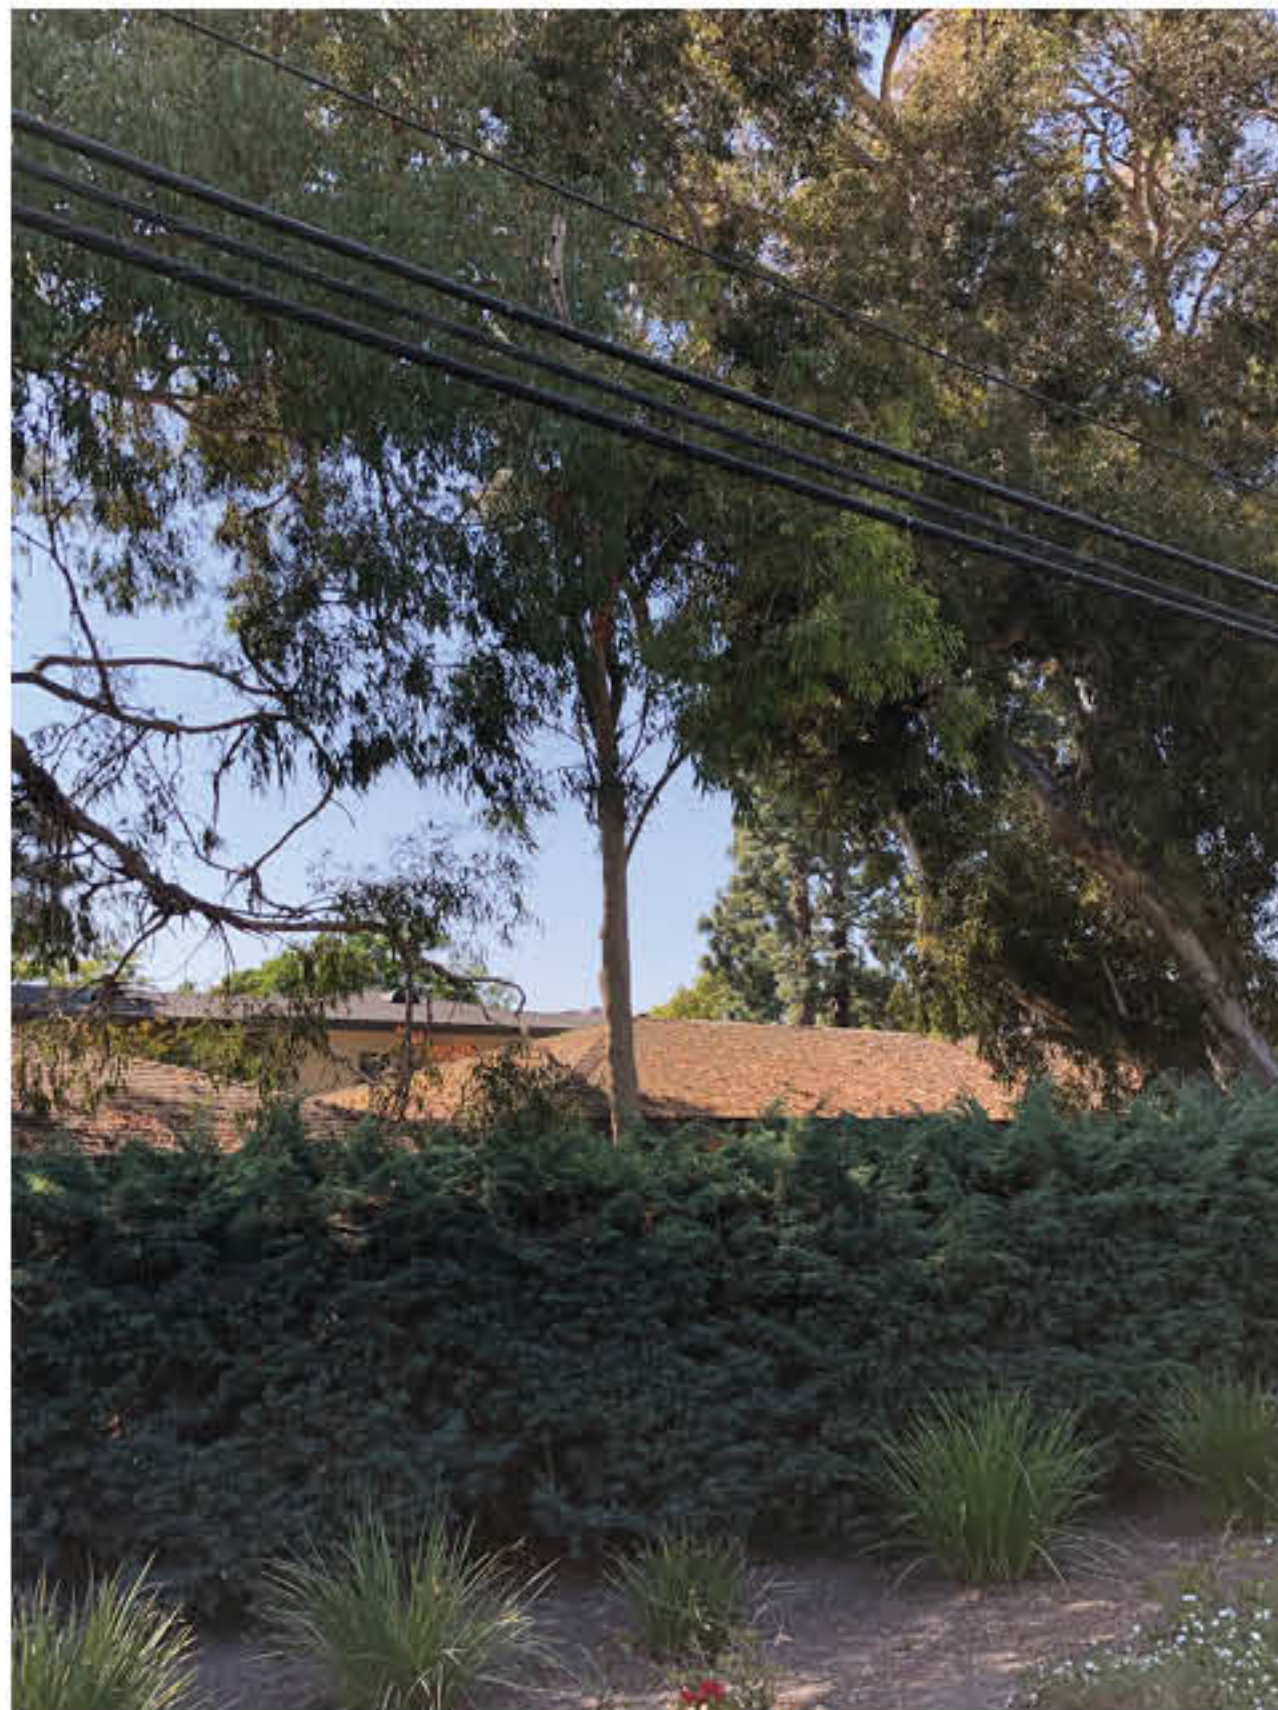
TREE 6 - *Eucalyptus viminalis*

COMMON NAME	TARGET PROXIMITY	OCC. RATE	HEALTH	DISPOSITION		
	manna gum	10	2	3	R		
6	<i>Eucalyptus viminalis</i>	Garage, Drive Aisle, Sidewalk	9.5	25	2	Young volunteer in moderate health with poor structure that is exhibiting symptoms of moderate stress such as crown dieback, evidence of psyllid infestation, and tortoise beetle damage to the leaves. Current size does not conflict with overhead power lines, but will develop identical issues as described with the previous eucalyptus trees in this area over time.	Tree is unsuitable for the location and will need consistent pruning once it matures to ensure safe clearance from nearby overhead power lines. It should be removed and replaced with a more suitable species in a location that does not conflict with overhead power distribution.
	COMMON NAME	TARGET PROXIMITY	OCC. RATE	HEALTH	DISPOSITION		
	manna gum	10	2	3	R		
7	<i>Eucalyptus viminalis</i>	Garage, Drive Aisle, Sidewalk	40.0	50	3	SCE has continually pruned northern portion of crown due to proximity to nearby overhead power lines. This has created an unbalanced crown weight distribution and places the cantilevered load over the adjacent row of garages on the VDM property. There are several instances of poor structure such as codominant leaders and included bark from years of utility pruning. Tree has developed a lean in the direction of the VDM garages and although the root collar indicates a stable root structure, the cantilevered weight of the crown combined with the uncorrected lean could lead to failure. Tree is in poor health with moderate indications of stress such as evidence of psyllid infestation and tortoise beetle damage to the leaves.	Southern portion of crown is oversized and will require consistent pruning to maintain a balanced shape and reduce the weight of the cantilevered limbs. Tree has outgrown its location and should be removed and replaced with a more suitable species in a location that does not conflict with overhead power distribution.

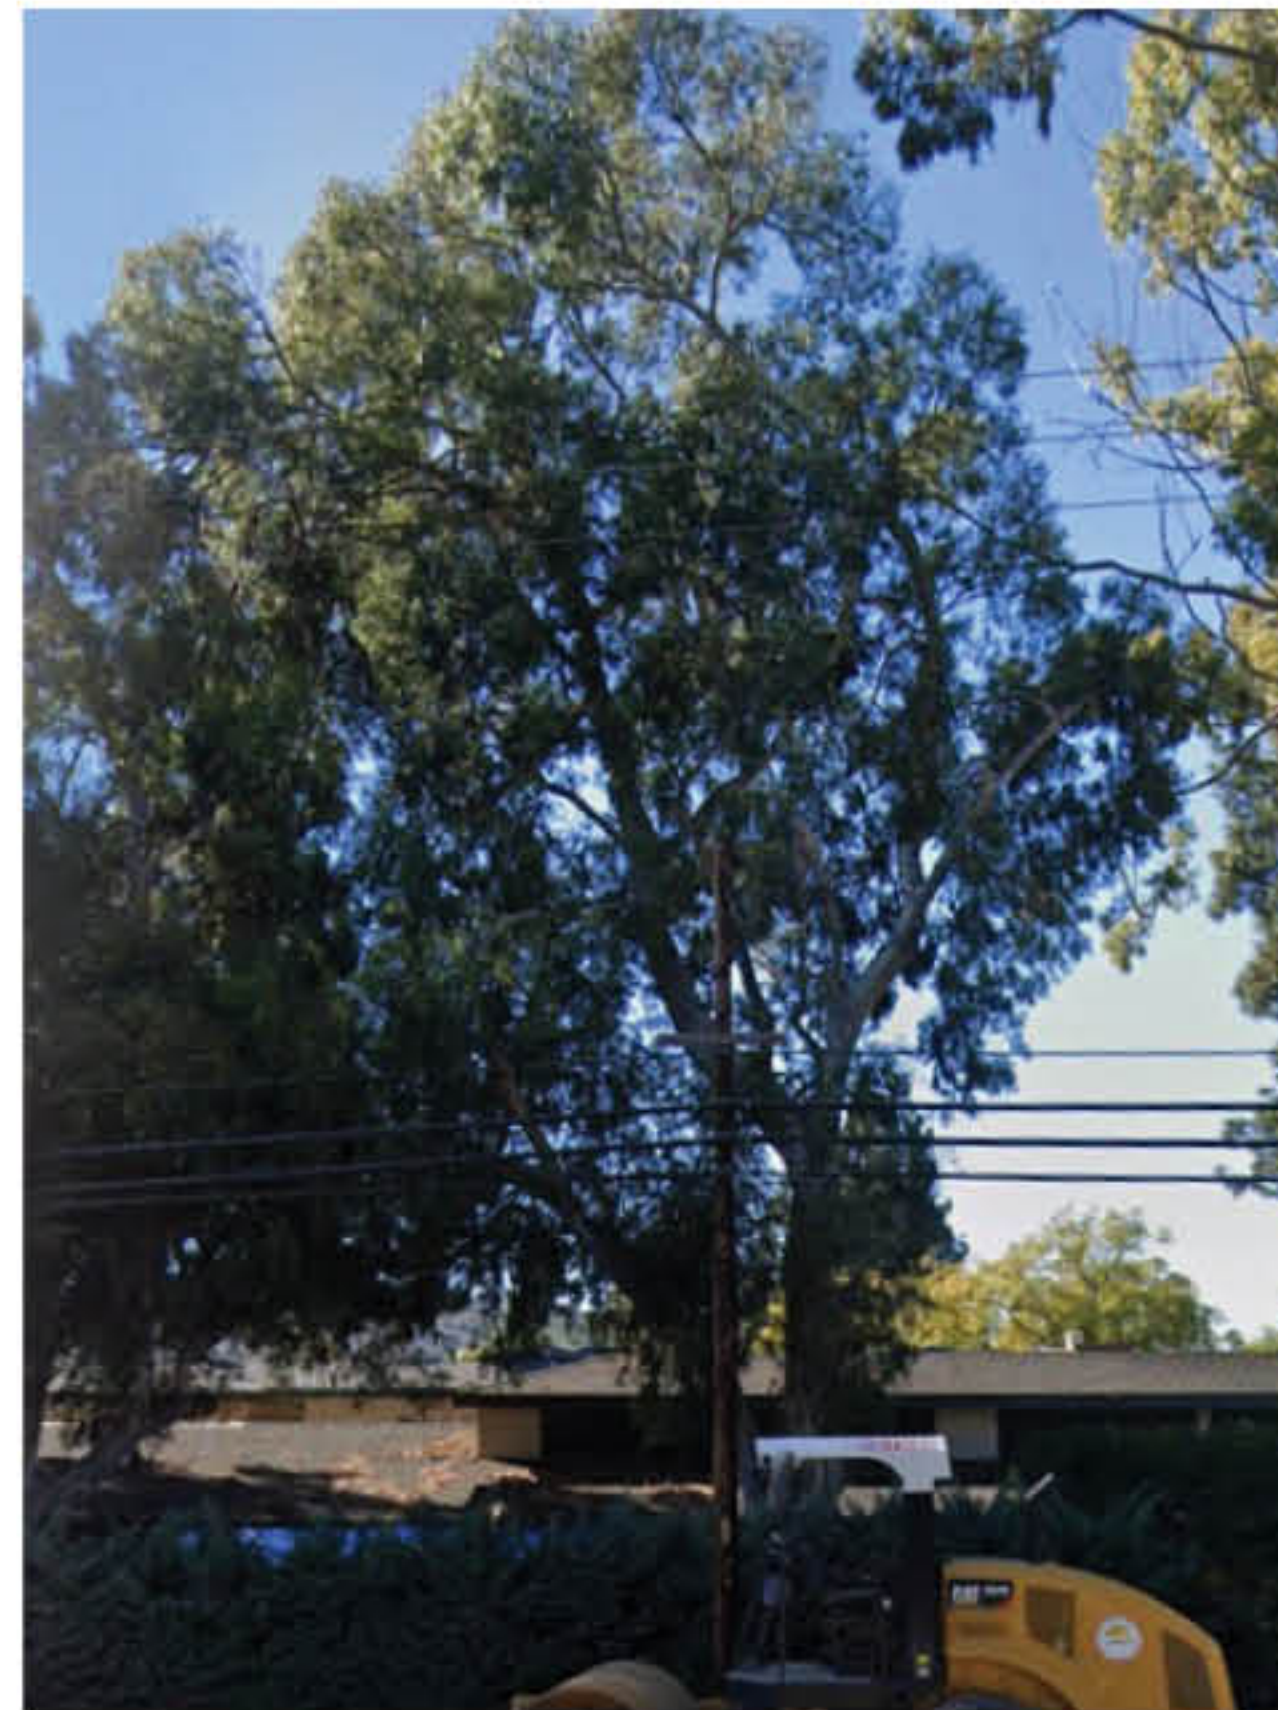
TREE 8 - *Eucalyptus viminalis*

COMMON NAME	TARGET PROXIMITY	OCC. RATE	HEALTH	DISPOSITION		
	manna gum	10	2	3	R		
8	<i>Eucalyptus viminalis</i>	Garage, Drive Aisle, Sidewalk	36.5	50	3	SCE has continually pruned northern portion of crown due to proximity to nearby overhead power lines. This has created an unbalanced crown weight distribution and places the cantilevered load over the adjacent row of garages on the VDM property. There are several instances of poor structure such as codominant leaders and included bark from years of utility pruning. Tree has developed a lean in the direction of the VDM garages and although the root collar indicates a stable root structure, the cantilevered weight of the crown combined with the uncorrected lean could lead to failure. Tree is in good health with slight indications of stress such as evidence of psyllid infestation and tortoise beetle damage to the leaves.	Southern portion of crown is oversized and will require consistent pruning to maintain a balanced shape and reduce the weight of the cantilevered limbs. Tree has outgrown its location and should be removed and replaced with a more suitable species in a location that does not conflict with overhead power distribution.

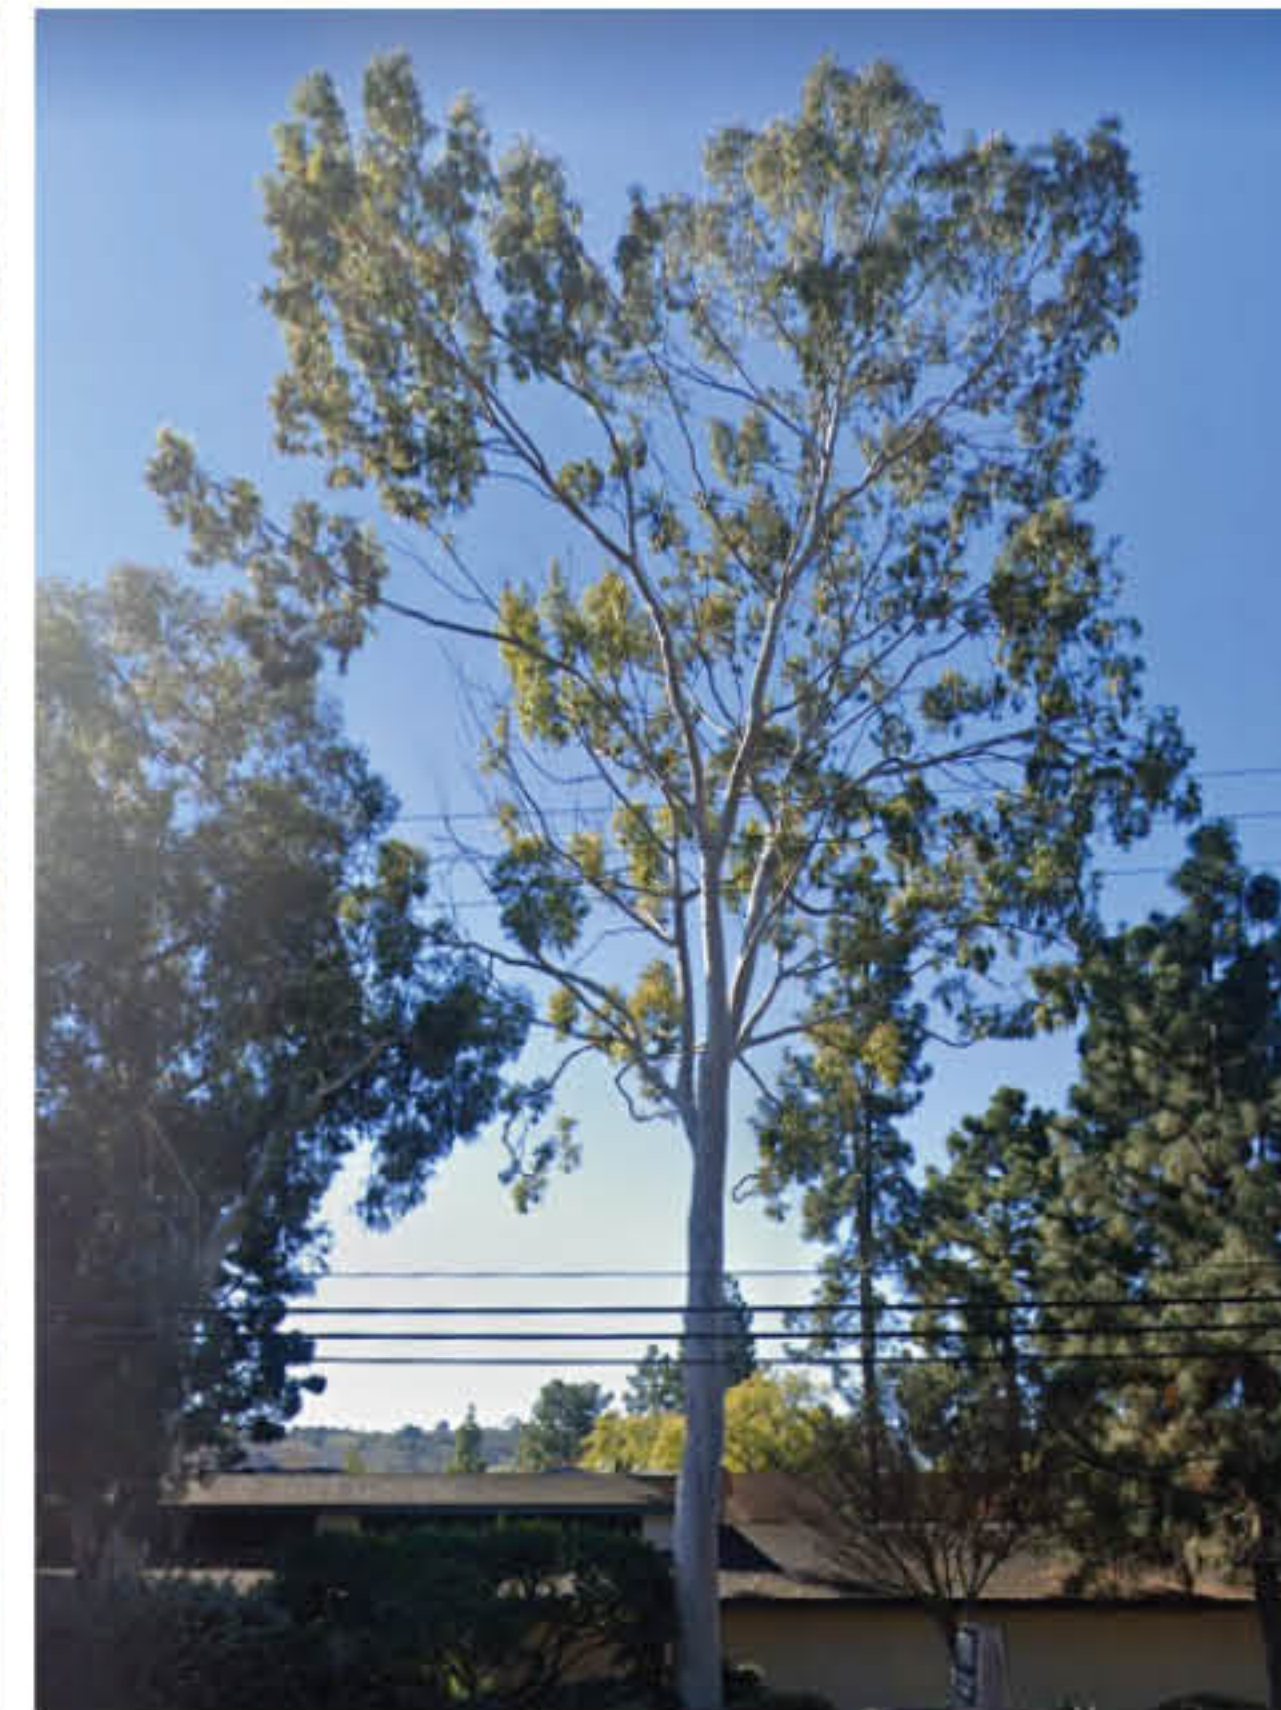
TREE 9 - *Corymbia citriodora*

COMMON NAME	TARGET PROXIMITY	OCC. RATE	HEALTH	DISPOSITION		
	manna gum	10	2	4	R		
9	<i>Corymbia citriodora</i>	Garage, Power lines, Drive Aisle, Sidewalk	27.5	65	4	The naturally upright and high branching structure of the lemon-scented gum has allowed this specimen to successfully grow past the overhead power lines with less oversight from SCE, which seems to have preserved its good form, balance, and structure. The trunk is very straight with adequate taper and appears very stable. The root collar is not well defined at the soil surface and may have been previously buried during the construction of an adjacent raised planter.	Using low impact excavation techniques and being careful not to damage the root collar or roots, uncover the root collar to see if
	COMMON NAME	TARGET PROXIMITY	OCC. RATE	HEALTH	DISPOSITION		
	lemon-scented gum	4	2	4	P

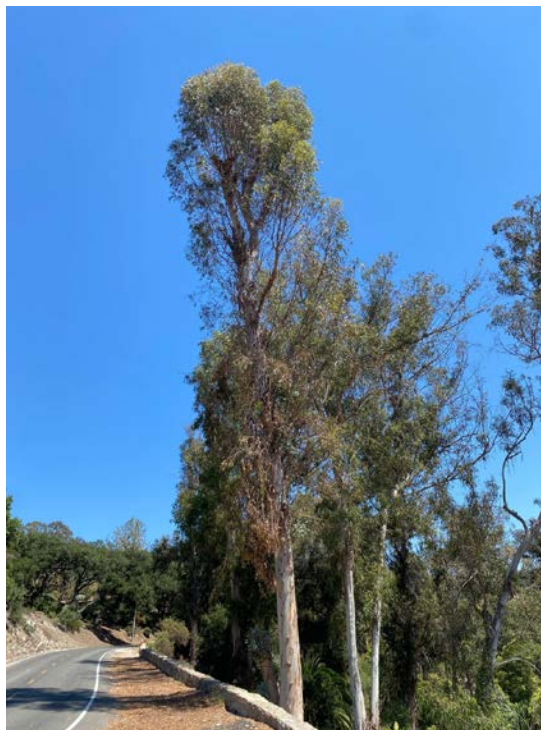
*Reason for Removal:* This is a previously topped eucalyptus tree; leaning over wall in direction of public roadway. New growth consists of hazardous water sprouts that are more prone to break off. Tree is unsightly and a risk to the historic wall.

*Proposed Replacement:* Yes  2 ea. California Coast Live Oaks No
