Subject: Draft Aquatic Resources Delineation for the 101 Garden Street Project in the City of Santa Barbara, California

This letter report (report) summarizes the methods and results of a formal aquatic resources delineation completed for the 101 Garden Street Project (Project) located in the City of Santa Barbara. The aquatic resources delineation focused on the previously identified ditch feature described in the previous biological studies (SAIC 2007 and Dudek 2018). Additionally, Dudek conducted field surveys of the entire Project site for aquatic features that could be considered jurisdictional to the U.S. Army Corps of Engineers (USACE), Regional Water Quality Control Board (RWQCB), California Department of Fish and Wildlife (CDFW), the California Coastal Commission (CCC), and the City of Santa Barbara under their Local Coastal Program (City 2019). An initial field survey was conducted in January 2019, and a follow-up survey was conducted in March 2022, to verify and update the findings of the 2019 survey.

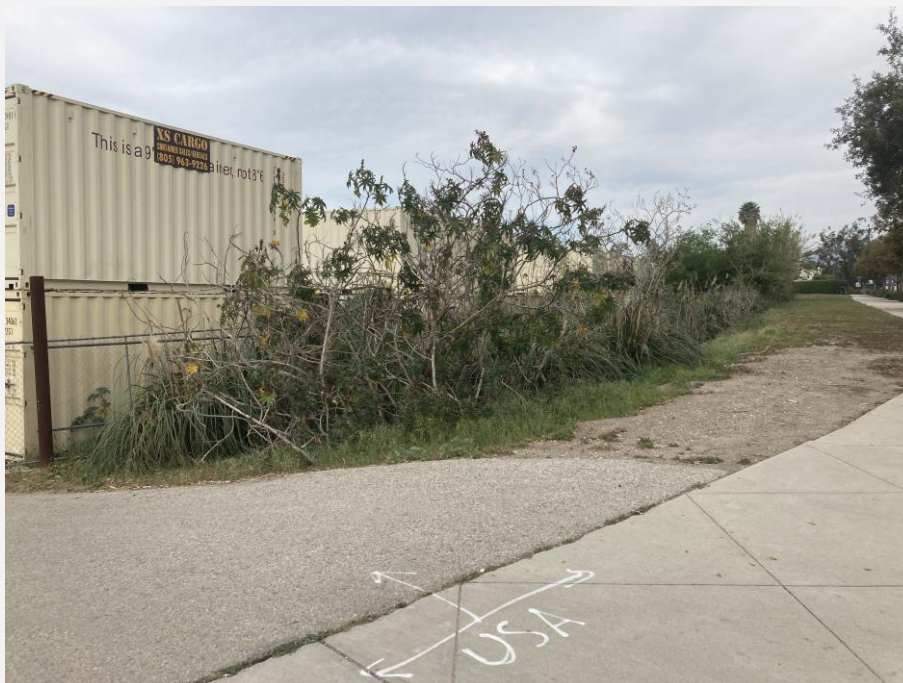
Photo 1. Looking northwest along the storm drain ditch, March 3, 2022

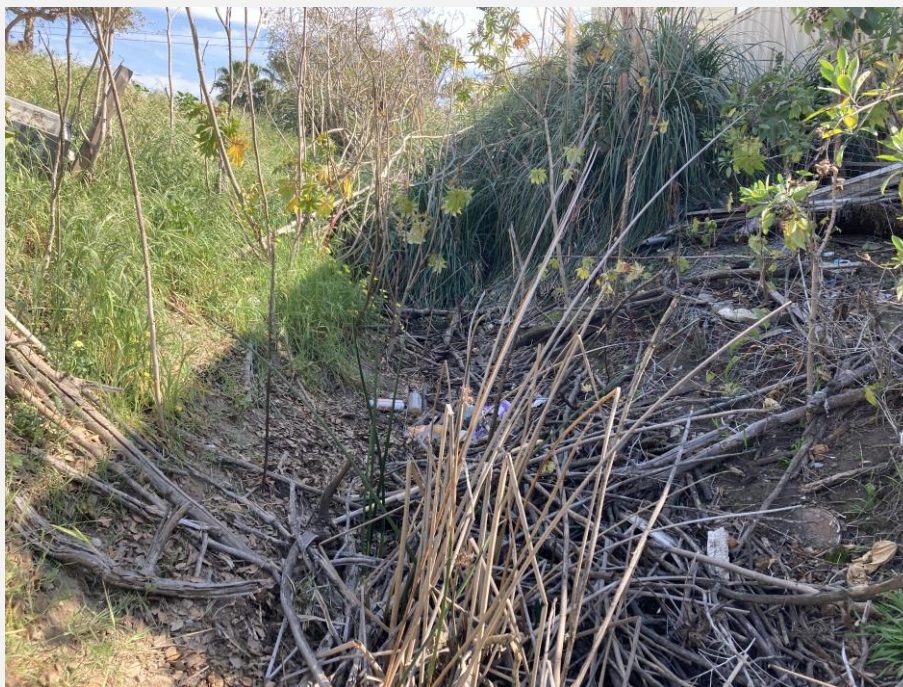
Photo 5. Looking southeast along the storm drain ditch, March 3, 2022

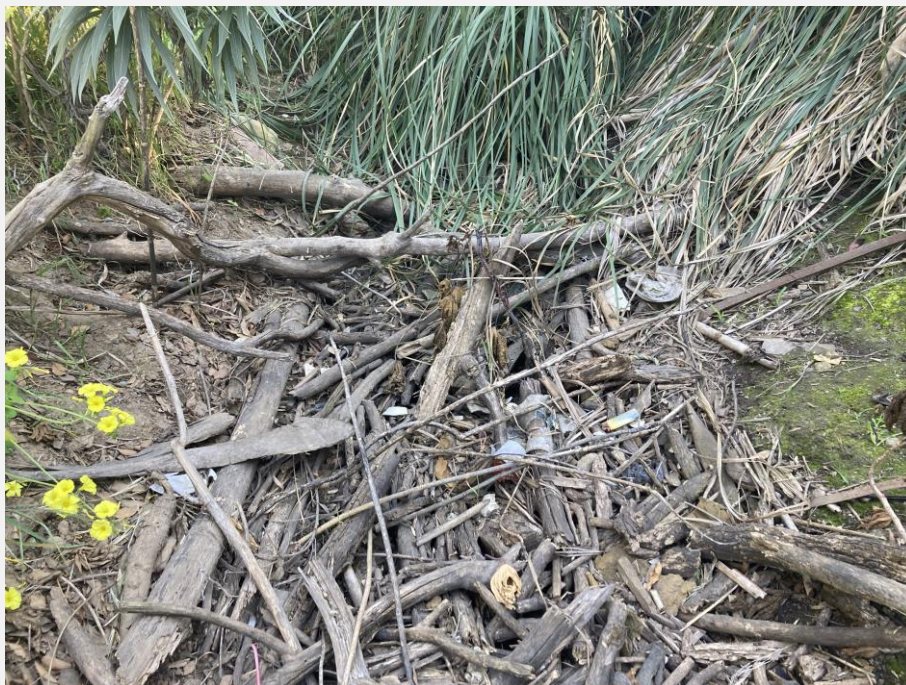
Photo 5. Debris within the storm drain ditch, March 3, 2022

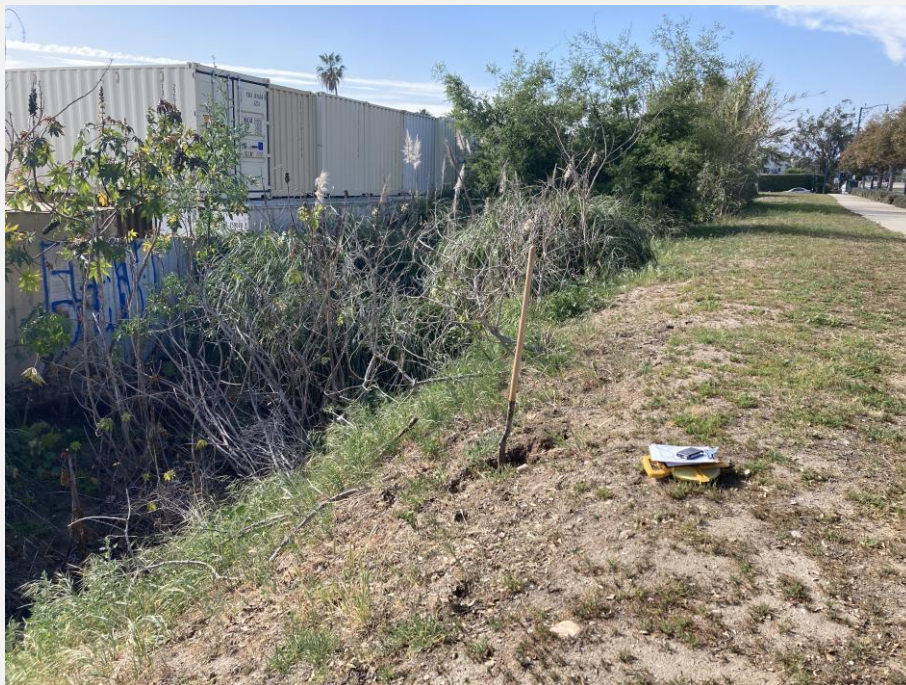
Photo 5. Looking northwest to SP02, March 3, 2022

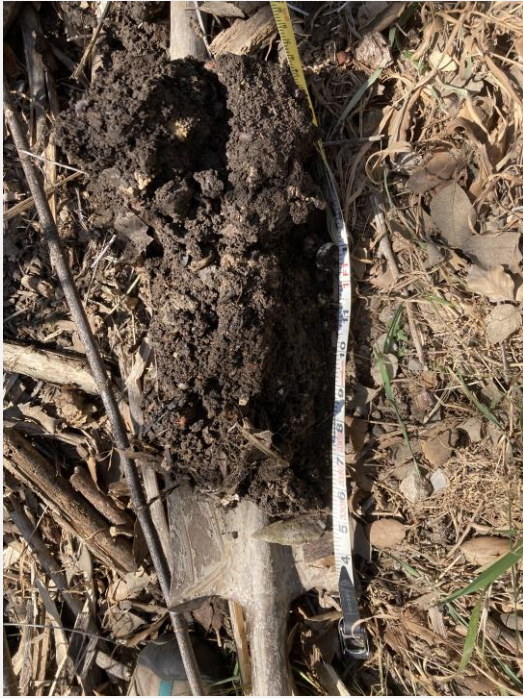
Photo 5. Soil profile for sample point SP01, March 3, 2022

Depth (inches)	Matrix		Redox Features				Texture	Remarks
	Color (moist)	%	Color (moist)	%	Type	Loc ²		
0-5	—	—	—	—	—	—	—	dead plant material
5-8	10YR 3/2	100	—	—	—	—	loam	high amounts organic dead
8-16	10YR 2/2	100	—	—	—	—	loam	high amount of rocks, plant material

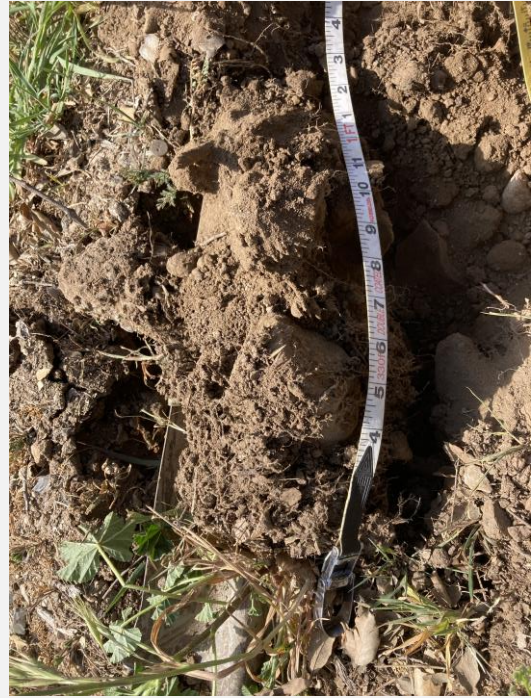
Photo 6. Soil profile for sample point SP02, March 3, 2022

Depth (inches)	Matrix		Redox Features				Texture	Remarks
	Color (moist)	%	Color (moist)	%	Type ¹	Loc ²		
0-13	10YR 3/3	100	—	—	—	—	loam	Some large rocks

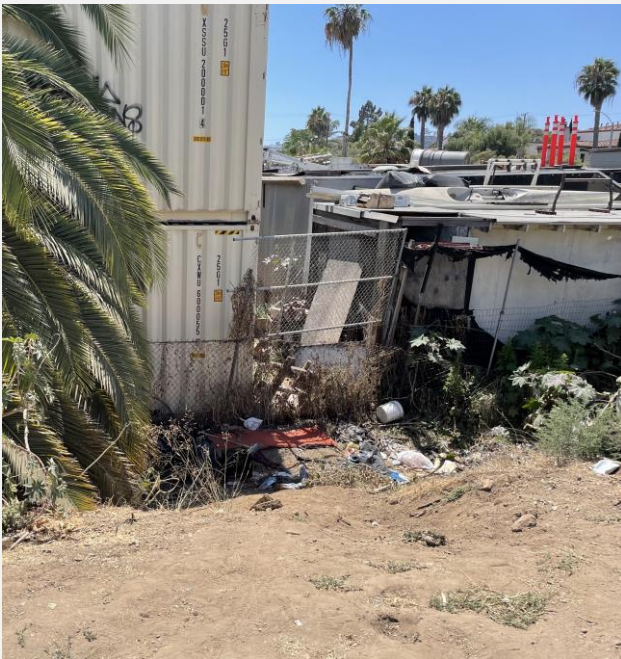
Potential for human-induced degradation or disturbance. The Garden Street Drain is currently highly disturbed, with several existing homeless encampments and several trash piles providing breaks in the vegetative cover. The entire surrounding area is already developed. Because of this baseline of disturbance, the feature does not meet this criterion as ESHA.

Photo 7. Trash associated with homeless encampment, August 3, 2022

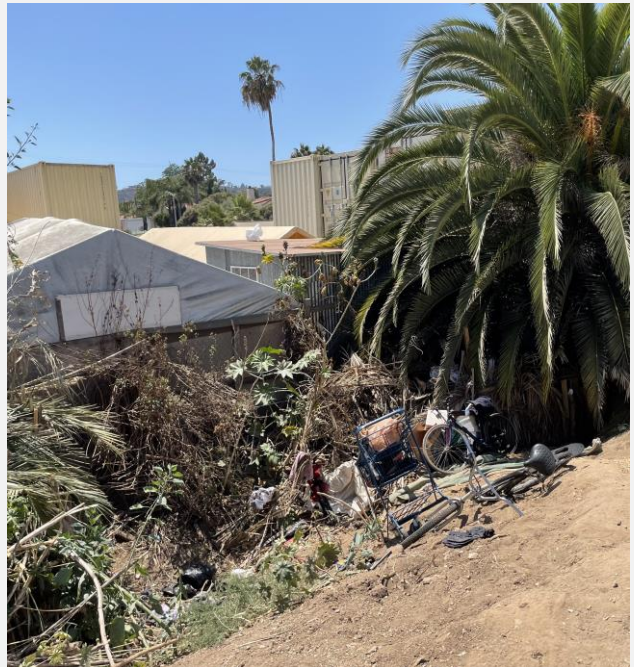
Photo 8. Trash within Garden Street Drain, August 3, 2022
