Annual WaterQualityFiscal YearMonitoring and2016Research Report

City of Santa Barbara Creeks Division December 31, 2016

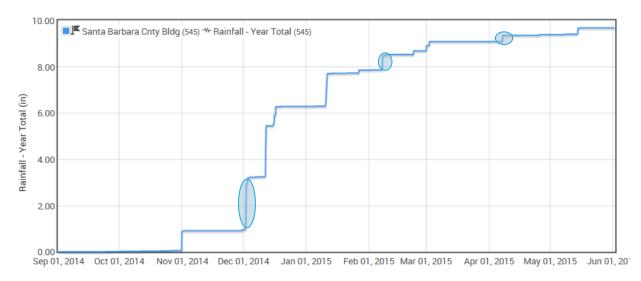
FIGURE 4. TOTAL RAIN ACCUMULATION IN WATER YEAR 2014-2015. BLUE OVALS INDICATE SAMPLED EVENTS.

Despite below-average rainfall, samples were collected and tested during three storms (**Error! Reference source not found.**). Rainfall patterns show that the storms were representative of rainfall throughout the year (**Error! Reference source not found.**). Due to rapidly changing forecasts, staff limitations, and small storms during most of the year, the goal of composite samples covering three time points for each storm was not achieved. Two samples were composited with two time points per location, and the third storm was sampled as a grab sample (although multiple sampling sites were used, as mapped above, at most locations).

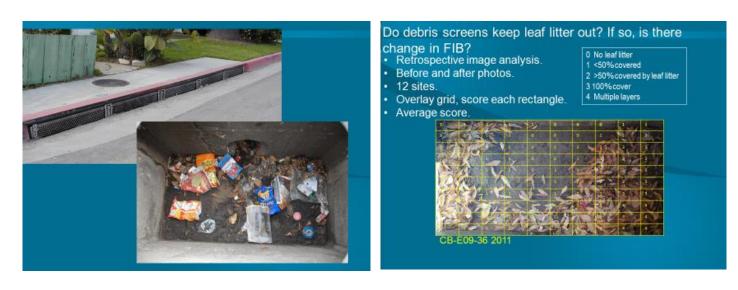
- 0 No leaf litter
- 1 <50% covered by leaf litter
- 2 >50% covered by leaf litter
- **3** 100% cover Evidence for multiple layers at
- 4 100% coverage

FIGURE 22. METHODS FOR CATCH BASIN LITTER SCORING

Photographs were taken every year inside the manhole or other opening of 12 catch basins. The photos were analyzed by placing a digital grid over each photo in Powerpoint (Figure 22). The grid was stretched to fit the photograph so that 100 grid spaces filled the photograph. Leaf litter in each grid space was ranked according to the following metric:
