# CHAPTER 2.4: EXTERIOR PLASTER AND MASONRY

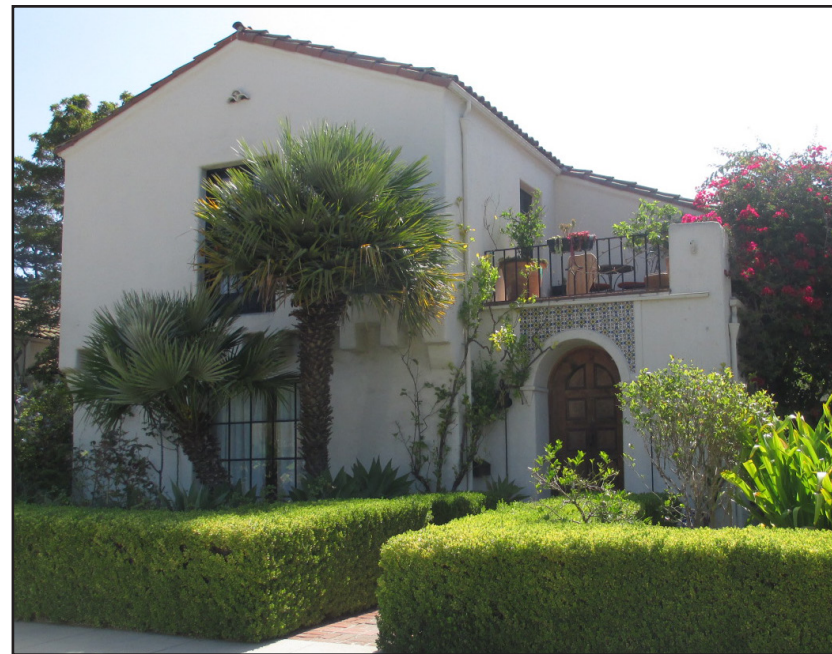
*Santa Barbara is famous for its white stucco historic resources, characteristic of the Spanish Colonial Revival, Mediterranean, and Mission Revival architectural styles.*

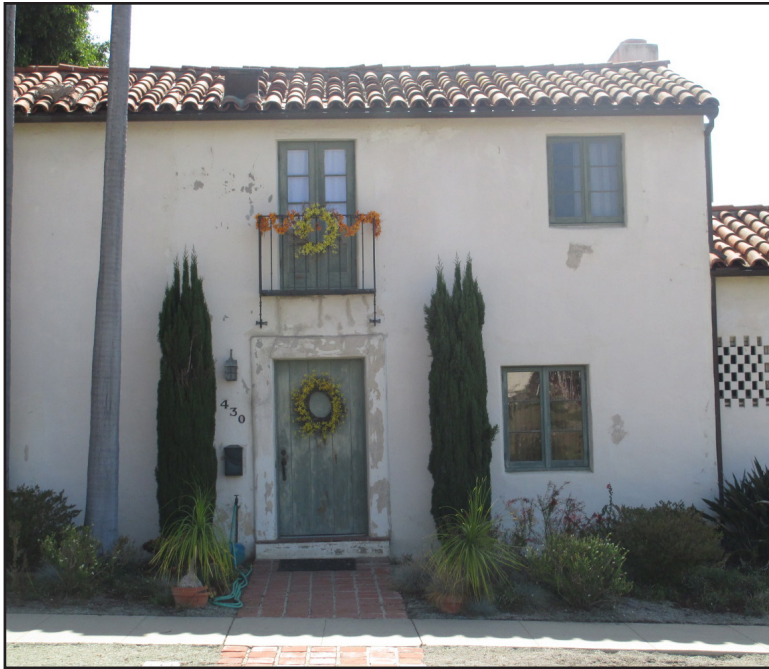
*Using true stucco rather than a synthetic stucco is recommended for repairing stucco on Santa Barbara historic resources.*

True stucco, or cement plaster, is a combination of sand, lime, Portland cement, water. In some cases, pigments were added to the mix to alter the finished color. True stucco coatings are recommended for historic structures. On the contrary, Exterior Insulation and Finish System, or EIFS, is a synthetic stucco system that includes an inner foam insulation board, a middle polymer, a cement base coat that is reinforced with fiberglass mesh, and an exterior textured finish coat. EIFS does not “breathe” and can trap moisture within the wall thickness which can cause mold and mildew to rot wood sills and framing. Because of its visual characteristics and the potential harm it can cause to a historic structure, synthetic stucco is not permitted by the Historic Landmarks Commission (HLC) on any contributing historic resources, Structures of Merit, or Landmarks.

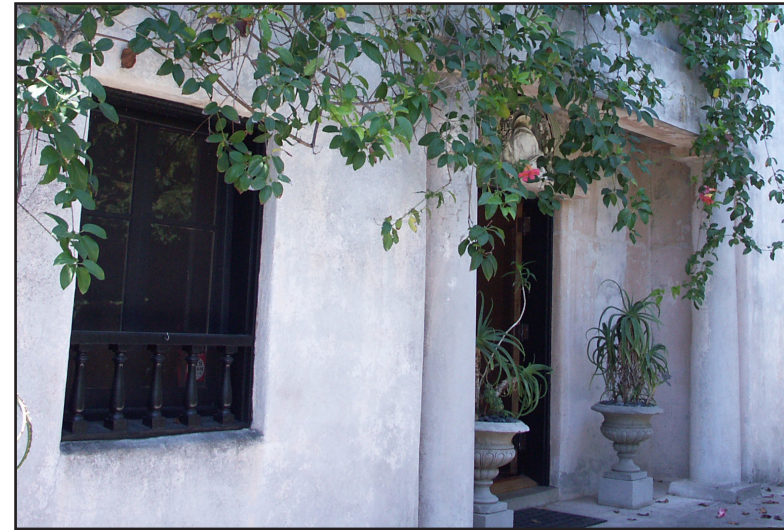
*Well maintained stucco can last hundreds of years.*

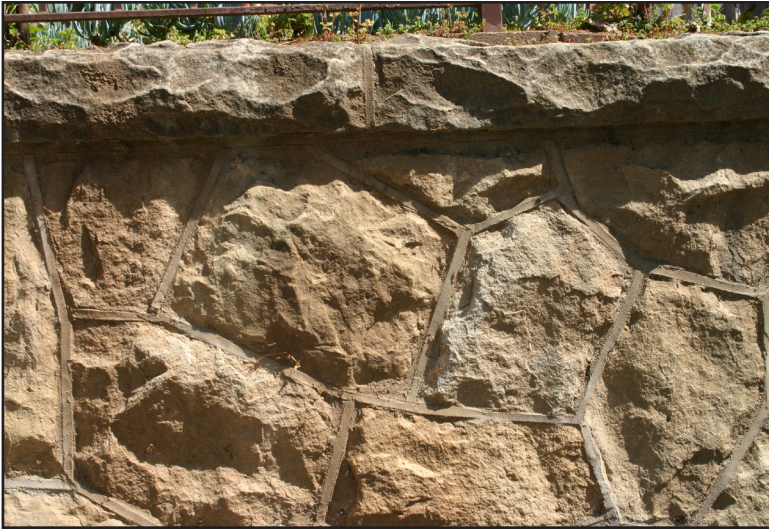
*Cut stone walls are common throughout Santa Barbara's historic neighborhoods.*

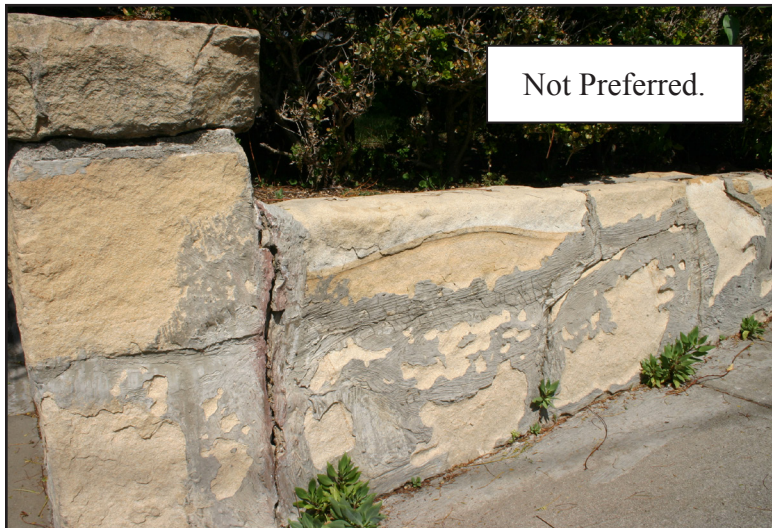
*Poor maintenance and improper repointing can damage stone walls.*

Replacing damaged mortar with compatible mortar is called repointing. Check the mortar between the stone or brick regularly. Mortar that has worn away from the brick or stone face or has vertical cracks should be replaced. The compatible mortar mixture must be the correct composition or it can cause damage and spalling to the stone or brick. A professional mason with experience in historic masonry may be required to do the work.

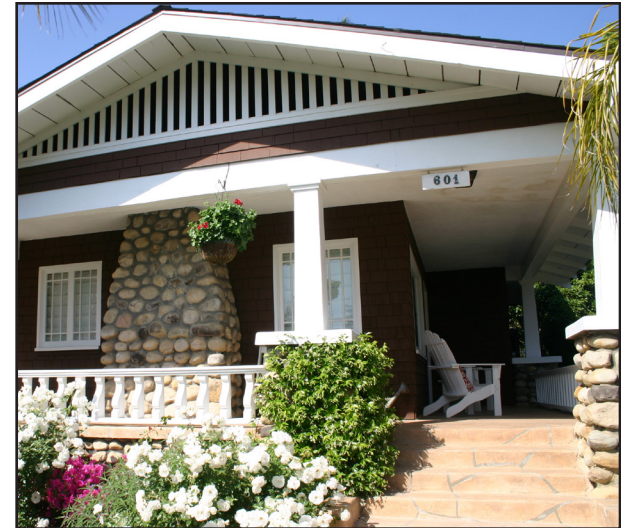
*Cobblestone chimney and piers are an important design feature of this Craftsman Style residence in the Bungalow Haven Neighborhood.*

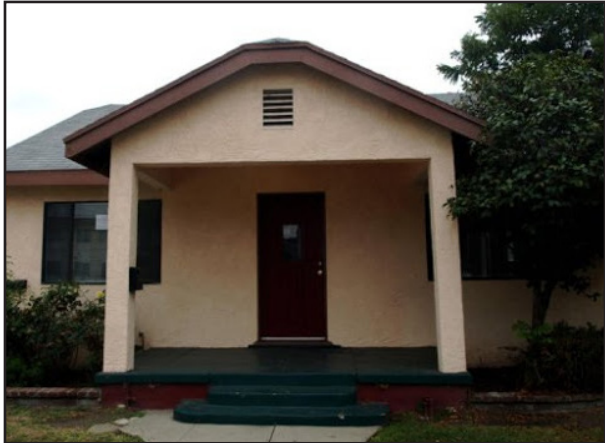
*Before: The wood sided Craftsman style bungalow was inappropriately covered with stucco. Photo from the eastsidela.com web site.*

- 2.4.13 Avoid sandblasting masonry.
- 2.4.14 Avoid coating stucco, brick, or stone with waterproof coatings.
- 2.4.15 Avoid application of stucco over a traditionally wood-sided structure.

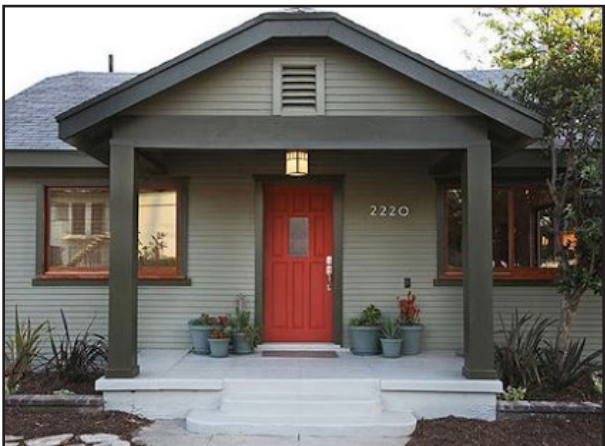
*After: The wood sided bungalow after the stucco was removed and the character-defining wood siding restored. Photo from the eastsidela.com web site.*
