**FRONT YARD SET BACK TREE REMOVAL
REQUEST**

Arborist Report

I was asked by Christopher Harris of Lambe Construction to visit the above site to help determine what effect construction would have on a 24" dbh (trunk diameter at breast height) Cook Pine, *Araucaria columnaris*. A previous residence building was demolished in May of this year to facilitate the construction of a new building. As a result, a trench was manually excavated east to west at approximately 3' from the tree's trunk base for the installation of a patio foundation (refer to the photograph on page 2).

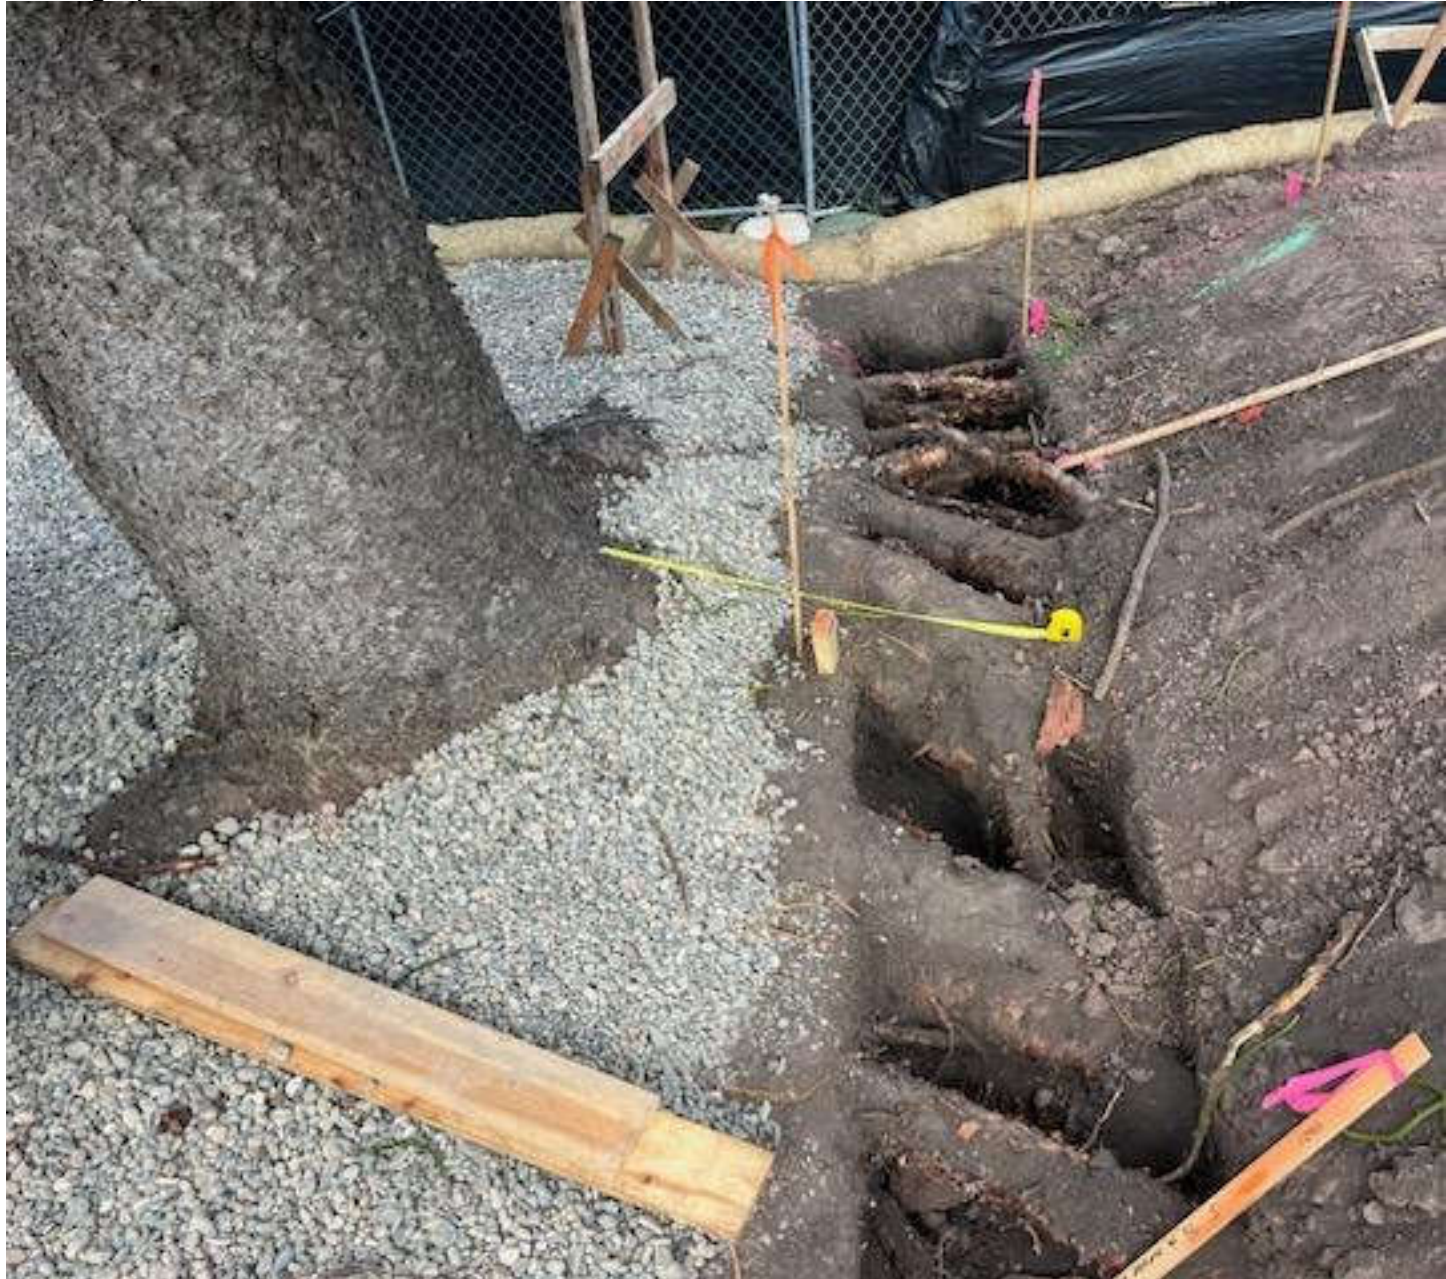
Photograph of Tree and Patio Foundation Trench

Figure 2. Photo shows the carefully excavated trench showing the tree's large roots extending toward the proposed building. The trunk edge is 3' from the center of the trench.

As can be seen in the photograph above, there are a multitude of major roots which were exposed through manual digging. Initially, our procedure was to carefully expose roots and install a foundation which would preserve them intact and without harming them: this is termed a grade beam on pylons where the pylon supports would be positioned between roots.

It was concluded that the protection of the tree's major roots could not be treated with the grade beam on pylon method of foundation support due to their close proximity to each other. As a result, the only option available for foundation installation would be a massive root severing with probable negative consequences for health and support.

I recommend, under the circumstances outlined above, that the tree be removed.
