City of Santa Barbara
Public Works Department

City of Santa Barbara Annual Wastewater Operations Management Report

Fiscal Year 2022 (July 1, 2021 – June 30, 2022)

Water Resources Division, Public Works Department
October 20, 2022

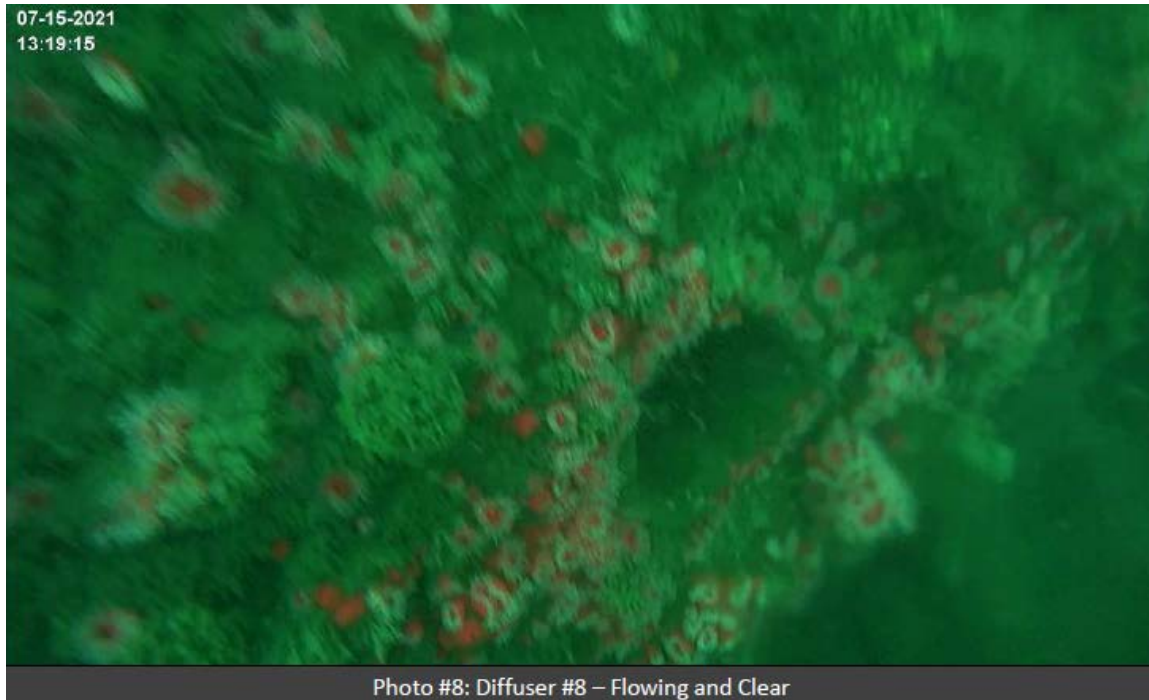
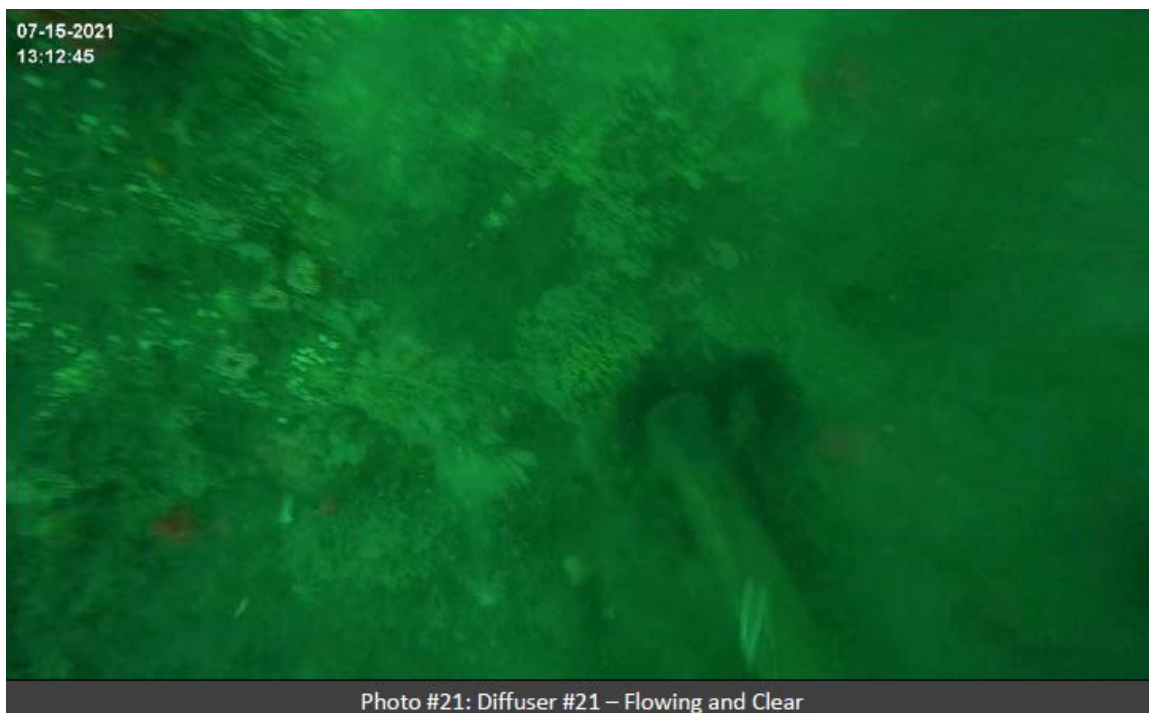
Below are typical photos from the dive inspection of the ocean outfall.

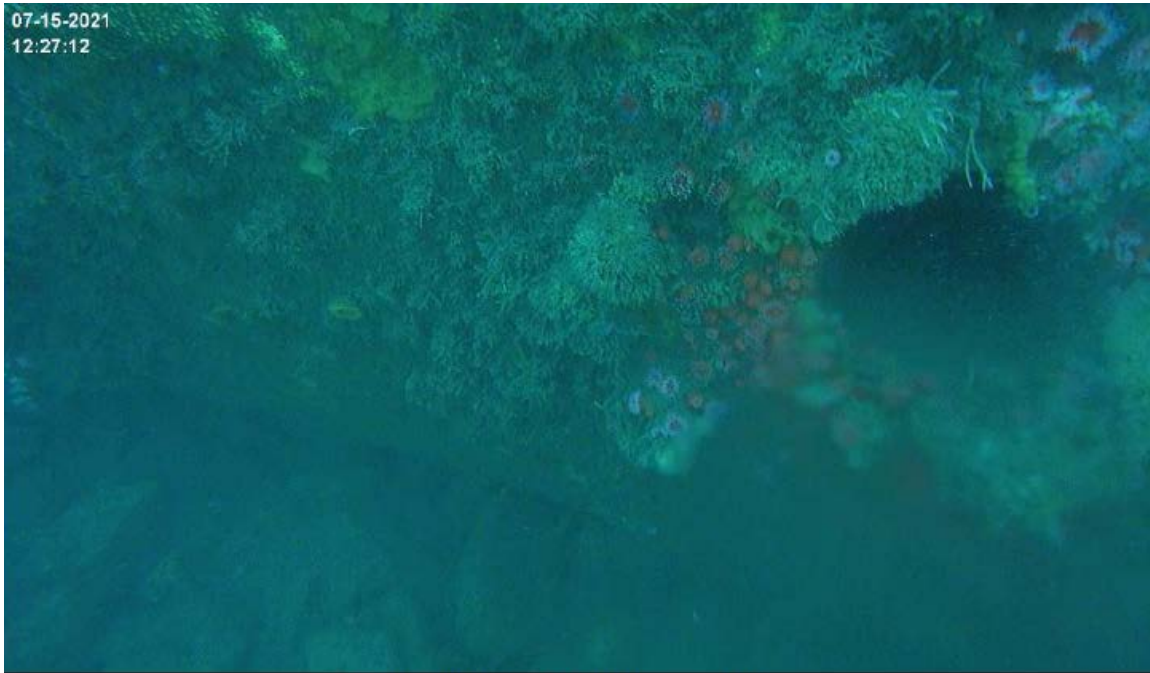
Photo #42: Diffuser #42 – Flowing and Clear

After completing the diffuser inspection, the diver began the swim by video inspection of the outfall. The outfall was found to be lying on firm bottom at approximate spring line. No scour or unsuspended joints were detected during the inspections. After inspecting all joints of pipe, a diver was sent back to the offshore end to deflate the lift bag thus closing the end gate. The gate had

been open for just over 4 hours. Outfall continues to be in good overall condition with no damage or anomalies found.

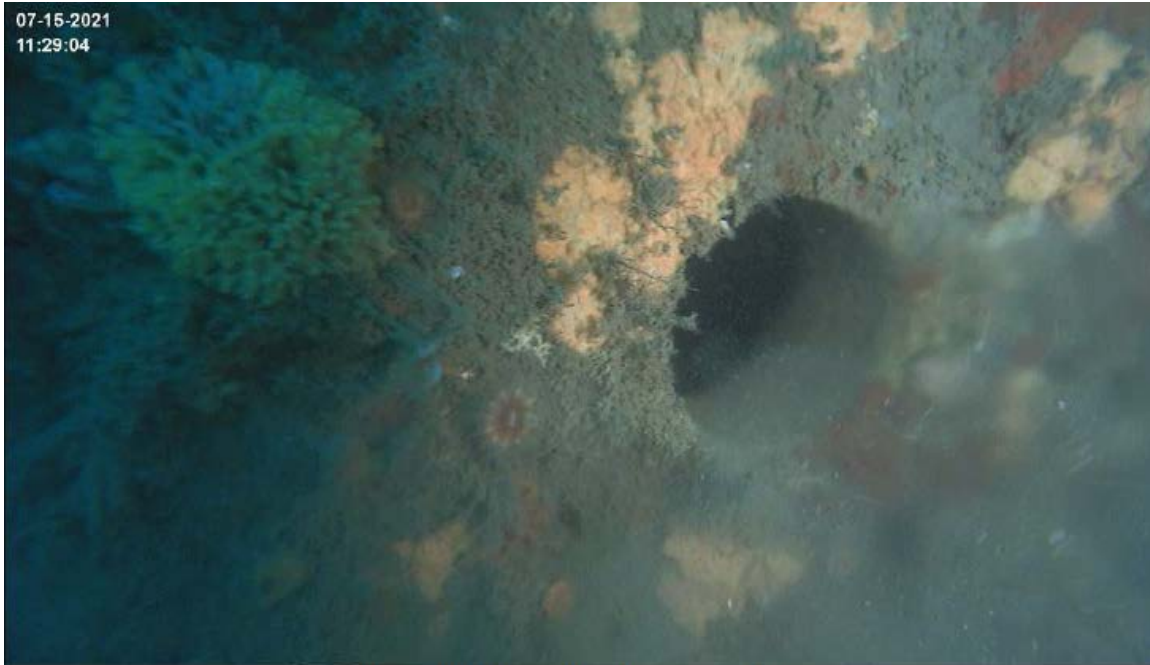
Photo #56: Diffuser #56 – Flowing and Clear

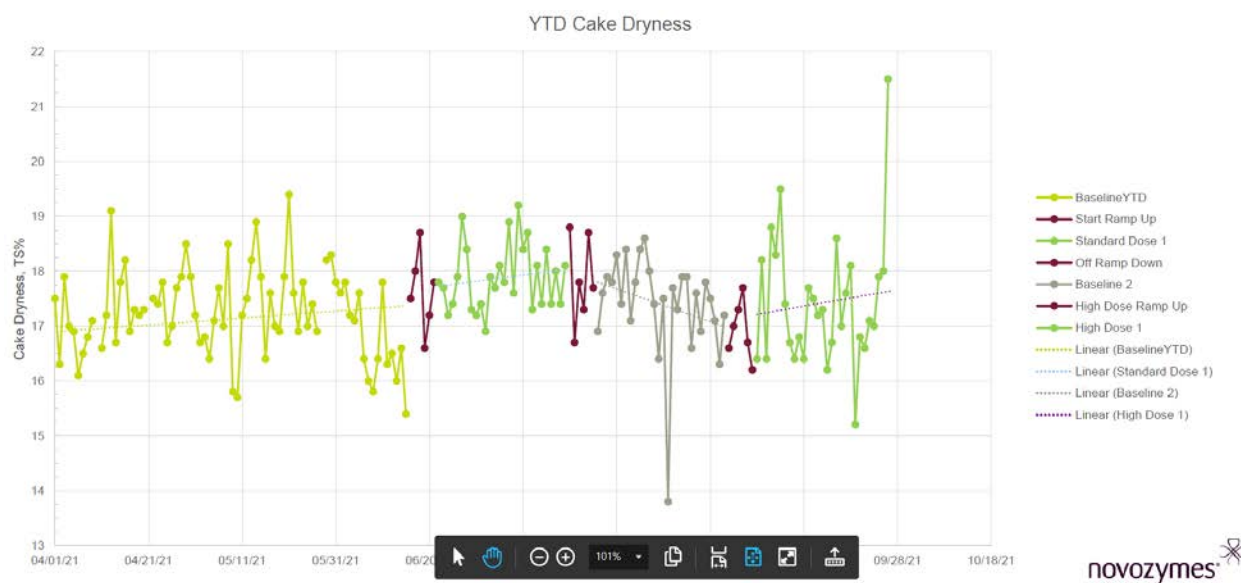
Novozymes BioSec Full Scale Trial

Based on the promising laboratory results, Novozymes provided pumping equipment and enzyme supplies to perform a full-scale trial of BioSec at El Estero. Novozymes started up their equipment and trained Operations staff on its Operation in June 2021. Full scale testing ran from June 2021 to October 2021. Operations staff and Laboratory staff performed their regular sampling and analysis and shared results with Novozymes. Initially staff saw a slight improvement in dewatering performance, but it was not sustained. It appeared that variability in the biosolids characteristics, namely percent volatile solids, affected the performance of the BioSec.

While the Trial results were inconclusive and the City did not opt to pursue further investment in this technology, the exercise was a positive experience for the Operations staff as it renewed operator attentiveness to dewatering operations and was a good training tool for new staff on dewatering system optimization.
