TREE INVENTORY AND ASSESSMENT

Project location: Garden Street Hotel, 101 Garden St., Santa Barbara 93101

February 22, 2022

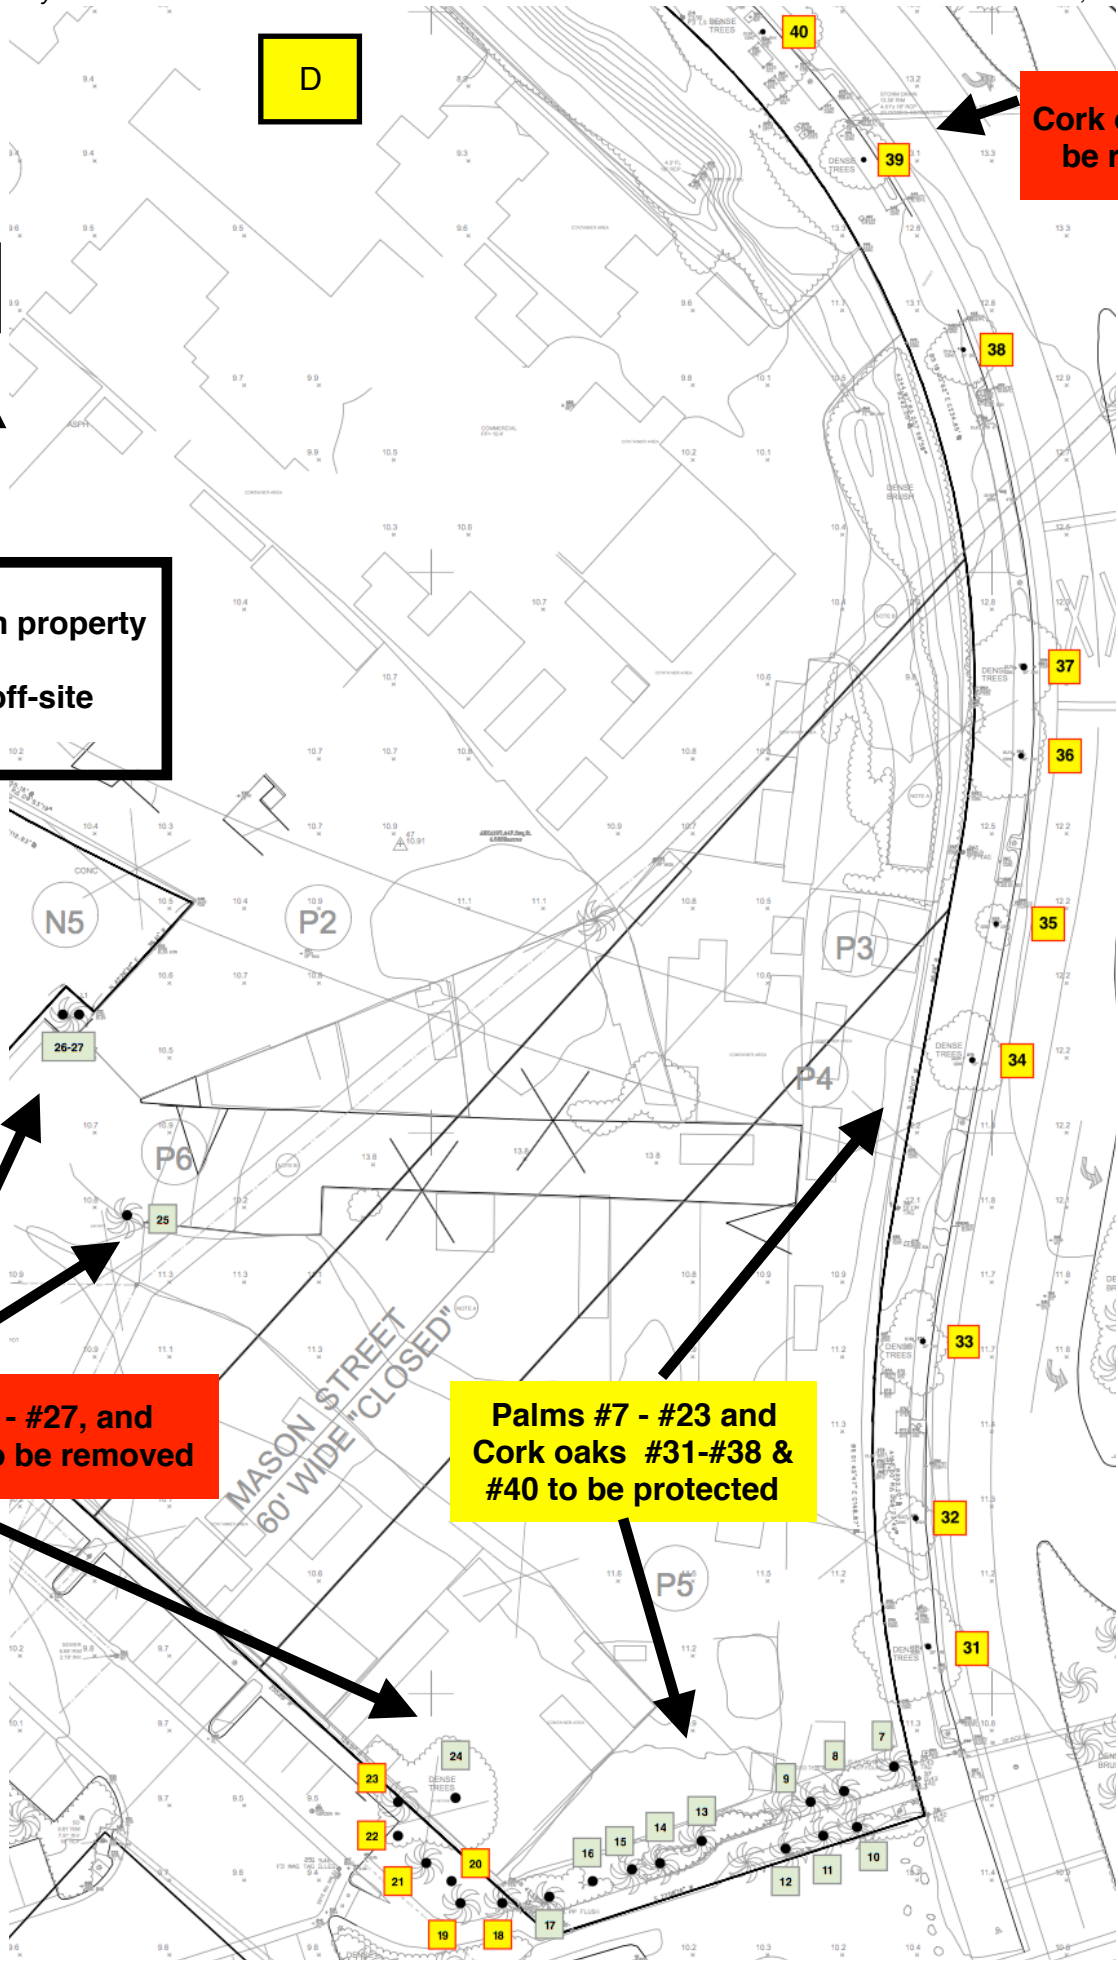
Cork oak #39 to be removed

Palms #25 - #27, and pepper #24 to be removed

Palms #7 - #23 and Cork oaks #31-#38 & #40 to be protected

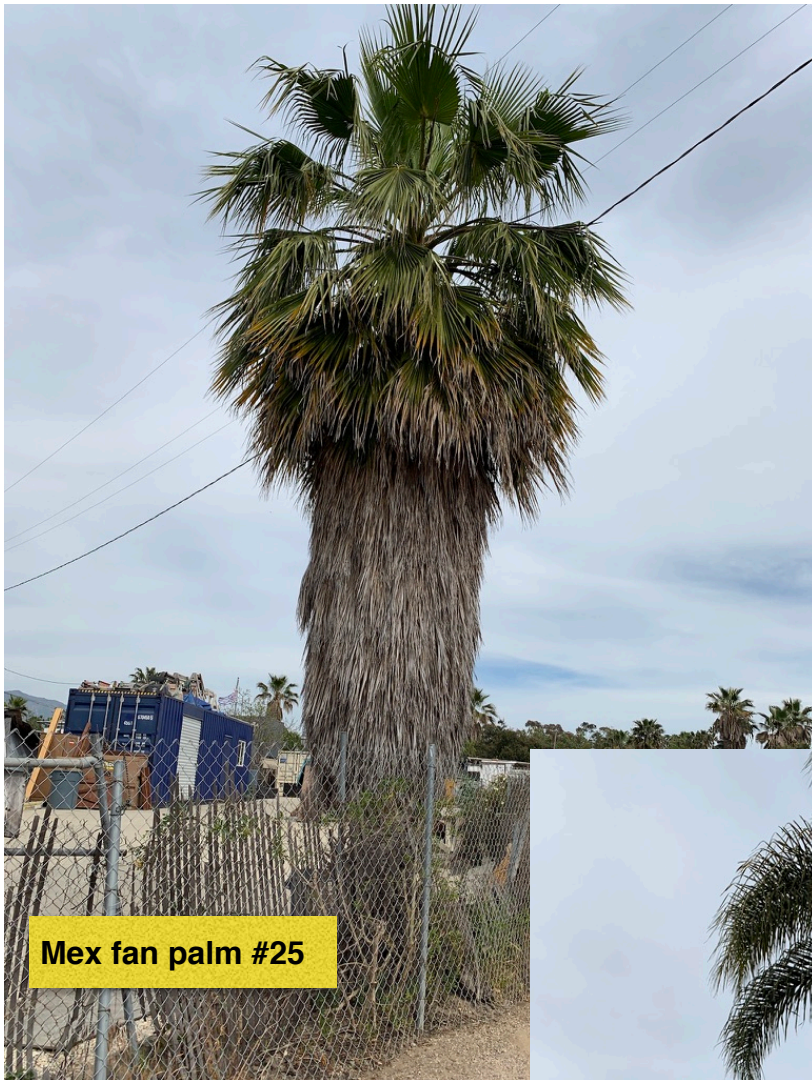
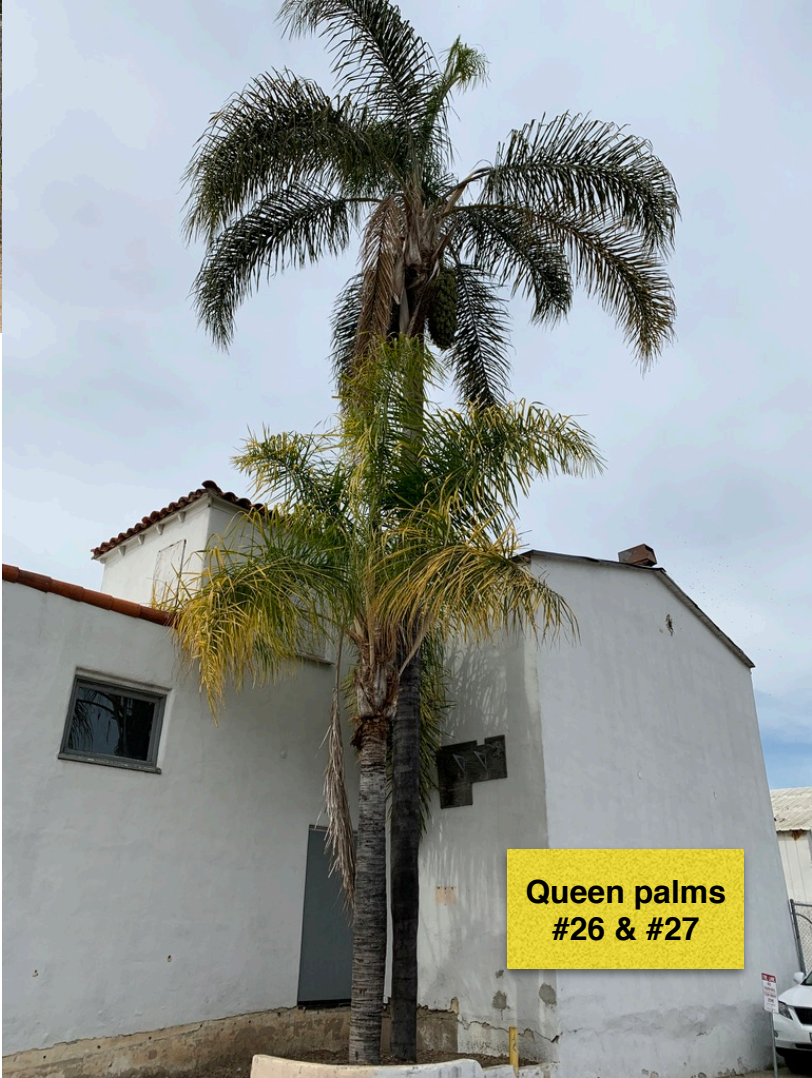
**Above: California pepper #24
Left: with 26" trunk**

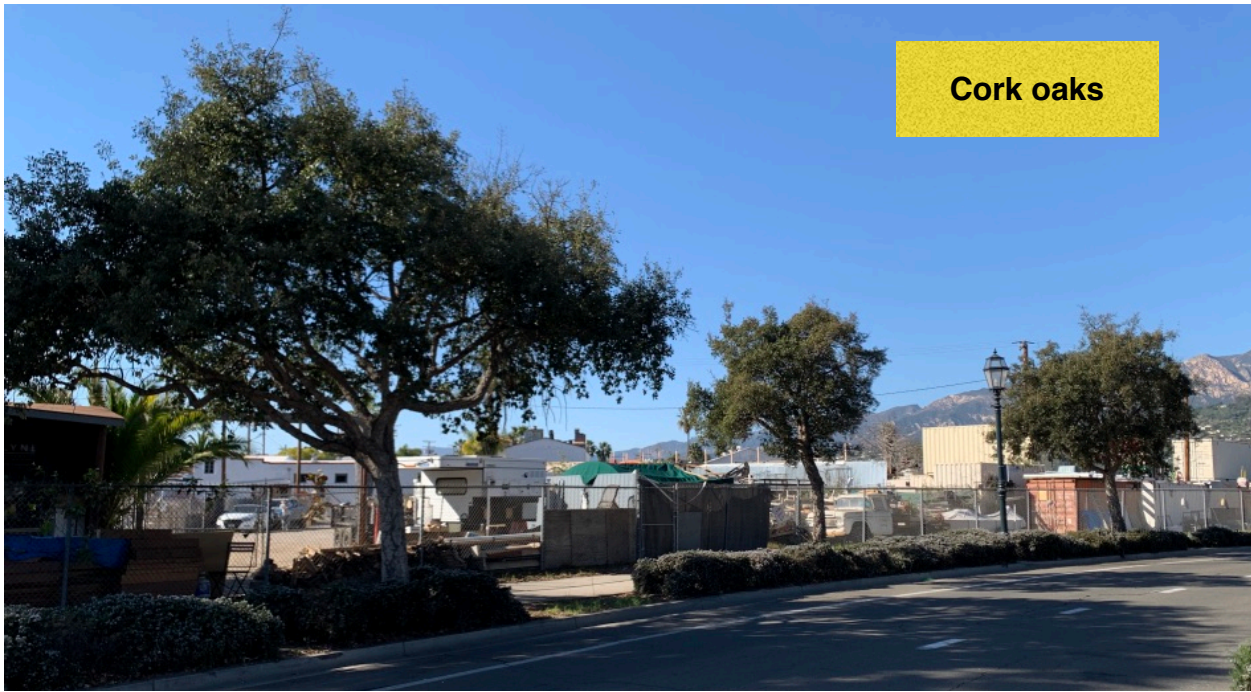
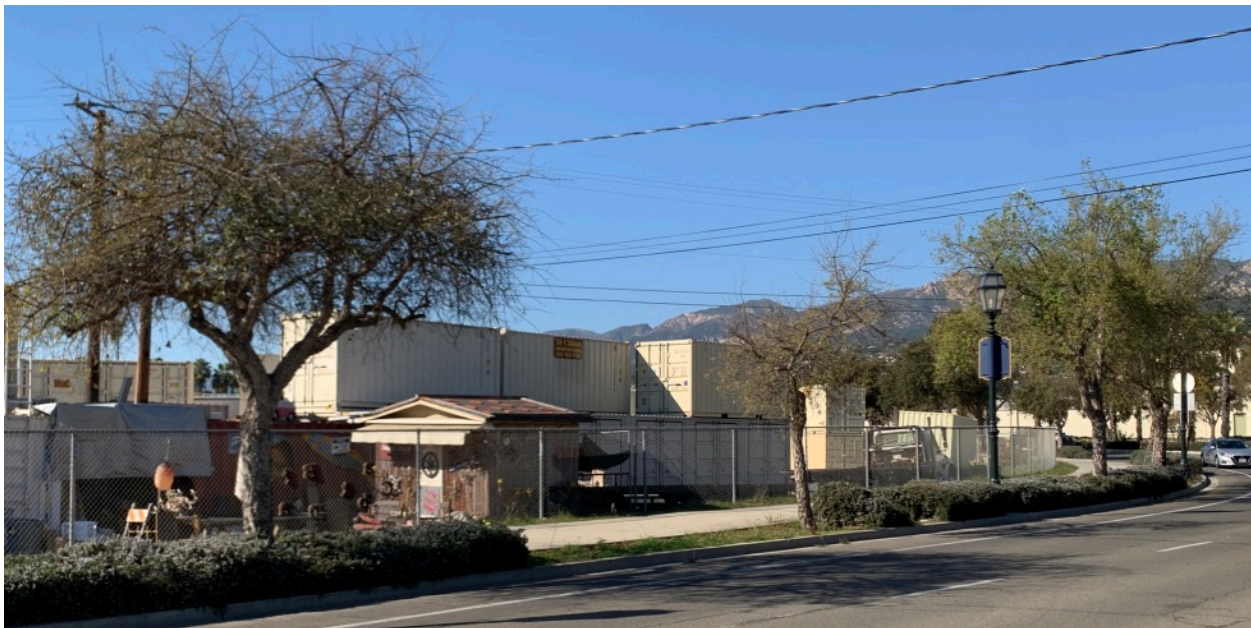
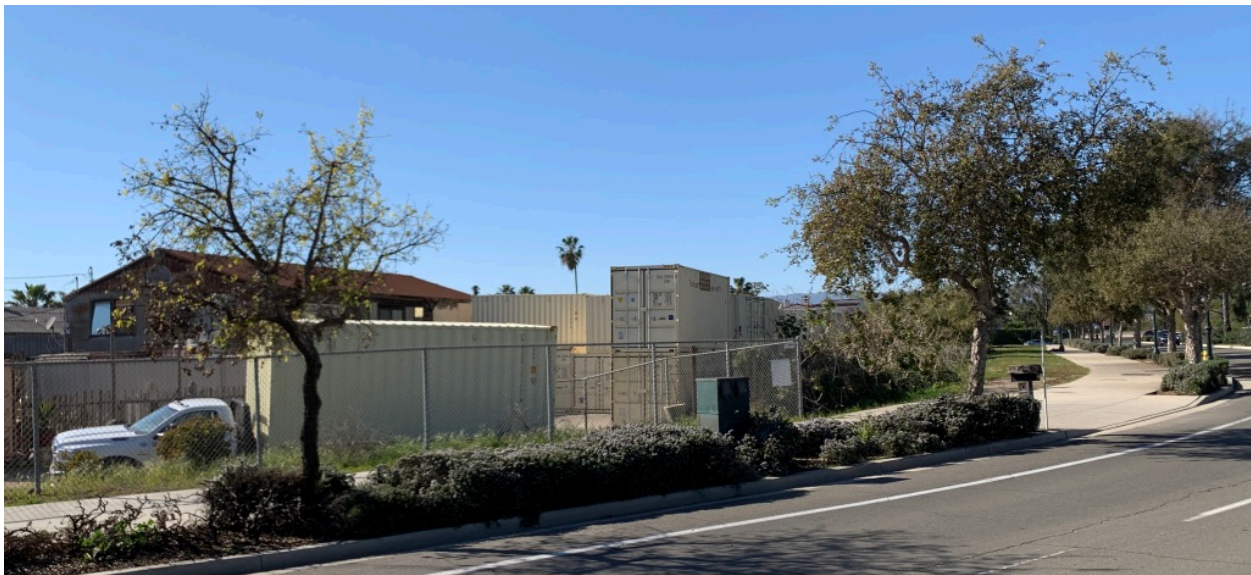
Cork oaks

9. The City has planted 19 Cork Oak trees along Garden Street that are mostly in fair condition after a significant infestation of oak worms. Most appear to be recovering fairly well and should survive.
