January 13, 2025

TREE ASSESSMENT, PROTECTION, AND MITIGATION PLAN

Job Location: 1 HOT SPRINGS RD., Santa Barbara, CA 93108

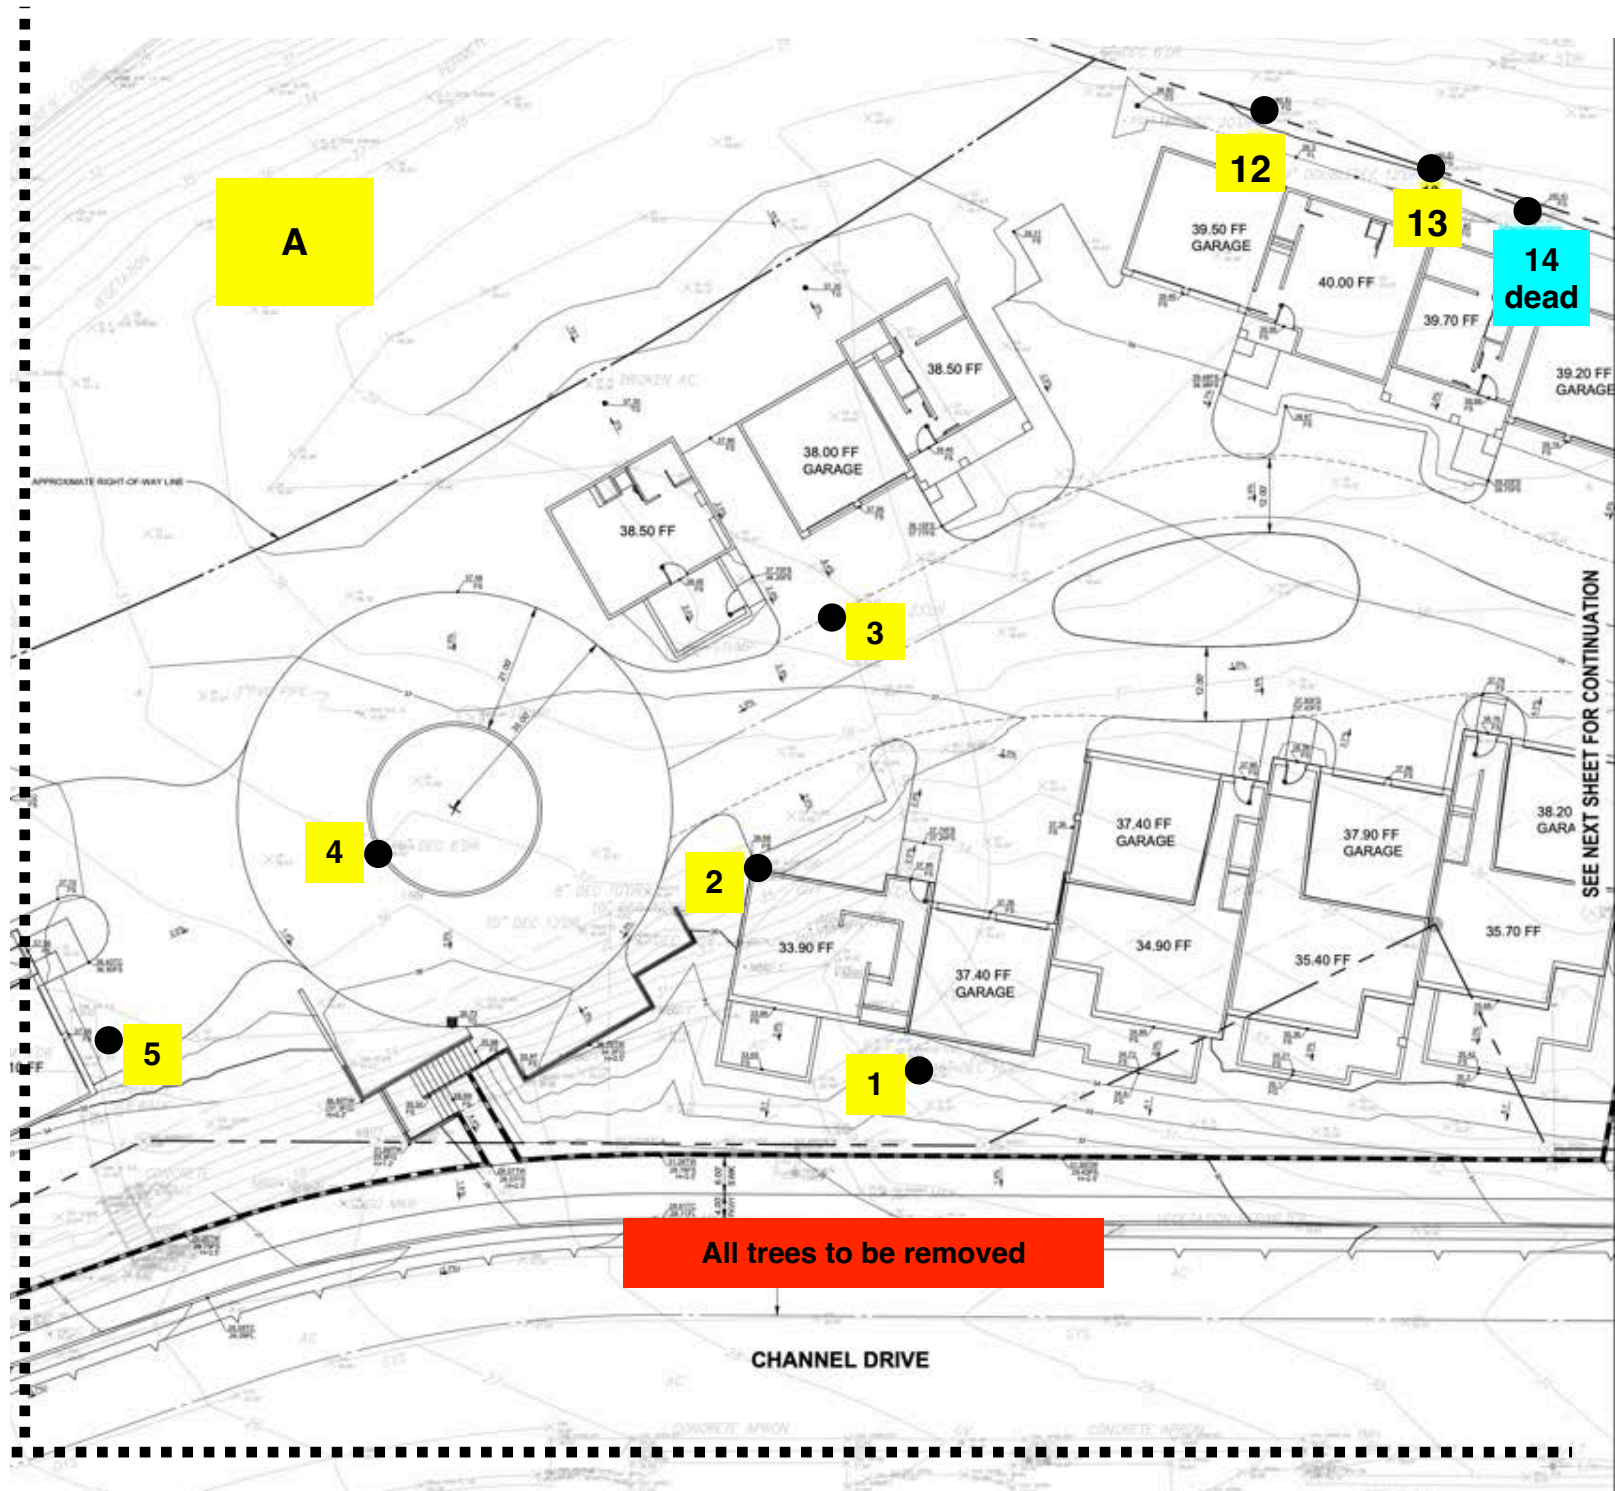
#	Type	DBH "	CRZ r'	Height	Condition	Comment	Project Impact
1	Flowering euc	19		M	F	Topped	Remove
2	Acacia	9		S	P	Small horizontal tree	Remove
3	Cypress	34		L	F	Senescent, dead top and declining	Remove
4	Acacia	6		M	F	Small volunteer	Remove
5	Date palm	36		S	G	Small volunteer	Remove
6	Bruhia	20		M	G	Could transplant	Remove
7	Cook pine	23		L	F	Significant lean to south	Remove
8	Oak	12	12	M	G	Not on survey, coupled with #9	Protect-outside of area
9	Oak	12	12	M	G	Not on survey, coupled with #8	Protect-outside of area
10	Pittosporum	12		M	P	Adjacent dead pitt	Remove
11	Oak	29	29	M	G	Low skirt, grows south	Protect-outside of area
12	Pittosporum	19		M	P	In decline	Remove
13	Eugenia	13/9		M	F	Not great	Remove
14	Oak	26	dead	M	Dead	Infested with oak bark beetles	Remove
15	Oak	13	13	M	G	Along north prop line	Remove
16	Sugar gum euc	36/ 33		L	G	Needs cleaning, lots of deadwood	Protect-outside of area
17	Oak	11	11	S	P	Severe sycamore borer	Protect-outside of area

18	Silk oak	20		M	P	Dying back	Remove
19	Oak	9	9	S	G		Protect-outside of area
20	Blue gum euc	32		L	F	Stressed, leans to south	Remove
21	Blue gum euc	38		L	F	Toward rd	Remove
22	Blue gum euc	26		L	F	Topped	Remove
23	Blue gum euc	37		L	F	Toward rd	Remove
24	Blue gum euc	42		L	F	Topped	Remove
25	Blue gum euc	44		L	F	Topped	Remove
