GILDA PUENTE-PETERS
ARCHITECTS

CENTRAL LIBRARY
ACCESSIBILITY SURVEY

July, 2007

CITY OF SANTA
BARBARA

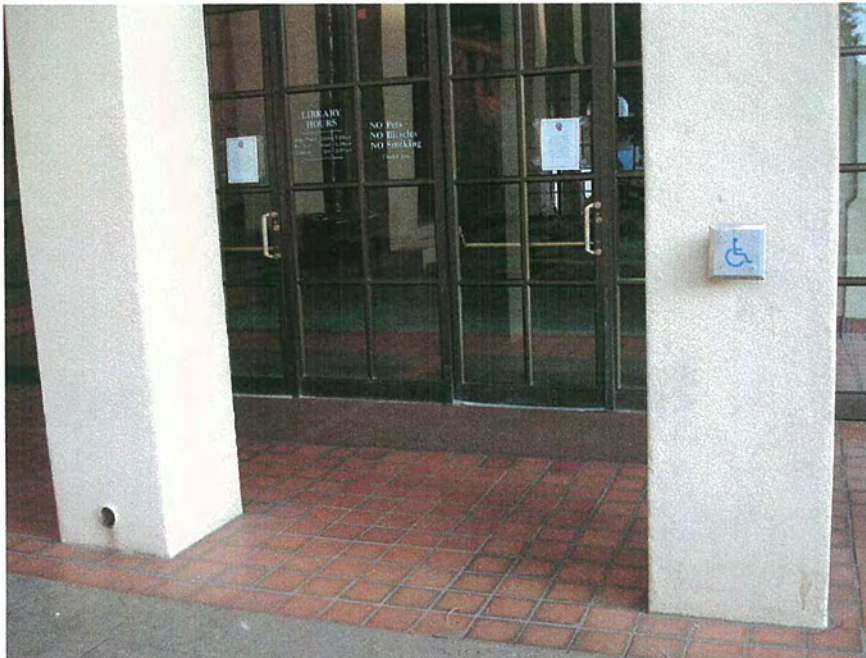
Building - Photo # 1

There is no International Symbol of Accessibility indicating the accessible door. Automatic door was not working at the time of the survey. There is no Tactile and Braille entrance identification sign. Glass doors do not have the required 10" smooth kick plate area.

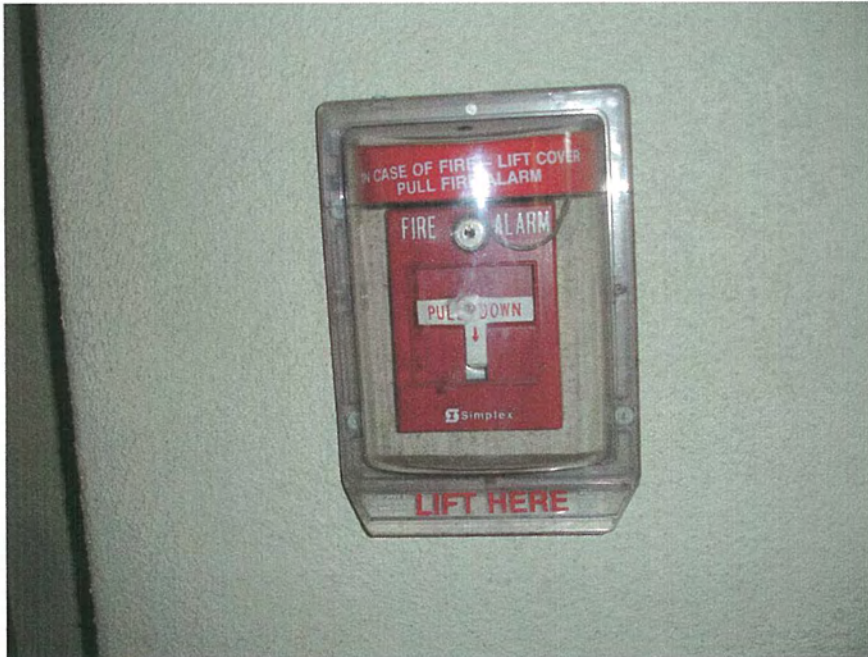
Building - Photo # 3

Fire alarm pull station requires tight grasping to operate and dual action, one to open the cover and another to trigger the alarm.

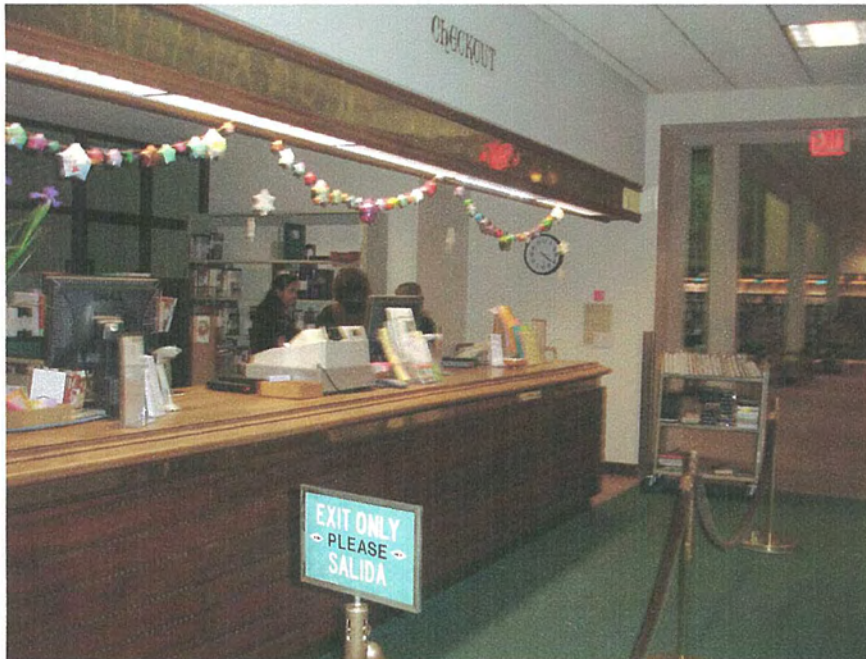
Building - Photo # 7

Checkout counter is too high 41" and does not have a low section of 34" maximum height by 36" wide minimum for wheelchair users. Crowd control ropes are not detectable by a white cane.

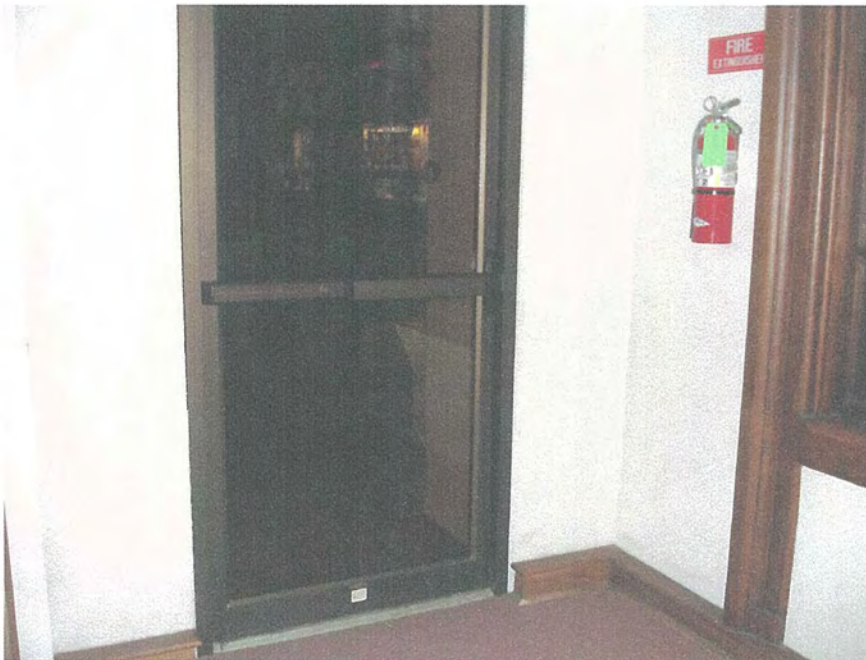
Building - Photo # 13

There is no Tactile and Braille "EXIT" identification sign. Glass doors do not have the required 10" smooth kick plate area. Fire extinguisher operable mechanism is mounted too high.

Door threshold height exceeds 1/2" including bevel section.	Change in level between 1/4" and 1/2" shall be beveled with a slope no greater than 1 unit vertical to 2 units horizontal. Change in level greater than 1/2" shall be accomplished by means of a ramp.	7/8" threshold at North exit doors.	ADAAG: 4.13.8	T24: 1133B.2.4.1	Remodel area to provide compliant door landing and threshold.	50	SF	\$25	\$1,250	2	
Bottom Kick plate.	10" high min. smooth, uninterrupted surface at push side of doors on accessible route. (CA only). Except for automatic & sliding doors.	Glass door has a 5" kick plate area.	ADAAG:	T24: 1133B.2.6; Fig. 11B-29	Provide kick plate on push side of door when altering area.	1	JOB	\$100	\$100	2	
		Photo #: 13

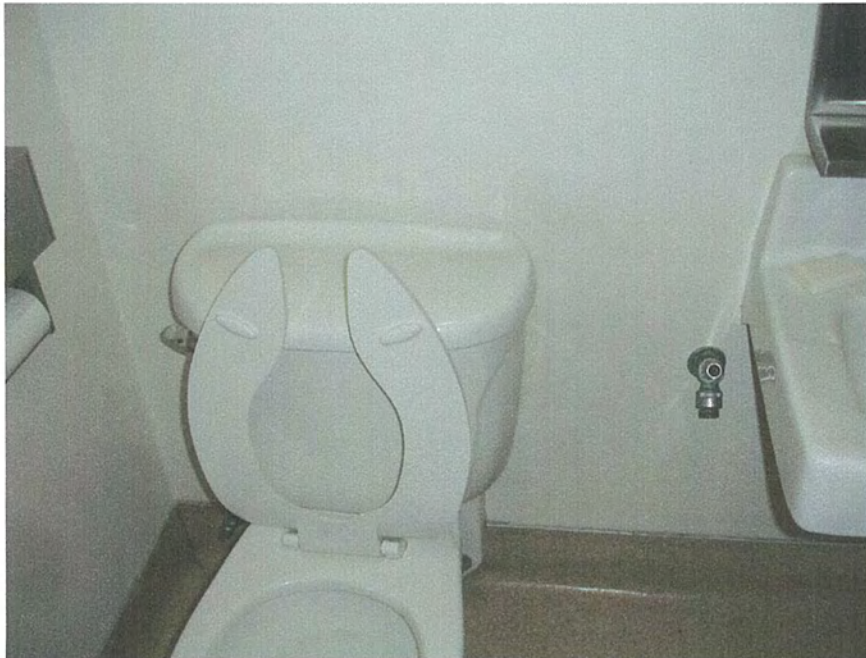
Building - Photo # 29

Boys and girls restrooms are inaccessible, too small without wheelchair maneuverable clearance, grab bars, strobe lights.

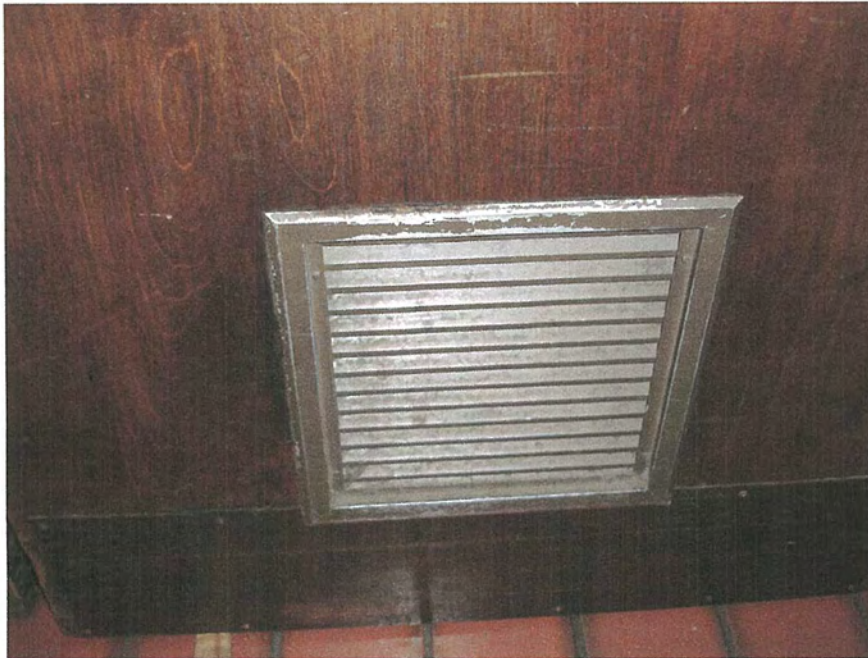
Building - Photo # 41

Surface mounted grill protrudes into the 10" kick plate area required to be smooth.

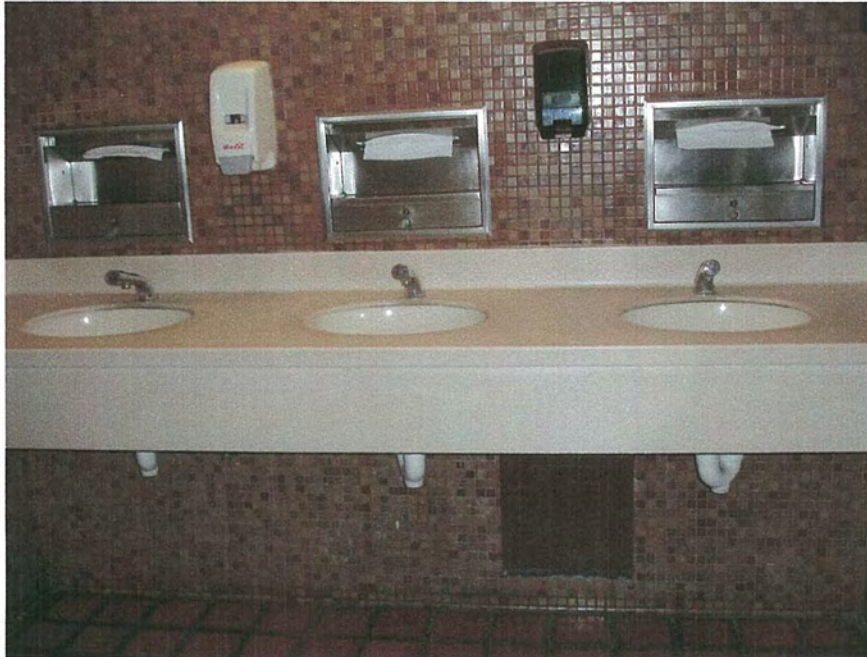
Building - Photo # 43

Vanity knee clearance is 26 ½" instead of 29" at the front and the top of counter 36 ¾" high instead of 34" maximum.

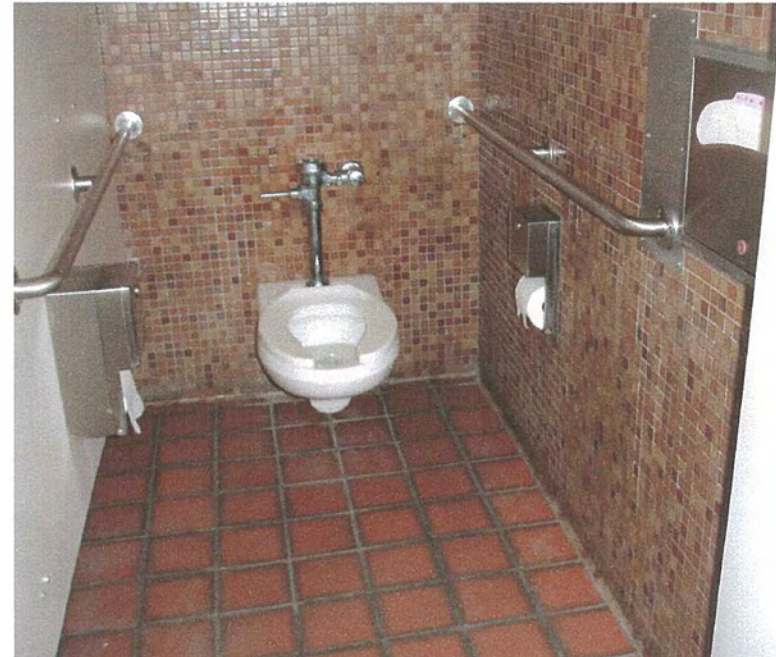
Building - Photo # 44

Men's water closet compartment is too narrow – 41" wide instead of 60". Water closet is located 19" from the wall to the centerline of fixture instead of 18" maximum. There is no back grab bar; seat cover dispenser is mounted too high.

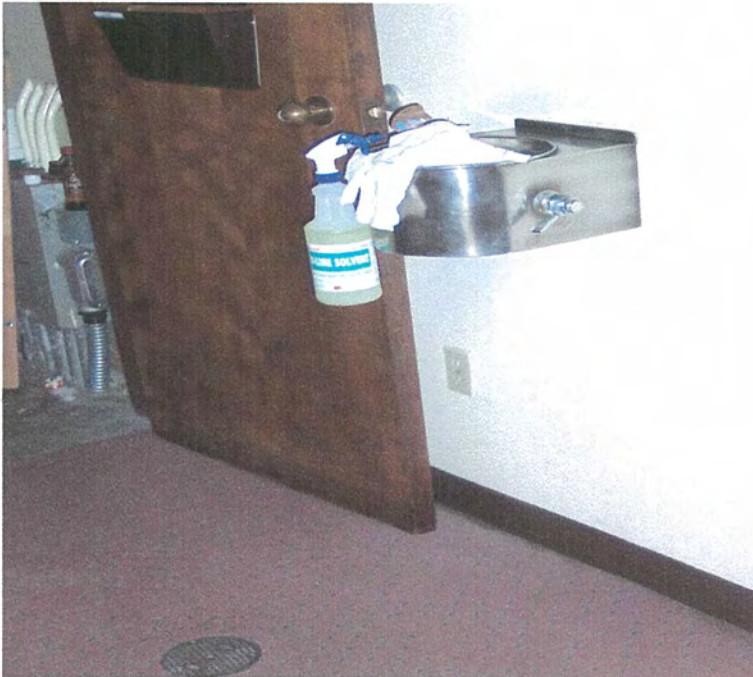
Building - Photo # 1

Drinking fountain is not located in an alcove and is not high/low. Bubbler is too high 41" instead of 36" maximum. Door hardware is not accessible type.

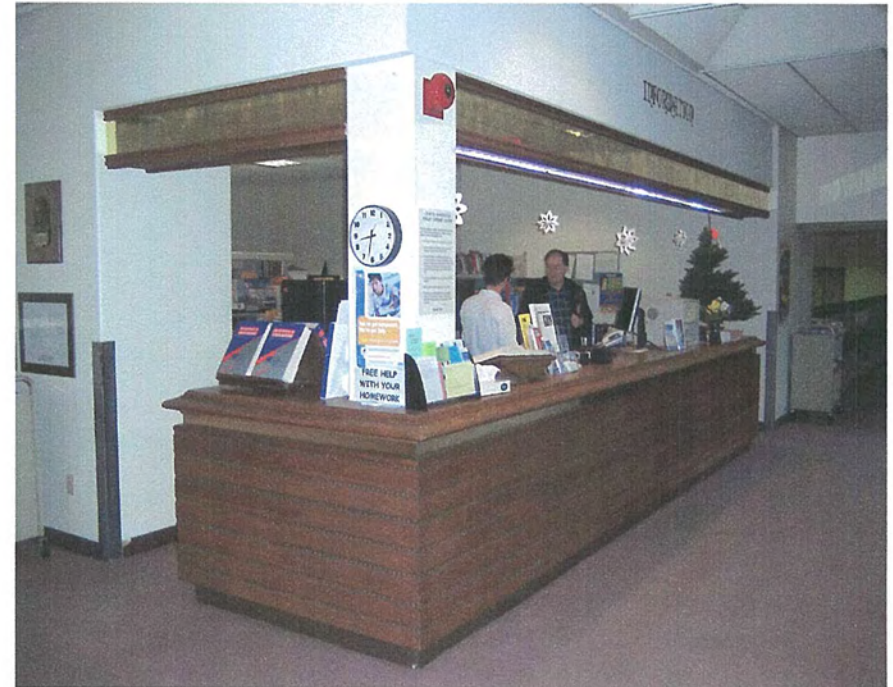
Building - Photo # 2

Service counter does not have a low section 34" maximum height – 41" high counter. Path of travel is 32" wide at one side and 34" at the other side instead of 36" minimum.

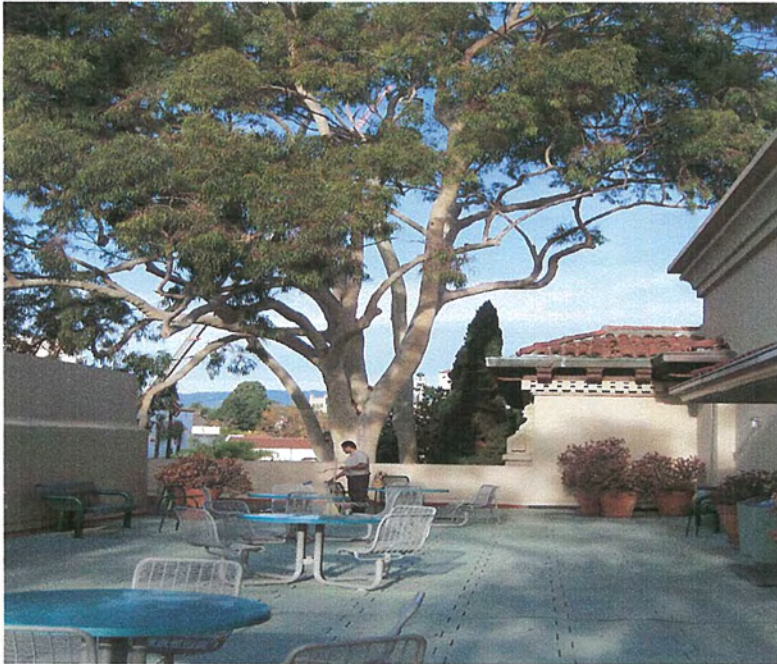
Building - Photo # 3

Terrace is not wheelchair accessible. A new ramp or wheelchair lift needs to be installed.

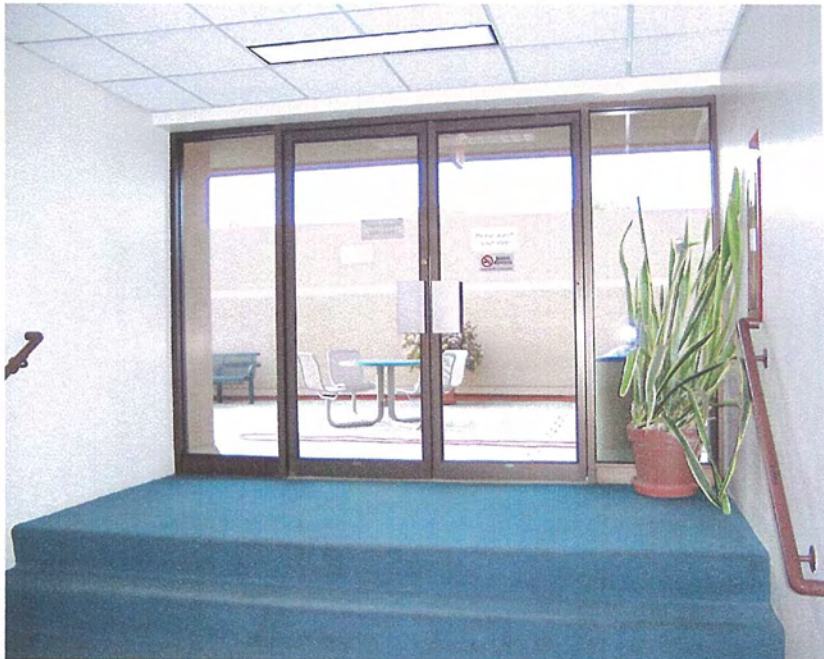
Building - Photo # 5

Stairs do not have contrasting color striping. Handrails do not have the required extensions. Terrace is not wheelchair accessible.

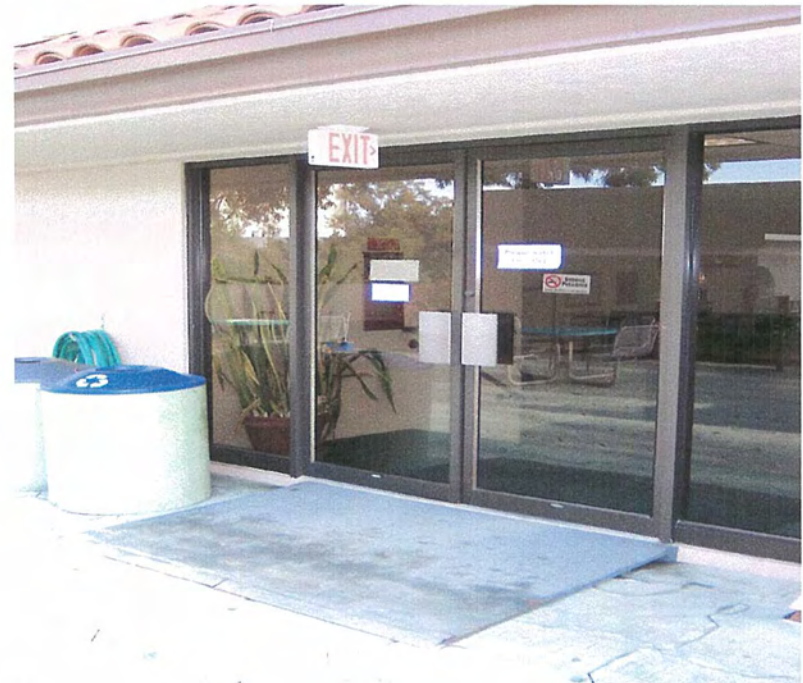
Building - Photo # 6

There is not a tactile and Braille "EXIT" sign and entrance sign.

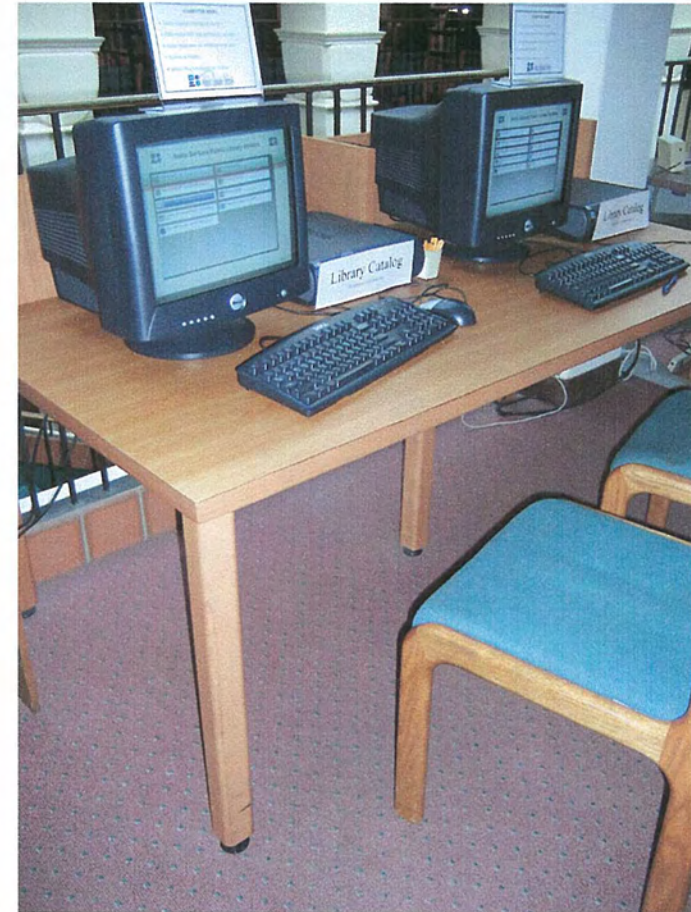
Building - Photo # 16

*Library catalog table has 26 ½" high knee clearance –
27" minimum required.*

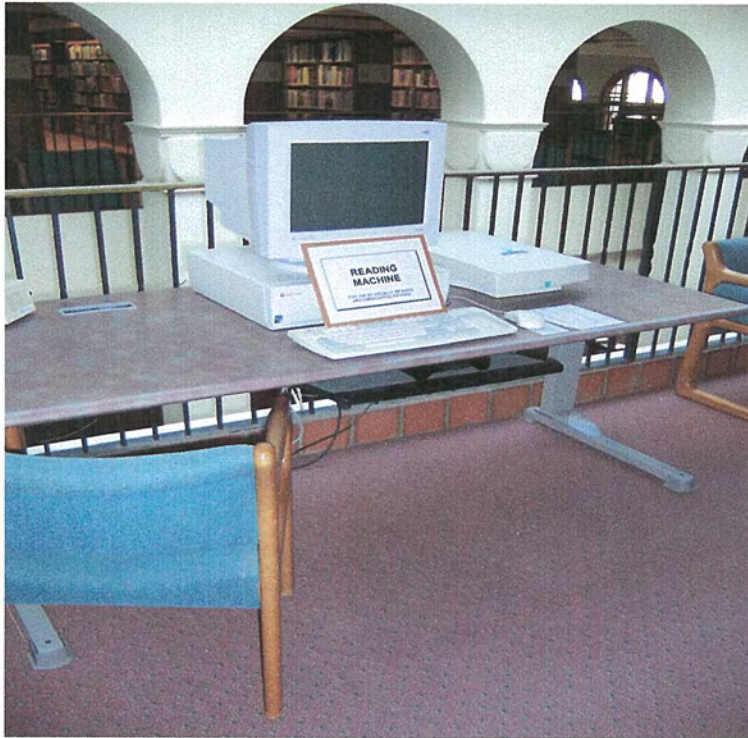
Building - Photo # 17

Do not use the term "handicapped" at reading machine table.

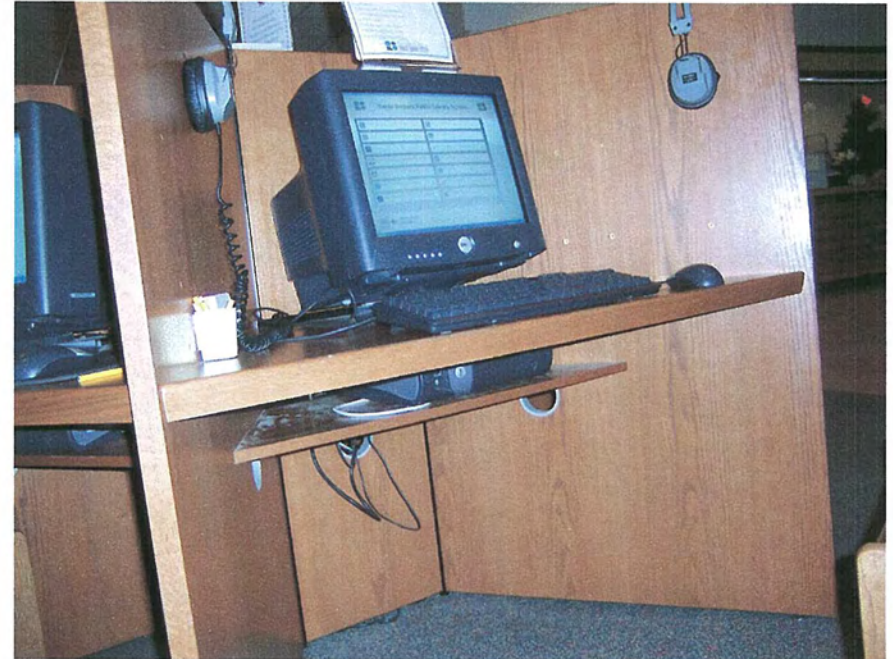
Building - Photo # 18

Internet station has 25" high knee clearance, instead of the 27" minimum required by code.

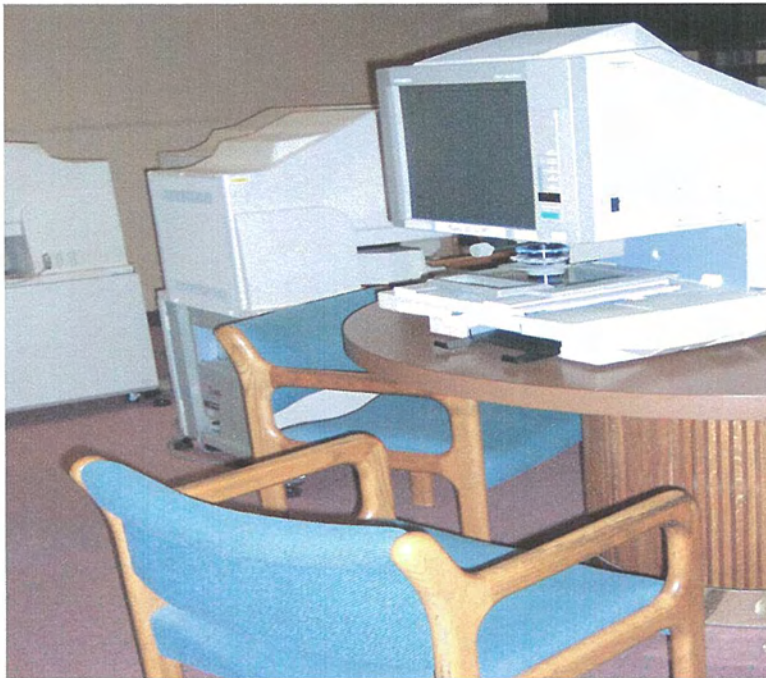
Building - Photo # 1

Microfiche reader sits on a table that does not have the required knee clearance, 16" deep clearance.

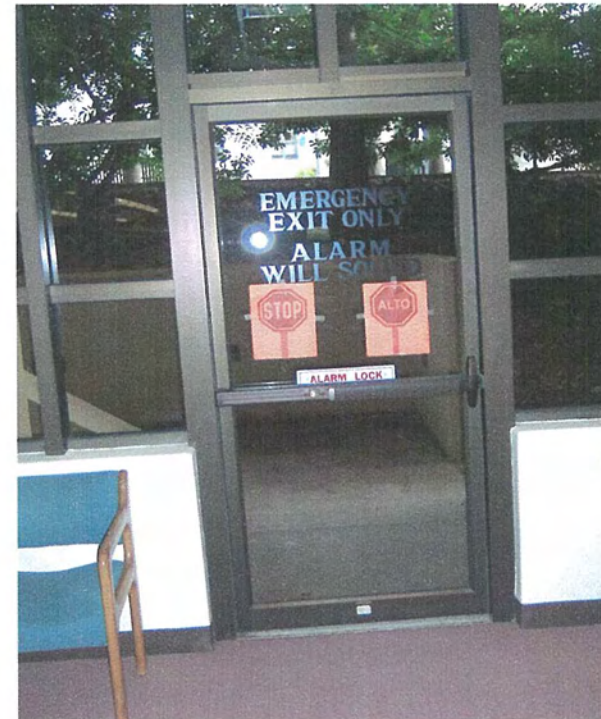
Building - Photo # 2

There is no tactile/Braille "EXIT" sign. Glass door has a 5" smooth kick plate instead of the required 10" kick plate.

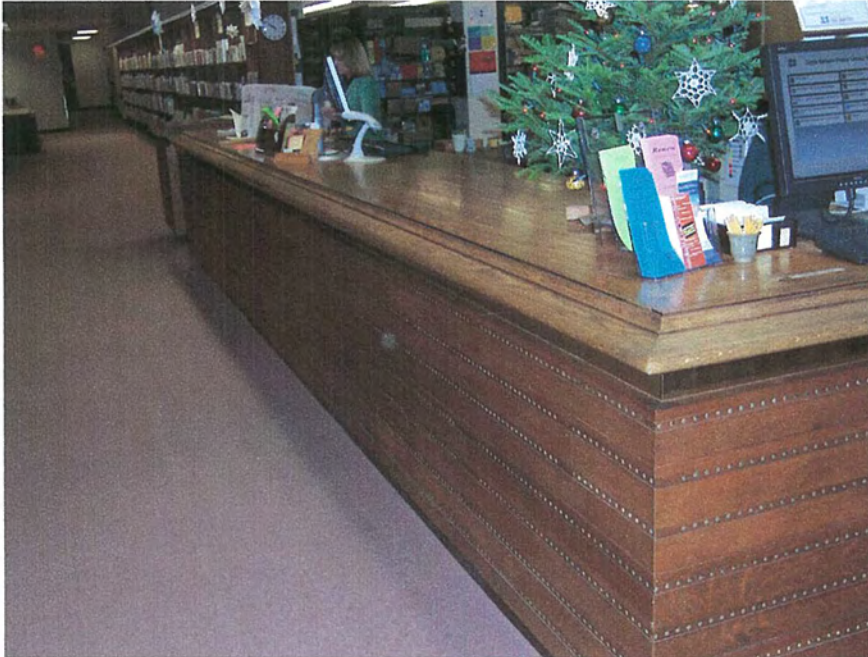
Building - Photo # 3

Counter is 42" high and does not have a 34" maximum height section, 36" wide for wheelchair users.

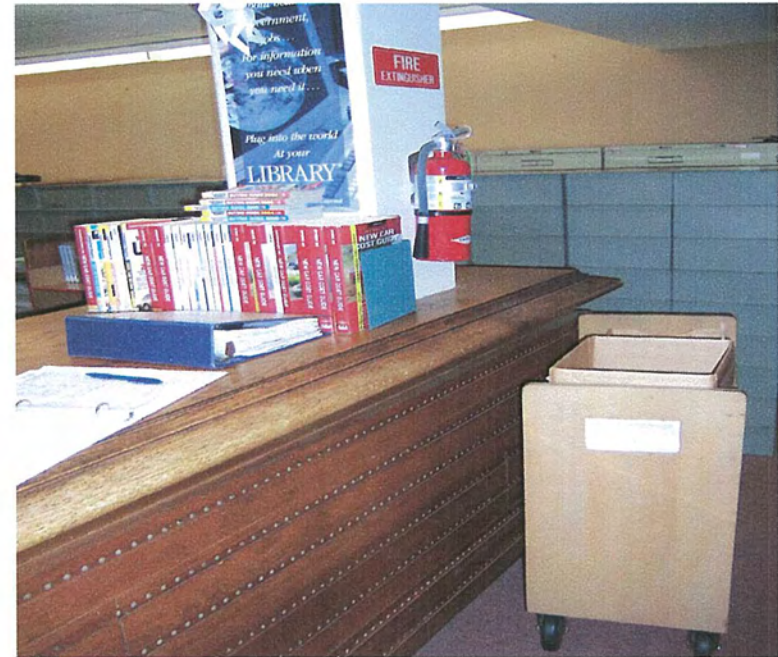
Building - Photo # 4

Counter is 42" high and does not have a 34" maximum height section, 36" wide for wheelchair users. Fire extinguisher operable mechanism is mounted at 59" high, above counter.

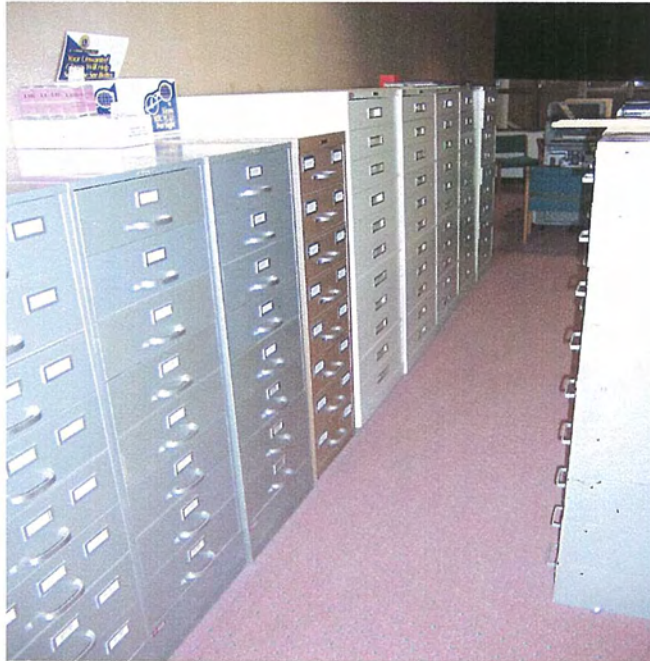
Building - Photo # 5

Path of travel between is too narrow and file cabinets not accessible - 29" wide.

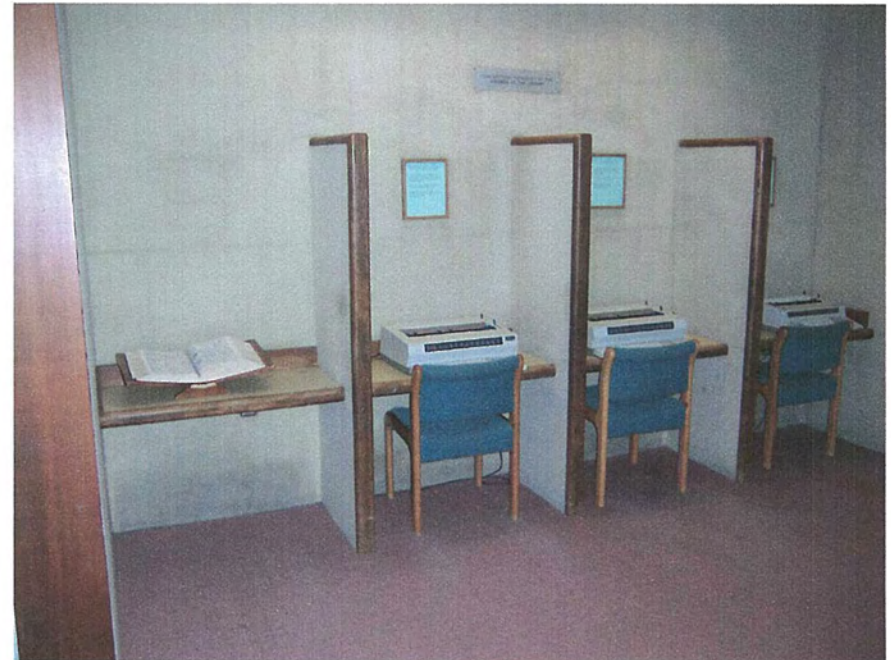
Building - Photo # 6

Built-in cubicles do not have the required knee clearance – 24 ½" under desktop.

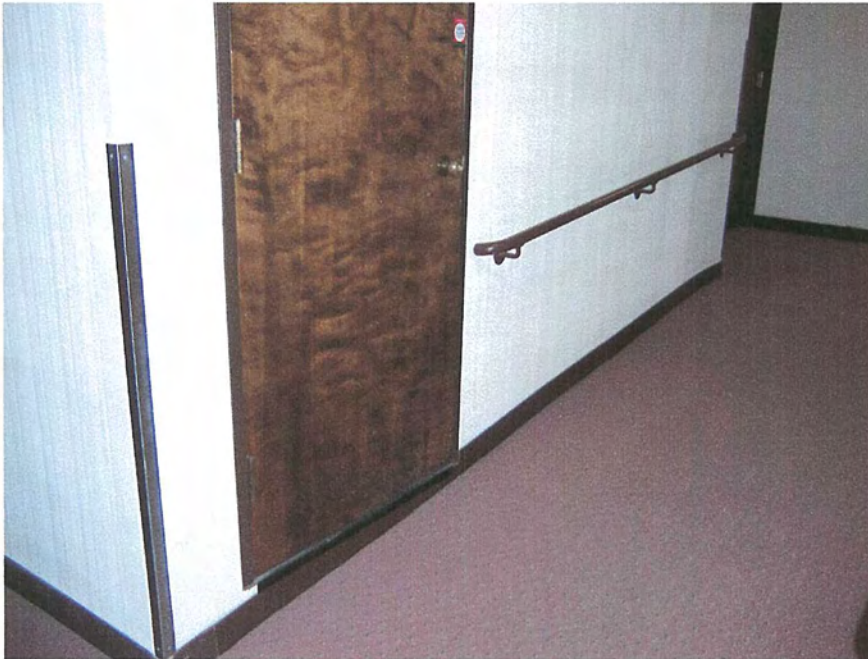
Building - Photo # 7

Ramp slope too steep, 9.6% instead of the maximum allowed 8.33%. Handrail mounted 2 ¼" from the wall and does not have the compliant extensions. Doorknob requires tight grasping to operate.

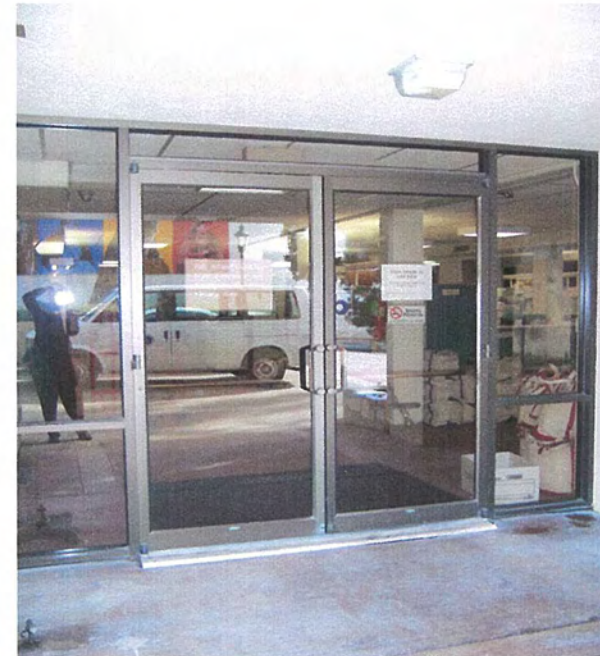
Building - Photo # 8

Door threshold not compliant 2" high. There is no tactile and Braille "EXIT" sign. Glass door does not have a compliant 10" smooth kick plate.

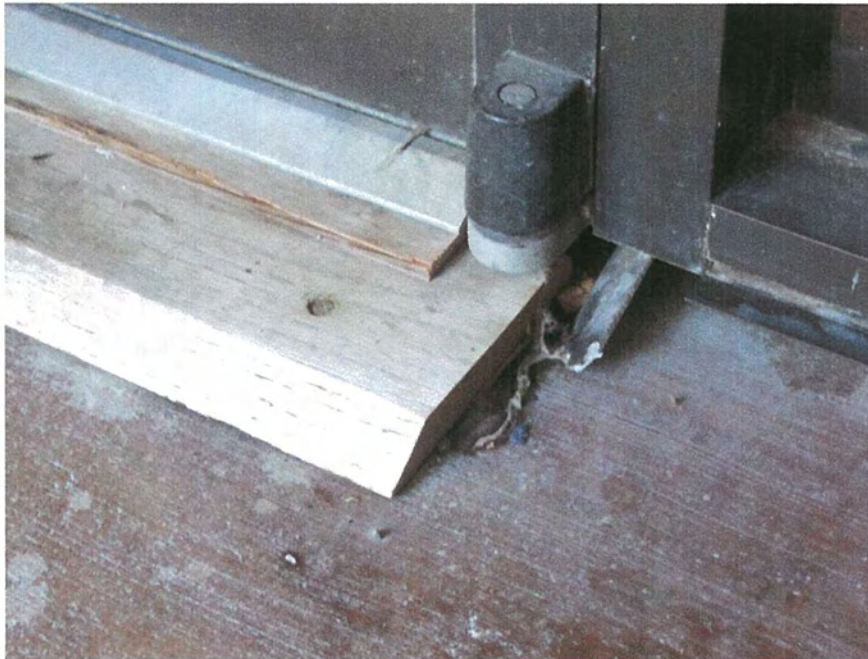
Building - Photo # 9

Door threshold not compliant 2" high instead of the required ½" maximum if beveled.

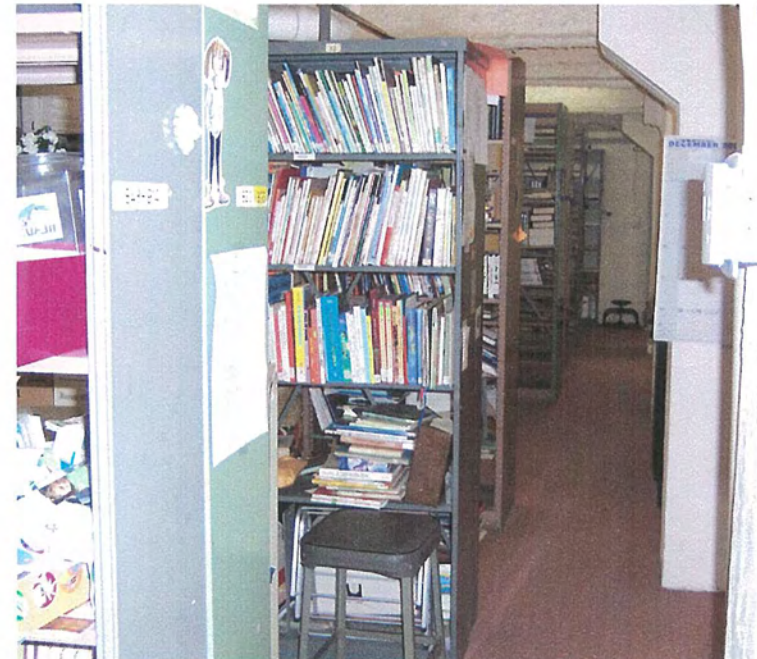
Building - Photo # 10

Path of travel between stacks and columns range from 27" to 31" wide.

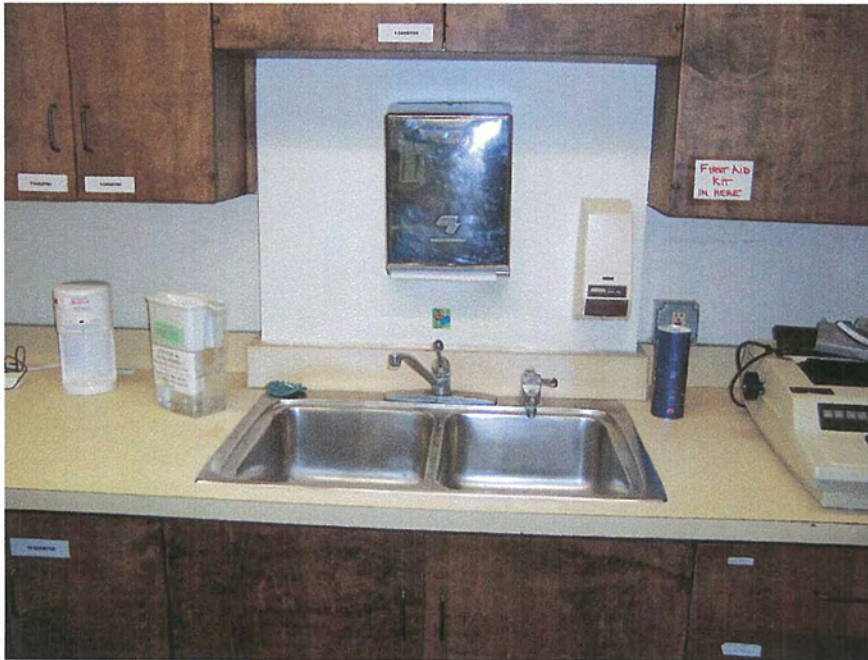
Building - Photo # 11

Sink does not have the required knee clearance. Paper towel and soap dispensers are mounted too high.

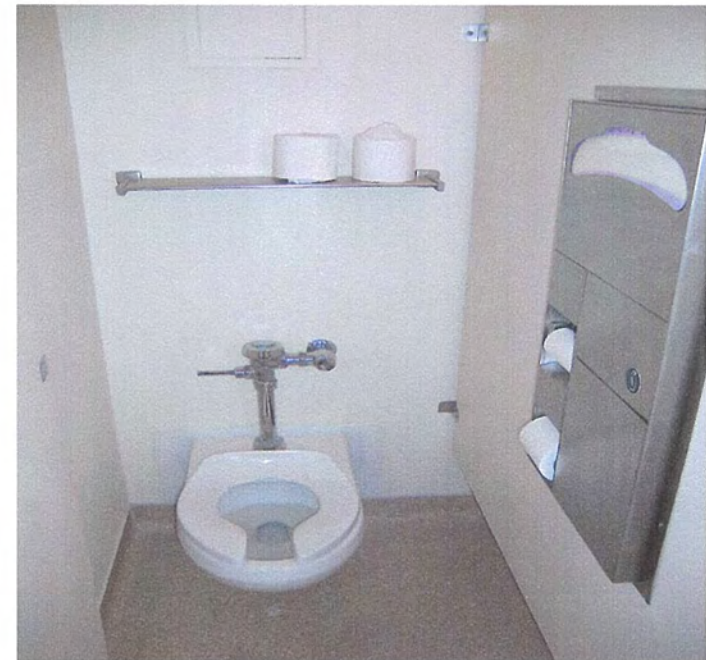
Building - Photo # 12

Narrow stall is not code compliant, it does not have the required wheelchair maneuverable clearance, grab bars.

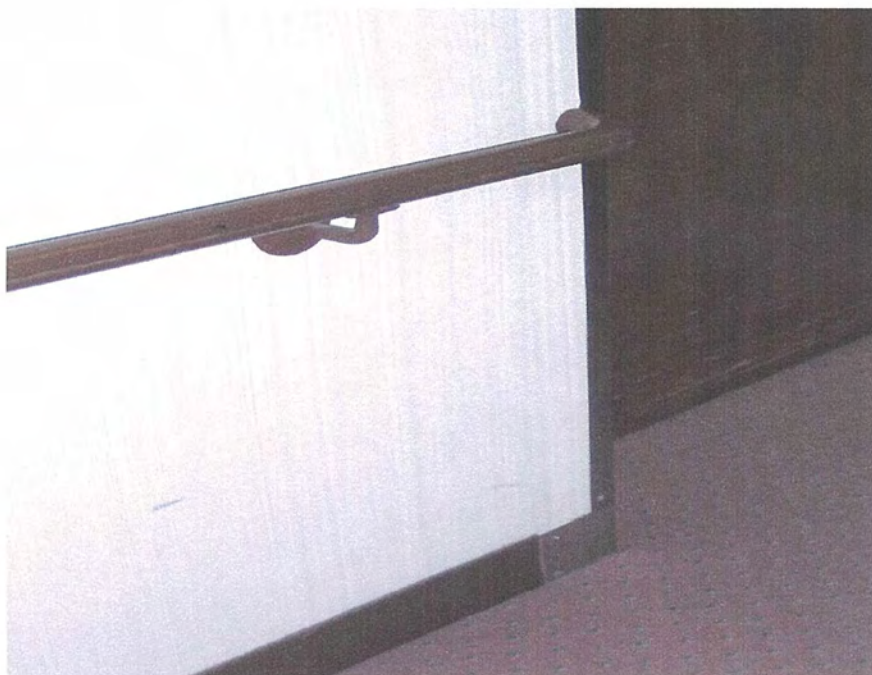
Building - Photo # 17

Handrails are mounted 2 ½" from the wall instead of the required 1 ½".

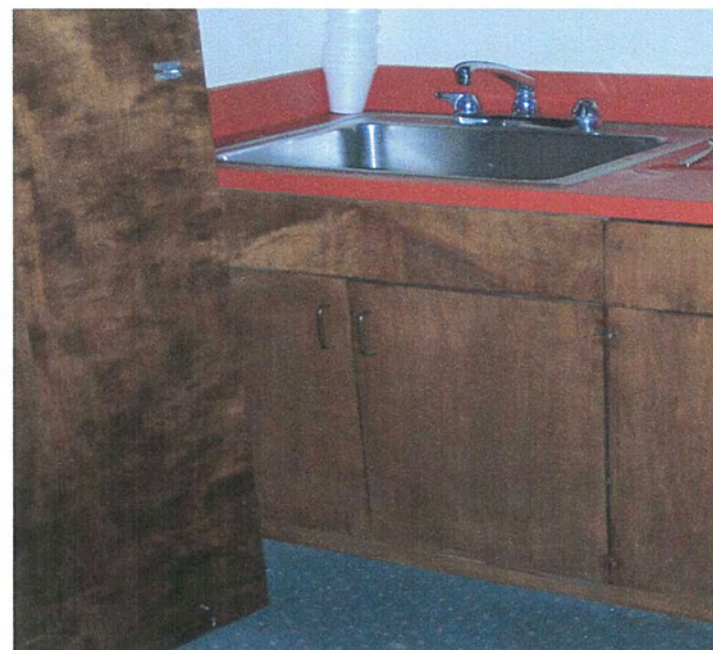
Building - Photo # 18

Sink does not have the required knee clearance.

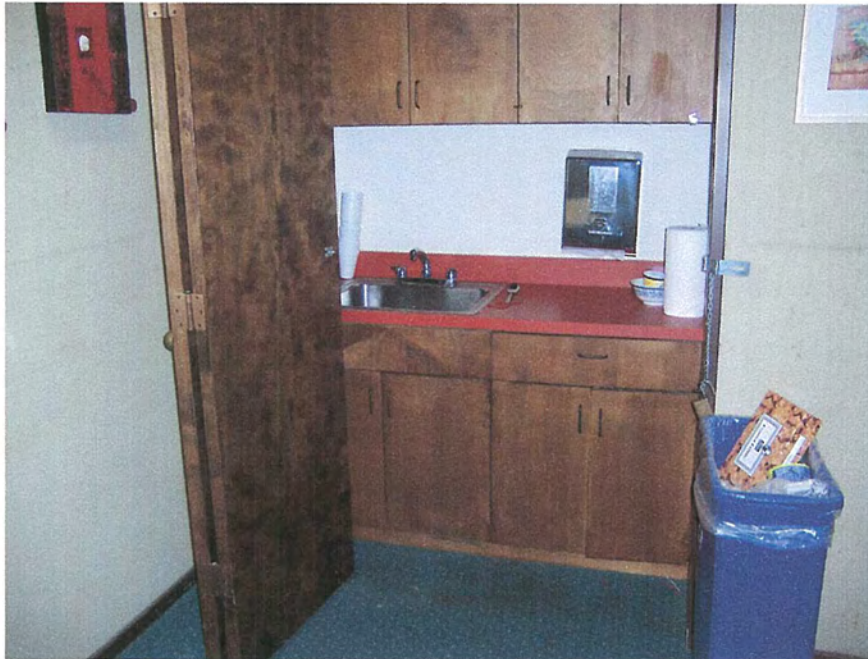
Building - Photo # 19

Sink does not have the required knee clearance.

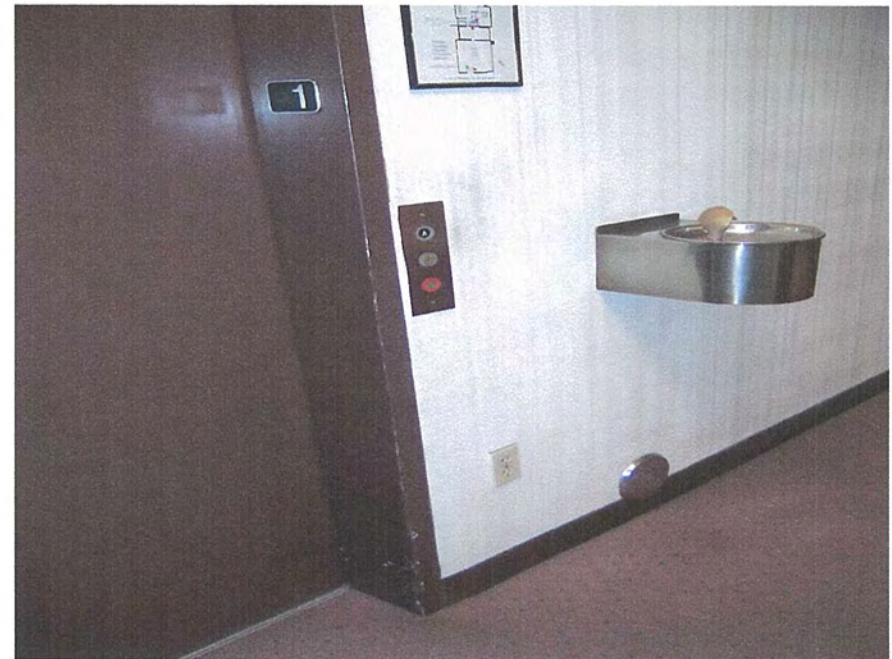
Building - Photo # 20

Drinking fountain does not have the required alcove or protective rails. The bubbler is mounted too high at 42" instead of the required 36" high.
