**CABRILLO PAVILLION ARTS
CENTER**
ACCESSIBILITY SURVEY

June, 2007

**CITY OF SANTA
BARBARA**

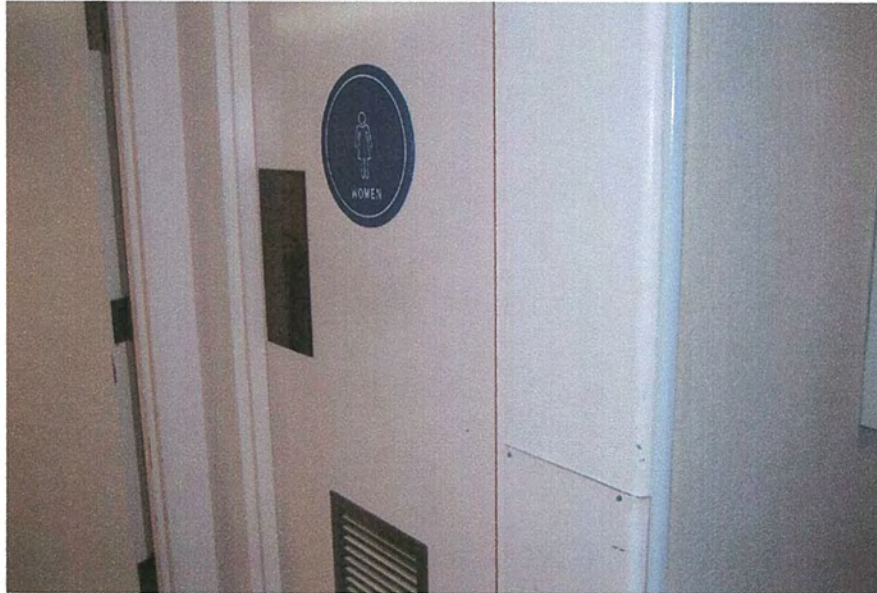
Building - Photo # 15

There is no tactile and Braille restroom identification sign.

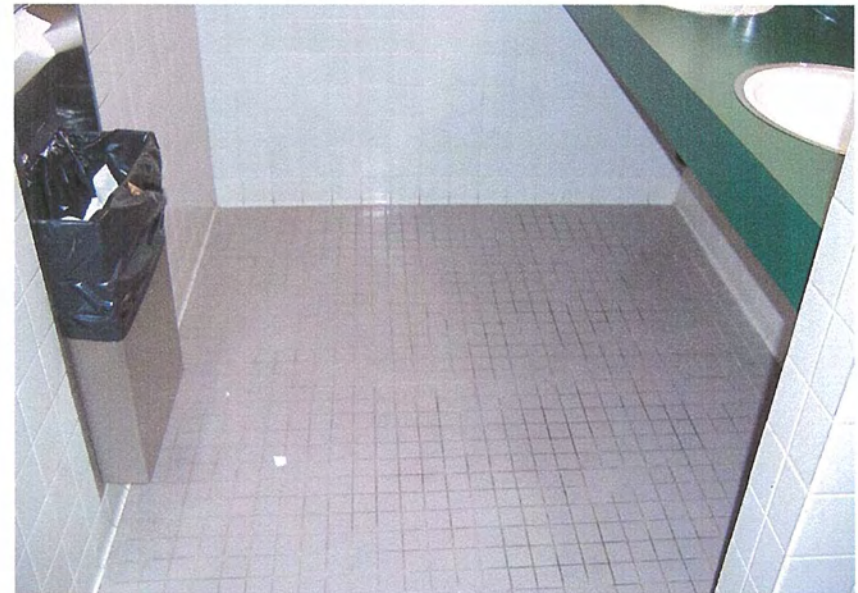
Building - Photo # 18

Path of travel to sink is reduced to be 42” wide clear at the trashcan location instead of the required 44” wide.

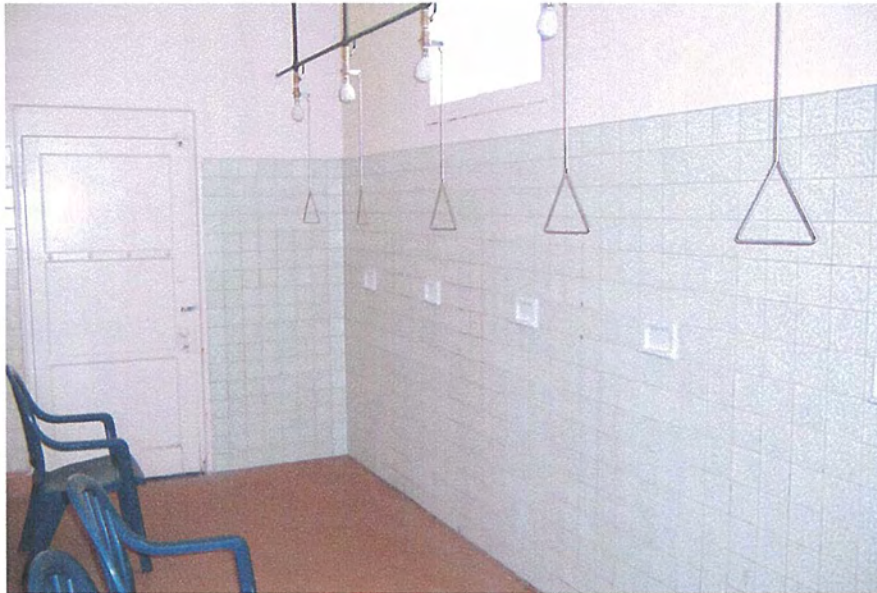
Building - Photo # 1

Shower pull handle located at 60" high.

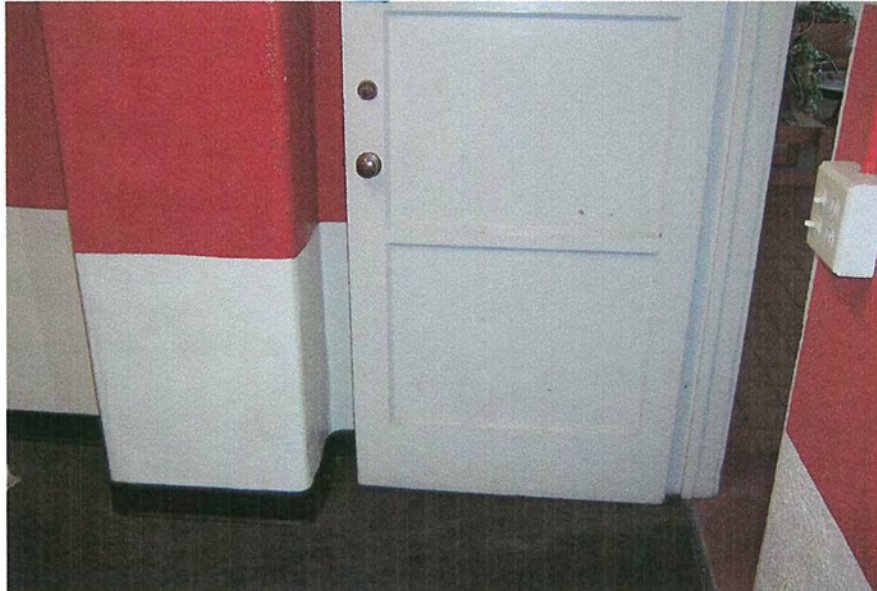
Building - Photo # 7

Door hardware is not accessible requires tight grasping to operate. Column located 40" in front of door does not provide the required 60" wheelchair maneuverable clearance.
