**GILDA PUENTE-PETERS**  
**ARCHITECTS**

**MACKENZIE PARK**  
**ACCESSIBILITY SURVEY**

**February, 2006**

**CITY OF SANTA**  
**BARBARA**

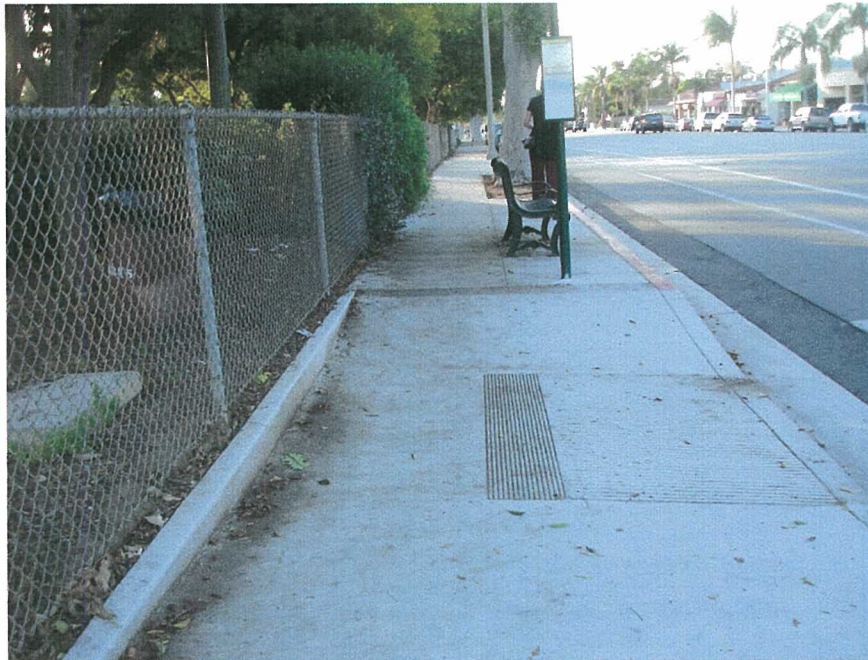
*Public Right-of-Way - Photo # 1*

*There are no detectable warnings at curb ramp. Curb ramp does not have contrasting color with adjacent surfaces. Top landing is 40" instead of the required 48" deep.*

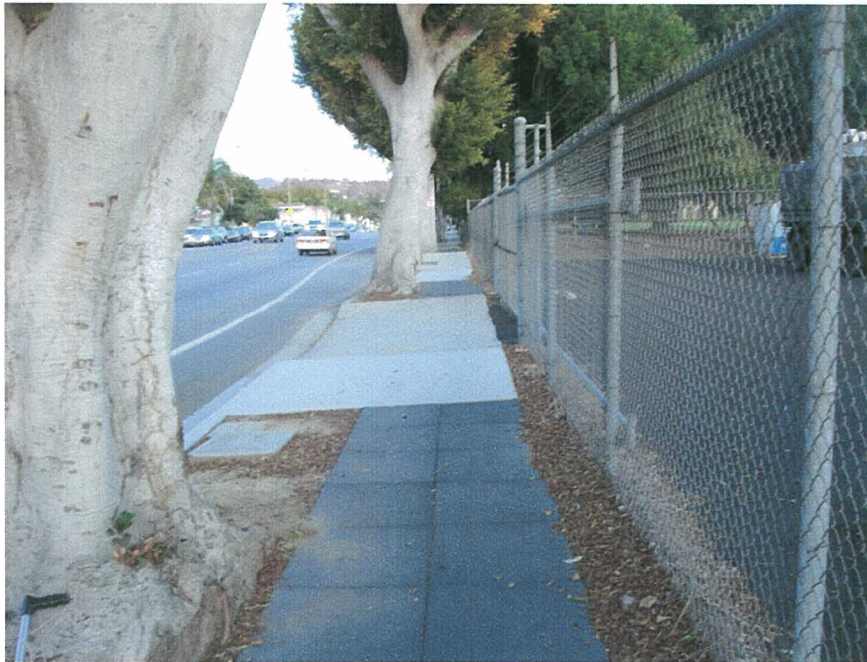
*Public Right-of-Way - Photo # 5*

*There are excessive cross slopes that range from 2.8%  
- 6.3%.*

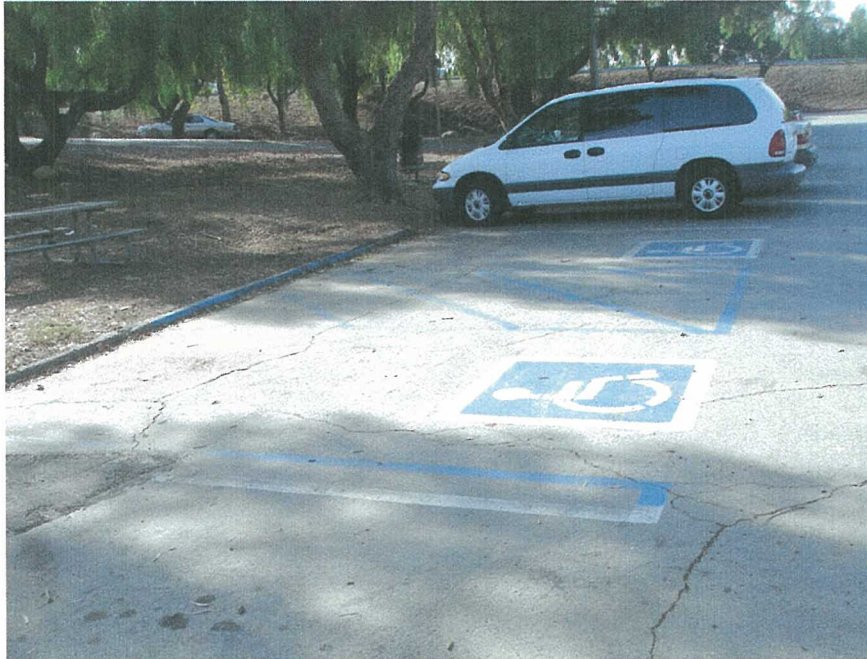
Site - Photo # 1

*Path of travel from accessible parking stall requires persons with disabilities to go behind a parked cars – no direct access provided in front of the access aisles to an accessible path of travel. There are no compliant parking and Tow-Away signs.*

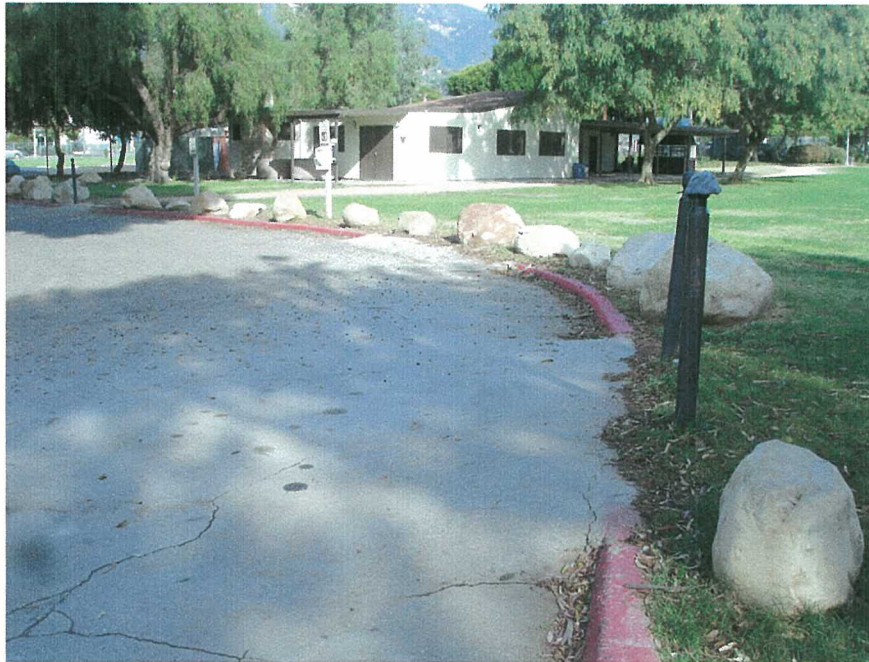
Site - Photo # 3

*Path of travel from accessible parking stalls to children's playground and Adult Center – Building E is not accessible, grass is not considered a firm, stable and slip resistant surface.*

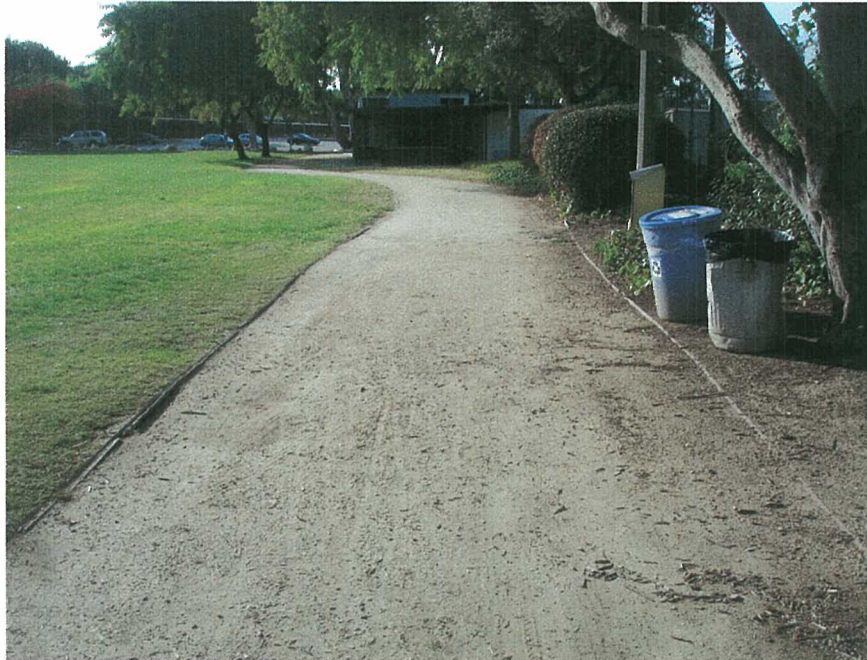
Site - Photo # 7

*Path of travel from Adult Center to score board is not accessible; it does not have a firm, stable and slip resistant surface.*

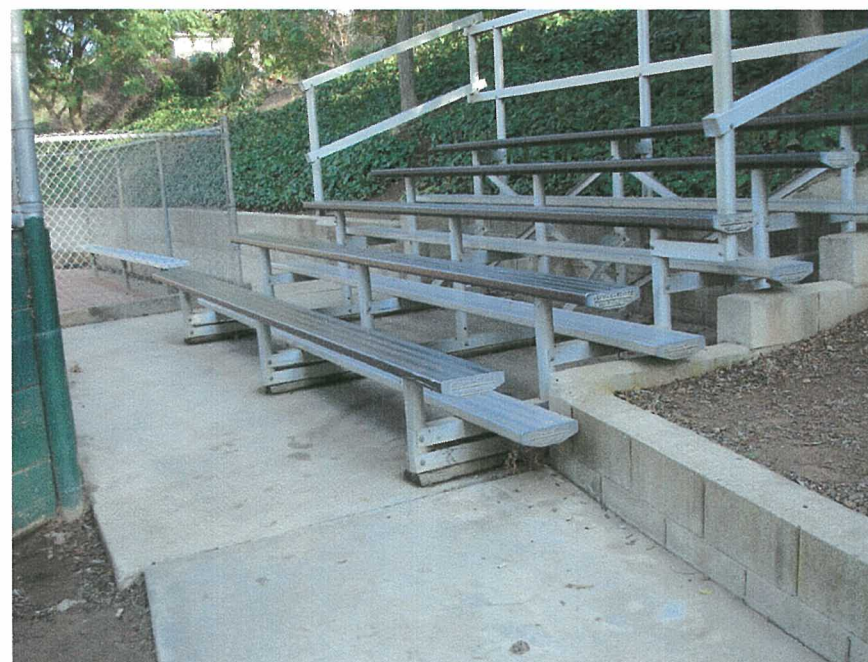
Site - Photo # 14

*Path of travel in front of bleachers is too narrow, 37 ½"  
wide. Bleachers do not have a designated wheelchair  
and companion seating within or adjacent to the  
bleachers with compliant signage – ISA International  
Symbol of Accessibility.*

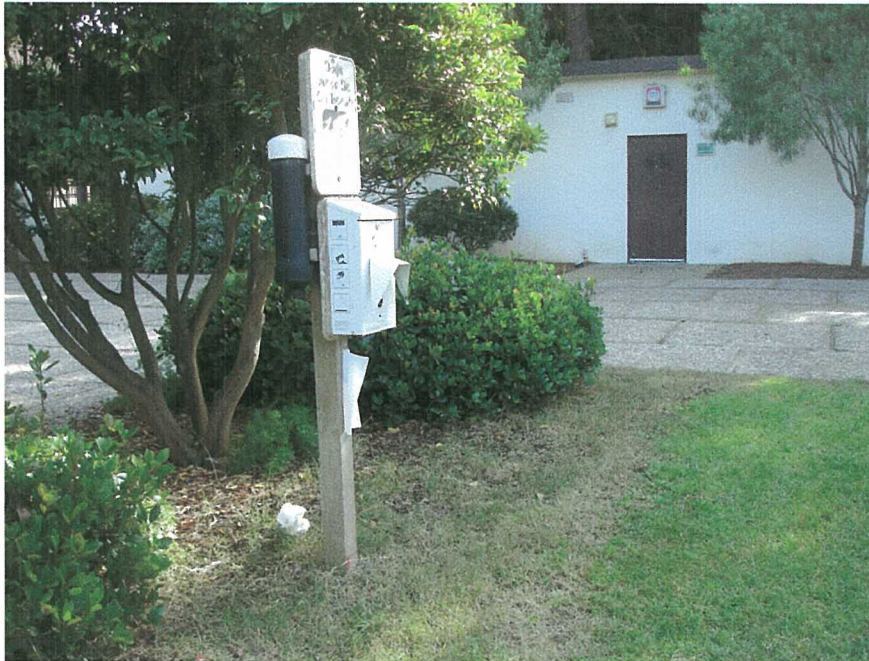
*Site - Photo # 17*

*Path of travel to pet's trash bag dispenser is not firm, stable and slip resistant.*

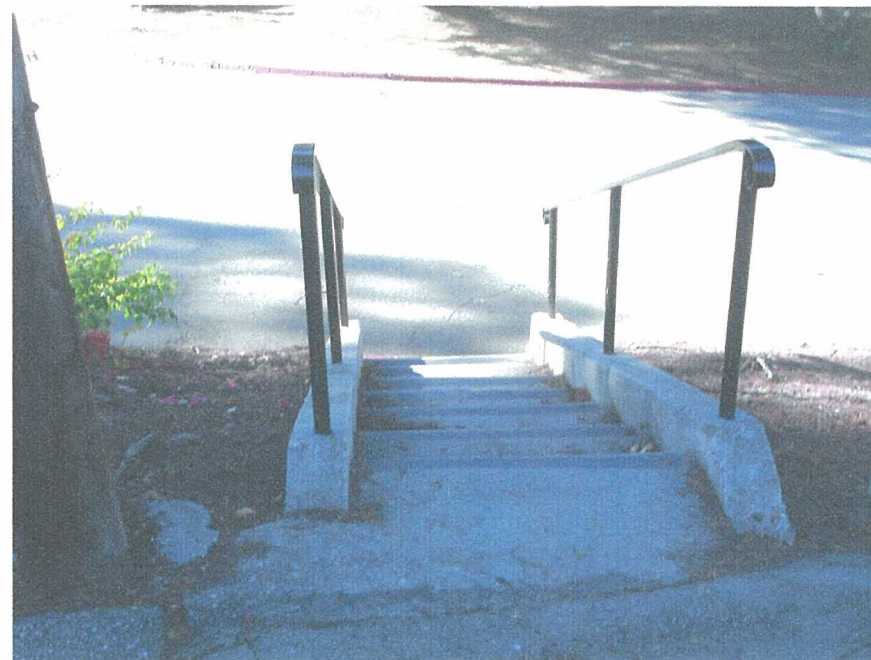
Site - Photo # 22

*Stair is 36" wide, risers 6" with the exception of the bottom riser 3 1/2" high. Non-compliant handrail extensions, contrasting color not 70% contrast. Debris accumulated on risers.*

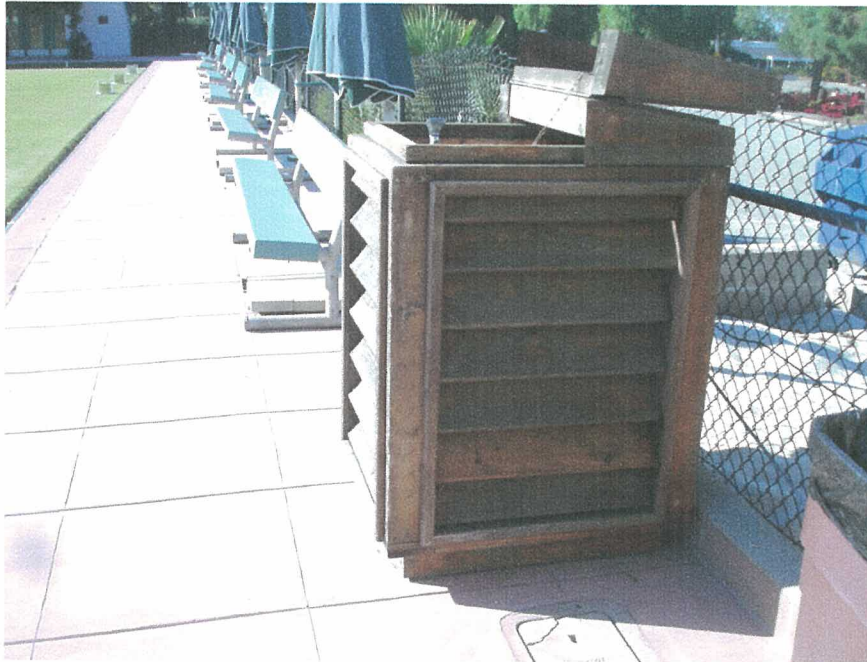
*Site - Photo # 27*

*Drinking fountain does not have the required knee clearance. No high/low drinking fountain provided.*

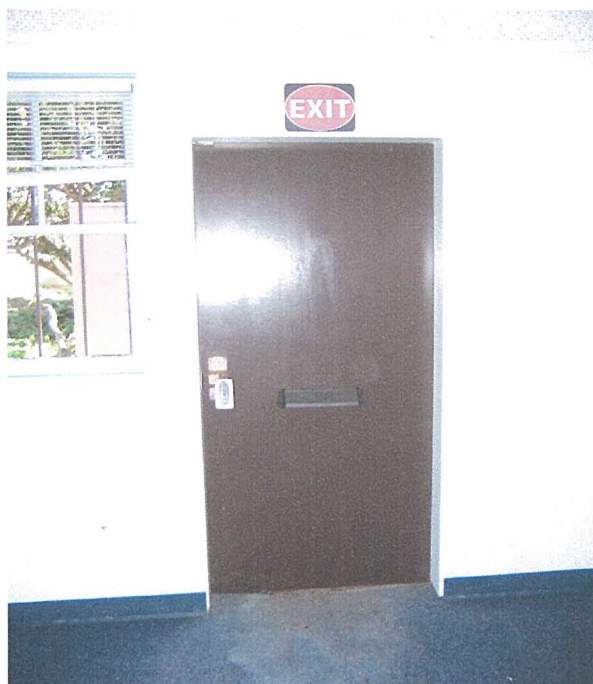
*Building - Photo # 1*

*There is not a tactile and Braille "EXIT" sign. There is not accessible type of door hardware that does not require tight grasping, pinching or twisting of the wrist.*

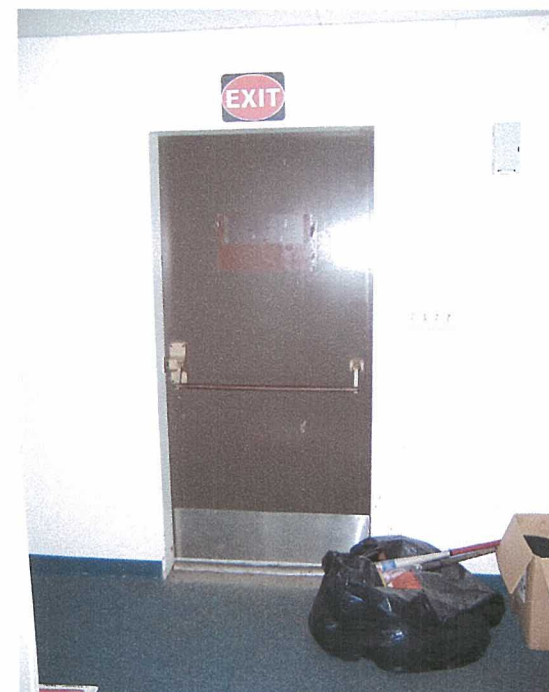
*Building - Photo # 2*

*There are not a tactile and Braille "EXIT" and room identification signs.*

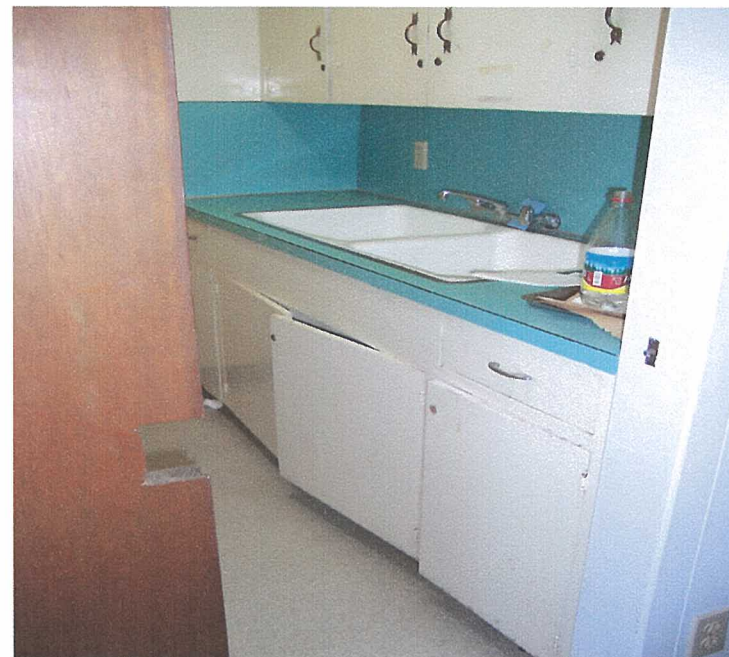
*Building - Photo # 4*

*Non-accessible sink – no knee clearance provided. Sliding door is 29 3/4" wide. There is not a 60" clear wheelchair turn around space at kitchen area.*

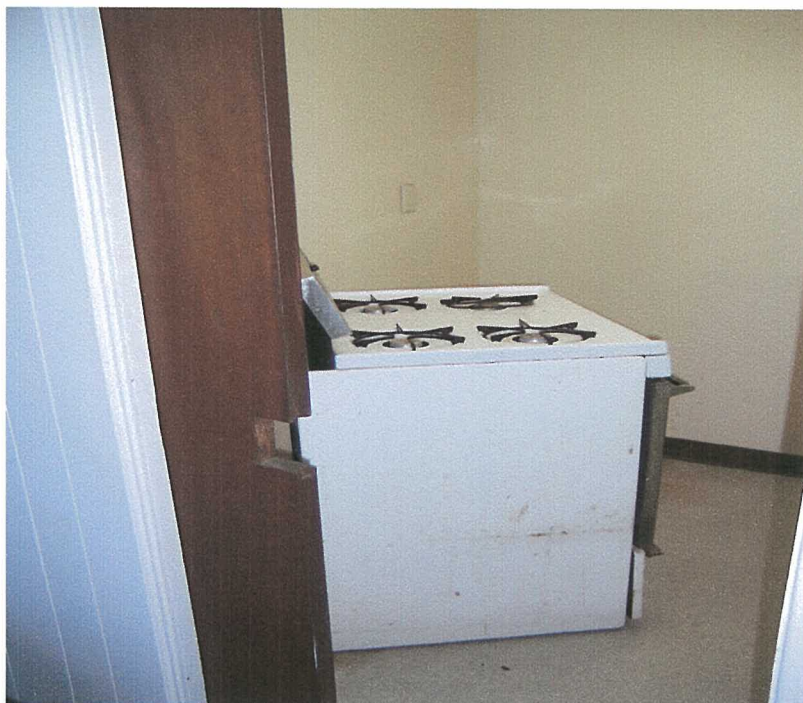
*Building - Photo # 5*

*Stove has back controls.*

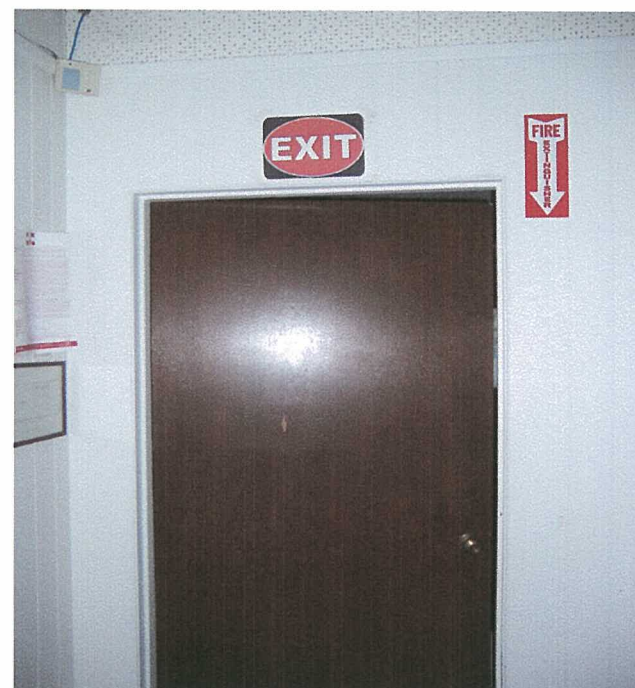
*Building - Photo # 6*

*There are not tactile and Braille "EXIT" and room identification signs. Door hardware requires tight grasping to operate.*

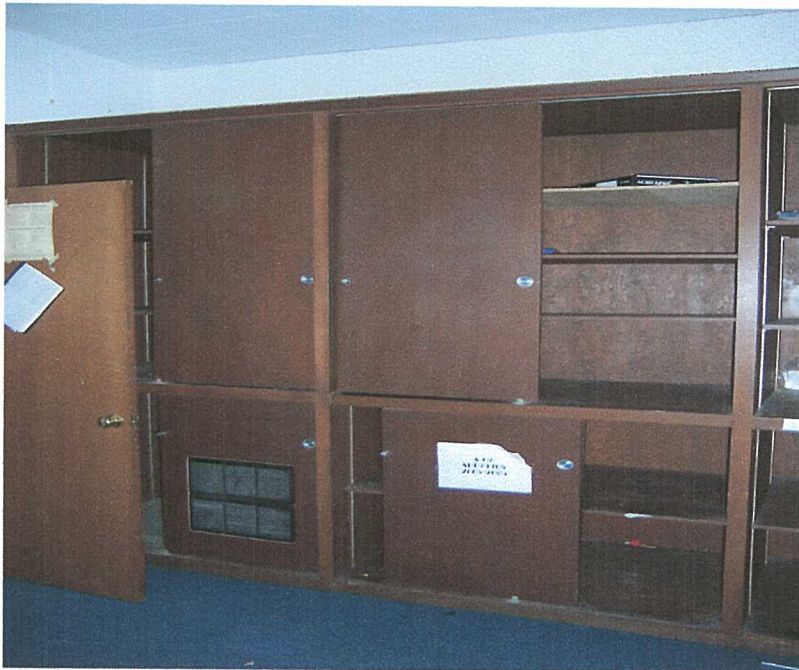
*Building - Photo # 7*

*Cabinet operable mechanisms are recessed and require tight grasping to operate.*

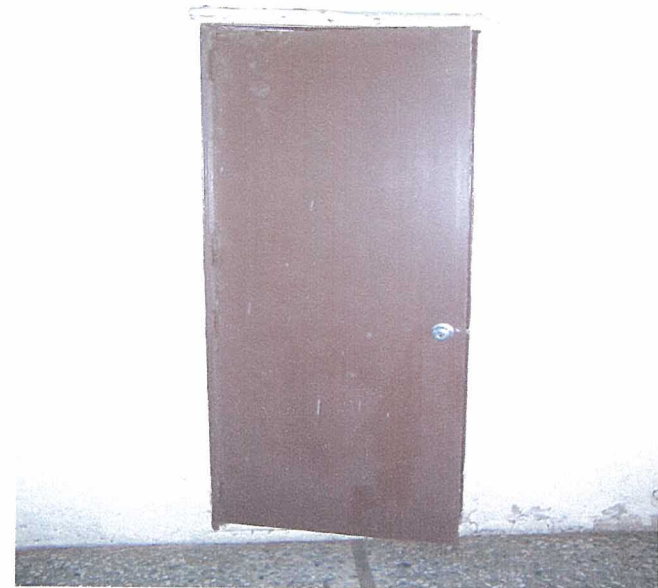
*Building - Photo # 8*

*Doorknob requires grasping to operate. Threshold is 3 1/2" high. There is not a tactile and Braille room identification signs.*

5 Office - 107									\$8,500		
Doors											
Door opening width measured between face of door & opposite stop.	32" clear opening width when 90° open.	Door width 29-1/2". Photo #: 8	ADAAG: 4.13.5 T24: 1133B.3.1.1.1; 1133B.2.3 Fig. 11B-33	Enlarge opening and replace door and door frame.	1	JOB	\$3,500	\$3,500	2

Door opening width measured between face of door & opposite stop.	32" clear opening width when 90° open.	Door width 27 1/2". Photo #: 8	ADAAG: 4.13.5 T24: 1133B.3.1.1.1; 1133B.2.3 Fig. 11B-33	Enlarge opening and replace door and door frame.	1	JOB	\$3,500	\$3,500	1	
Door opening hardware, type.	Lever type, panic bars, push-pull or other operable hardware with single effort without requiring tight grasping.	Hardware not accessible type. Photo #: 8	ADAAG: 4.13.9 T24: 1133B.2.5.1	Provide lever type or other accessible hardware, mounted between 36" to 44" high.	1	JOB	\$390	\$390	2	
Door threshold height exceeds 1/2" including bevel section.	Change in level between 1/4" and 1/2" shall be beveled with a slope no greater than 1 unit vertical to 2 units horizontal. Change in level greater than 1/2" shall be accomplished by means of a ramp.	3 1/4" threshold. Photo #: 8	ADAAG: 4.13.8 T24: 1133B.2.4.1	Remodel area to provide compliant door landing and threshold.	100	SF	\$25	\$2,500	1

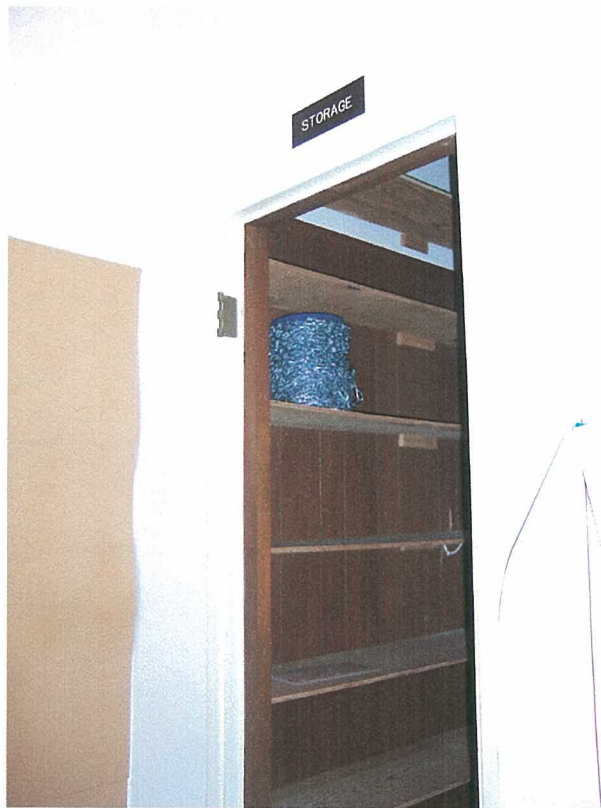
*Building - Photo # 9*

*Cased opening is 22 ½" wide – not wheelchair accessible. There is no tactile and Braille room identification sign.*

Permanent room & space signs.		Raised letters & Braille, on wall adjacent to latch side of door, 60" above floor, contrasting color, no obstacles within 3" of sign.	None. Storage cased opening 22 1/2" wide. Photo #: 9	ADAAG: 4.1.2(7); 4.30.4 & 4.40.5 T24: 1117B.5.9; 1117B.5.6	Provide the required tactile permanent room signage.	1	JOB	\$100	\$100	3	
-------------------------------	--	---	---	---	--	---	-----	-------	-------	---	--

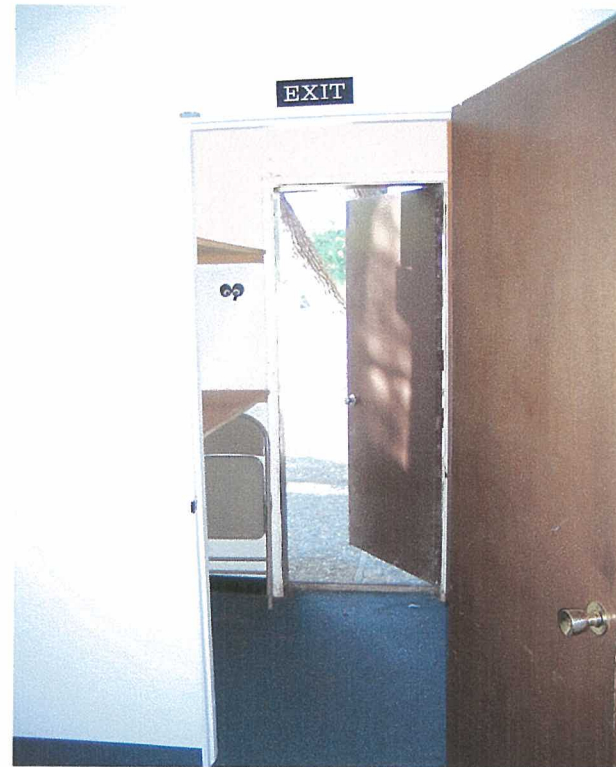
*Building - Photo # 10*

*There are not tactile and Braille "EXIT" and room identification signs. Door hardware requires tight grasping to operate. This EXIT is not accessible due to the step to the exterior walk. No directional signage provided.*

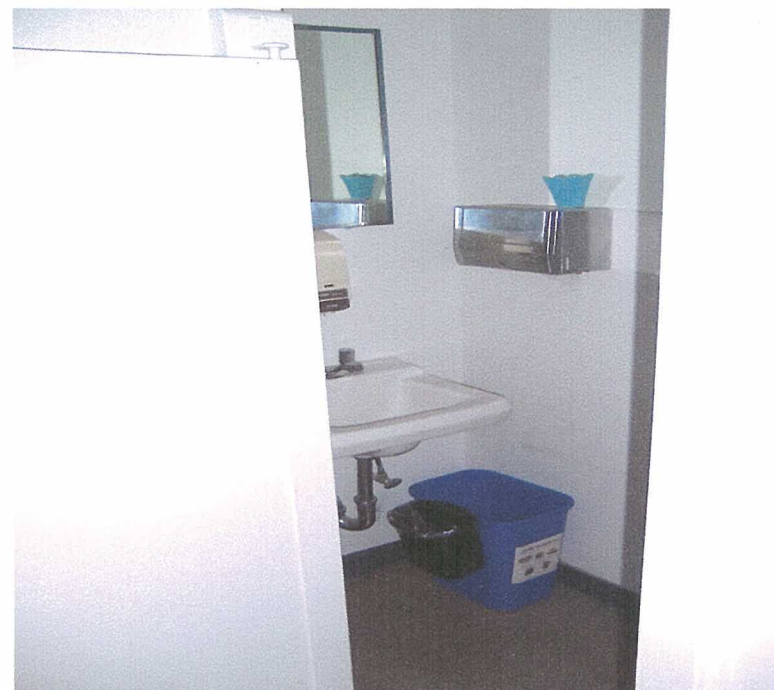
*Building - Photo # 12*

*Sink does not have insulation, mirror, paper towel and soap dispensers are mounted too high.*

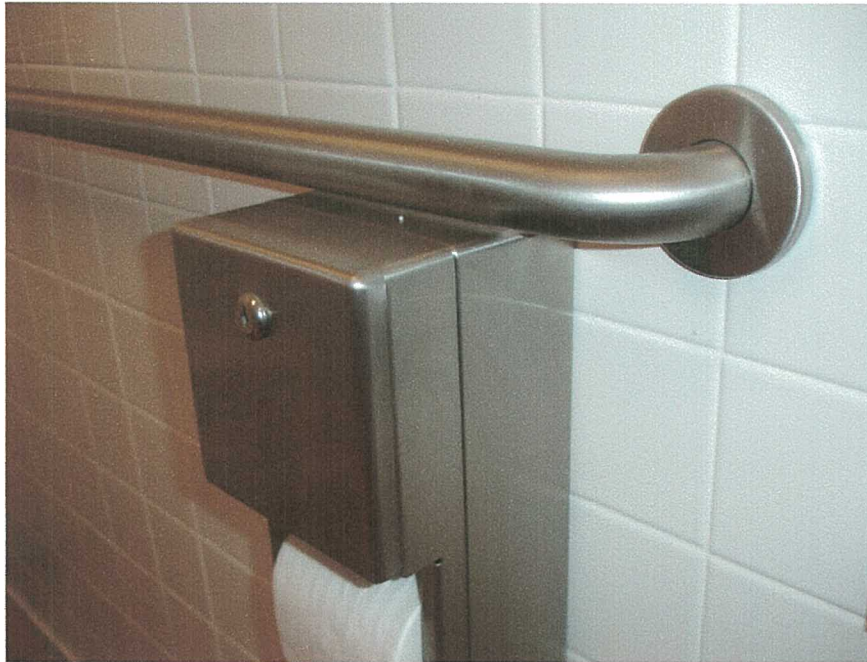
*Building - Photo # 9*

*Toilet paper dispenser is mounted too close to grab bar.*

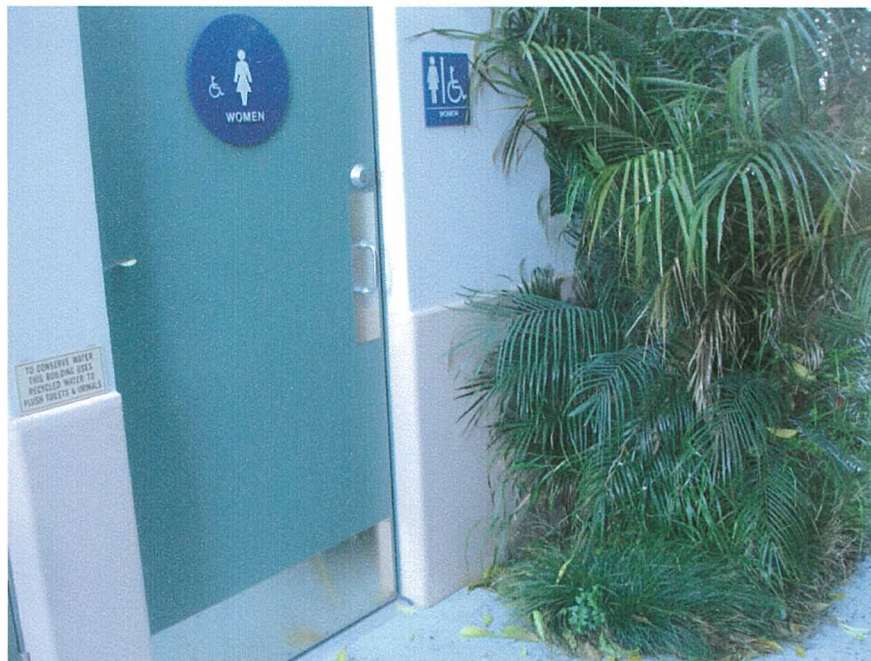
*Building - Photo # 13*

*7" exterior door strike side clearance due to the location of planter, instead of the required 24" minimum.*

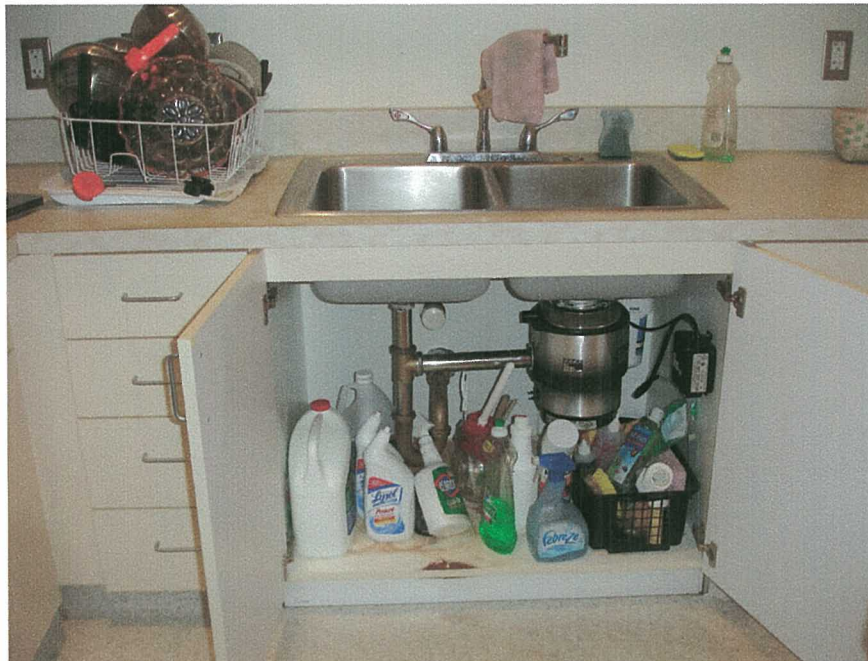
*Building - Photo # 15*

*Sink does not have compliant knee clearance due to the location of garbage disposal, pipe configuration and bottom shelf.*

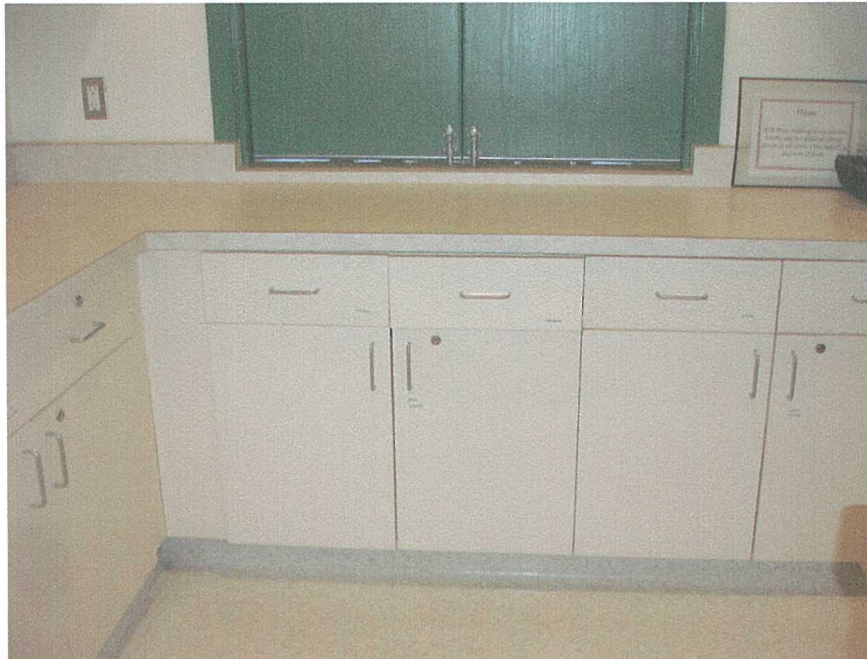
*Building - Photo # 17*

*Pass through window is mounted too high at 36" high instead of the required 34" maximum.*

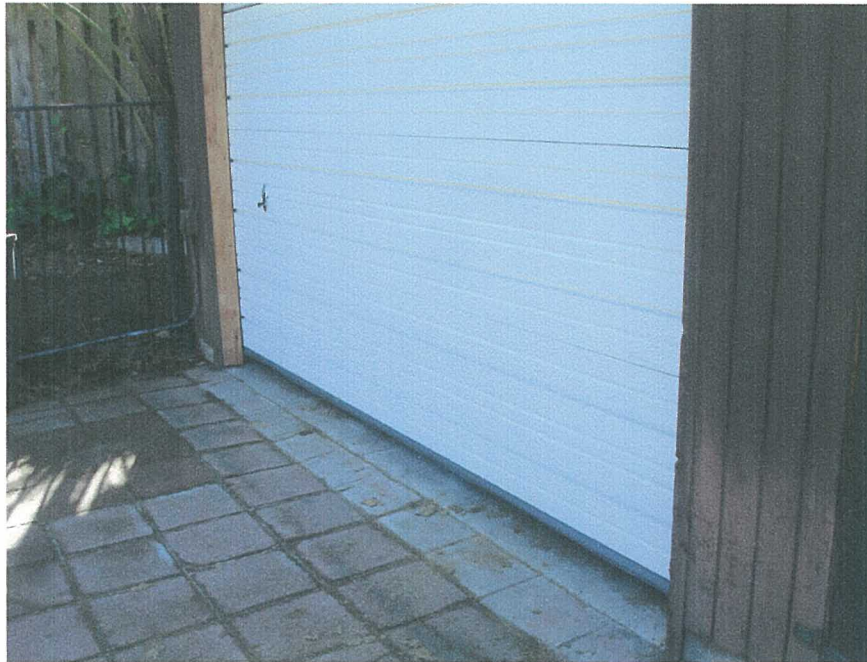
*Building - Photo # 1*

*Garage door hardware requires tight grasping and twisting of the wrist to operate. There is not a tactile and Braille room identification sign.*

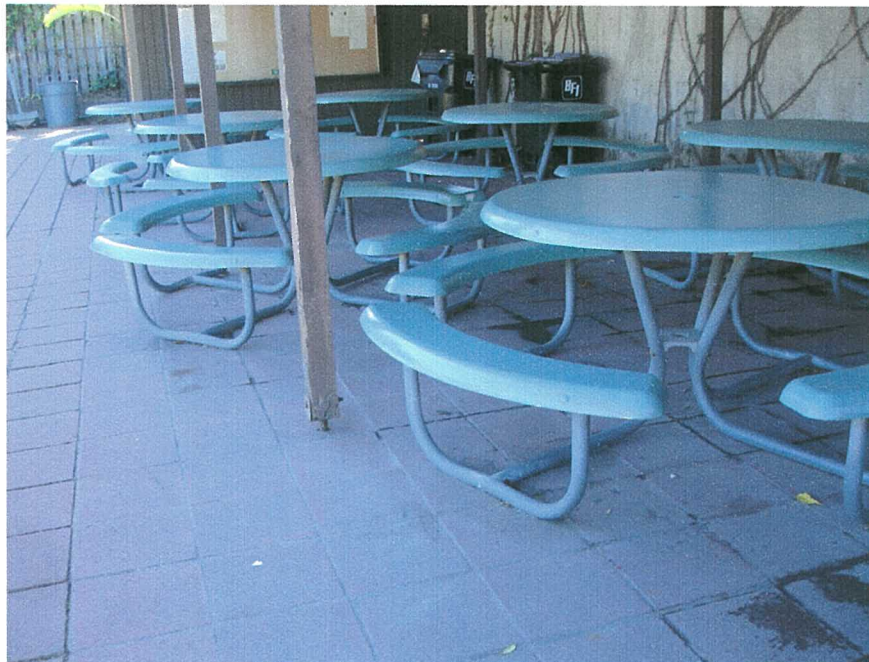
*Building - Photo # 3*

*Picnic tables are not accessible; they do not have the required knee clearance for wheelchair users.*

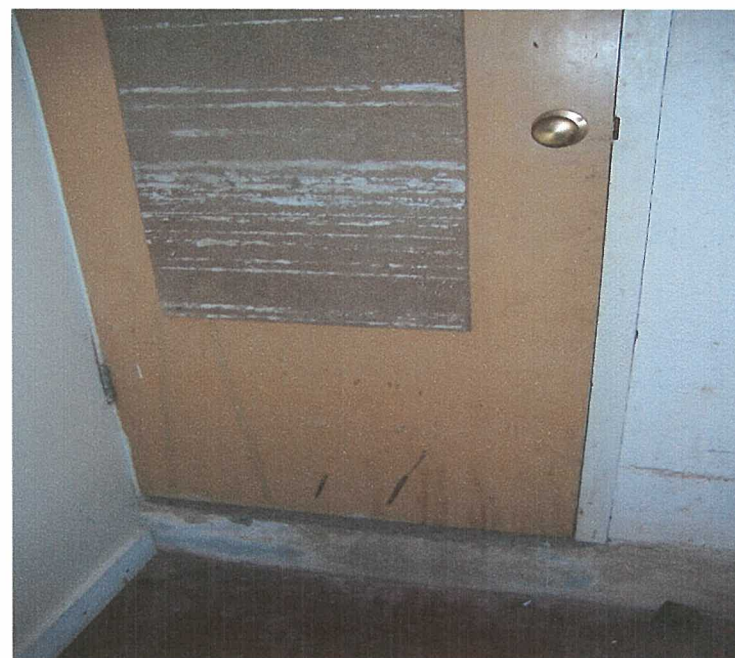
*Building - Photo # 2*

*Door hardware requires tight grasping to operate and twisting of the wrist to operate. 6" high step to pipe chase room makes it not accessible, but this type of room is not required to be accessible.*

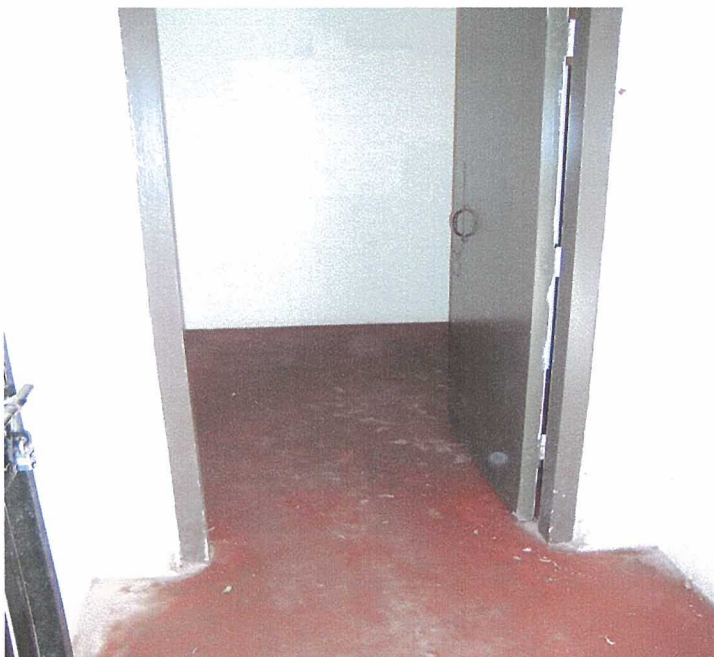
*Building - Photo # 3*

*Door does not have tactile and Braille room identification sign.*

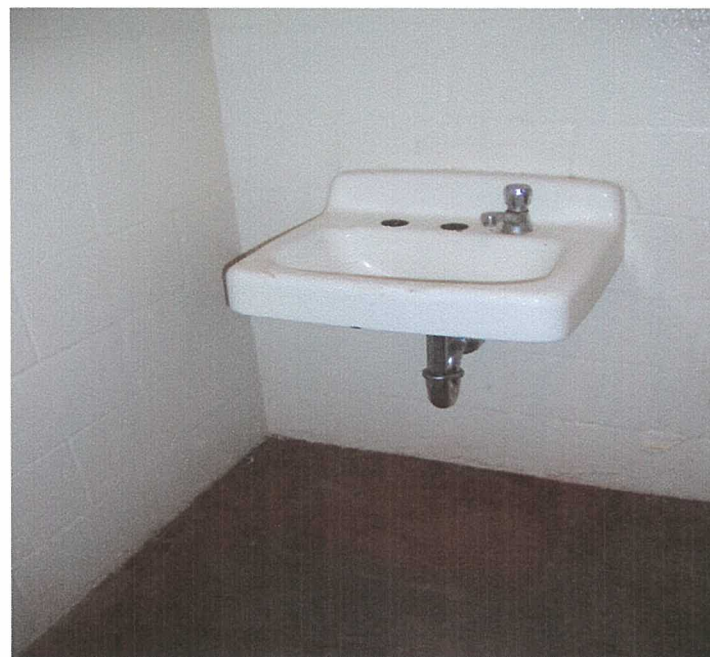
*Building - Photo # 4*

*Sink does not have pipe insulation.*

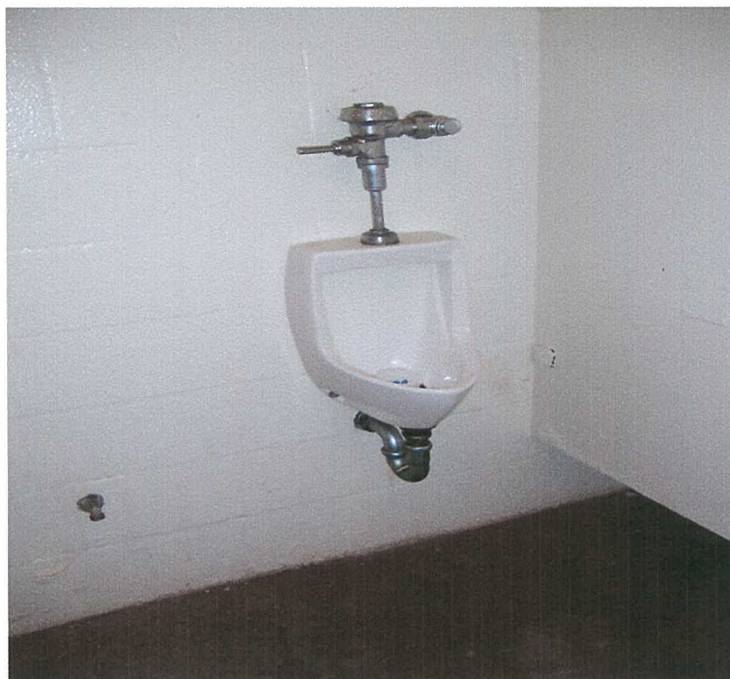
*Building - Photo # 5*

*Urinal mounted too high, flush valve too high.*

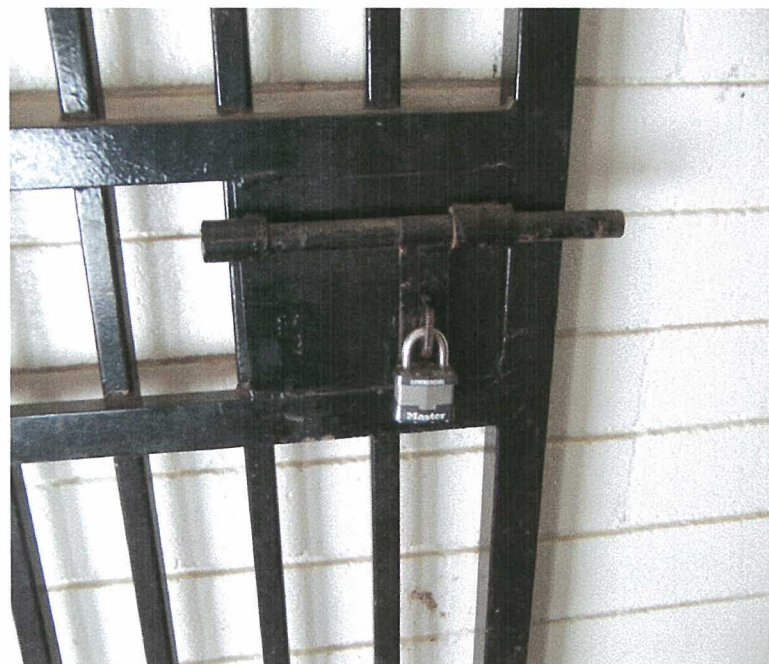
*Building - Photo # 6*

*Gate at Men's restroom does not have the required kick plate and accessible door hardware. There is no compliant restroom tactile and Braille signage as well as the triangle door sign required in California.*

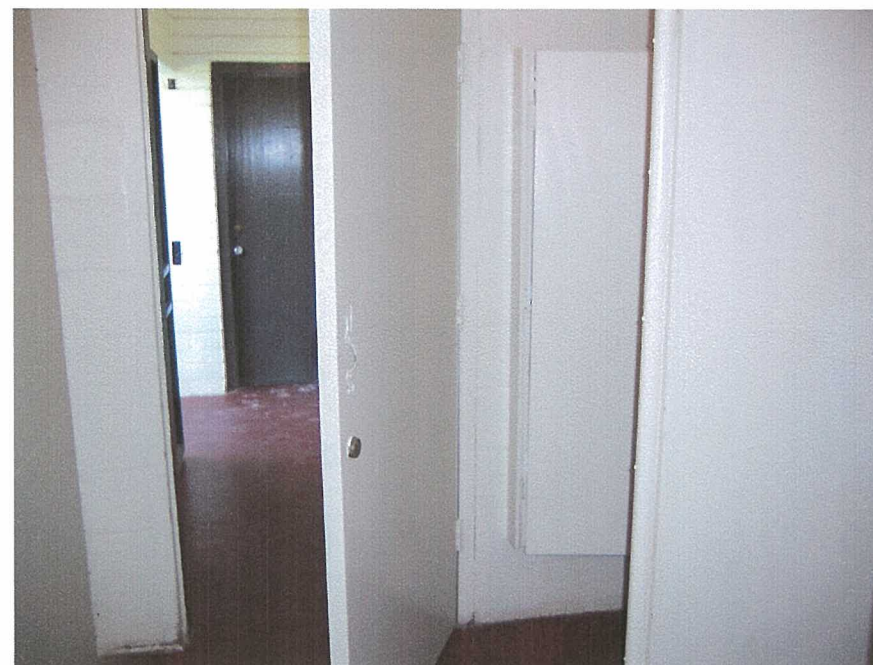
*Building - Photo # 8*

*There is not the required pull side strike clearance at door as well as compliant door hardware and restroom signage.*

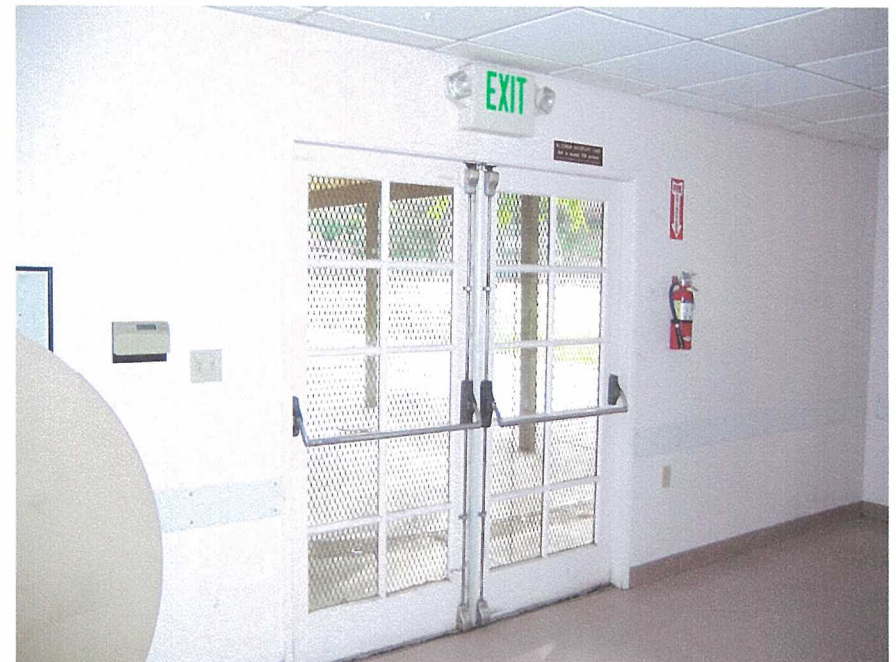
*Building - Photo # 4*

*There is not a tactile and Braille "EXIT" sign. Panic rod protrudes into the bottom kick plate area required to be smooth. Fire extinguisher mounted too high.*

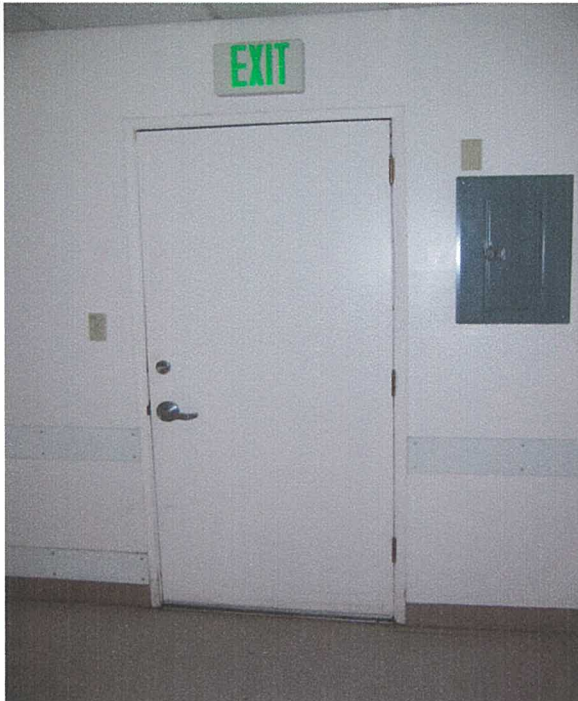
*Building - Photo # 5*

*There are not tactile and Braille "EXIT" and room identification signs.*

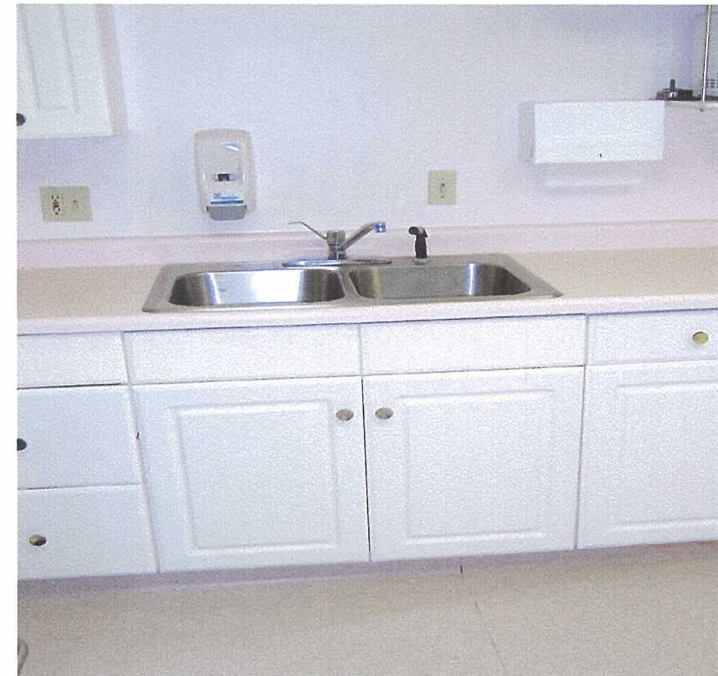
*Building - Photo # 6*

*Non-accessible sink – no knee clearance provided.  
Soap and towel dispensers are mounted too high.*

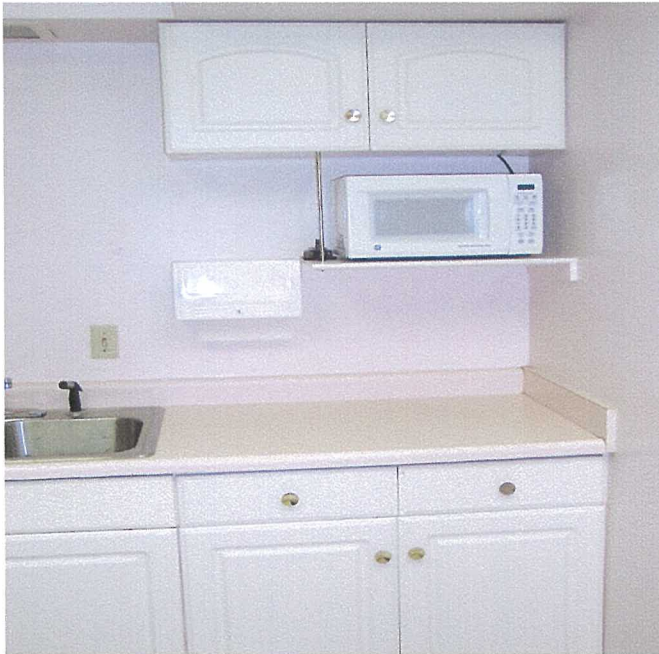
*Building - Photo # 7*

*Microwave controls and paper towel dispensers are mounted too high. Kitchen cabinet knobs require tight grasping to operate, provide U-pull type hardware.*

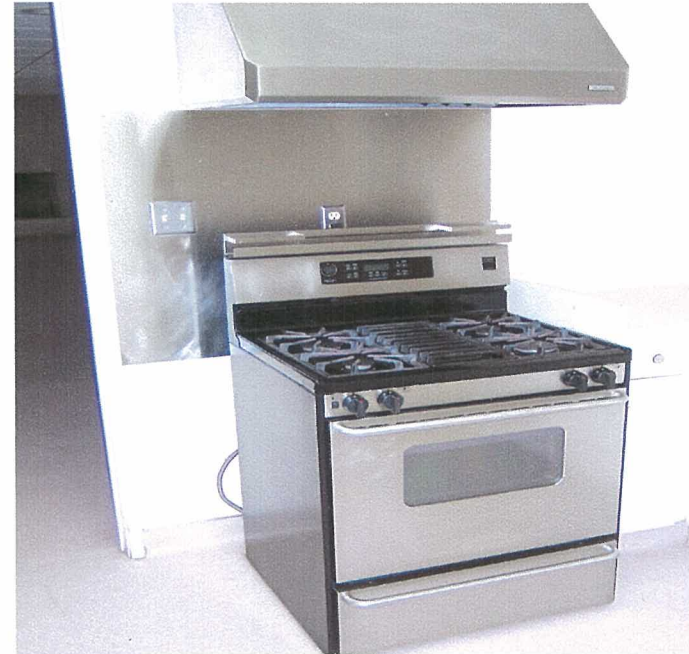
*Building - Photo # 8*

*Gas range controls are mounted on the back of the stove. Switches are mounted at 51" high instead of 48" high.*

Forward approach reach range to objects or controls.	Mounting height 48" or less than 15" high, when clear space allows only forward approach.	Kitchen range has back controls. Photo #: 8	ADAAG: 4.2.5  T24: 1118B.5	Provide a new range with front controls.	1	JOB	\$100	\$100	3

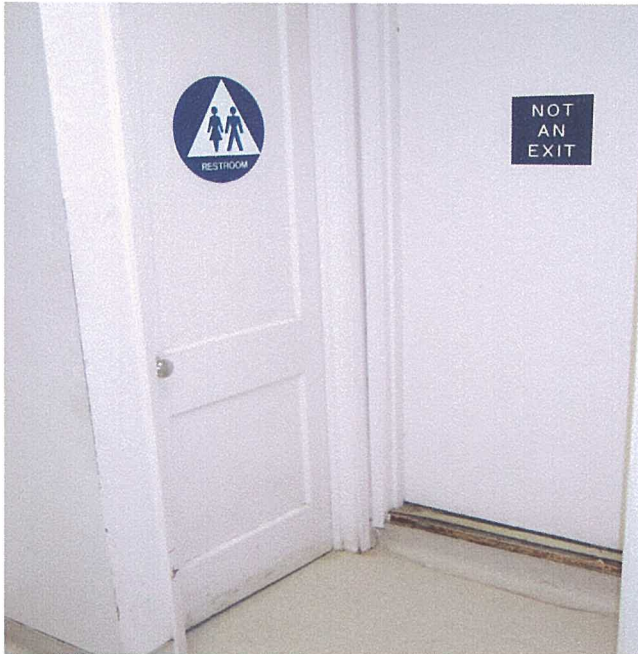
*Building - Photo # 9*

*There are not tactile and Braille "NOT AN EXIT" and room identification signs.*

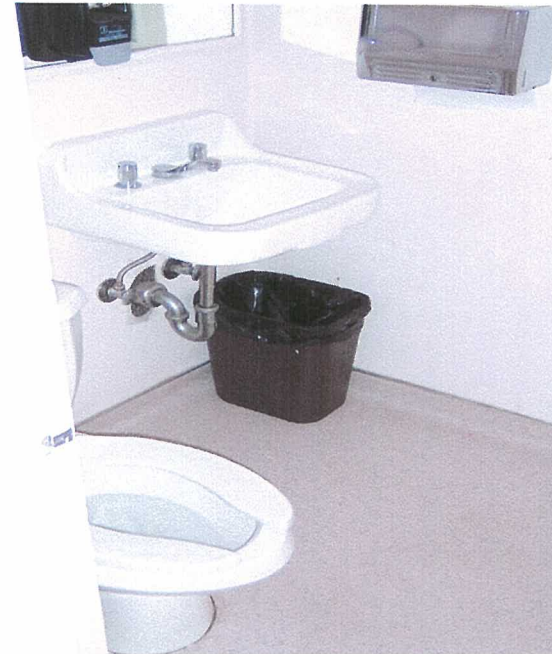
*Building - Photo # 10*

*Restroom is too small and does not have the required wheelchair maneuverable clearances. Sink does not have pipe insulation; soap and paper towel dispensers are mounted too high.*

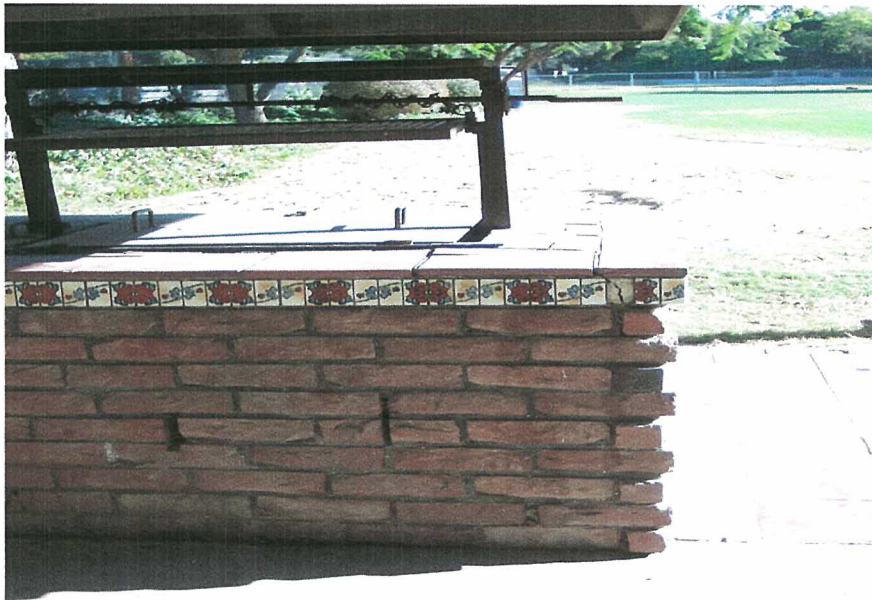
*Building - Photo # 11*

*Bar B.Q. fire pit is mounted too high-39" high. Fire pit crank is mounted at 75" high.*

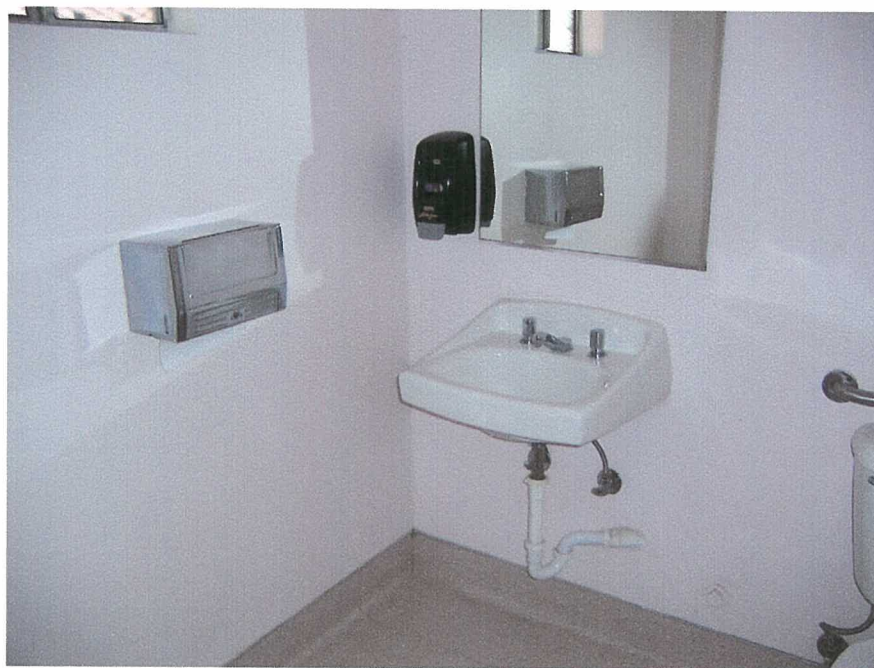
*Building - Photo # 13*

- . Soap and paper towel dispensers are mounted too high. Mirror is mounted at 42 ½" high.*

Adult: Sanitary facilities dispensers and accessories.		Accessories shall be mounted 40" from floor to highest operating slot or control: towels, soap, sanitary napkins, seat covers, waste receptacles etc.	Mirror mounted at 42 1/2" high. Photo #: 13	ADAAG: 4.27 T24: 1115.B.9.2	Lower accessible restroom accessories.	1	JOB	\$350	\$350	2
