**GILDA PUENTE-PETERS**  
**ARCHITECTS**

**MACKENZIE PARK**  
**ACCESSIBILITY SURVEY**

**February, 2006**

**CITY OF SANTA**  
**BARBARA**

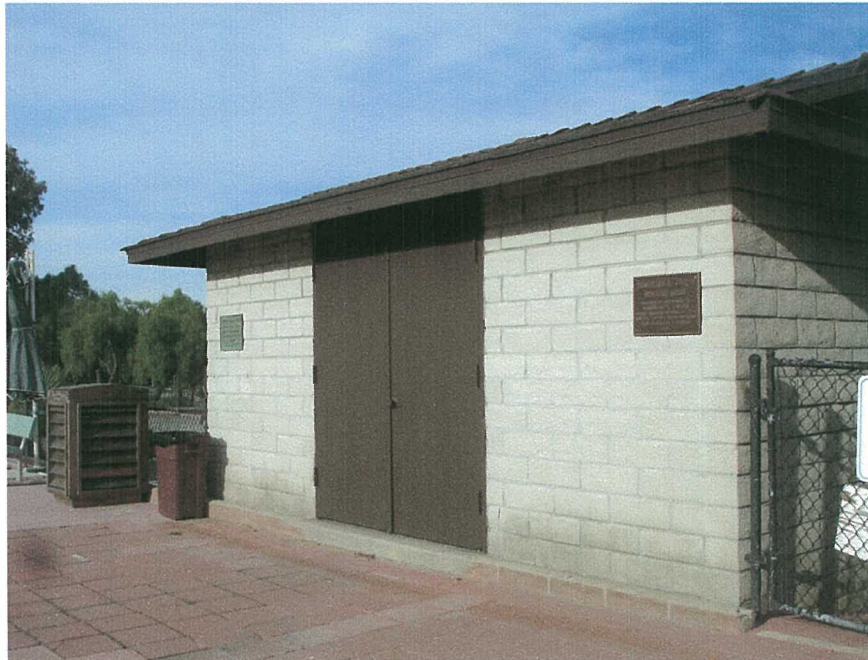
*Building - Photo # 1*

*Door hardware requires tight grasping and twisting of the wrist to operate. There is not a tactile and Braille room identification sign. Step makes this storage room inaccessible. There is no contrasting color striping at step.*

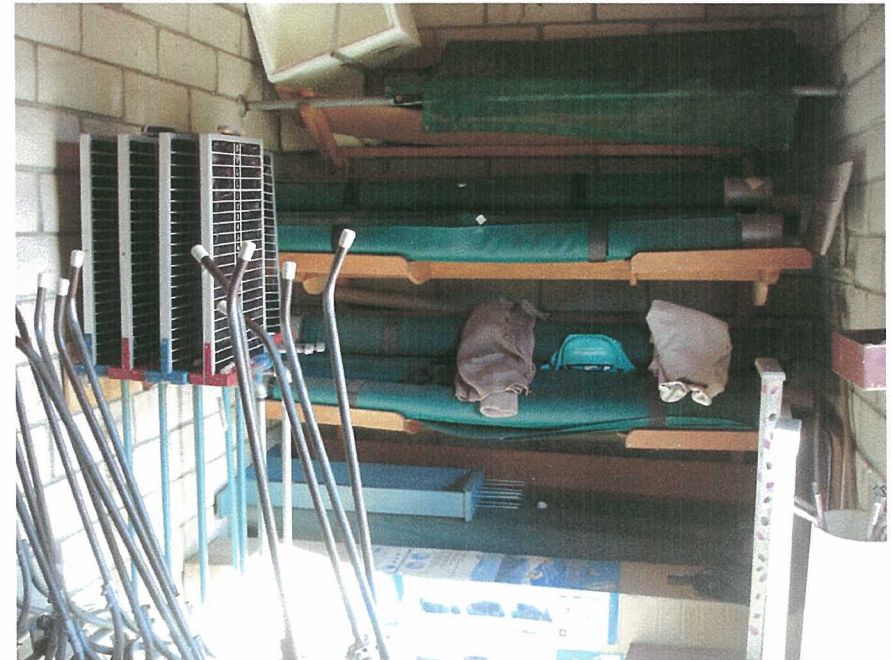
*Building - Photo # 2*

*Equipment storage is not accessible, there is a step to it. Team players assist persons with disabilities retrieving the equipment.*

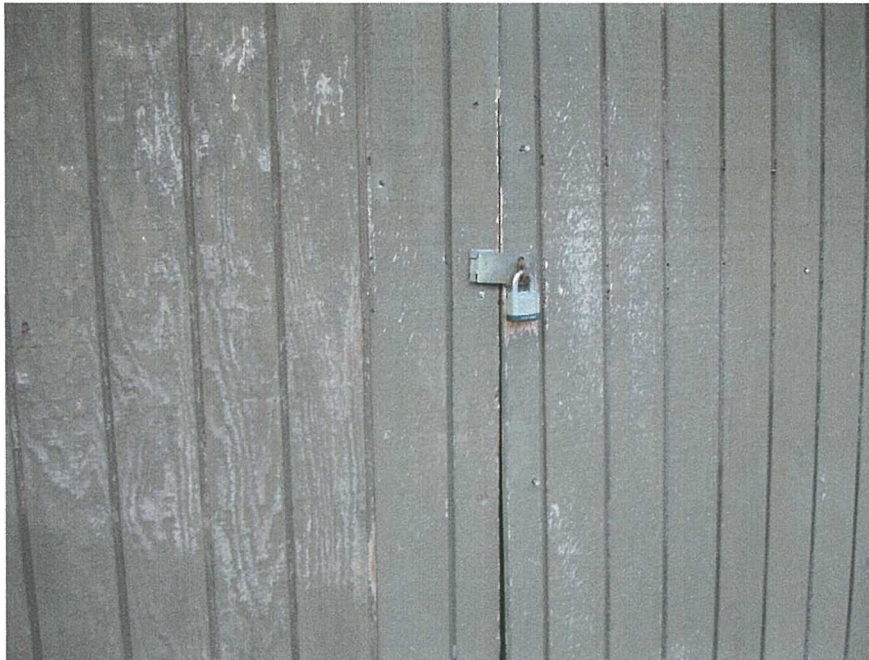
*Building - Photo # 3*

*Door padlock requires tight grasping and twisting of the wrist to operate. There is not a tactile and Braille room identification sign.*

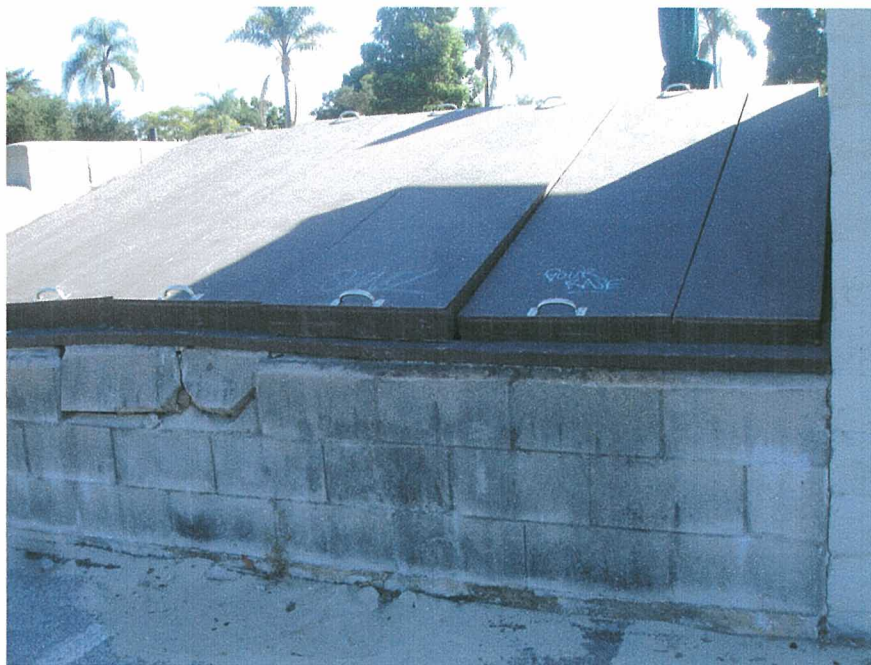
*Building - Photo # 7*

*Wheelchair users due to the nature of the activity cannot operate sand covered storage.*

Forward approach reach range to objects or controls.	Mounting height 48" or less than 15" high, when clear space allows only forward approach.	Covered sand pit requires lifting by a person with disabilities. Photo #: 7	ADAAG: 4.2.5 T24: 1118B.5	Provide equivalent facilitation at other uncovered sand pit area.	REF.	\$0			4
--	---	--	------------------------------	---	------	-----	--	--	---

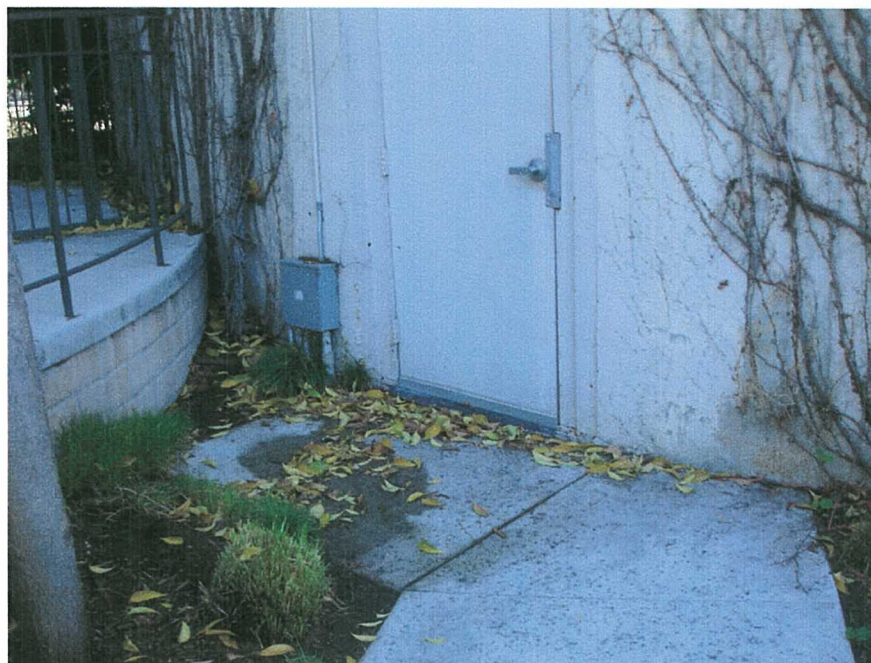
*Building - Photo # 1*

*There is no tactile and Braille room identification sign.  
This storage building does not have public access and is  
used only by staff.*
