**ALICE KECK PARK MEMORIAL
GARDENS
ACCESSIBILITY SURVEY**

June, 2007

CITY OF SANTA BARBARA

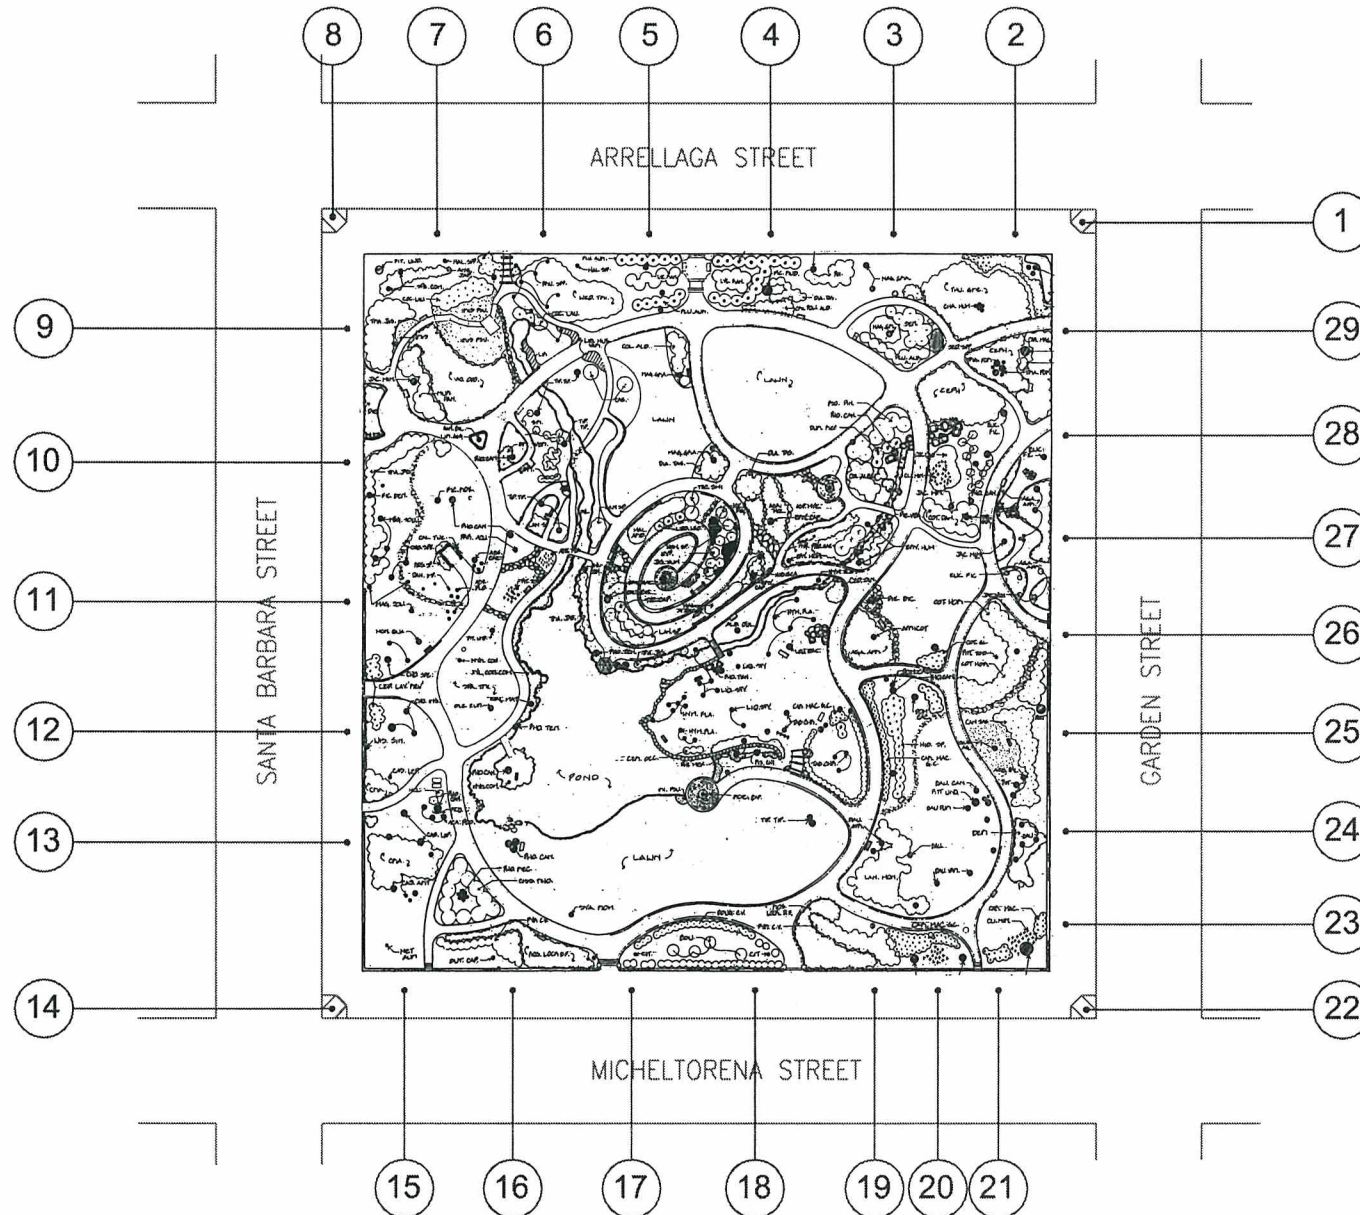
Public Right-of-Way - Photo # 1

Existing curb ramp with multiple code non-compliances.	Multiple code requirements.	Curb ramp running slope 9.5%; flair sides slope ranges from 11.5% to 7.2%; bottom landing 2'; grooves 4" wide; no detectable warnings and not contrasting color with adjacent surfaces. Photo #: 1	ADAAG: 4.7 T24: 1127B.5	Remove existing curb ramp and provide new curb ramp, with the required slopes, top and bottom landings, 12" grooves, detectable warnings, contrasting color with adjacent surfaces and "No-parking zone" red striping at each side of curb ramp.	1	JOB	\$5,900	\$5,900	3
--	-----------------------------	---	--------------------------------	--	---	-----	---------	---------	---

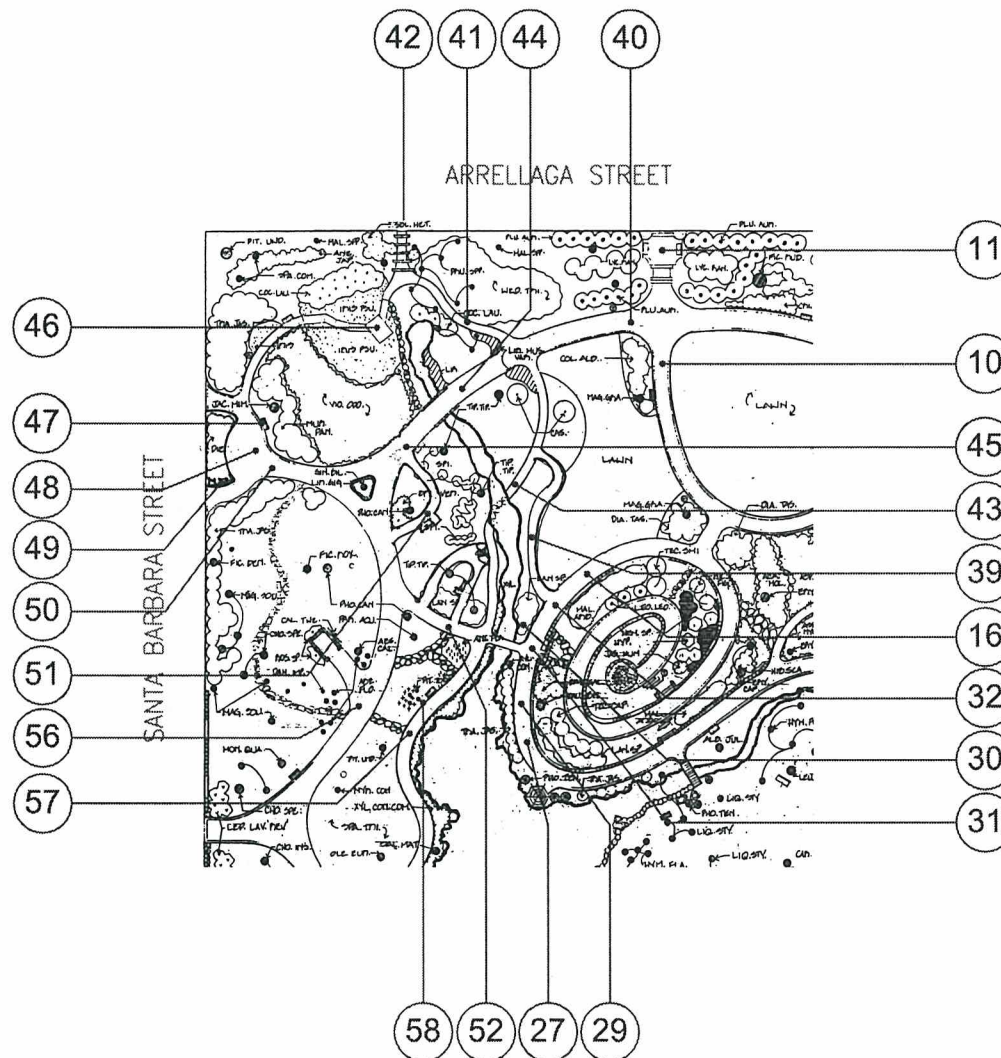
Site - Photo # 1

Pavement dislocations.	Beveled edge 1:2 max. (between 1/4" and 1/2")	1" drop from sidewalk to decomposed granite surface. Photo #: 1	ADAAG: 4.5.2 T24: 1133B.7.4	Remove, replace or repair surface area to correct abrupt change in level.	9 SF	\$22	\$198	3
------------------------	--	--	------------------------------------	---	------	------	-------	---
