**CONEJO
AREA CITY
DOCUMENTS**

2005 PRELIMINARY GEOLOGY OBSERVATIONS

SUBJECT: Preliminary Geologic Observations, January 13 and February 1, 2005, of the Conejo Road Landslide Area, City of Santa Barbara, California

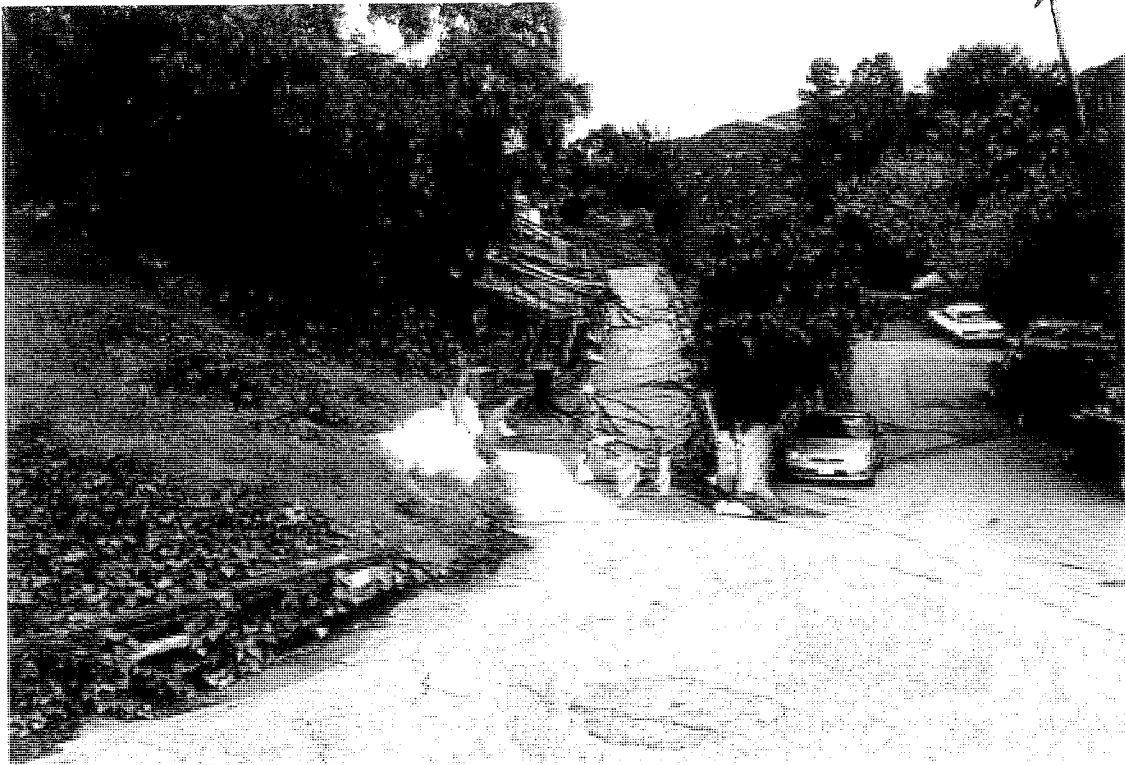
The pavement in Ealand Place underlain by Slide Mass C was down dropped but did not show obvious signs of recent pavement cracking. However, the driveway to 16 Ealand Place was covered with plastic sheeting. Some slippage in the head scarp area may be occurring. This slippage is upslope from the Ealand Place survey monitoring point. Earth movement may not be immediately reflected at the survey point. Photographs 11 and 12 in Appendix A illustrate this area.

Photo 12 Looking north at driveway entrance to 16 Ealand Place, 1/13/05.

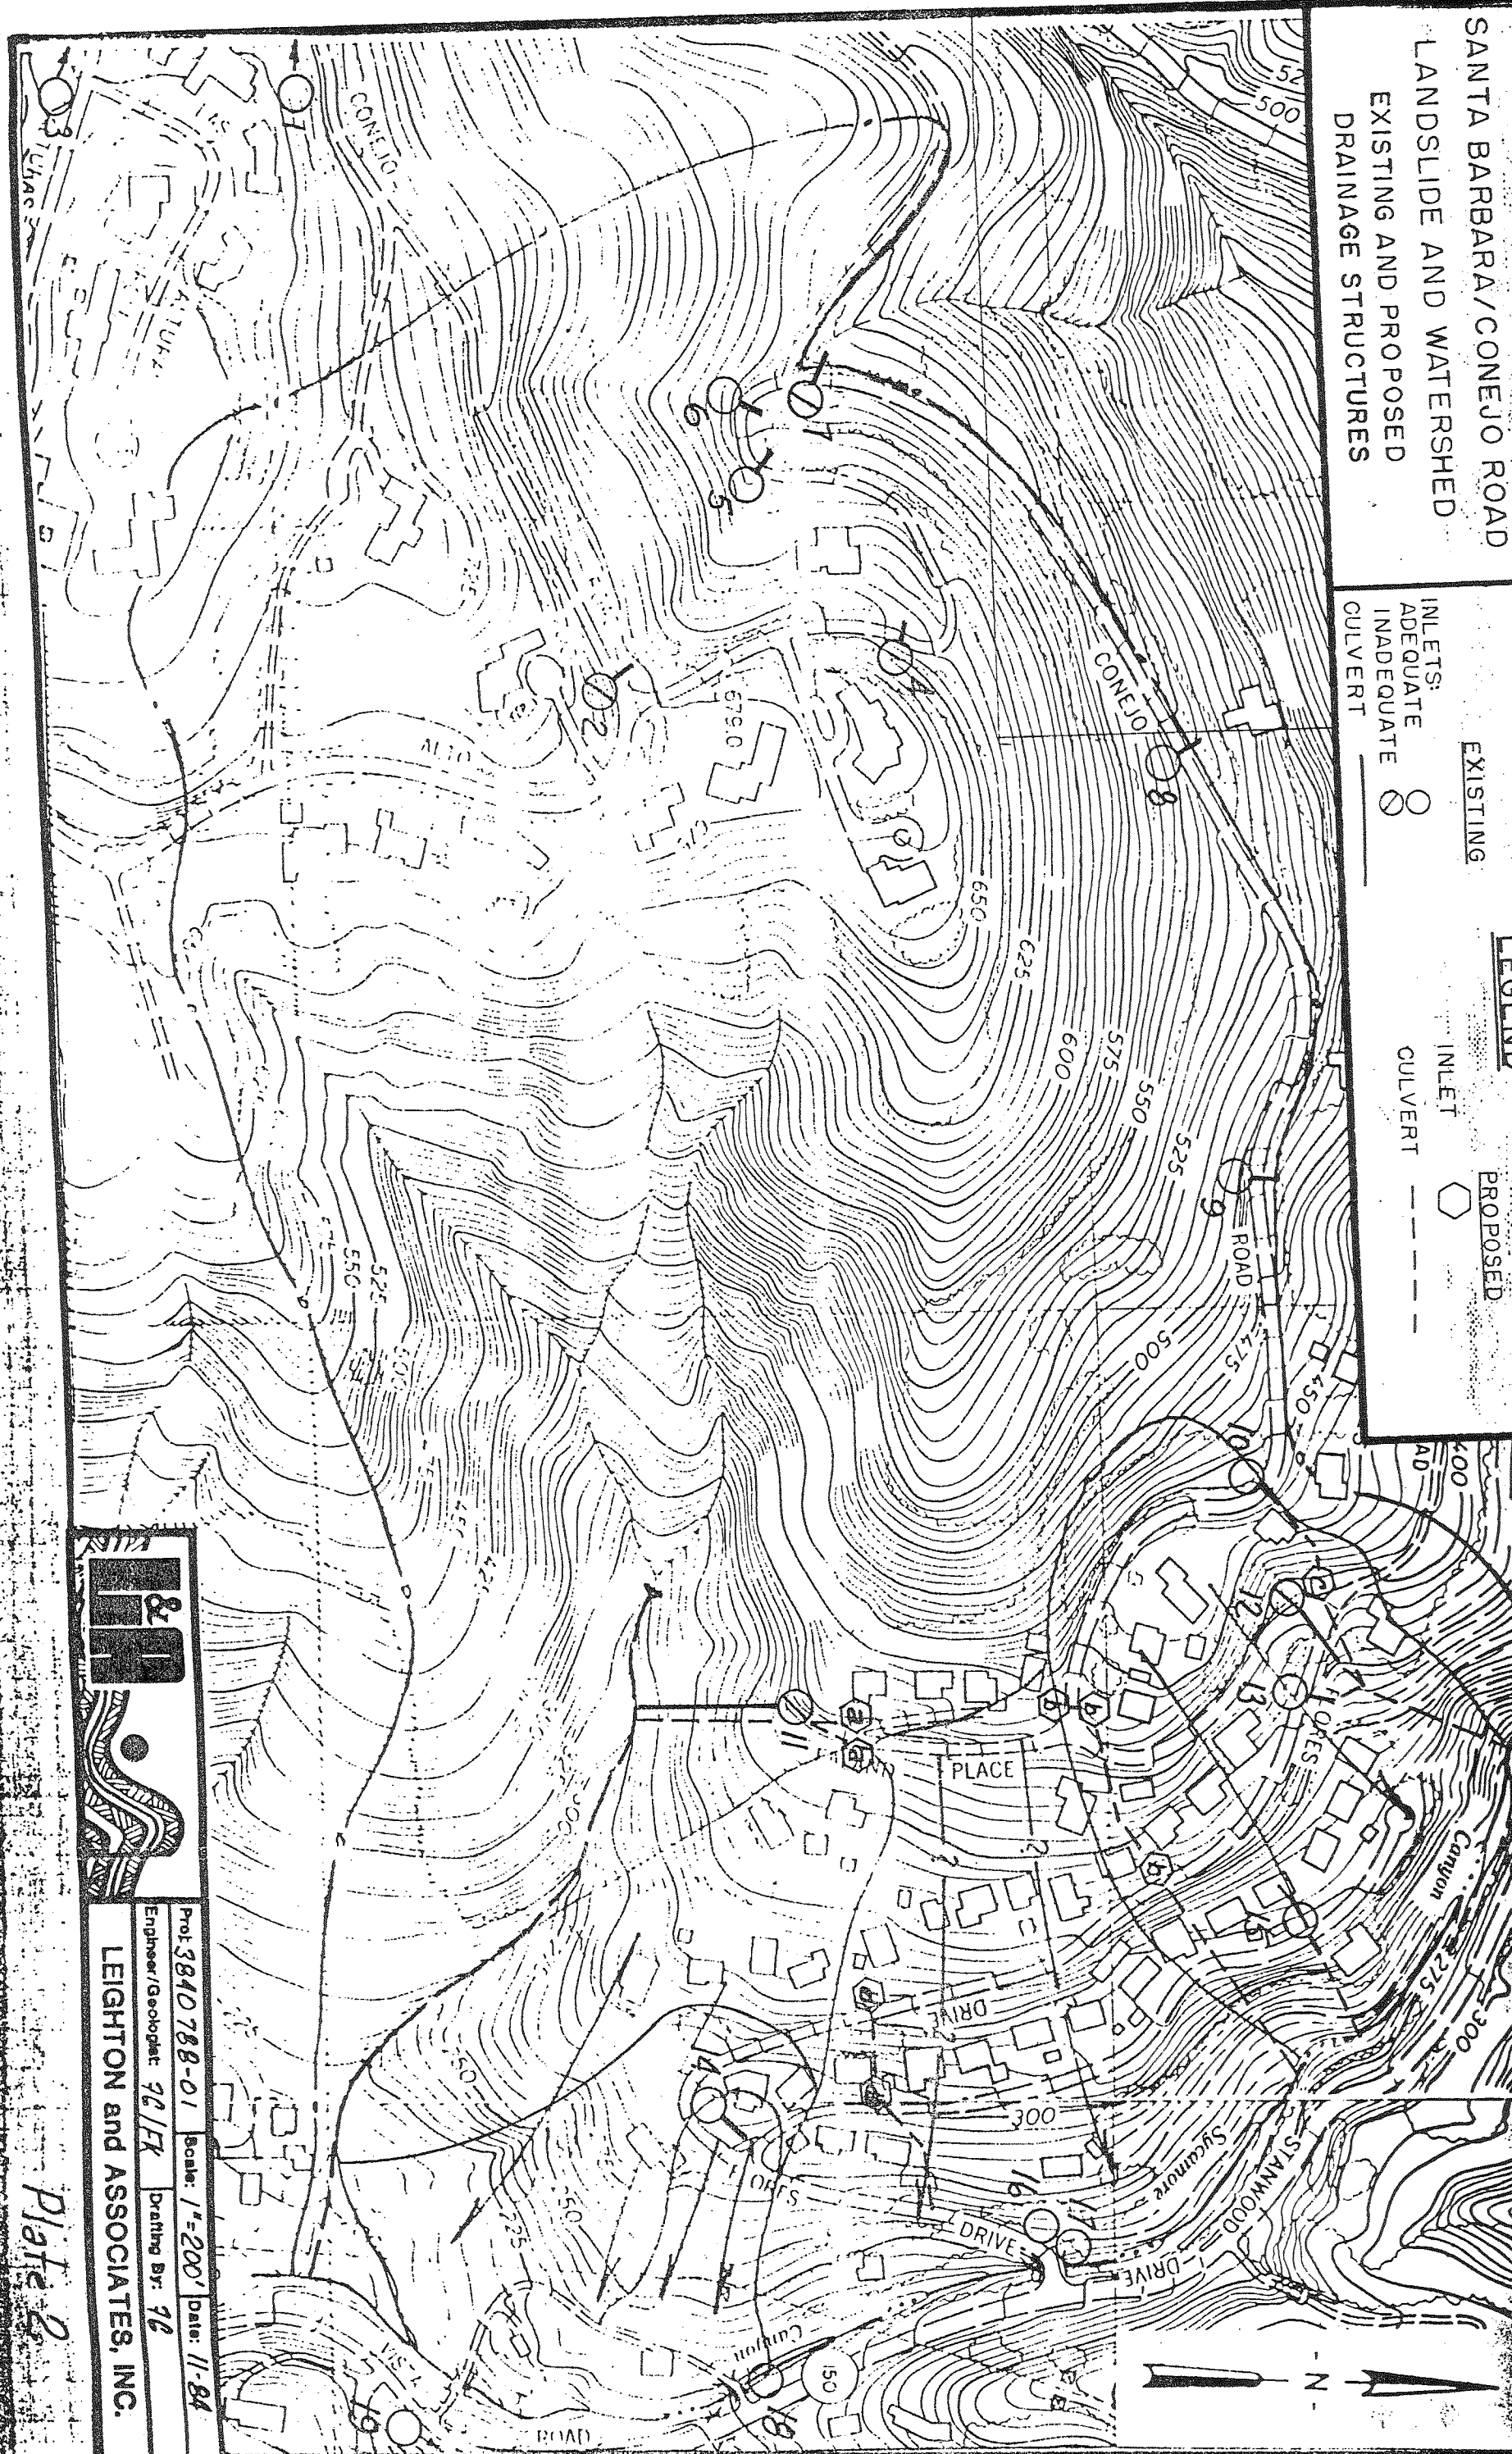
Plate 2

A horizontal drain system (hydrauger) has been proposed for dewatering the Conejo Road Landslide, Parts A, B and C. Additional areas for subsurface drainage include Landslides D and E. A typical system is shown on Plate 3. Further analysis of this system has revealed several factors that influence the feasibility of such a system. These factors are the low yield of water that was encountered in borings; discontinuous or perched-appearing nature of these seeps; lack of historic high water yields from the underlying bedrock; and the fact that horizontal drains installed in landslides stand the risk of being sheared, rendering them useless.

3. Site A appears to be the best site to begin subsurface dewatering (see Plate 3). The phreatophytes in this canyon are the only visible indication of surface seepage at this time, and the hydraugers can be located near the back of the slide plane, possibly intercepting seepage in this area before it enters the main slide mass. Site B would be the second priority set-up site because hydraugers could penetrate to the rear of the active Slide Mass A and portions of Slide Mass B. The cost of installing all hydraugers is expected to be from One Hundred Forty Thousand Dollars to One Hundred Sixty-Five Thousand Dollars (\$140,000-\$165,000).

2. Subsurface dewatering should be done on a phased basis. Hydraulgers should be installed in alphabetical order as shown on Plate 3. Sites A and B should be designed immediately and Sites C through I should await determination of the effectiveness of A and B.

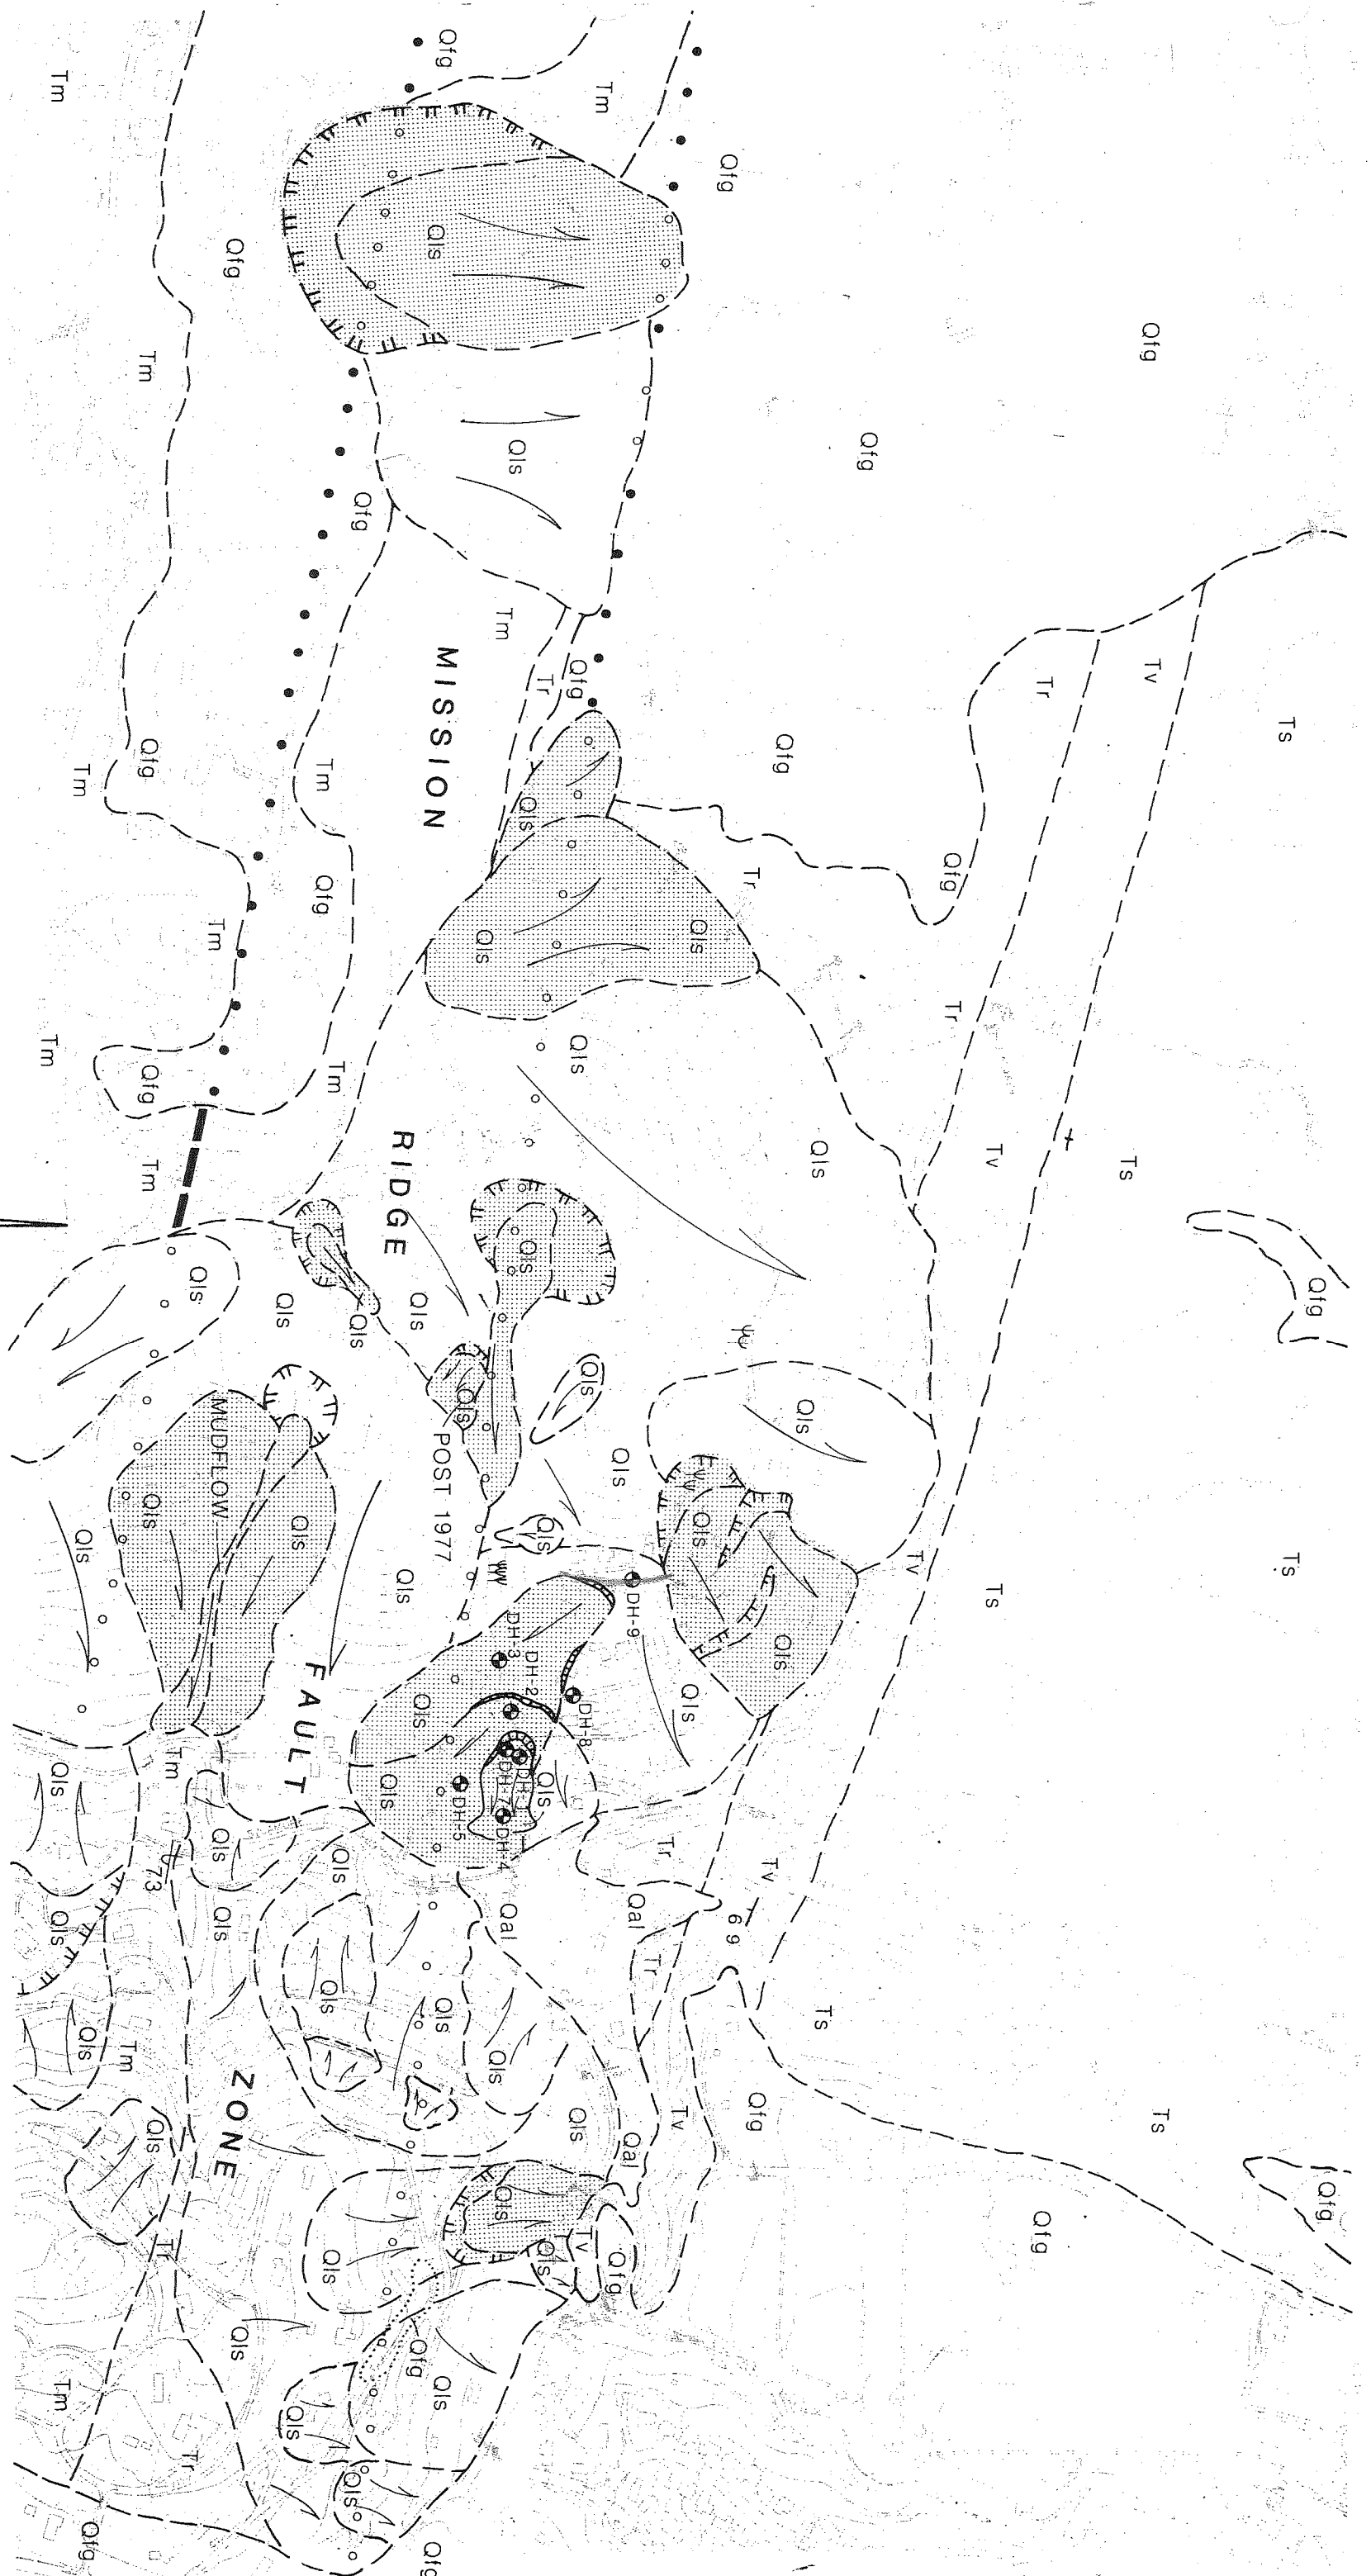
PLATE 1
 GEOTECHNICAL MAP
 CONEJO ROAD LANDSLIDE
 V83113A
 APRIL, 1984

The Conejo Road landslide, as presently defined, comprises two and possibly three roughly concentric slide masses. The configuration and postulated depths of these landslides are shown in plan on Plate 1 - Geotechnical Map and in section on Plates 3.1 through 3.3 - Geotechnical Cross Sections. The slide plane for Slide Mass A is relatively well defined based on the data obtained from the borings. However, the depths to slide plane B and particularly slide plane C are poorly defined and conjectural, and additional exploration would be required for accurate definition.
