## ORTEGA PARK MURAL EVALUATION REPORT

JULY 13, 2021

Prepared by:  
**Site & Studio Conservation, LLC.**  
Kiernan Graves  
Evelynn Bird  
Abigail Rodriguez  
Magdalena Solano

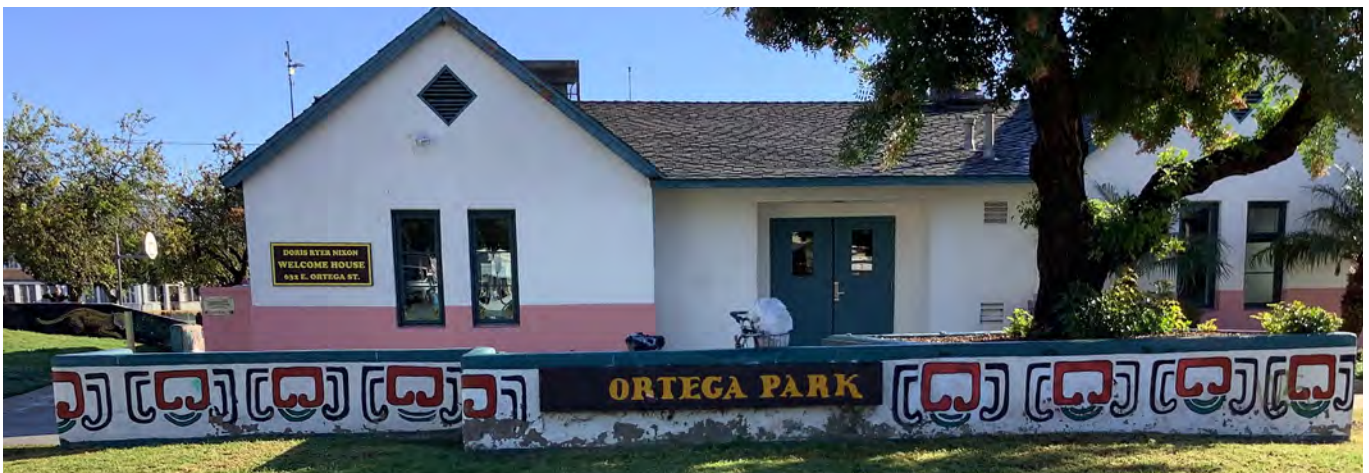
This decorative scheme was not intended to be part of the survey, however after discussion with Vallejo and learning that it was painted by him, it was included for documentation purposes. As there are very few records pertaining to this area of the park it is unknown how much the mural has been restored over time, but according to Vallejo, it appears the same as when he painted it, likely as part of the 1985-6 renovations. (Figure 5)

Figure 5. Decorative symbols painted by Vallejo.

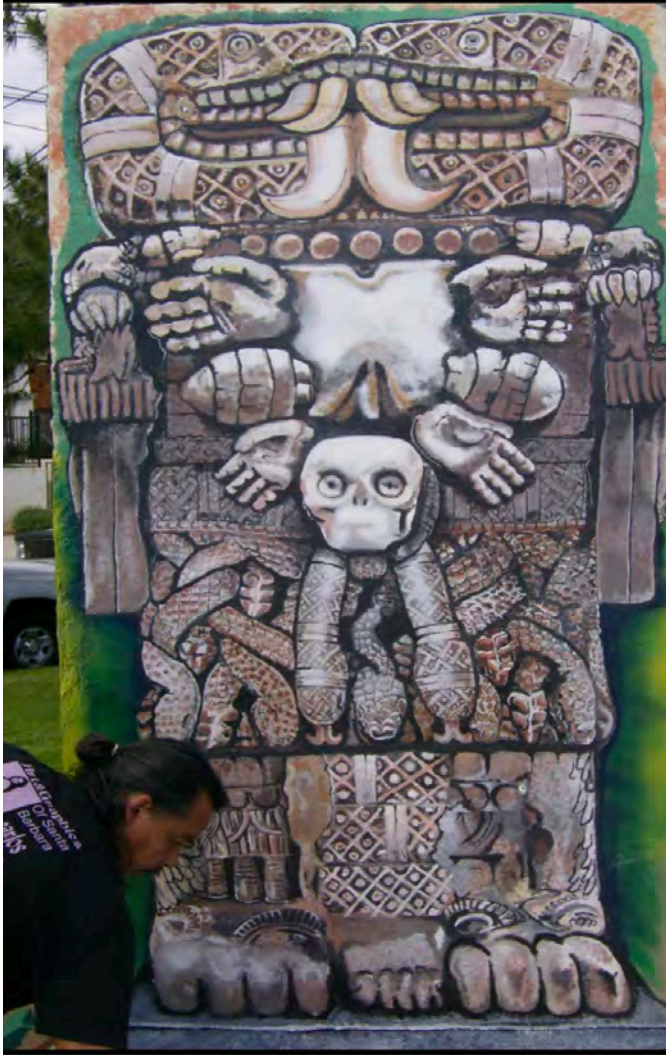
Due to health and safety concerns of the neighborhood, the stage walls were torn down in 2004 and the murals painted on them destroyed. What remains today are low retaining walls which flank a tall central panel, left in place because of the electrical box attached to the back. These murals have gone through a multitude of iterations, namely because after the stage walls were demolished, the SBAA designated the space for ongoing training of the young artists working on the mural painting and restoration projects. Since the demolition of the stage, the works of art on the walls were always intended to be temporary and are completely repainted every few years. Of interest, the general subject matter of each area has remained the same, even as new artists put their own style on the subject matter (Figures 6 and 7).

Figure 6. Cuellar painting the original *Coatlicue* in 2007  
(Image from Venegas 2020)

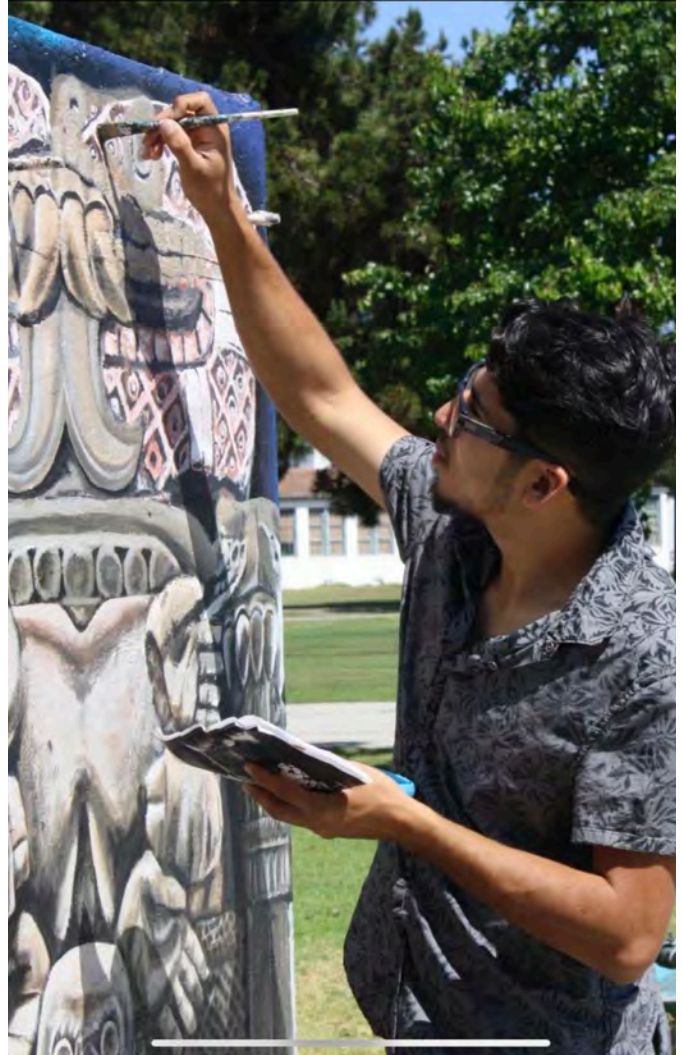
Figure 7. M. Rodriguez painting a new version in 2016.  
(Image from Venegas 2020)

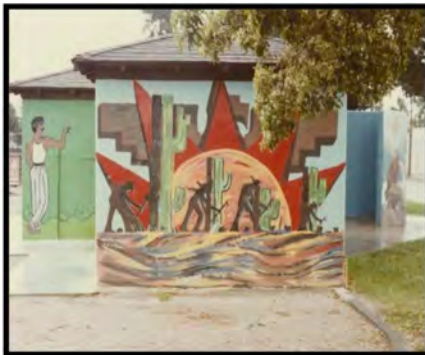
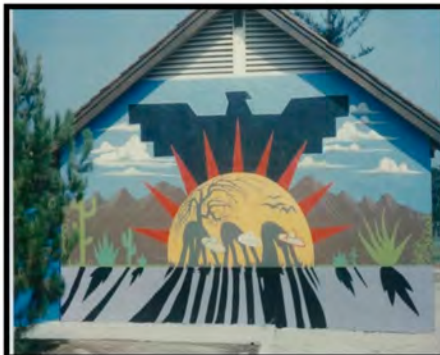
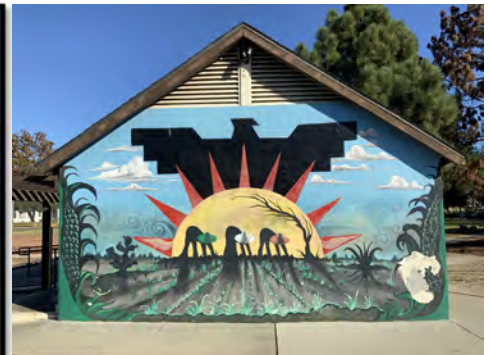
*Campesinos* first painted by Vallejo is a mural that has changed fairly significantly in composition—though not in the feeling nor subject matter—at two different times throughout its life. In 1985-6, the original building was torn down and Vallejo repainted his own design, changing a great deal of the composition but retaining the same style and content. Most recently, with Vallejo's permission, Unzueta again repainted the mural in the same location, adding a number of decorative elements but to the landscape, creating what most of the artists agree to be a more balanced and elevated design, but left the main composition, style and palette the same (Figures 8, 9, 10).

Beginning with *Campesinos* in 1979, this set of three murals functions as a tangible connection between California/Chicano/Santa Barbara history and present Eastside residents. *Campesinos* was painted by Armando Vallejo 1979 and subsequently repainted in 1986. Though he modified his original composition and style, the subject matter, iconography and powerful imagery remained. In 2008, during a restoration project for the two surrounding murals, Unzueta repainted the mural and altered the composition by adding and changing several elements of the mural. It was at this time that the corn, cactus, wind swirls, crops in the foreground, and colors on the hats were added. The mural, as it stands today, has a solid black Huelga eagle rising behind the sun, symbolically referencing the United Farm Workers labor movement. Additionally, the red, white, and green hats of the *Campesinos* are a reference to the Mexican flag. The bent position of the figures is a tribute to the backbreaking work and struggle of Mexican-American immigrants labor in California's agricultural industry, some of whom reside in the eastside of Santa Barbara. The powerful and symbolic imagery of the farm worker was particularly mentioned as meaningful and important by many of the community members interviewed (Figures 8, 9 and 10).

Figures 8, 9, 10. *Campesinos* and its iterations, from left to right: 1979, 1985, present.  
(Archival images from Venegas 2020)

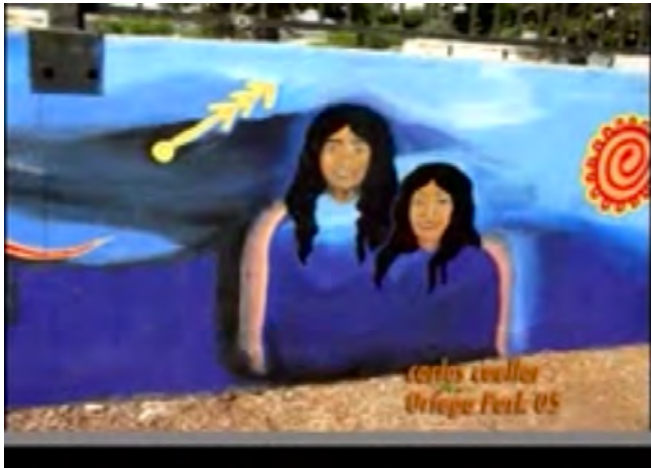
Figure 13. *Aztec Chumash Solstice* before restoration. (Image is taken from a video put together with archive images by Cuellar.)

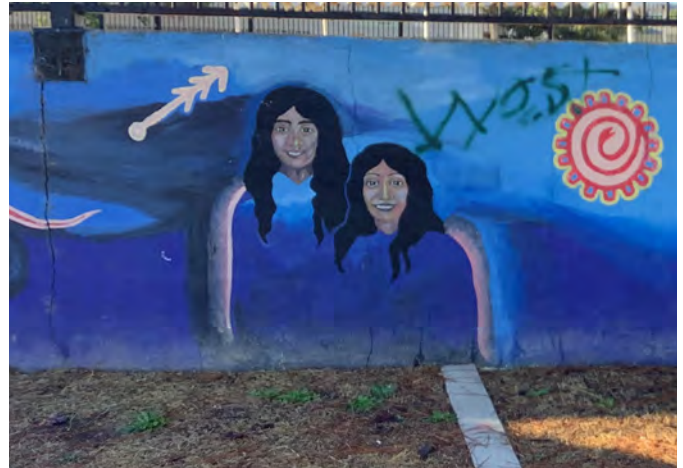
Figure 14. *Aztec Chumash Solstice* after restoration.

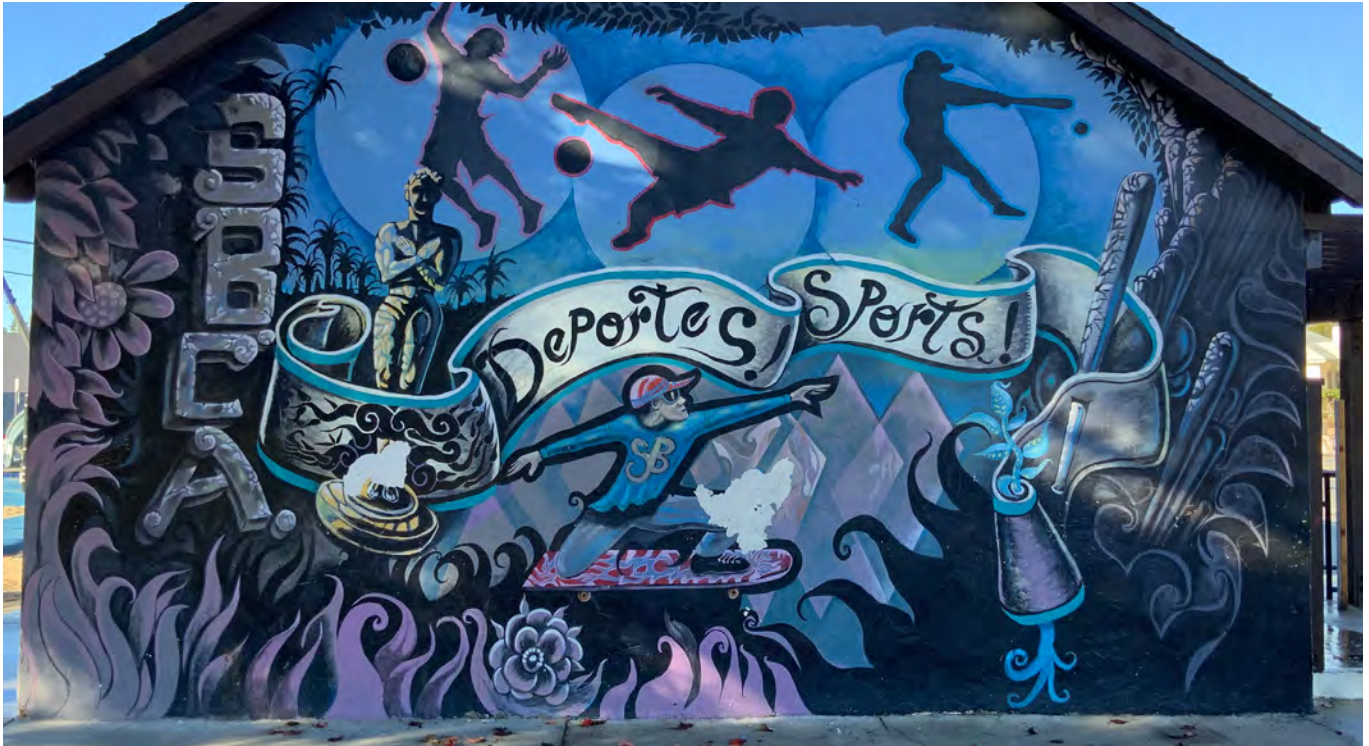
Figure 15. *Deportes*

referencing the numerous t-ball and softball leagues who use the park. The entire work makes use of a limited palette by skillfully contrasting dark and light across the wall. The scene overall appears to be enveloped by nature, giving a soft edge to the urban landscape (Figure 15).

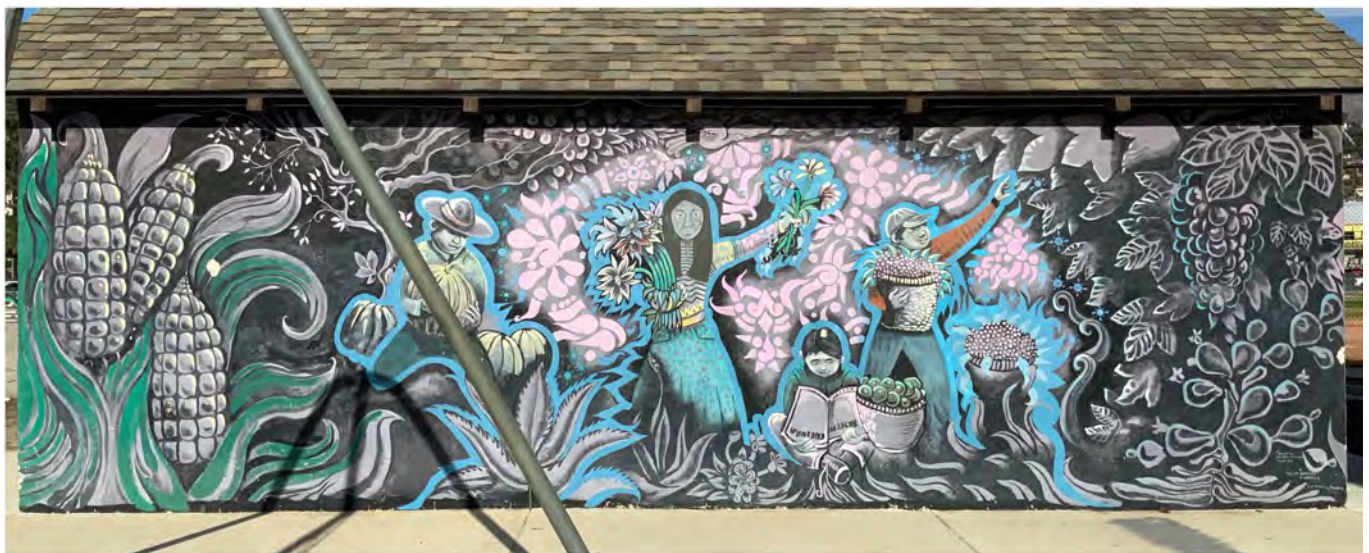
Figure 16. *Niños de Maíz*

The final mural on the restroom building is *Niños del Maíz*. This mural was painted in 2008 as a replacement for a damaged work by Unzueta. Unzueta has stated that the work pays homage to the farmworker families in the Santa Barbara region. When this mural is put in conversation with Vallejo's *Campesinos*, a strong tangible connection between the past and the present is presented for the patrons of the park. Restored in 2011, the mural is framed by local crops: ears of corn on the proper right and grape vines on the proper left. There are four figures in the middle, surrounded by a soft pink Otomi-inspired floral design. Each figure is actively engaged with a different activity, including inspecting a pumpkin, selling flowers, and picking grapes. The figure at the center and foreground of the mural is holding a book open next to what appears to be a basket of avocados. The pages of the book say "RESPETO CULTURA" or respect culture. Similar to the *Campesinos* mural, *Niños del Maíz* communicates a rich story about local agriculture, Chicano laborers, and culture through a limited but dynamic palette. The strength of the messages in each of these murals is amplified by the relationship of the three works to one another. Together they elicit themes of community, history, and identity (Figure 16).

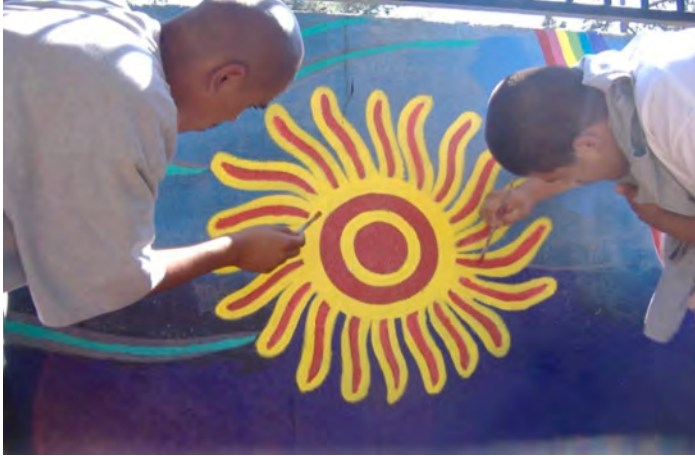
Of the seven murals surrounding the pool area, three are found on the interior of the walls of the pool fence, three are painted on the exterior of these walls, and one is found on the south facing exterior wall of the pool house. All of the murals contain similar themes. Four of the murals are original to the first phase of mural making at Ortega Park from 1979-1980 and contain themes of indigenous cultures with subject matter and inspirations from the Chumash tribe, Aztec and Mayan civilizations. These are some of the oldest exterior murals that exist in Santa Barbara.<sup>4</sup> Although these original murals have been restored, the restoration to *Aztec Chumash Solstice*, *Comic Unity*, and *Codex Cospi* was sensitive to original composition and palette (Figure 17).

Figure 17. Detail from *Aztec Chumash Solstice* showing the restoration work during 2005 (Image from Venegas 2020)

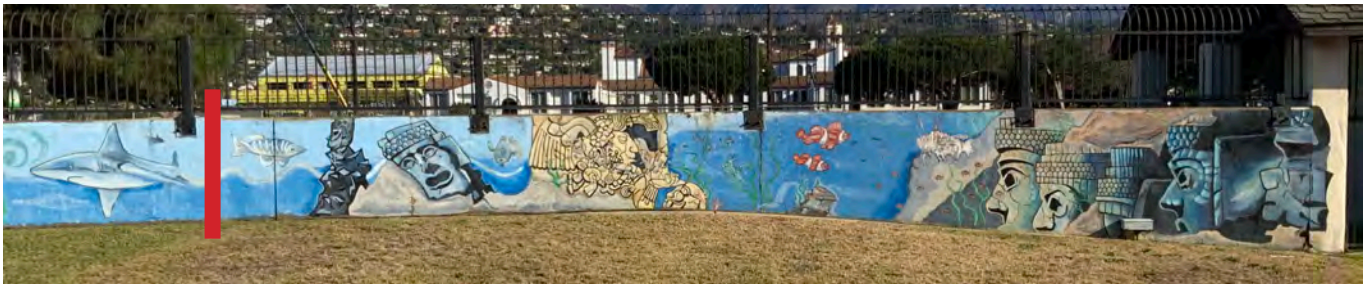
Figure 18. Detail from *Dolphins* and the entire composition of *Underwater Atlantes/Toltecas*, with the red line showing the delineation between the two murals, according to Cuellar.

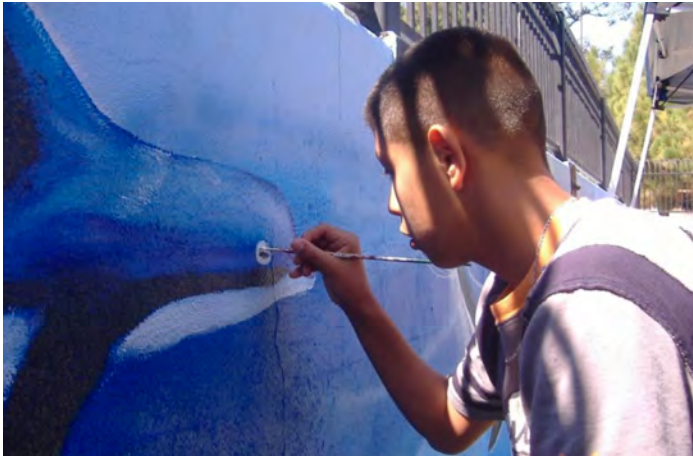
fond memories of swimming in the pool in the summer and learning about aquatic life through these murals (interview by Solano with Diana Cabral, Unzueta's niece, January 2021) (Figure 19).

Figure 19. Detail from *Dolphins* showing painting in progress.  
(Image from Venegas 2020)

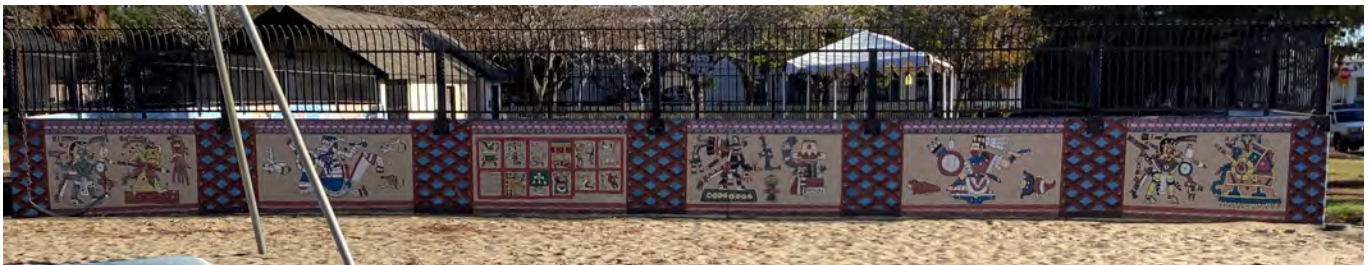
Figure 20. *Codex Cospi*

On the exterior wall of the pool, all murals date to 1979. *Codex Cospi*, painted by artist John Russell, depicts scenes from an Aztec manuscript that has origins from Puebla or Tlaxcala (Miller 2012). These manuscripts and murals depict divine cycles of cosmic creation in the form of an early calendar, with a large focus on ritual and Quetzalcoatl, perceived as the creator god (Figure 20).

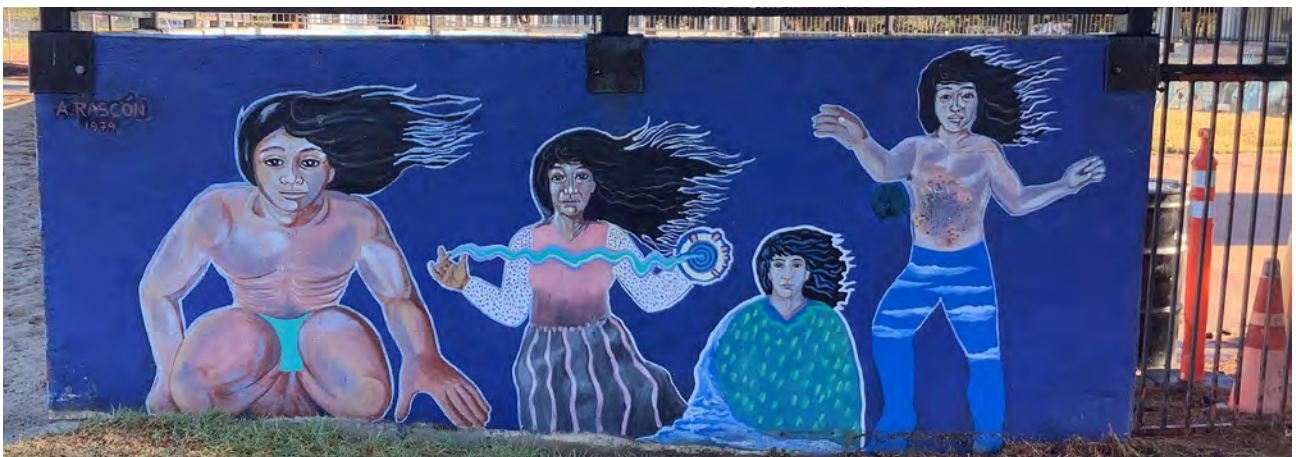
Figure 22. *Cosmic Unity*

*Cosmic Unity* (Figure 22), located on the west wall of the pool was also painted in 1979 by Rascon and has been restored many times as well over the decades. The four figures seem to represent how the Chumash believe that humans are connected to the elements of the earth. The figure furthest on the left is to represent man himself, simply clothed. The other figures on the right being water, land and sky. "When we become a part of nature, and let nature become a part of us, we start to understand the time that nature lives by, a natural time. The Chumash lived by Nature's time, not man's time. When we pay attention to the seasons, and the changes, and the helpers and the keepers from each direction, we gain useful lessons about life; they help us understand our role in it. Each season held a special place in relationship with life's cycles" (Waiya 2020). The murals appear to blend and represent the Chicano and Chumash cultural beliefs of cosmic relation between man and earth. However, in interviews with T. Caulderon and Jessa Calderon (J. Caulderon) (Chumash) and Liggett, they all believed that *Cosmic Unity* is a beautiful mural that represents the multicultural communities of Santa Barbara and Southern California and while the artist's intention here was to include the Chumash culture, the symbol in the hands of the female figure is not specifically Chumash.
