Site Accessibility Evaluation

Alice Keck Park
219 E Micheltorena St
Santa Barbara, CA 93101
Accessibility Evaluation
Inspection Date: 08/24/2023
Inspectors: Scott Saddlemire

SALLY SWANSON
ARCHITECTS, INC.

Report Date: 11/03/2023

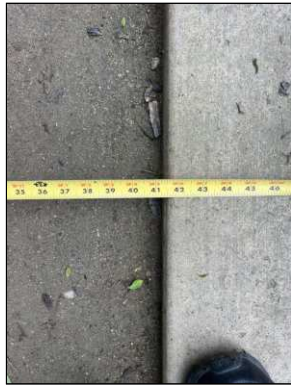
Finding: 1 Additional Finding Photos

The route of travel does not provide the required minimum width.

See exception 3 in the findings section

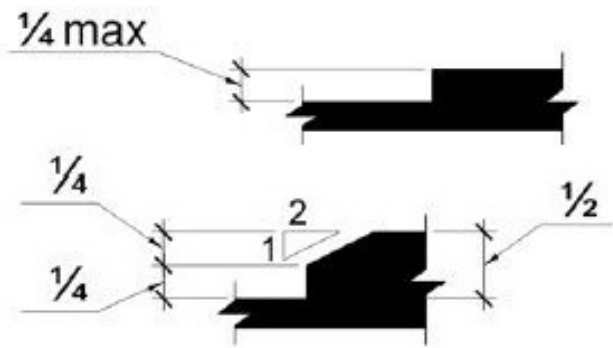
Finding: 2 (Continued)

The walkway contains abrupt vertical edges and/or variations over 1/4 inch.

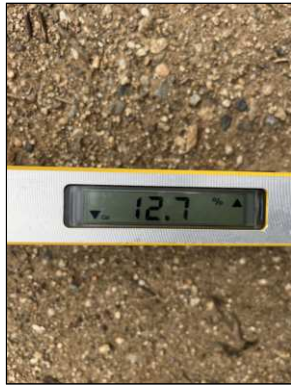
Finding: 3 Additional Finding Photos

The accessible route has running slopes greater than 5% and has not been constructed as a ramp (i.e. handrails, edge protection, etc.). Cross slopes are greater than 2% across the width of the walk.

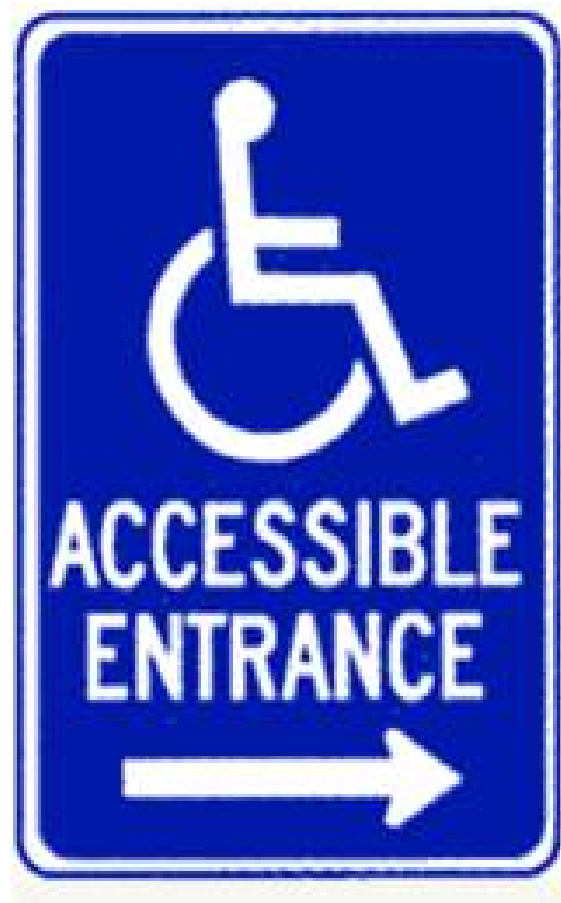
Finding: 4 (Continued)

The entrance is not accessible and is missing signage. An identification sign identifying that this entrance is not accessible and directional signage pointing to the accessible entrance is required.

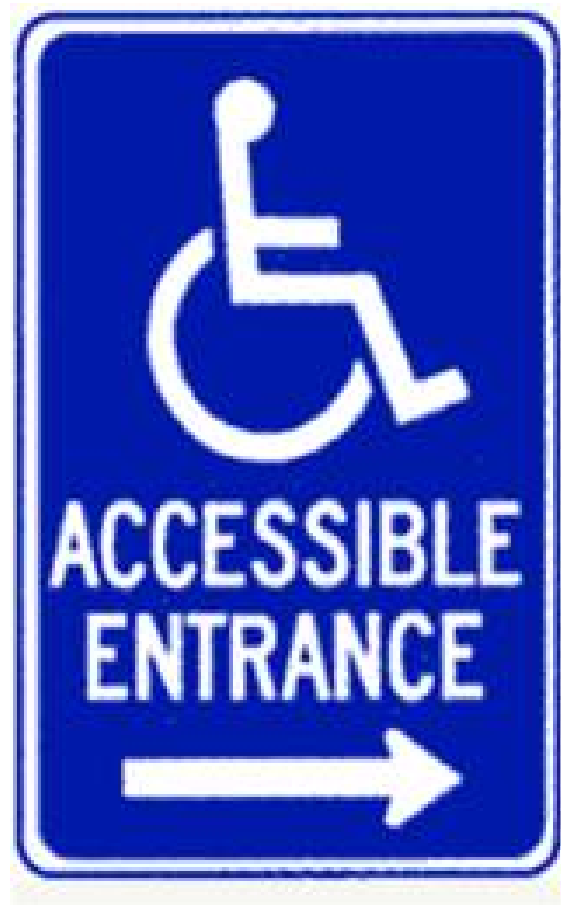
Finding: 10 *(Continued)*

The entrance is not accessible and is missing signage. An identification sign identifying that this entrance is not accessible and directional signage pointing to the accessible entrance is required.

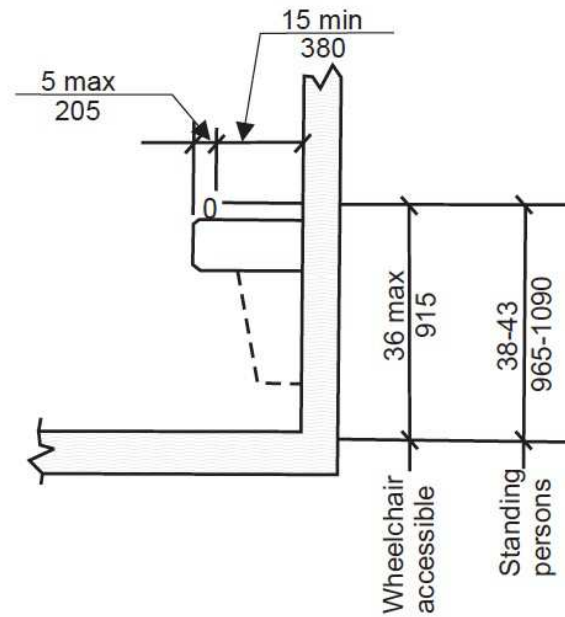
Finding: 11 (Continued)

There is no drinking fountain for standing persons.

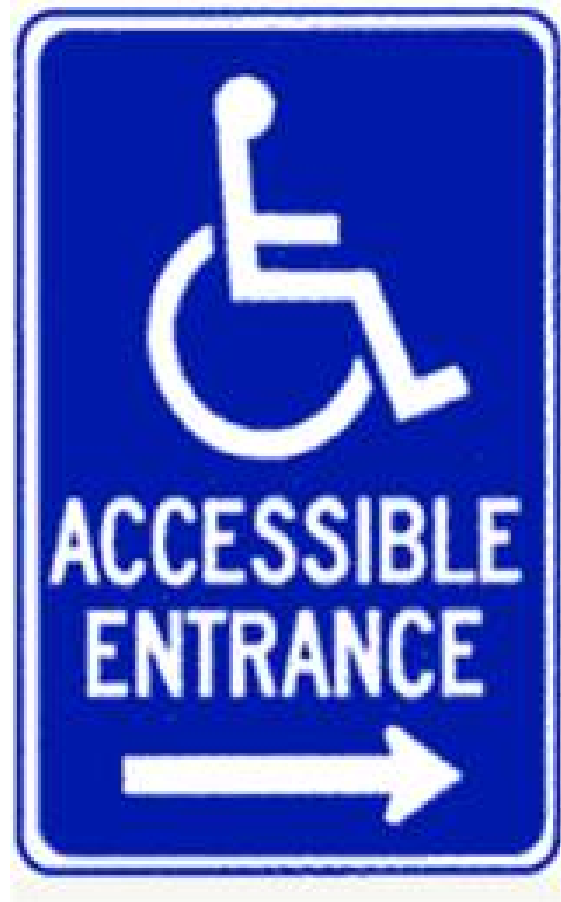
Finding: 13 *(Continued)*

The entrance is not accessible and is missing signage. An identification sign identifying that this entrance is not accessible and directional signage pointing to the accessible entrance is required.

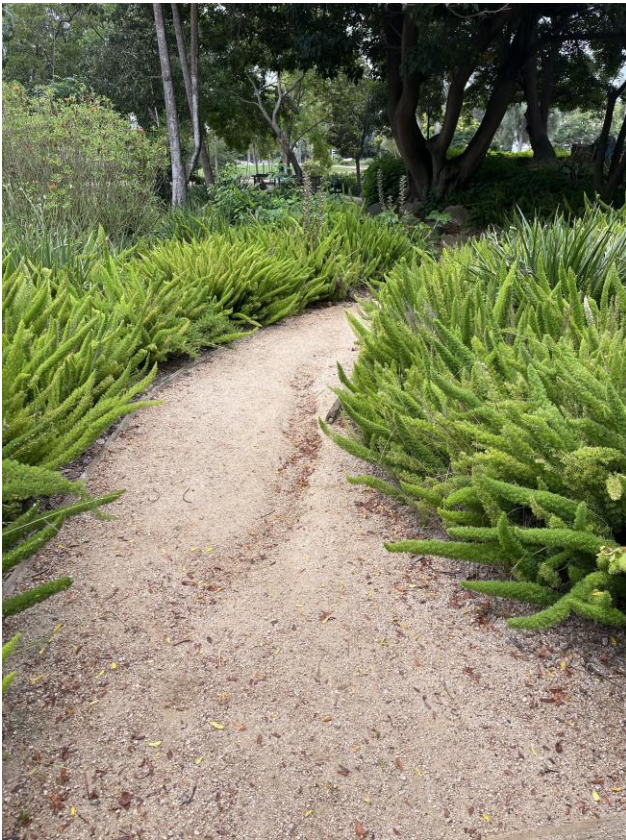
Finding: 15 (Continued)

The walkway contains abrupt vertical edges and/or variations over 1/4 inch.

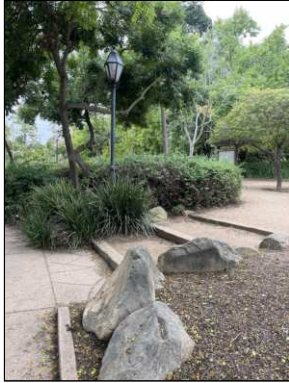
Finding: 16 Additional Finding Photos

The stairway is missing or contains contrasting stripes that are not on the required treads.

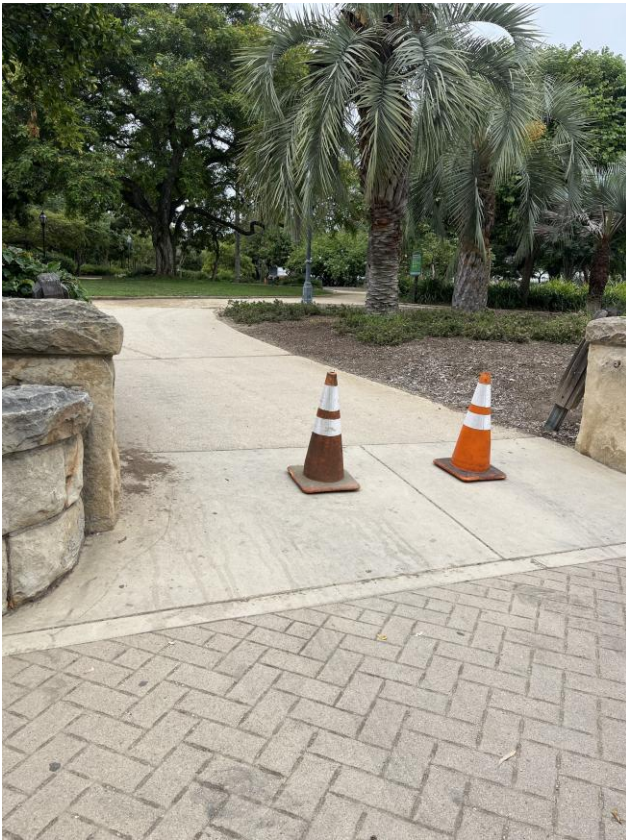
Finding: 19 *(Continued)*

The entrance is not accessible and is missing signage. An identification sign identifying that this entrance is not accessible and directional signage pointing to the accessible entrance is required.

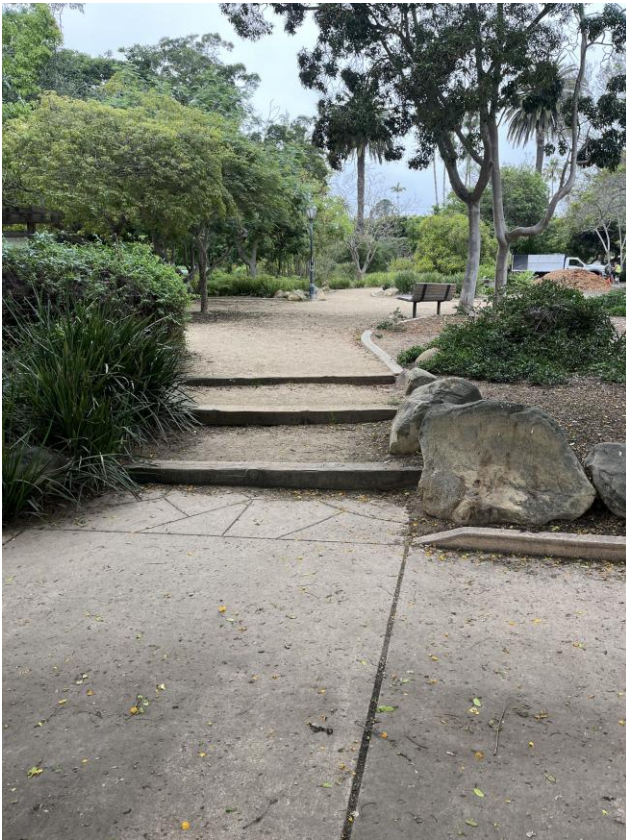
Finding: 20 (Continued)

The entrance is not accessible and is missing signage. An identification sign identifying that this entrance is not accessible and directional signage pointing to the accessible entrance is required.

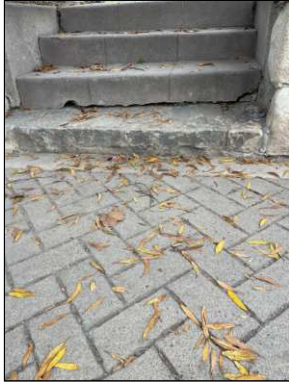
Finding: 23 Additional Finding Photos

The stairway is missing or contains contrasting stripes that are not on the required treads.

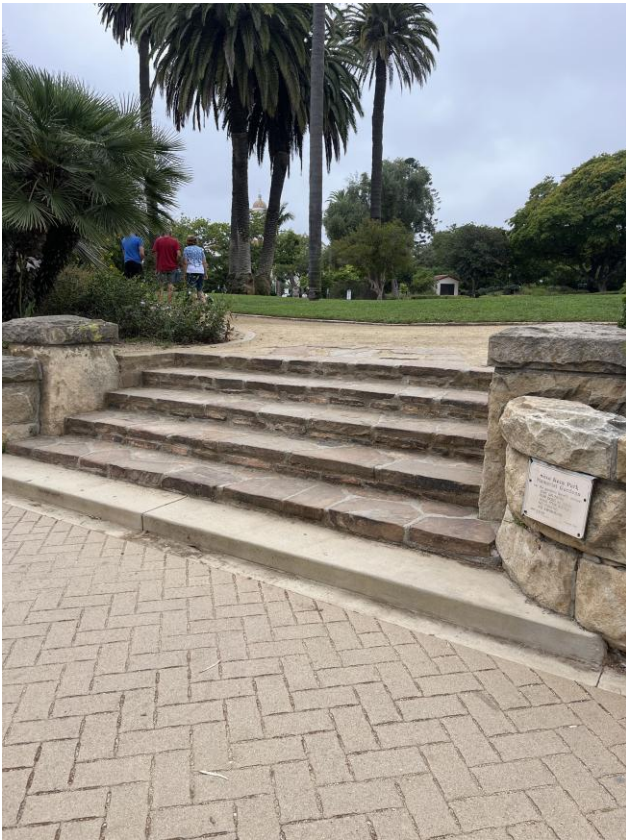
Finding: 24 (Continued)

The entrance is not accessible and is missing signage. An identification sign identifying that this entrance is not accessible and directional signage pointing to the accessible entrance is required.

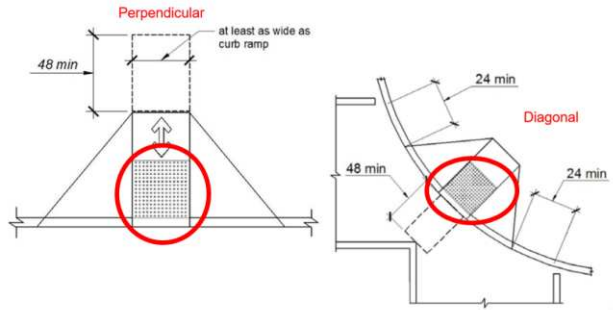
Finding: 27 (Continued)

The detectable warning is missing at the curb ramp.

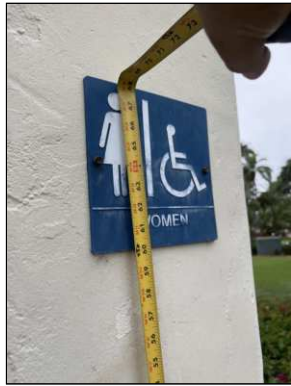
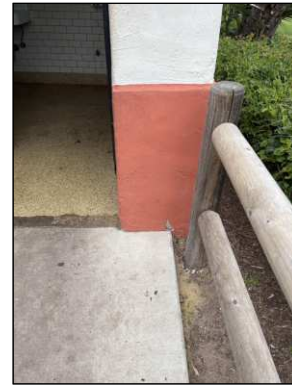
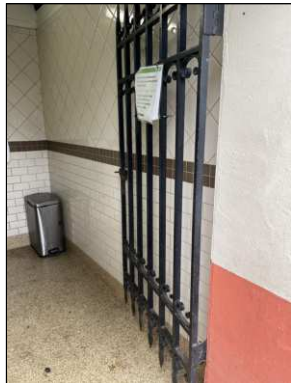
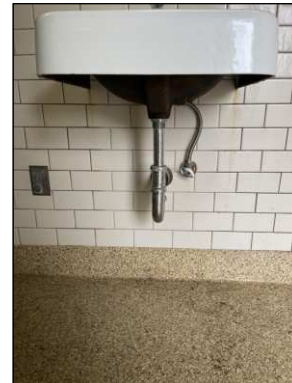
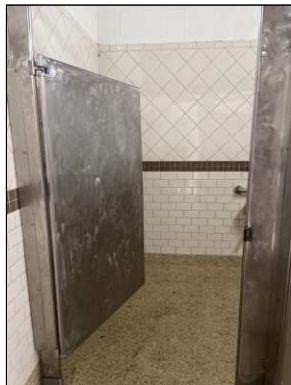
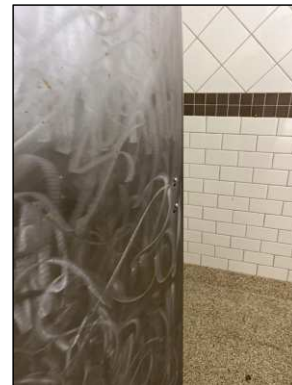
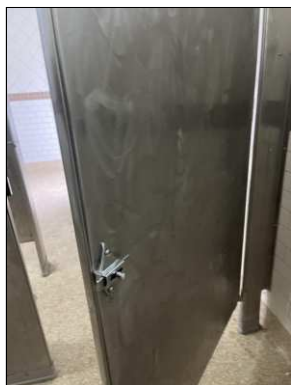
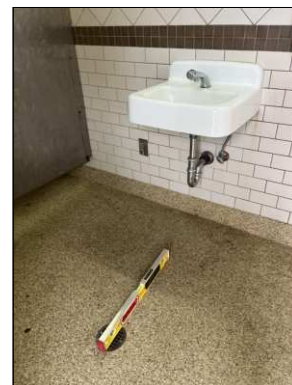
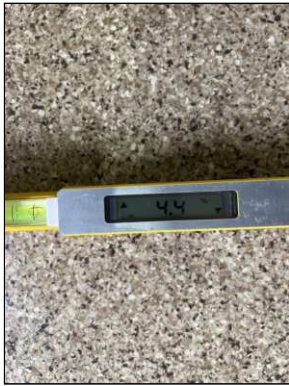
Finding: 29 Additional Finding Photos

The geometric sign for the women's room is missing.

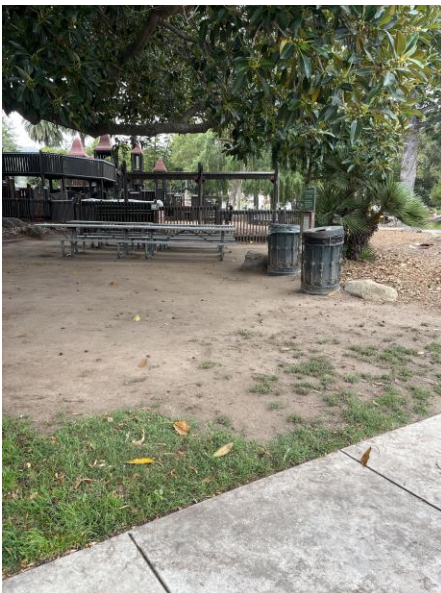
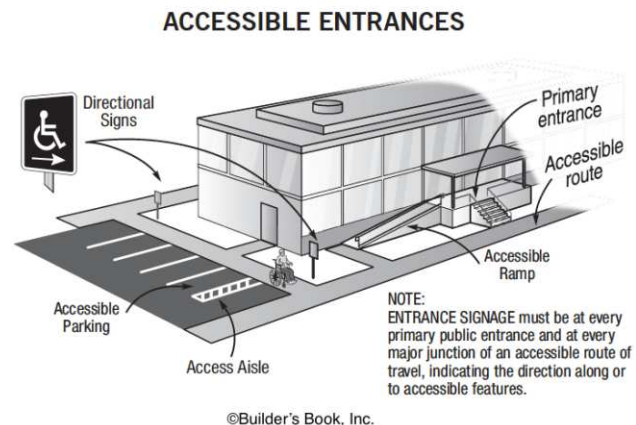
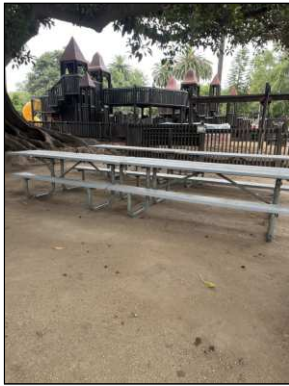
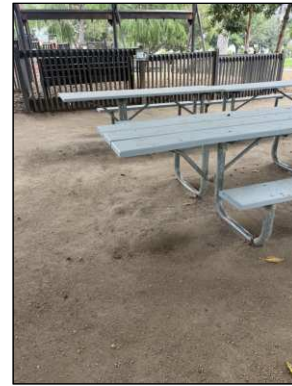
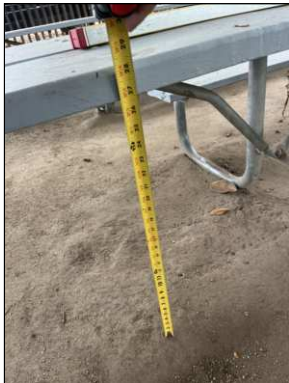
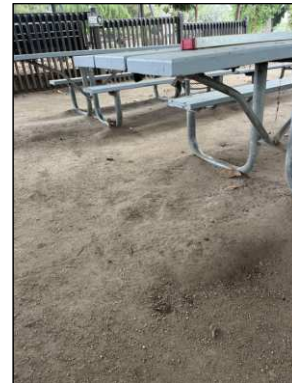
Finding: 30

There is no accessible route to the accessible element.

There are accessible tables, but no accessible route to the tables.

Provide accessible route to the picnic tables

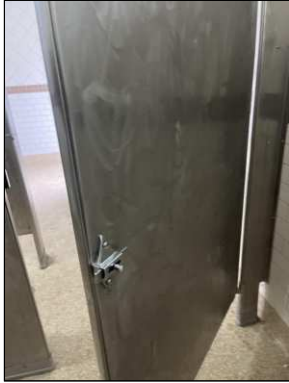
Finding: 39 Additional Finding Photos

The water closet compartment is missing a loop handle on both sides of the door.

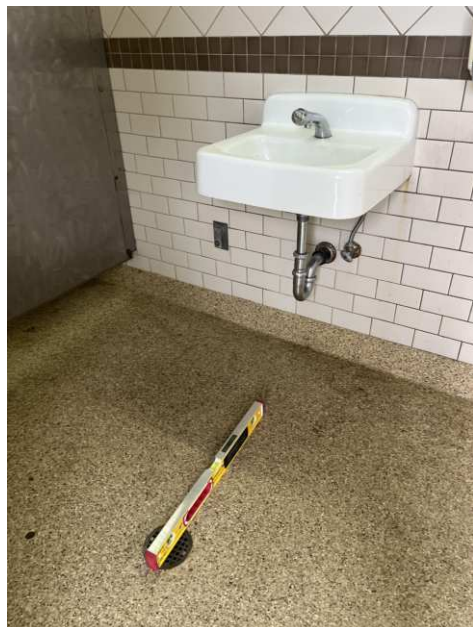
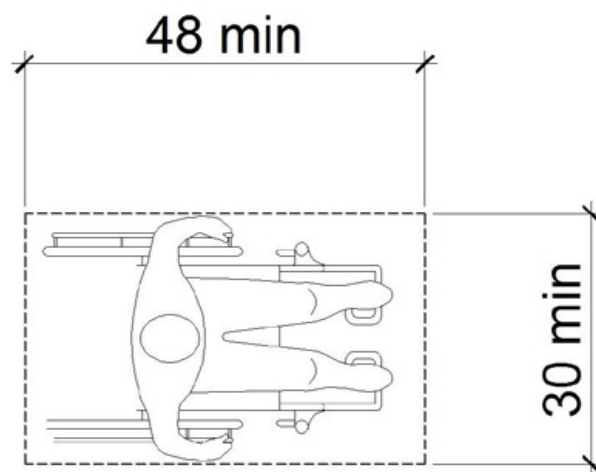
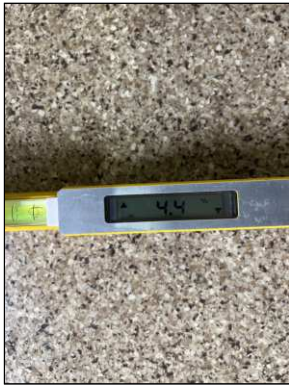
Finding: 40

not level floor space

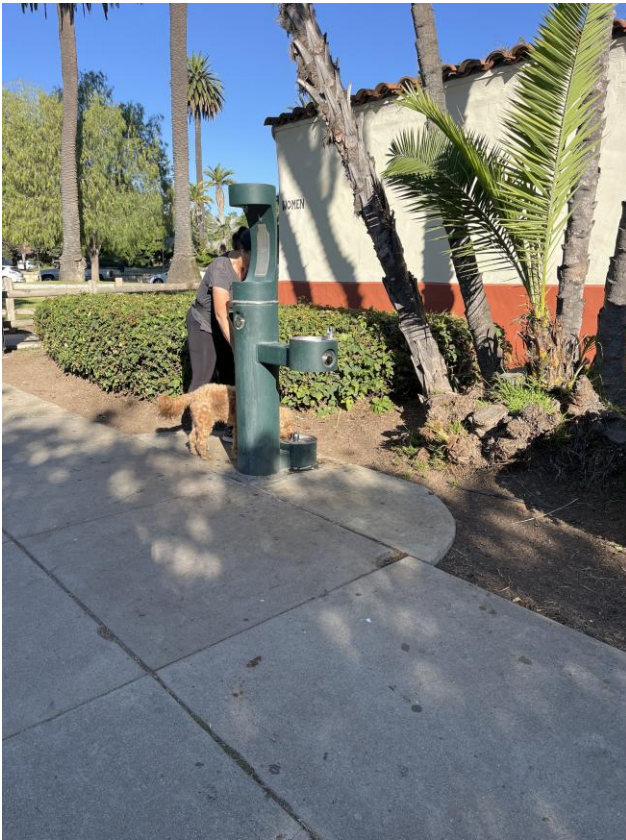
Finding: 42 (Continued)

There is no drinking fountain for standing persons.

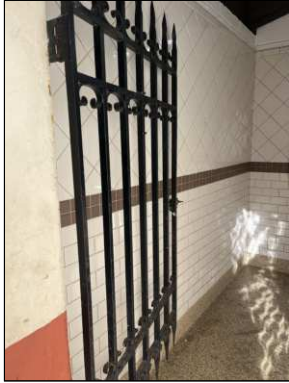
Finding: 44 Additional Finding Photos

The geometric sign for the men's room is missing.

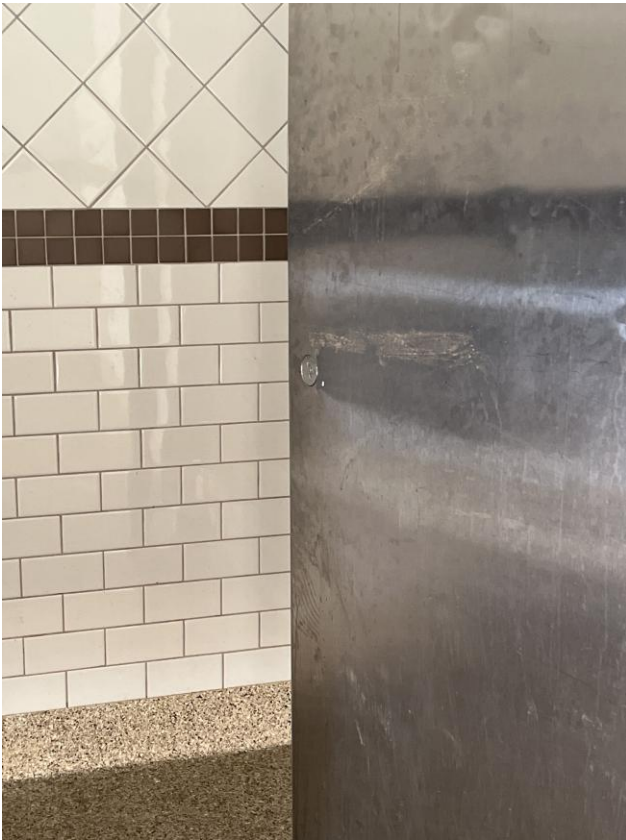
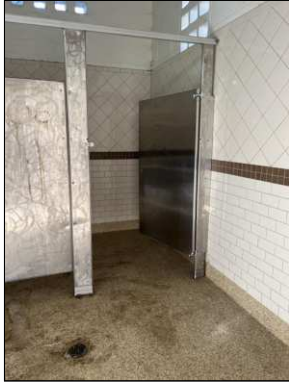
Finding: 47 (Continued)

The water closet compartment is missing a loop handle on both sides of the door.

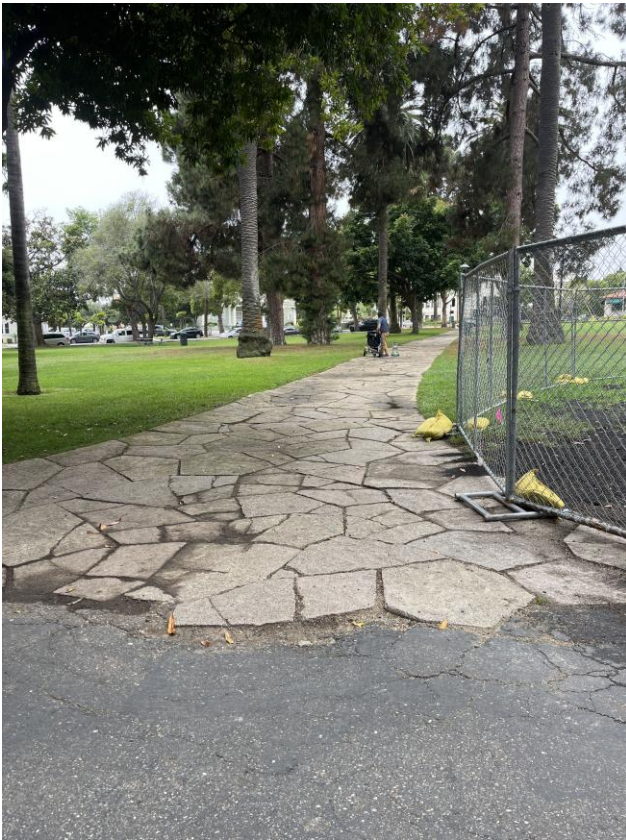
Finding: 51 (Continued)

The entrance is not accessible and is missing signage. An identification sign identifying that this entrance is not accessible and directional signage pointing to the accessible entrance is required.

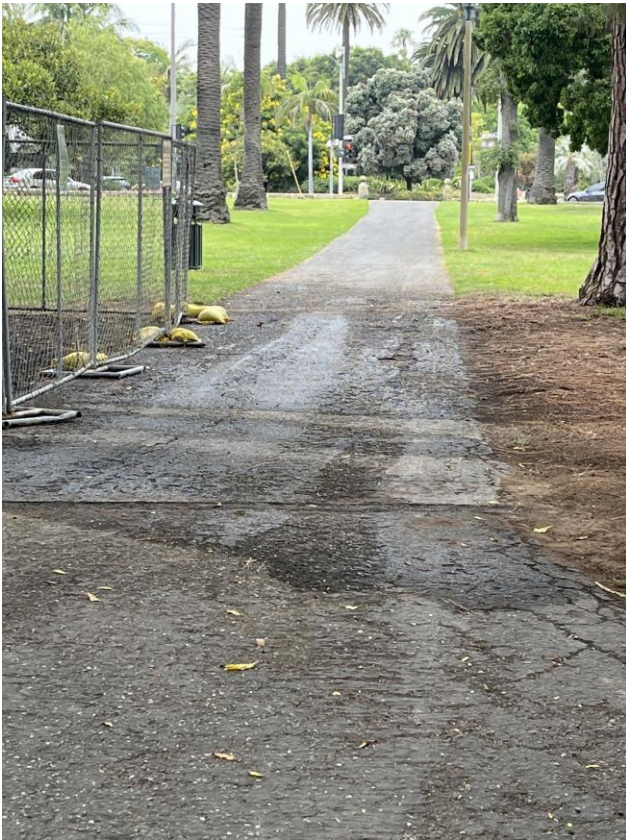
Finding: 53 (Continued)

The entrance is not accessible and is missing signage. An identification sign identifying that this entrance is not accessible and directional signage pointing to the accessible entrance is required.
