Bellosguardo Foundation (Clark estate)

July 10, 2022

ARBORIST FIELD REPORT for Clark Estate

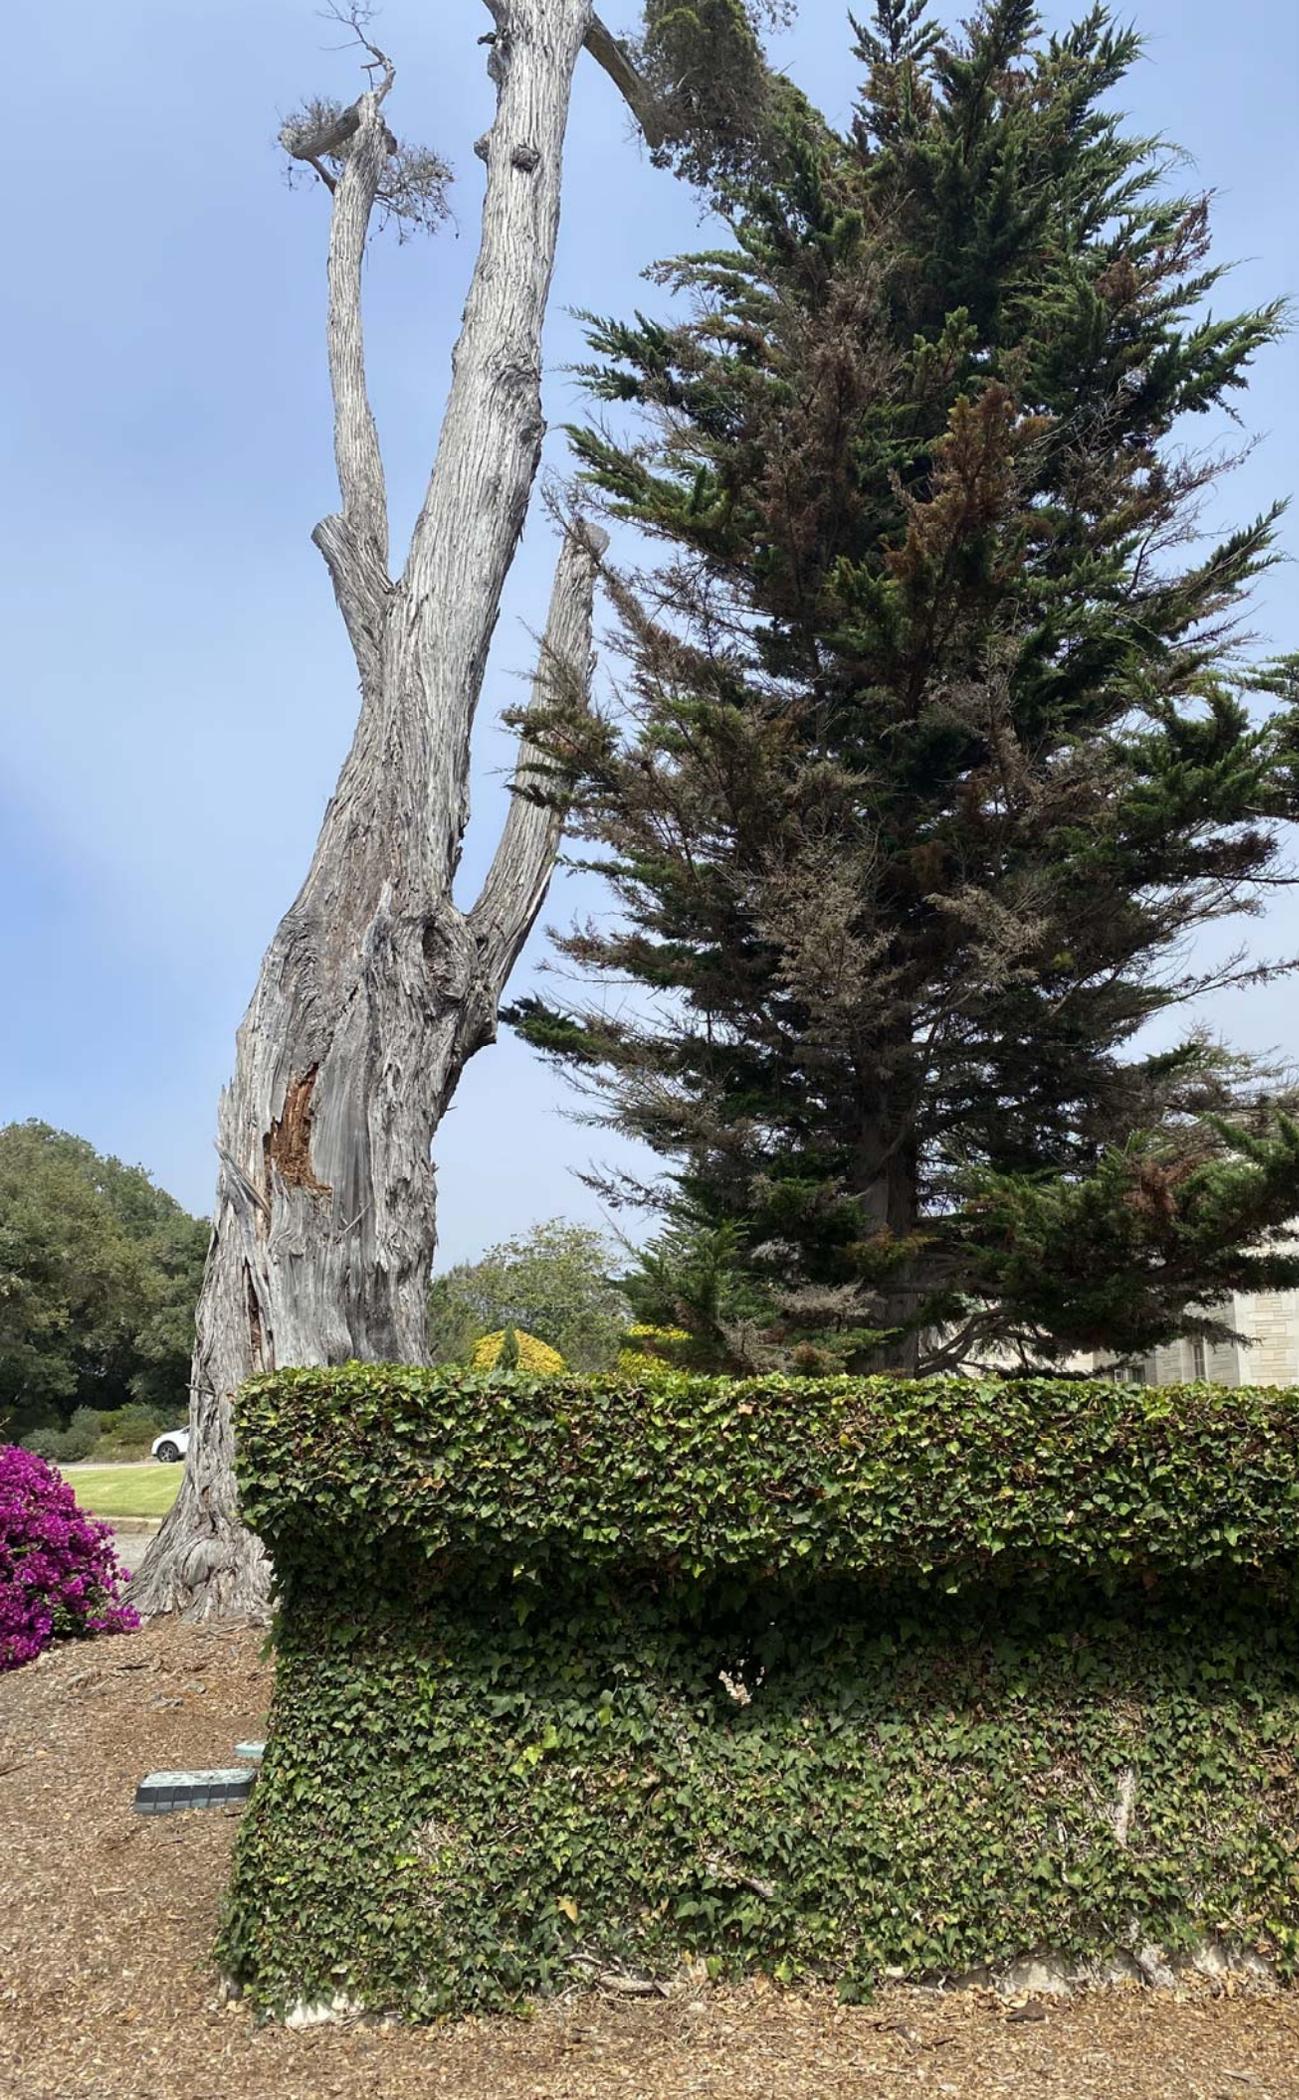
This old tree is close to death and will not recover. As the tree declines, so does the root system. Although the remaining tree is primarily a trunk, degrading roots predispose the tree to failure. Any person or vehicle would likely be crushed if the tree were to contact them.

Below left: Looking slightly southwesterly at the declining tree with the adjacent young cypress to the left.

- This tree will not recover and should be removed.
- Although it is statistically unlikely to fall at the exact moment that a person or vehicle is beneath it, there are no significant benefits to retaining the tree. There are multiple other habitat trees nearby on the site.

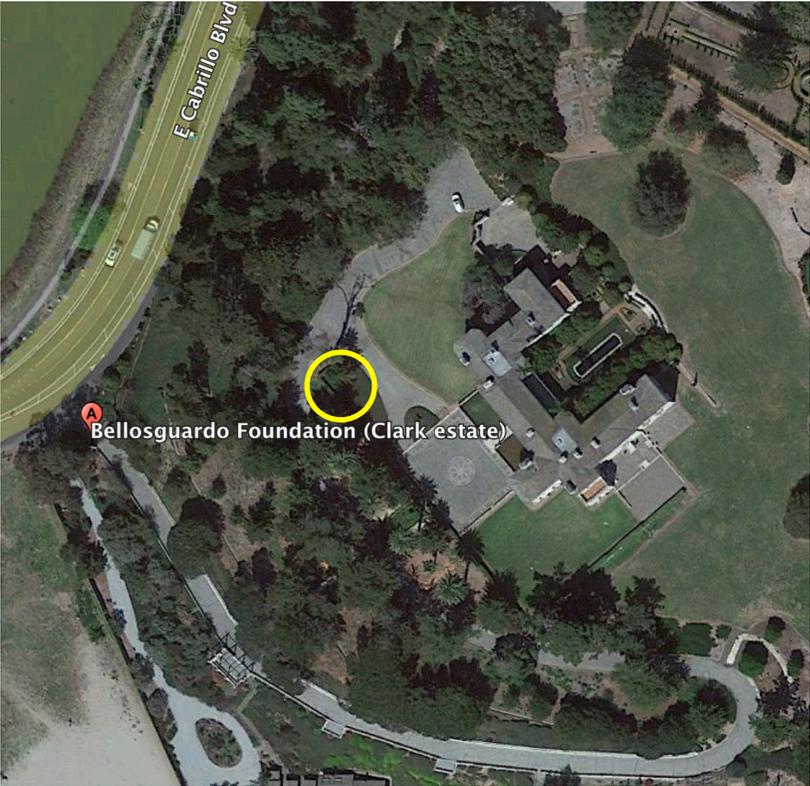
Left: Yellow circle indicates location of tree at northwestern section of property. Note underlying driveway and parking area.
