**July 2022**

*Location of Tree:* 624 E. De La Guerra Plaza/ 726 State St., Santa Barbara CA 93101

**Tree Species:** *Washingtonia robusta*, **Common Name:** Mexican Fan Palm

## **ARBORIST FIELD REPORT - Mexican Fan Palm at 726 State St.**

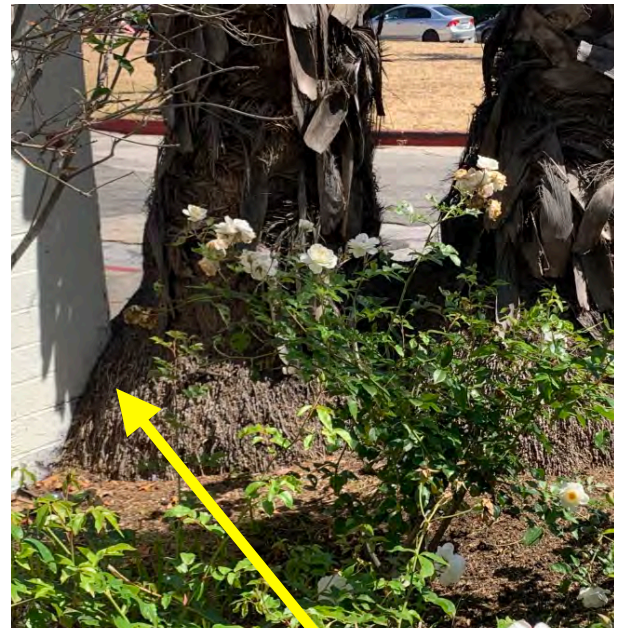
The RIZ extends  
more than 24" above  
the ground, blocks  
drainage and applies  
pressure to the  
building corner.

Also note damage to  
sidewalk (repaired  
with grinding)

- Remove the northern trunk of the palm as low as possible and then grind a portion of its stump below ground level to provide at least 24" of clearance from building.
- Every month, irrigate the remaining tree to moisten the soil to approximately 6"-12" below ground. Apply water at the base of the tree and extend approximately 6" outward. This should help the tree develop more roots.
- Removing the one trunk and portion of the stump will absolve the conflict between the tree and building and provide adequate support for the remaining trunk.
- Repair the concrete to change the flow of water away from the building corner.

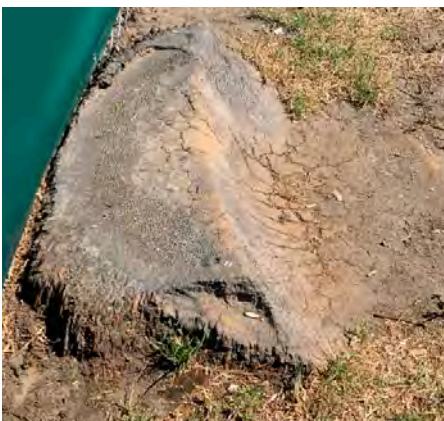
Lower right: Remove northern trunk and grind stump along dotted line, similar to palm stump below, in De La Guerra Plaza
