Santa Barbara Police Station Building Assessment Study

12/9/2010

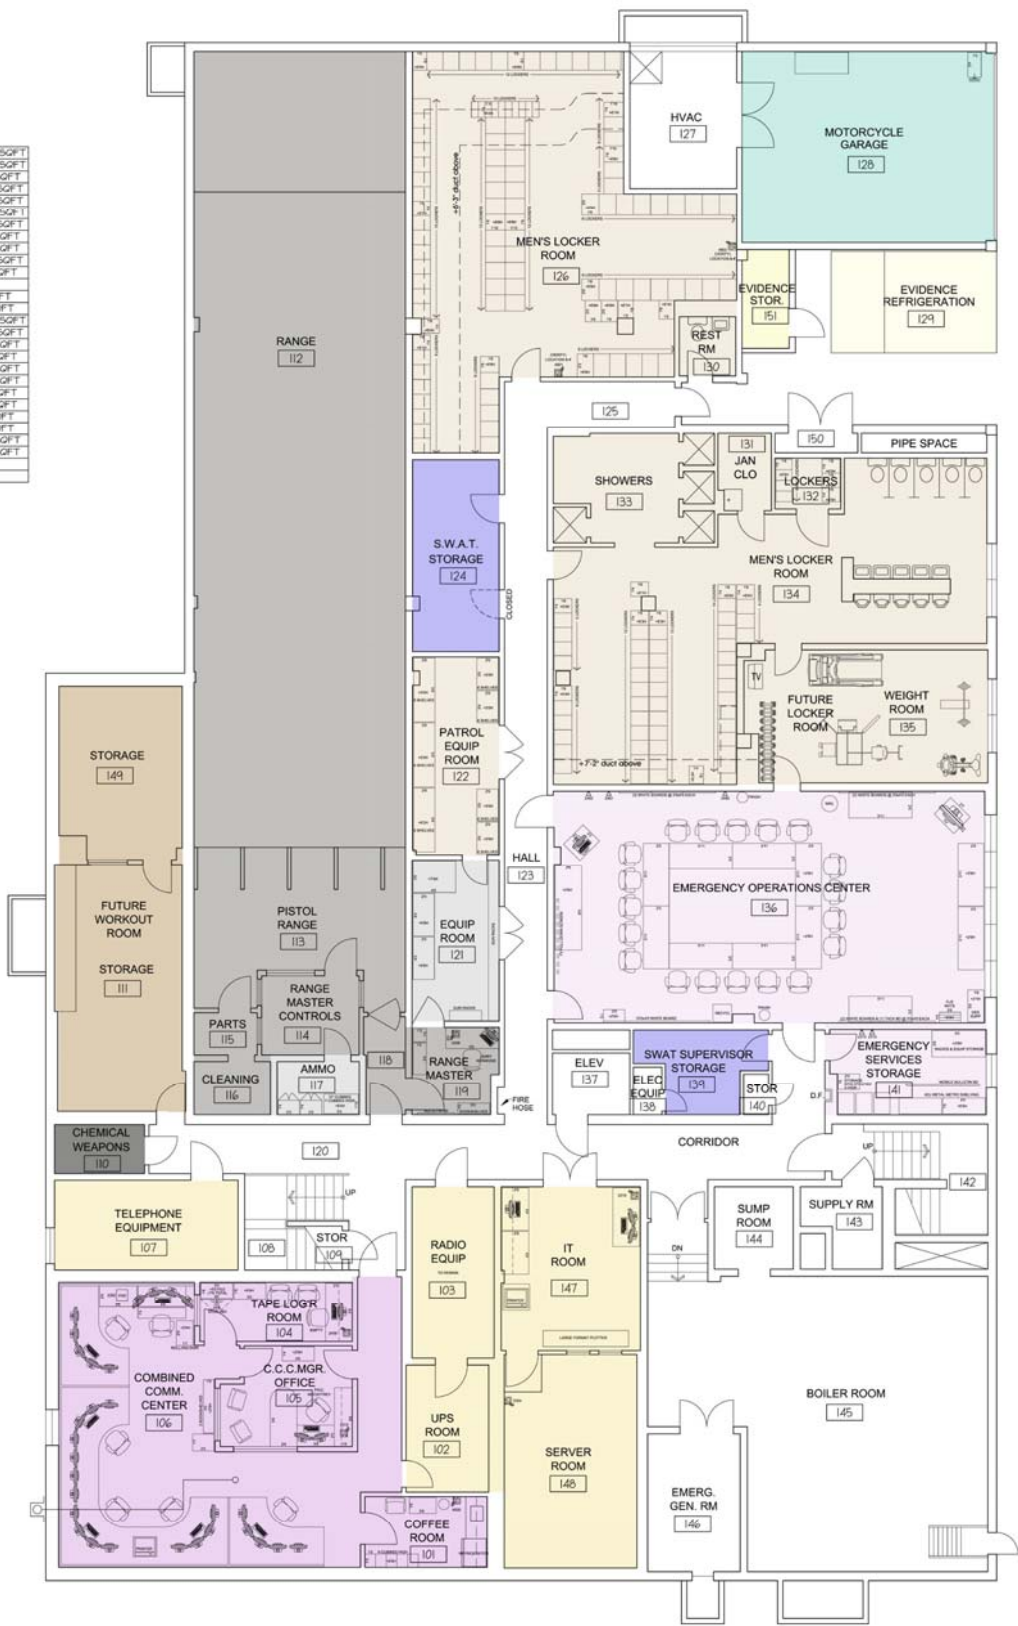
EXISTING
BASEMENT FLOOR PLAN
1

ROOM NAME	NET AREA
01 COFFEE ROOM	76 SQFT
02 UPS ROOM	42 SQFT
03 RADIO EQUIP	123 SQFT
04 TAPE LOG'R ROOM	80 SQFT
05 C.C.C. MGR. OFFICE	108 SQFT
06 COMBINED COMM. CENTER	617 SQFT
07 TELEPHONE EQUIPMENT	144 SQFT
08 STAIR	61 SQFT
09 STORAGE	15 SQFT
10 CHEMICAL WEAPONS	34 SQFT
11 STORAGE	275 SQFT
12 RANGE	1476 SQFT
13 PISTOL RANGE	266 SQFT
14 RANGE MASTER	48 SQFT
15 PARTS	24 SQFT
16 CLEANING	36 SQFT
17 APPO	34 SQFT
18 VESTIBULE	35 SQFT
19 RANGE MASTER	64 SQFT
20 CORRIDOR	425 SQFT
21 EQUIP ROOM	124 SQFT
22 PATROL EQUIP ROOM	149 SQFT
23 HALL	278 SQFT
24 S.W.A.T. STORAGE	145 SQFT
25 HALL	278 SQFT
26 MEN'S LOCKER ROOM	600 SQFT
27 HVAC	128 SQFT
28 MOTORCYCLE GARAGE	422 SQFT
29 EVIDENCE REFRIGERATION	147 SQFT
30 REST ROOM	24 SQFT
31 JAN CLO	35 SQFT
32 CLOSET	24 SQFT
33 SHOWERS	154 SQFT
34 MEN'S LOCKER ROOM	740 SQFT
35 WEIGHT ROOM	275 SQFT
36 EMERGENCY OPERATIONS CENTER	675 SQFT
37 ELEVATOR	42 SQFT
38 ELEC EQUIP	12 SQFT
39 SWAT SUPERVISOR STORAGE	76 SQFT

40 STOR	4 SQFT
41 EMERGENCY SERVICES STORAGE	115 SQFT
42 STAIRS	17 SQFT
43 SUPPLY ROOM	47 SQFT
44 SUPP ROOM	67 SQFT
45 BOILER ROOM	783 SQFT
46 EMERG GEN RM	200 SQFT
47 IT ROOM	248 SQFT
48 SERVER ROOM	181 SQFT
49 STORAGE	14 SQFT
50 CLOSET	41 SQFT
51 EVIDENCE STORAGE	
TOTAL	10,731 SQFT

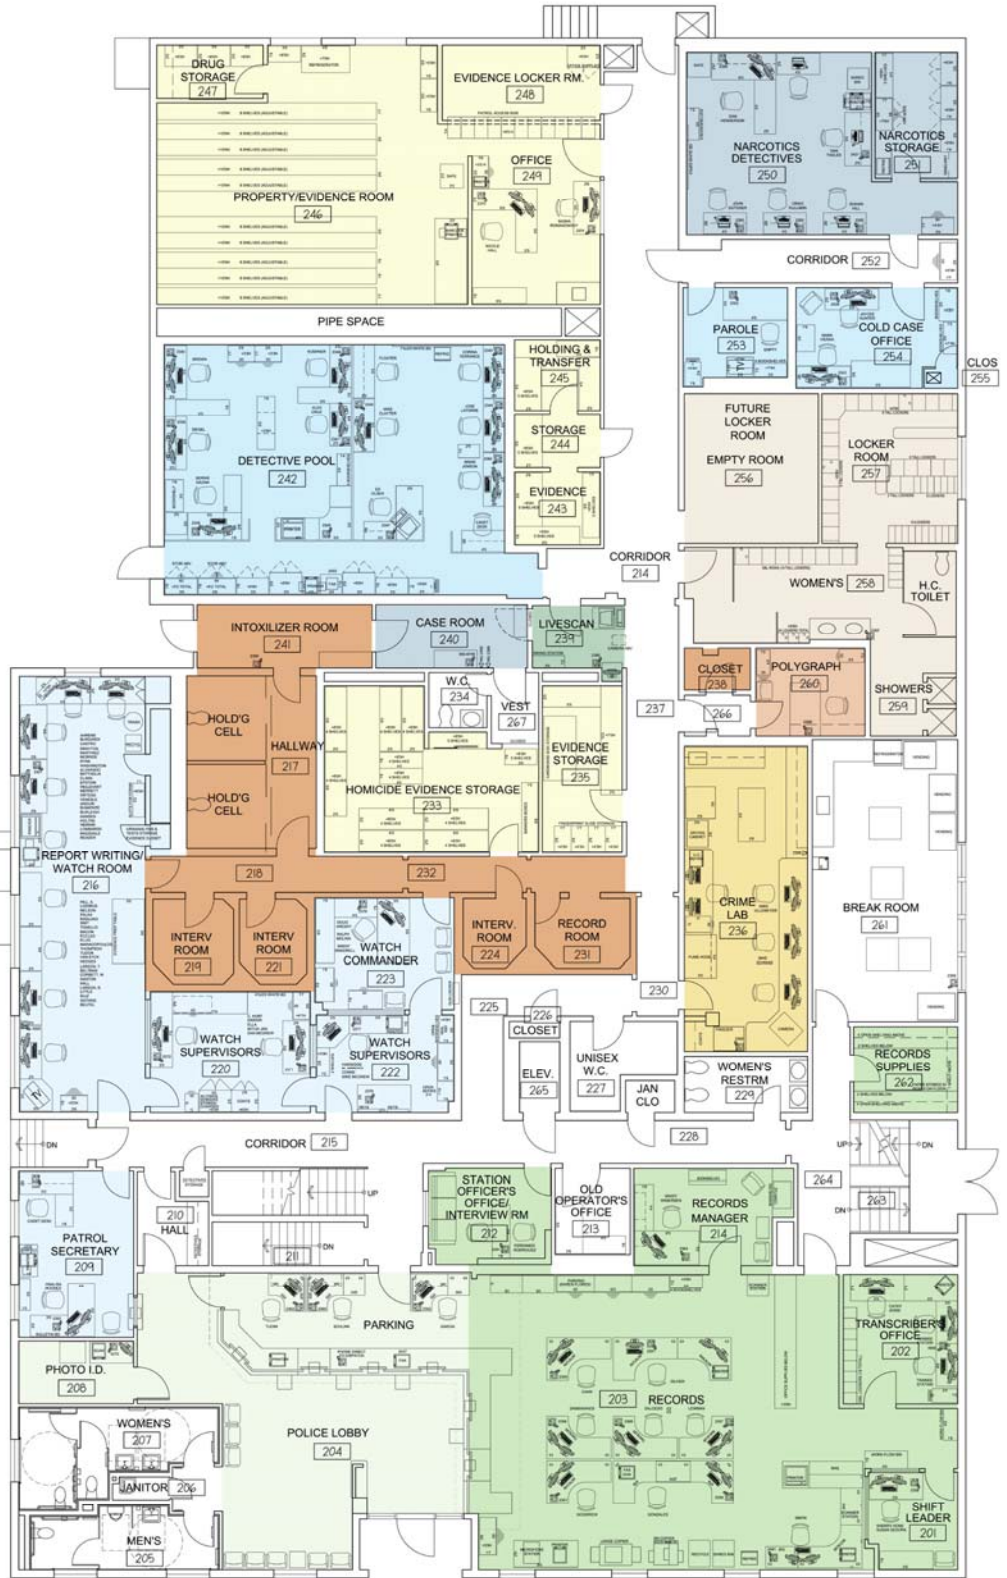
EXISTING
FIRST FLOOR PLAN

RTH	ROOM NAME	NET AREA
201	SHIFT LEADER	74 SQFT
202	TRANSCRIBER'S OFFICE	124 SQFT
203	RECORDS	1242 SQFT
204	POLICE LOBBY	467 SQFT
205	MEN'S ROOM	93 SQFT
206	JANITOR	11 SQFT
207	WOMEN'S ROOM	132 SQFT
208	PHOTO I.D.	45 SQFT
209	PATROL SECRETARY	166 SQFT
210	HALL	50 SQFT
211	STAIRS	58 SQFT
212	STATION OFFICER/INTERVIEW RM	56 SQFT
213	OLD OPERATOR'S OFFICE	57 SQFT
214	RECORDS MANAGER	135 SQFT
215	CORRIDOR	323 SQFT
216	REPORT WRITING/WATCH ROOM	156 SQFT
217	HOLDING CELLS	155 SQFT
218	CORRIDOR	80 SQFT
219	INTERVIEW ROOM	57 SQFT
220	WATCH SUPERVISORS	164 SQFT
221	INTERVIEW ROOM	46 SQFT
222	WATCH SUPERVISORS	117 SQFT
223	WATCH COMMANDER	135 SQFT
224	INTERVIEW ROOM	36 SQFT
225	CORRIDOR	160 SQFT
226	CLOSET	7 SQFT
227	UNISEX W.C.	66 SQFT
228	JAN CLO	14 SQFT
229	WOMEN'S RESTROOM	61 SQFT
230	CORRIDOR	43 SQFT
231	RECORD ROOM	65 SQFT
232	CORRIDOR	37 SQFT
233	HOMICIDE EVIDENCE STORAGE	258 SQFT
234	W.C.	26 SQFT
235	STORAGE	115 SQFT
236	CRIME LAB	328 SQFT

237	CORRIDOR	160 SQFT
238	CLOSET	23 SQFT
239	LIVESCAN	51 SQFT
240	CASE ROOM	84 SQFT
241	INTOXILIZER ROOM	97 SQFT
242	DETECTIVE POOL	758 SQFT
243	RAPE	52 SQFT
244	VEST	41 SQFT
245	HOLDING & TRANSFER	155 SQFT
246	PROPERTY/EVIDENCE ROOM	628 SQFT
247	DRUG STORAGE	49 SQFT
248	EVIDENCE LOCKER ROOM	103 SQFT
249	OFFICE	203 SQFT
250	NARCOTICS DETECTIVES	334 SQFT
251	NARCOTICS STORAGE	90 SQFT
252	CORRIDOR	83 SQFT
253	PAROLE	135 SQFT
254	COLD CASE OFFICE	135 SQFT
255	CL	6 SQFT
256	EMPTY ROOM	175 SQFT
257	LOCKER ROOM	177 SQFT
258	WOMEN'S ROOM	216 SQFT
259	WOMEN'S SHOWERS	73 SQFT
260	POLYGRAPH	84 SQFT
261	BREAK ROOM	95 SQFT
262	RECORDS STORAGE	78 SQFT
263	STAIRS	105 SQFT
264	CORRIDOR	49 SQFT
265	ELEV	25 SQFT
266	VEST	23 SQFT
267	VEST	29 SQFT
268	VEST	28 SQFT
TOTAL		10,082 SQFT

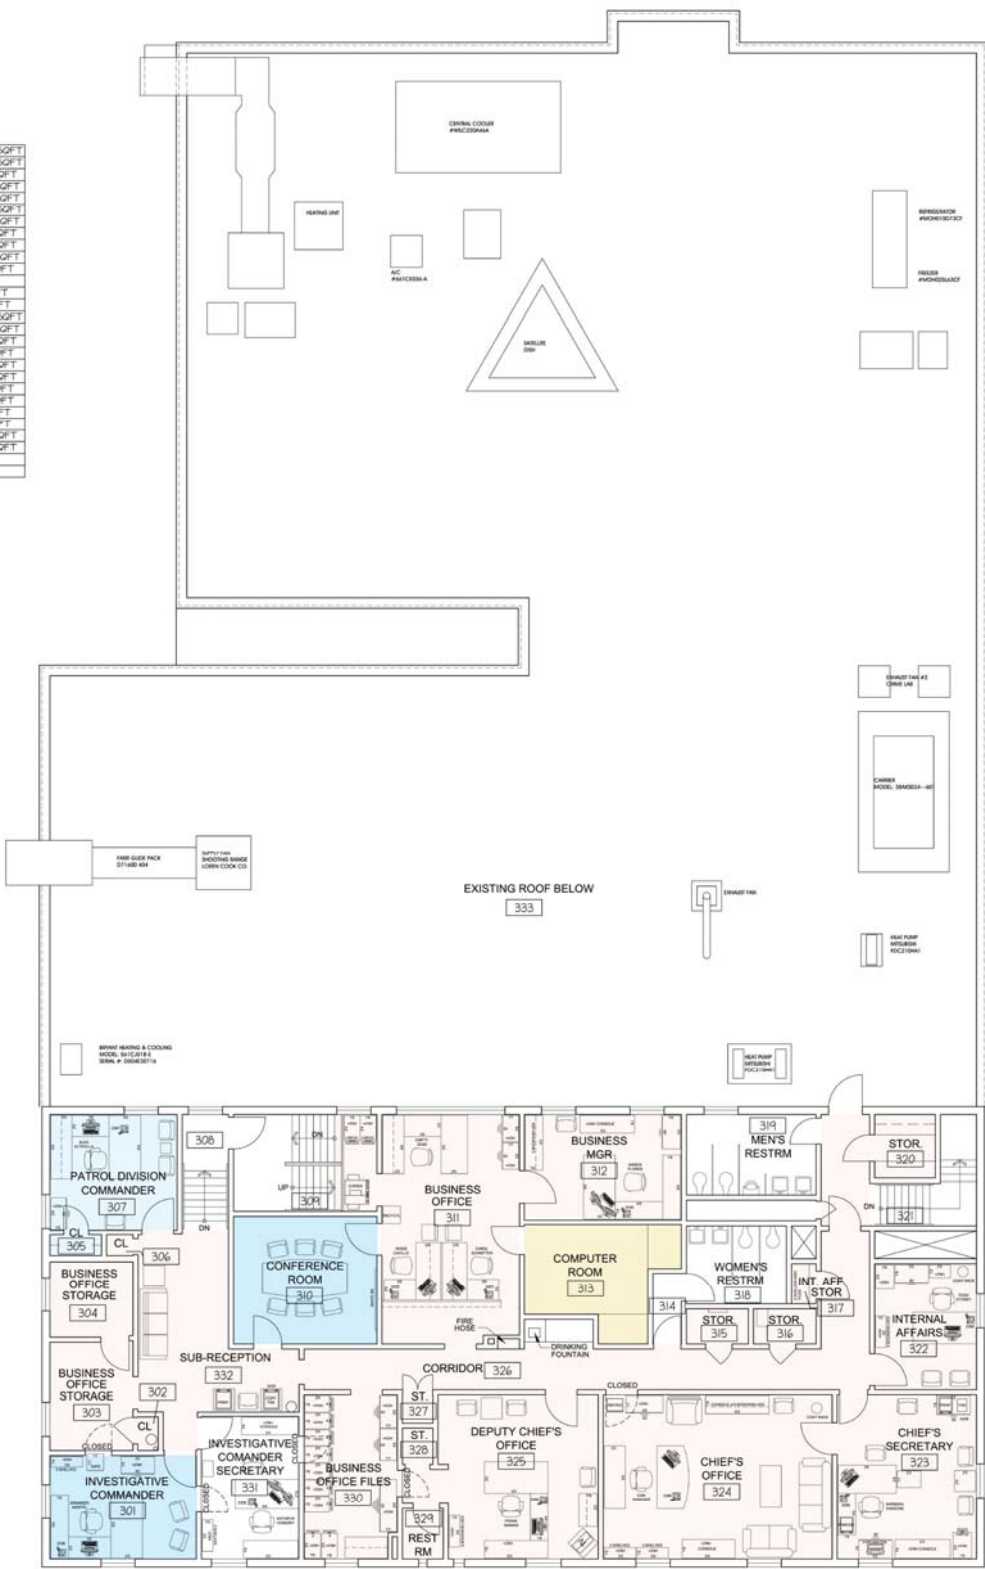
EXISTING
SECOND FLOOR PLAN

RPM	ROOM NAME	NET AREA
301	INVESTIGATIVE COMMANDER	136 SQFT
302	CL	6 SQFT
303	BUSINESS OFFICE STORAGE	50 SQFT
304	BUSINESS OFFICE STORAGE	56 SQFT
305	CL	10 SQFT
306	CL	9 SQFT
307	PATROL DIVISION COMMANDER	130 SQFT
308	STAIR	49 SQFT
309	STAIR	123 SQFT
310	CONFERENCE ROOM	164 SQFT
311	BUSINESS OFFICE	274 SQFT
312	BUSINESS MGR	147 SQFT
313	COMPUTER ROOM	126 SQFT
314	VEST	65 SQFT
315	STOR	20 SQFT
316	STOR	20 SQFT
317	STOR	41 SQFT
318	MEN'S RESTRM	70 SQFT
319	MEN'S RESTRM	42 SQFT
320	STOR	34 SQFT
321	STAIR	63 SQFT
322	INTERNAL AFFAIRS	195 SQFT
323	CHIEF'S SECRETARY	204 SQFT
324	CHIEF'S OFFICE	336 SQFT
325	DEPUTY CHIEF'S OFFICE	240 SQFT
326	CORRIDOR	275 SQFT
327	ST	10 SQFT
328	ST	10 SQFT
329	REST RM	14 SQFT
330	BUSINESS OFFICE FILES	135 SQFT
331	INVEST. COMMANDER SEC.	125 SQFT
332	SUB-RECEPTION	146 SQFT
333	EXISTING ROOF BELOW	1757 SQFT
	TOTAL (NOT INCLUDING ROOF)	3351 SQFT

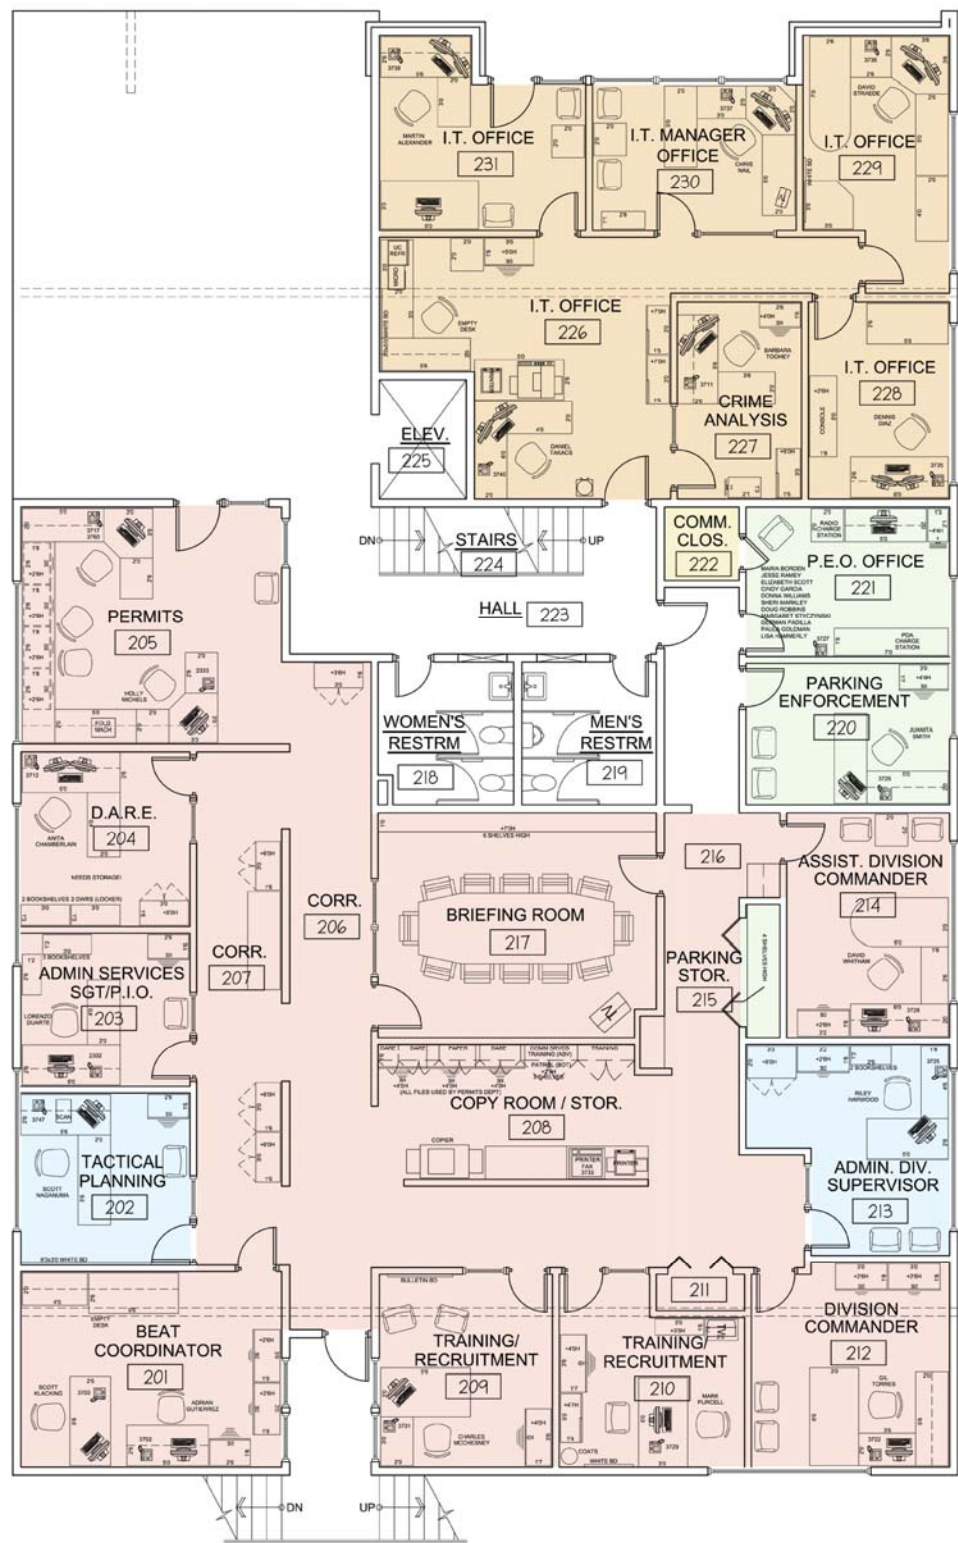
1 EXISTING ANNEX FIRST FLOOR PLAN

COLOR	DEPARTMENT NAME	SIZE
A	ADMINISTRATIVE STAFF	2395 SQFT
B	ADMINISTRATIVE SERVICES	2472 SQFT
C1	PARKING DEPARTMENT	1015 SQFT
C2	RECORDS DEPARTMENT	1526 SQFT
D	DETECTIVES	1894 SQFT
E	PATROL / WATCH COMMAND	2245 SQFT
F	EMERGENCY OPERATIONS CENTER	1004 SQFT
G	CRIME LAB	328 SQFT
H	HOLDING CELLS	767 SQFT
I	PROPERTY/EVIDENCE	1575 SQFT
J	NARCOTICS DETECTIVES	515 SQFT
K	FURNITURE STORED LONG-TERM	
L	LIVESCAN	51 SQFT
M	POLYGRAPH	64 SQFT
N	MEN AND WOMEN'S LOCKER ROOMS	2424 SQFT
O	FIRING RANGE	1946 SQFT
P	MOTORCYCLE PARKING	404 SQFT
Q	SWAT LOCKER/ARTORY/WEAPONS	221 SQFT
R	WORKOUT/HEIGHT ROOM	462 SQFT
S	RADIO RM/IT/SERVER/TELE/COMM	993 SQFT
T	911 CALL CENTER	819 SQFT
U	REFRIGERATED EVIDENCE STORAGE	147 SQFT
V	CHEMICAL WEAPONS	34 SQFT
W	FIREARMS/AMMUNITION	34 SQFT
X	I.T. DEPARTMENT	1183 SQFT
Y	BICYCLE STORAGE/MAINTENANCE	792 SQFT
Z	EXTERIOR PROPERTY STORAGE	
AA	VEHICLE COUNT

RM#	ROOM NAME	NET AREA
201	BEAT COORDINATOR	192 SQFT
202	TACTICAL PLANNING	109 SQFT
203	ADMIN SERVICES SGT	98 SQFT
204	D.A.R.E. OFFICE	112 SQFT
205	PERMITS	261 SQFT
206	CORRIDOR	180 SQFT
207	CORRIDOR	165 SQFT
208	COPY ROOM/STORAGE	215 SQFT
209	TRAINING/RECRUITMENT	126 SQFT
210	TRAINING/RECRUITMENT	119 SQFT
211	STORAGE	279 SQFT
212	DIVISION COMMANDER	150 SQFT
213	ADMIN DIV SUPERVISOR	136 SQFT
214	ASSIST DIV COMMANDER	138 SQFT
215	PARKING STORAGE	17 SQFT
216	HALLWAY	260 SQFT
217	BRIEFING ROOM	234 SQFT
218	WOMEN'S RESTRM	65 SQFT
219	MEN'S RESTRM	72 SQFT
220	PARKING ENFORCEMENT	108 SQFT
221	PARKING PEO	115 SQFT
222	COMM. CLOS.	20 SQFT
223	OPEN CORRIDOR	153 SQFT
224	OPEN STAIRS	52 SQFT
225	ELEVATOR	39 SQFT
226	I.T. OFFICE	281 SQFT
227	CRIME ANALYSIS	93 SQFT
228	I.T. OFFICE	105 SQFT
229	I.T. OFFICE	128 SQFT
230	I.T. OFFICE	114 SQFT
231	I.T. OFFICE	129 SQFT
TOTAL		4265 SQFT

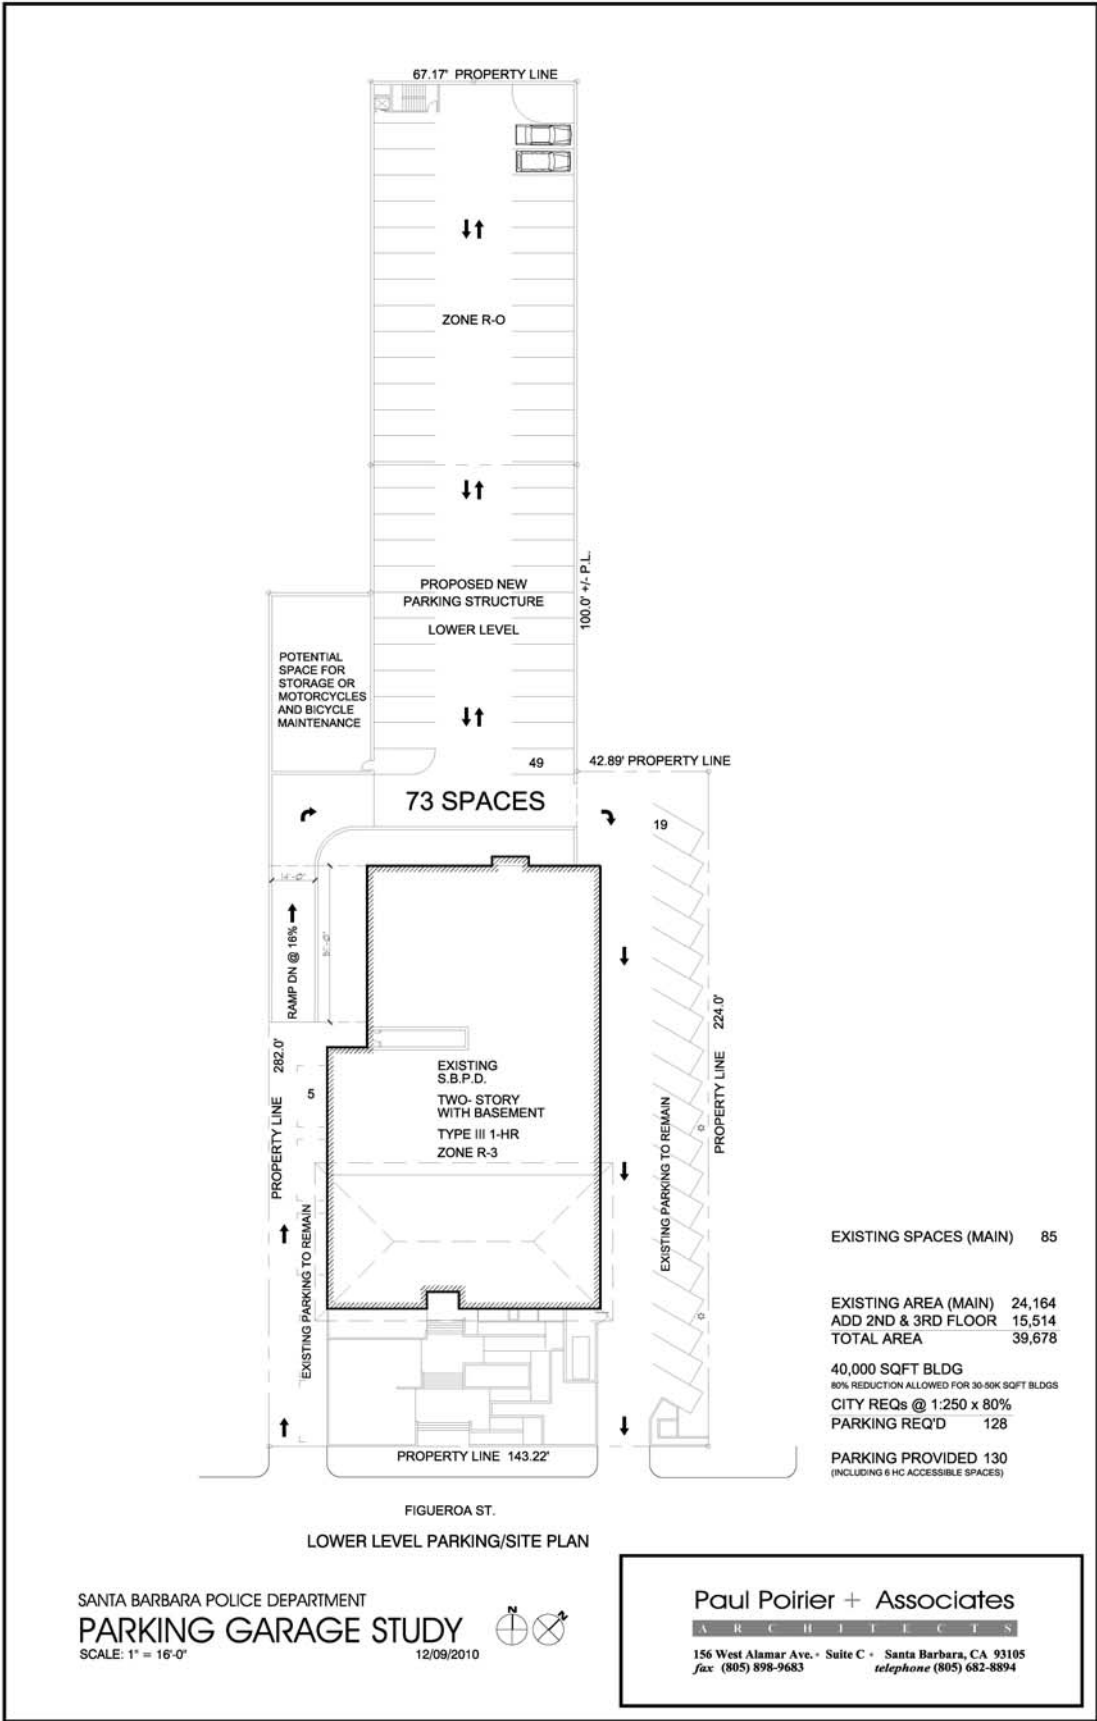
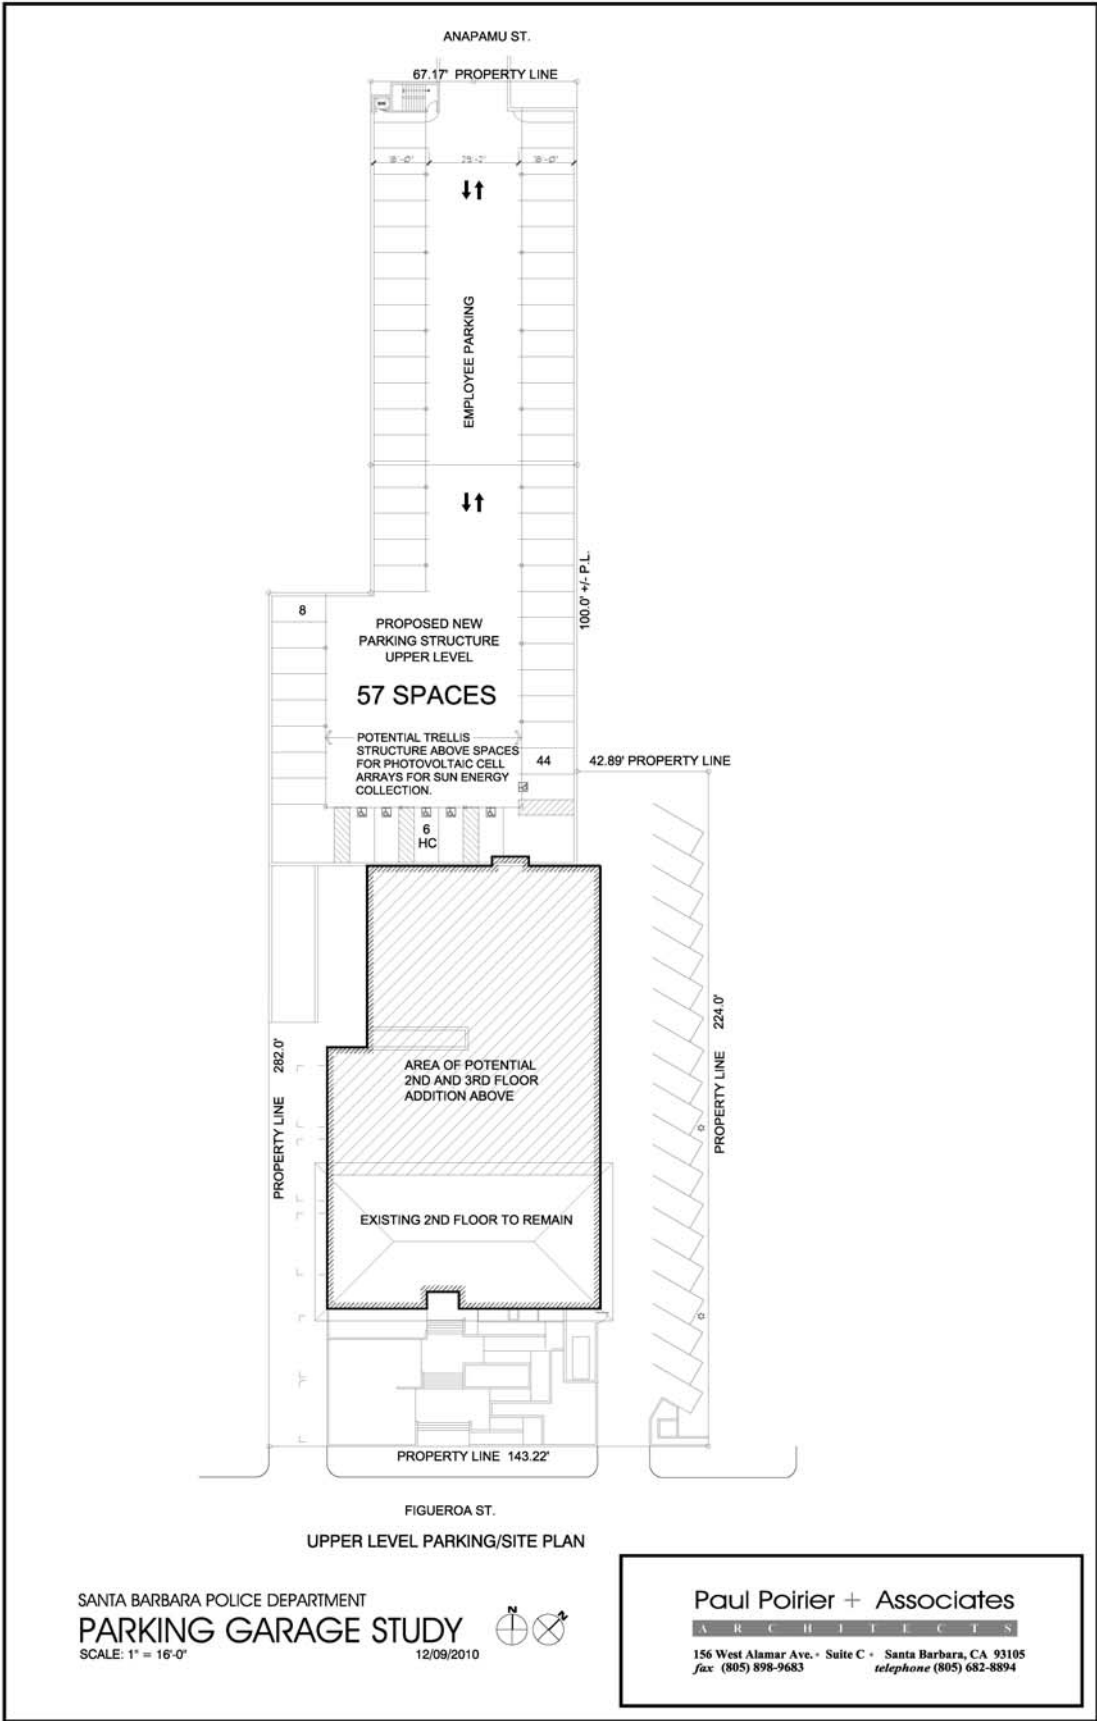
See attached for existing on site parking and proposed parking structure layouts.
