8.1 DETERMINING CREEK TOP OF BANK

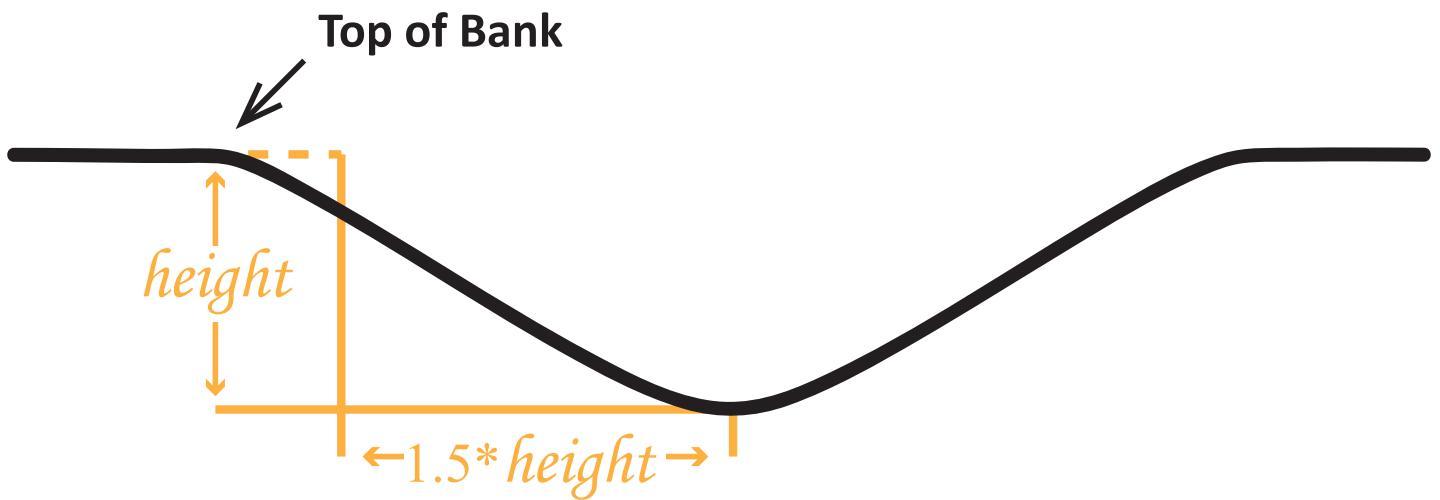
Case 1: Bank Slopes with a Single Defined Hinge Point

Case 1. *Bank Slopes with a Single Defined Hinge Point.* Case 1 occurs where the creek has a sloped bank rising from the toe of the bank to a hinge point at the generally level upper ground. The hinge point is the "top of bank." If the FEMA

100-year flood surface elevation is higher than the top of bank, the location of the top of bank does not change and is the hinge point. If the existing slope of the bank is steeper than 1.5 (horizontal):1 (vertical), the intersection of a projected plane with a 1.5:1 slope from the toe of bank to the generally level upper ground is the “top of bank.”

Case where existing slope of the bank is less steep than 1.5 (horizontal) : 1 (vertical)

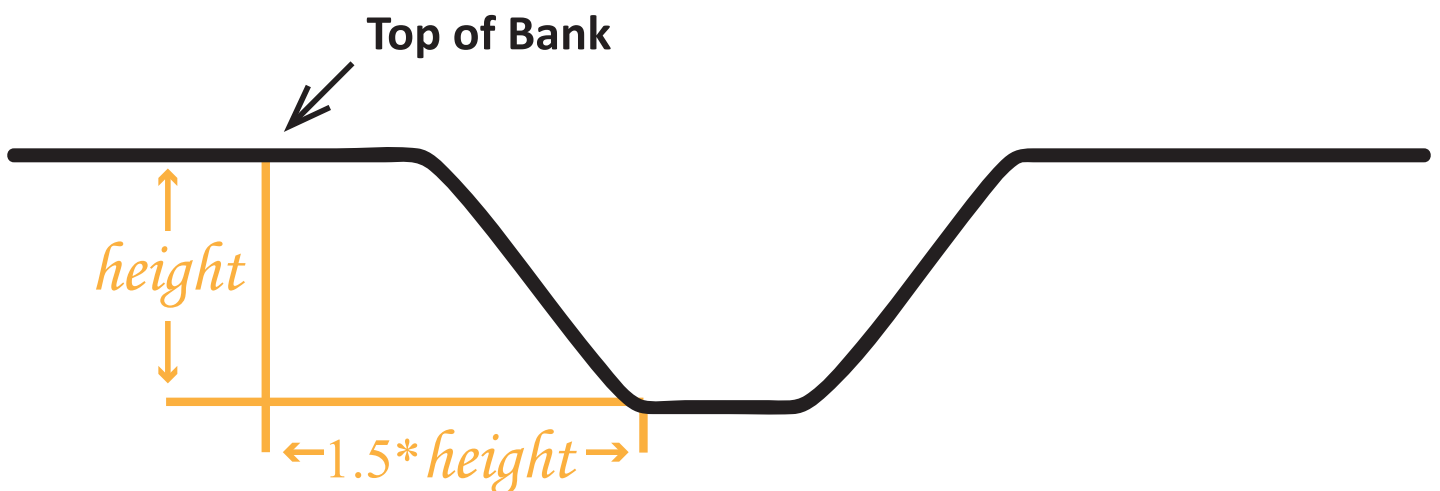
Case where existing slope of the bank is steeper than 1.5 (horizontal) : 1 (vertical)

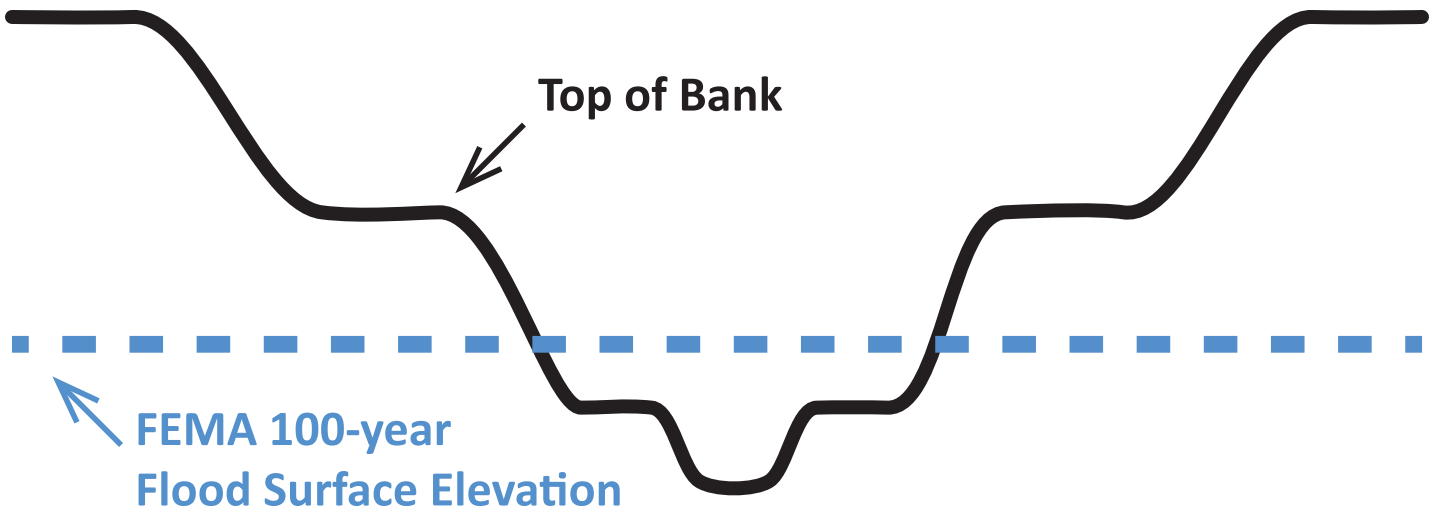
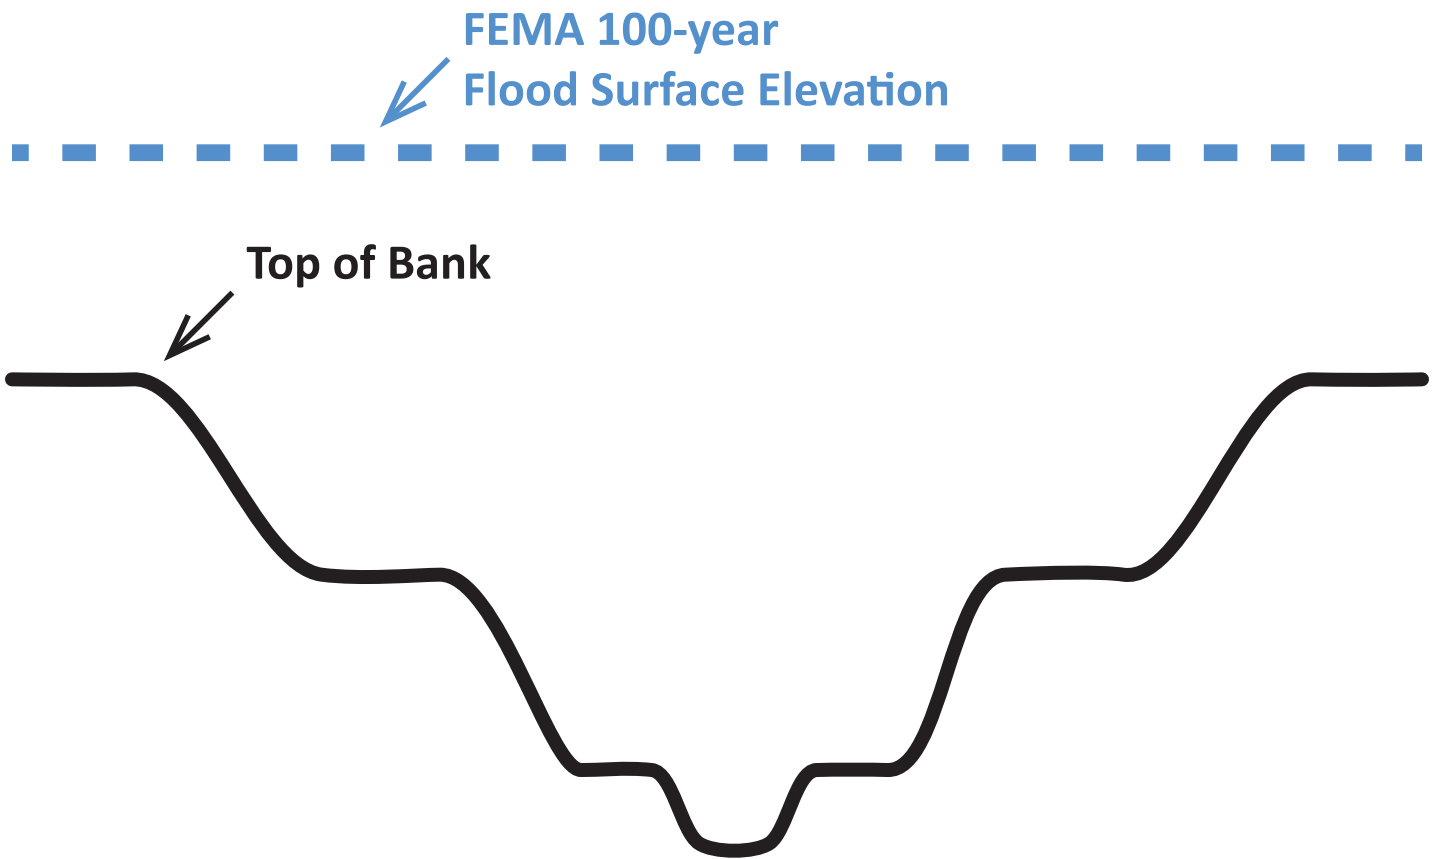
Case 2: Bank Slopes with Multiple Hinge Points

Case 2. *Bank Slopes with Multiple Hinge Points.* Case 2 occurs where the creek bank slope rises from the toe of the bank, levels off one or more times, then rises to a hinge point at the generally level upper ground. In this case, the hinge point at or directly above the FEMA 100-year flood surface elevation is the “top of bank.” If the FEMA 100-year flood surface elevation is above the highest hinge point, the location of the top of bank does not change and is the highest hinge point.
